Evaluation of Erosion of the Dummy “EE” Plate 19 in YA Type ATR Fuel Element During Reactor PALM Cycles

August 2016

Advanced Test Reactor

INL/EXT-16-38324
Revision 0

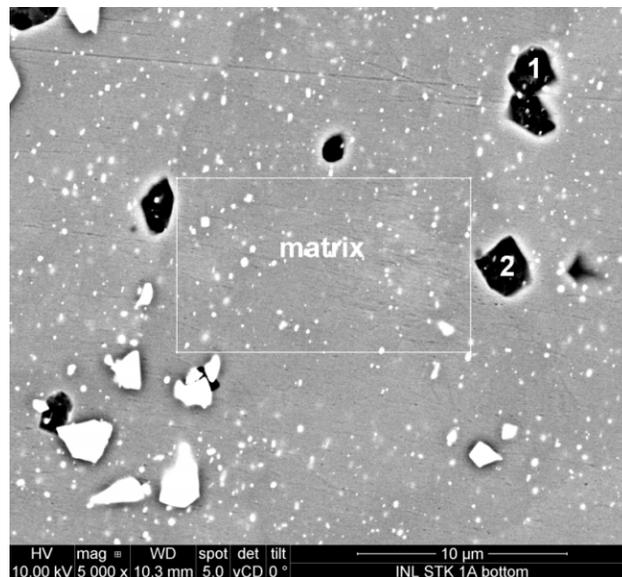
Figure 11. Typical microstructure of AA6061 “dummy” plate: saturated Al-based solid solution, particles of Mg_2Si (dark, 1 and 2), and white particles of Fe-bearing phases such as Al_3Fe , Al_5FeSi , etc. (our data).

According to Figure 11, particles of Mg_2Si , Al_3Fe , Al_5FeSi etc. were found in samples of the dummy sheet. In general, a number of different phases may form in the Al-Mg-Si-Fe system (“mimicking” alloy 6061 to a certain extent), including saturated solid solution (Al), Mg_2Si in different forms, Al_3Fe , Al_5FeSi , Al_8Mg_5 , etc. Clearly, this alloy, similar to any industrial alloys, is characterized

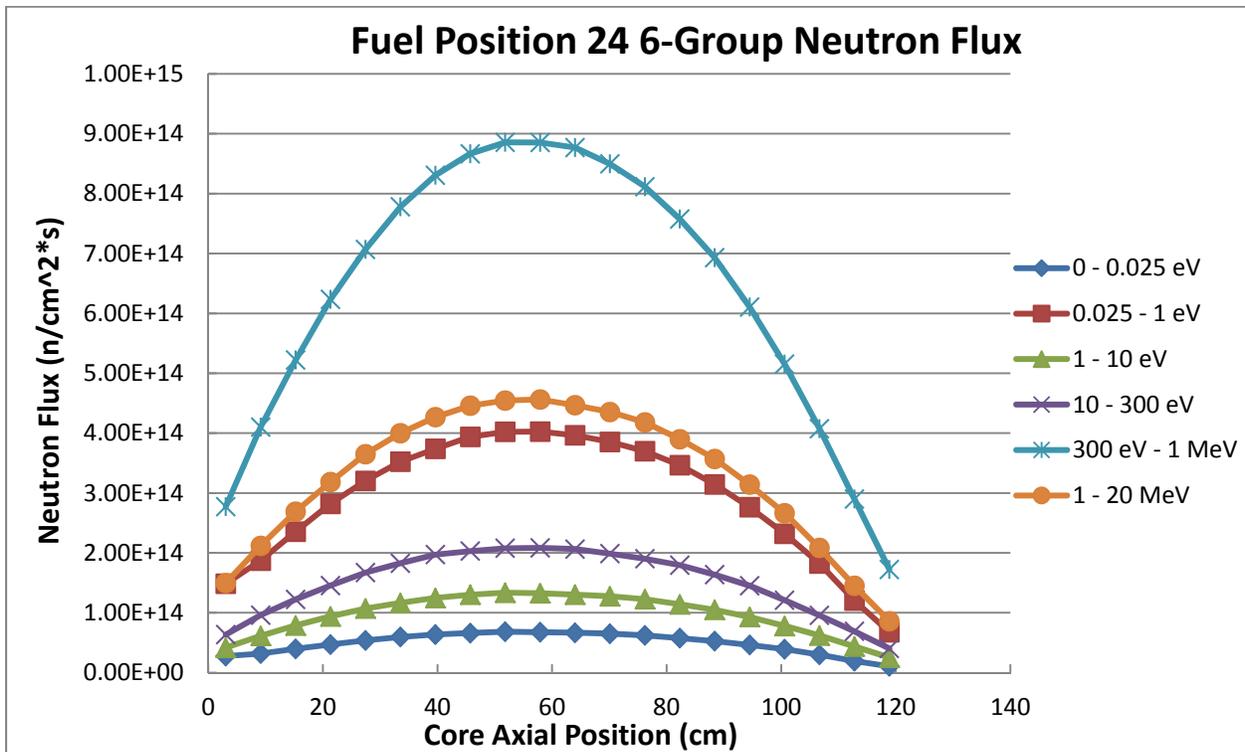
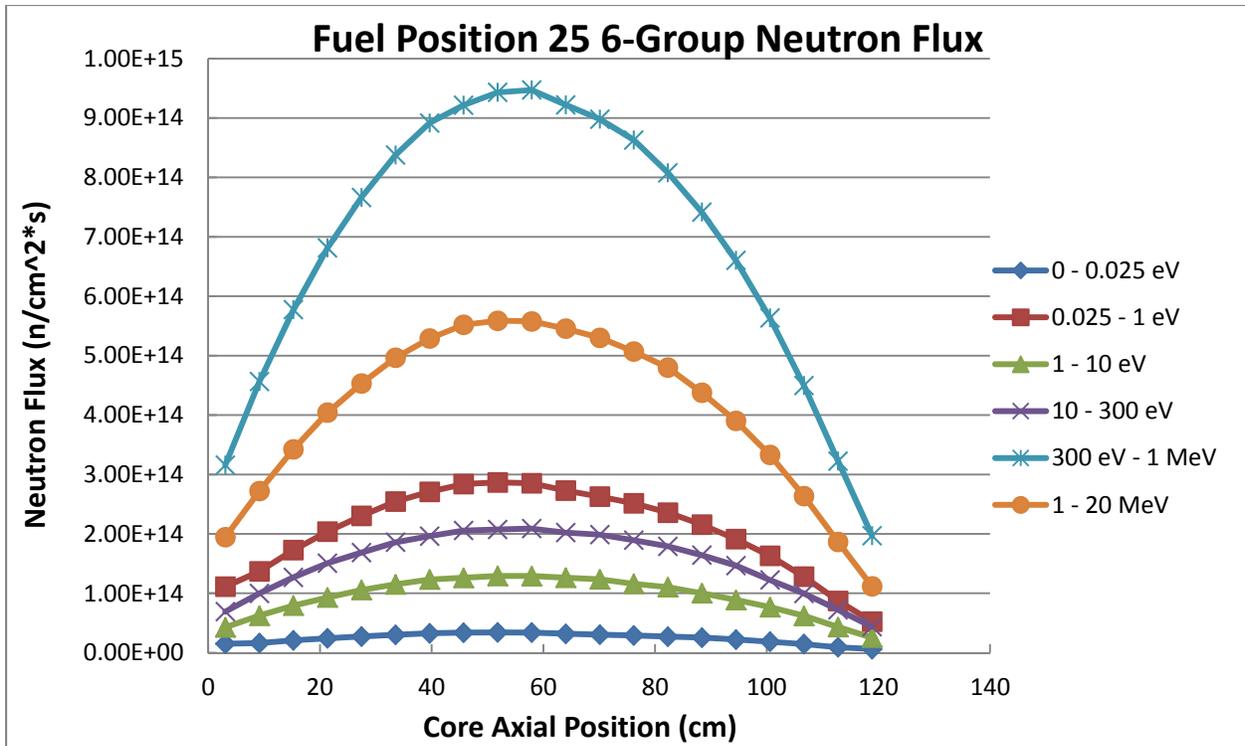
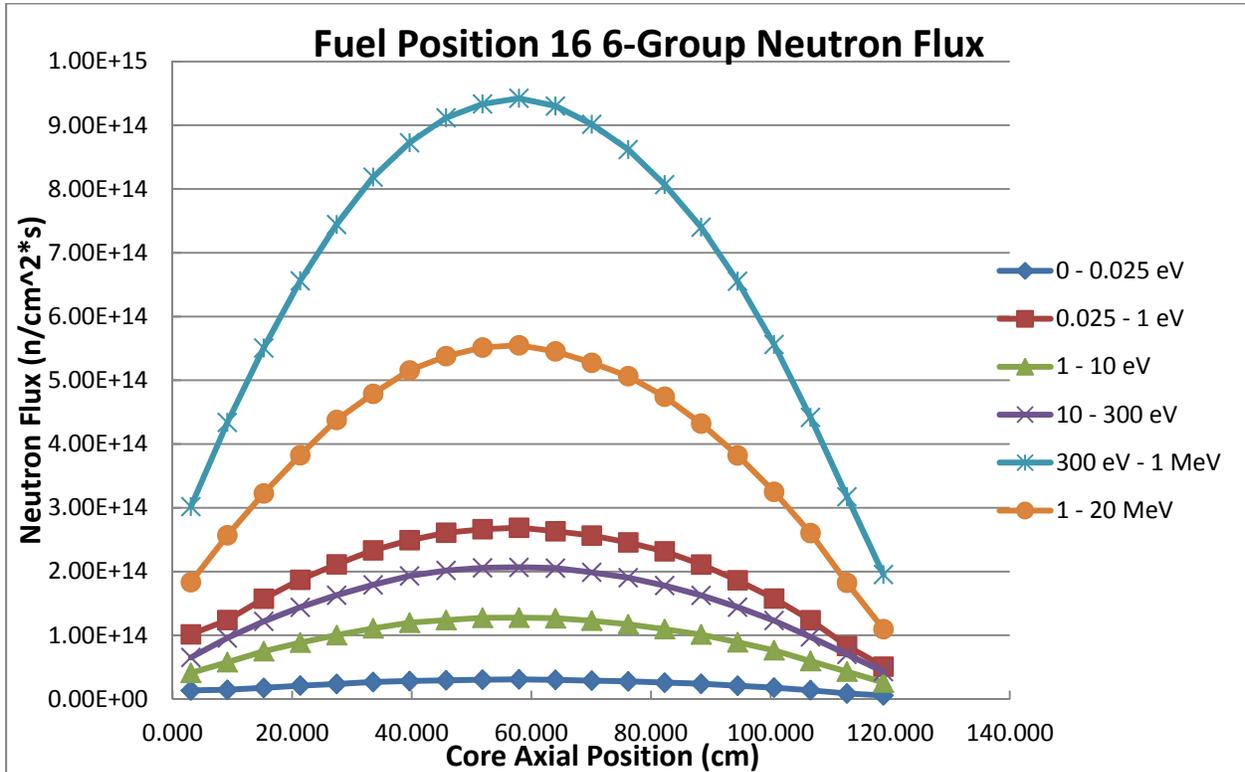
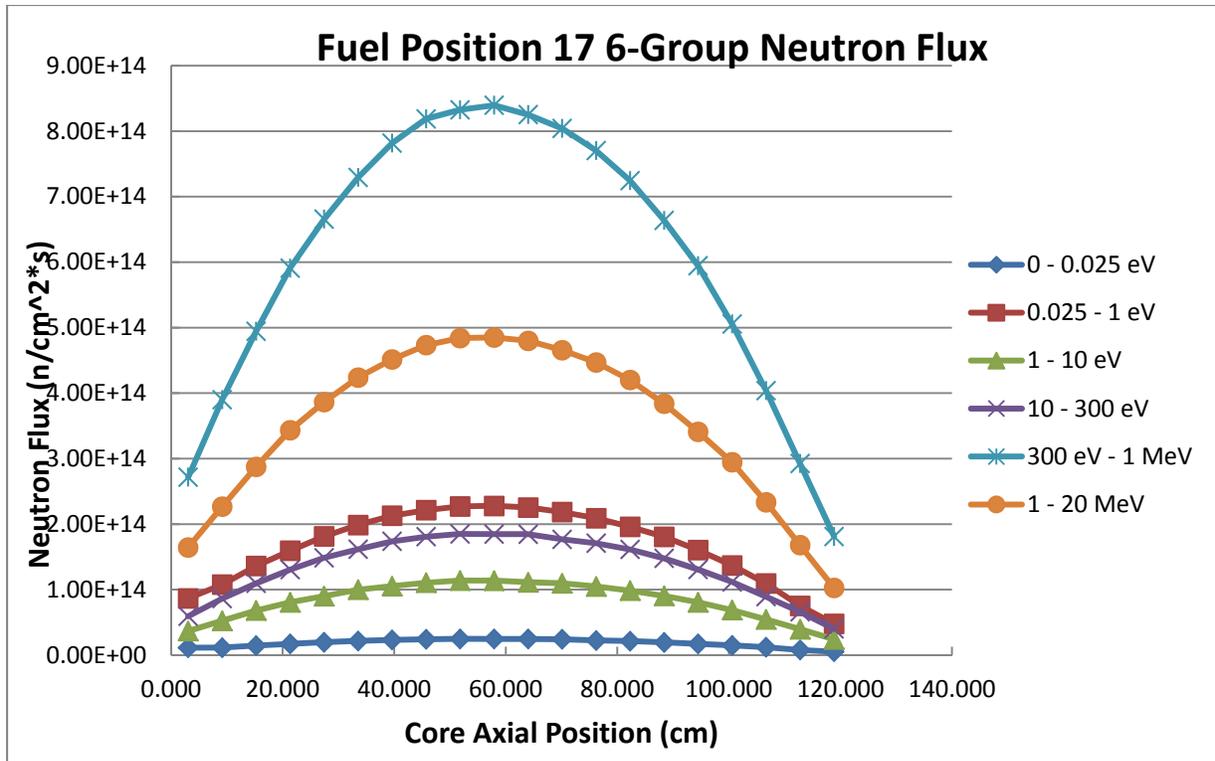
The maximal values of the neutron flux were realized in the central part(s) of the corresponding elements, which may contribute to the observed corrosion/erosion described in Section 1 of this Report.

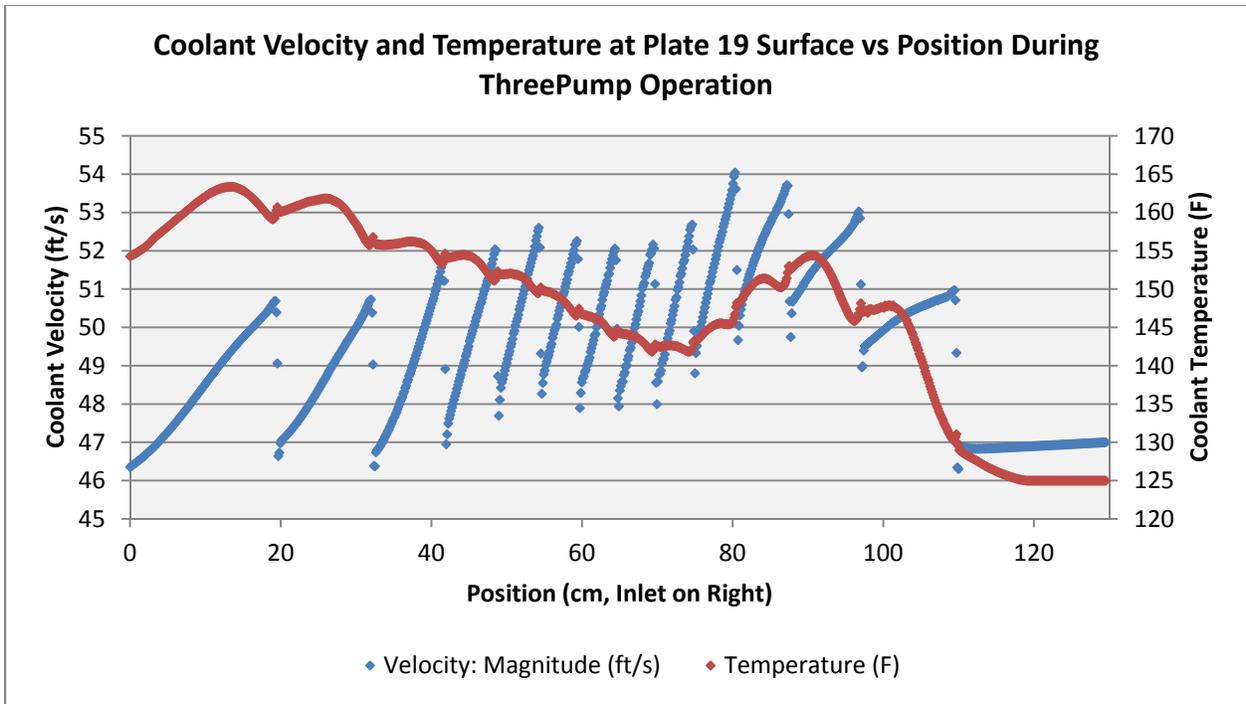
Initial results of the thermo-hydraulic model indicated that at each of the stress-relief cuts a large velocity discontinuity occurs, resulting in a sharp increase and subsequent drop-off in coolant velocity. Additionally, the temperature profile at the plate face was not the expected linear increase; two distinct maxima are present near the top and bottom of the coolant channel. Specifically, these maxima are 1) just before the third cut, and 2) just after the last, or 13th, cut. The results of this standard case are shown in Figure 24.

Figure 24. Cycle 153B; Coolant velocity and temperature vs position for three primary coolant pumps in Coolant Channel 20.

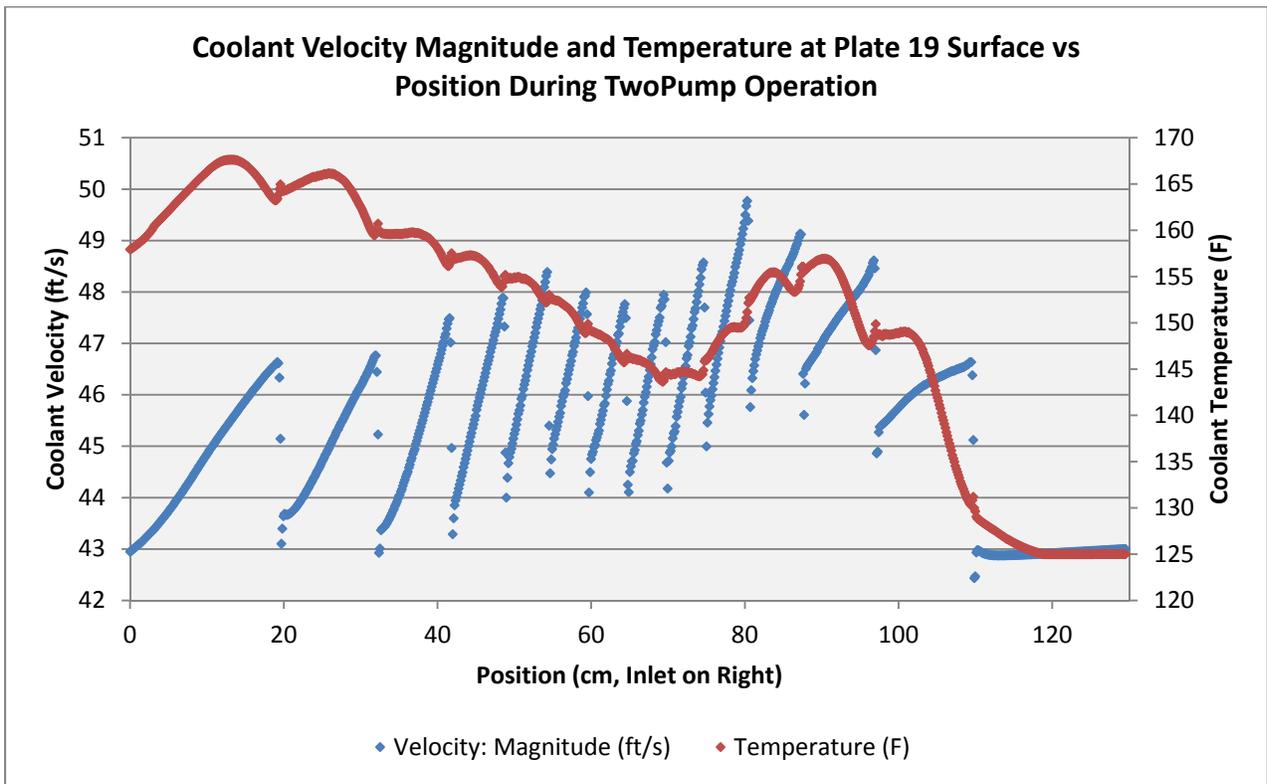
A second case was run using the same parameters but reducing the inlet velocity to two-pump operation (43 ft/s) to investigate the velocity and temperature profiles. Figure 25 shows the results of the two-pump operation with nearly identical results. The main difference between two and three pump operation is the coolant velocity magnitude, as expected. The slight reduction in flow resulted in slightly higher temperatures with all other input parameters held constant.

Figure 25. Cycle 153B; Coolant velocity and temperature vs position for two primary coolant pumps in Coolant Channel 20.

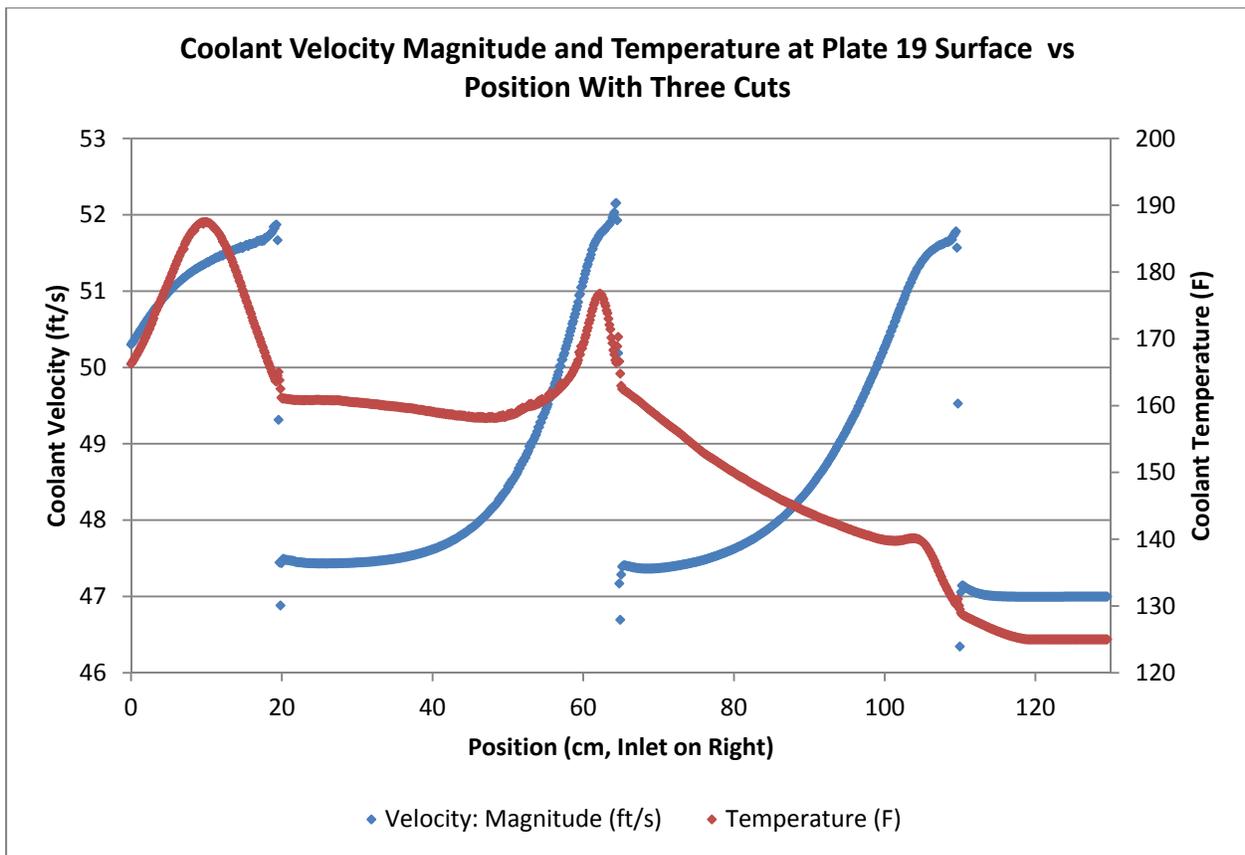
To further explore and verify the temperature profile of these standard cases, the coolant channel geometry was modified. Instead of 13 cuts, only three were used (no. 1, no. 7, and no. 13). The results in Figure 28 demonstrate that the distribution profile (shape) depends almost exclusively upon the absence or presence of horizontal cuts and their total number.

Figure 28. Cycle 153B; coolant velocity and temperature vs position – system with three cuts.

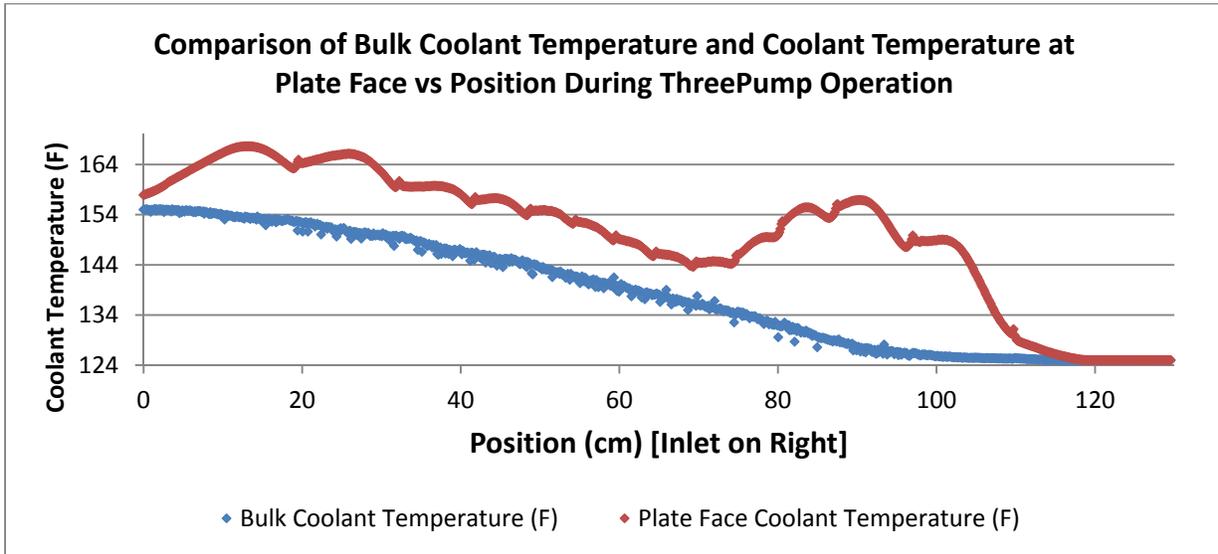
While the phenomena detailed above may cause the coolant temperature profile at the plate surface to appear strange, the temperature profile of the bulk coolant still exhibits the expected “S” curve, as shown in Figure 29.

Figure 29. Cycle 153B; coolant temperature at the plate face compared to bulk coolant temperature.

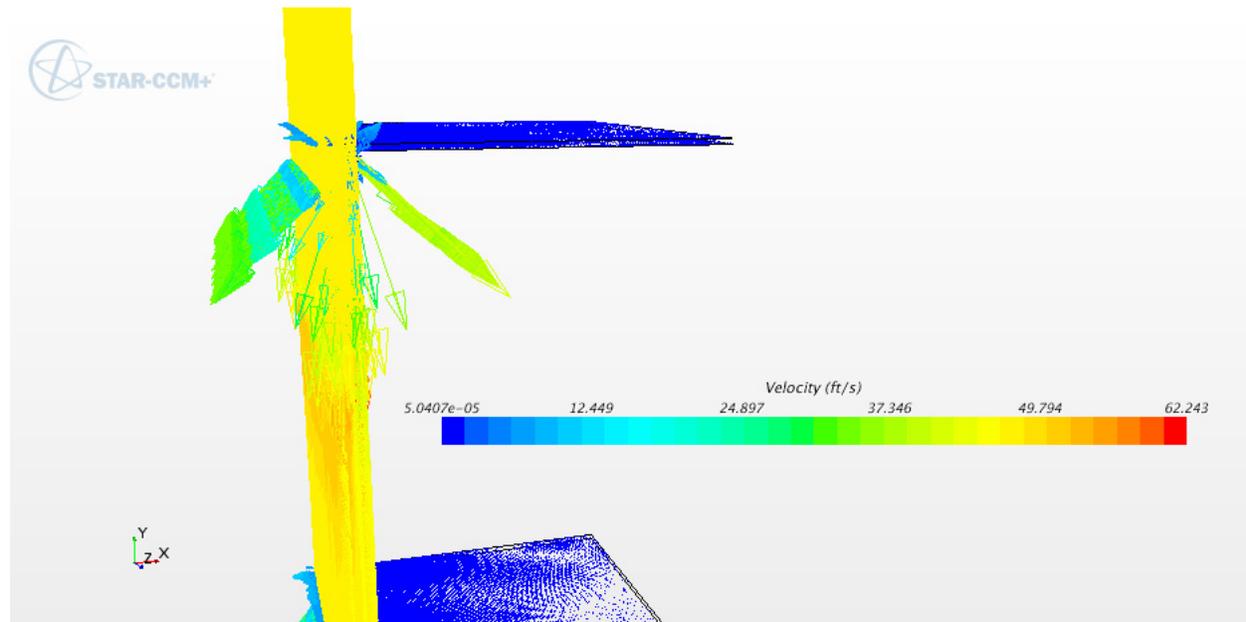
The chamfer modification had a modest impact on the coolant velocity vectors. There are still velocity vectors toward the plate, but these are reduced in number and much more spread out axially.

Figure 31. Flow structure in 3D: the same as the previous figure, but with a vector field distribution for flow velocities in the direct vicinity of the cut.

As these simulations identified erosion as a possible primary contributor to the YA-Plate 19 pitting degradation issue, the channel geometry was further modified to attempt to find a solution to the post-cut flow perturbations. A proposed solution was to exaggerate the chamfer on the bottom of the cut to observe how this change affected the solution, even though this change would likely not be beneficial as the reflector block ligaments are only 1/8 in. thick. Figure 30 shows the model geometry at a single cut site and the velocity magnitude as a result of the modification. The new bottom, “deep” chamfer is 1/8 in. deep, compared to 1/64 in. in the standard case.
