FY2016
3RD QUARTER
INL/EXT-16-39633

IDAHO NATIONAL
LABORATORY
QUARTERLY
OCCURRENCE
ANALYSIS

DEEPER LEARNING THROUGH
EVENT ANALYSIS

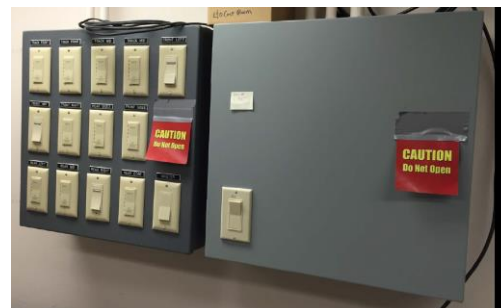
NE-ID--BEA-MFC-2016-0015 (Significance Category 3)

While performing a walkdown of an electrical system to

support remodeling of a conference room in Building 752 at the Materials and Fuels Complex

(MFC), the Building Supervisor opened an electrical panel so that Engineering could evaluate the panel internals. When the Building Supervisor closed the panel door, he observed a spark. The Building Supervisor immediately tagged out the panel and barricaded the area.
