**IDAHO NATIONAL  
LABORATORY  
QUARTERLY  
OCCURRENCE  
ANALYSIS**

**DEEPER LEARNING THROUGH  
EVENT ANALYSIS**

## INL/EXT-17-43652 – 4<sup>th</sup> Quarter FY-17

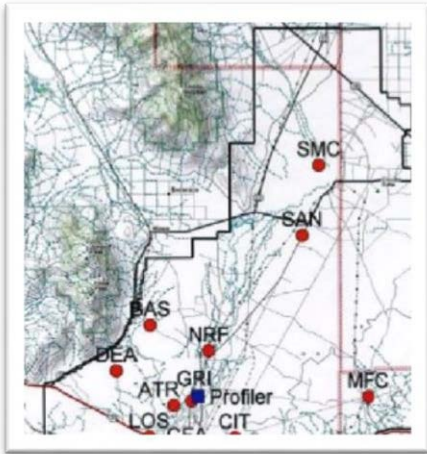
#### Electrical Cable Damaged at Remote Handled Low Level Waste Excavation

One of the 13 stations on the INL Site was installed outside the perimeter fencing near the southwest corner of the ATR Complex with a 120 volt (V) electrical service connection. However, following completion of the NOAA Weather Project, plant drawings and/or schematics were not updated to reflect installation of the buried electrical lines.

In 2014, the Remote Handled Low-Level Waste (RHLLW) Facility initiated construction outside the perimeter fencing near the south west corner of the ATR Complex. On June 26, 2014, a subsurface investigator and the project manager agreed to exempt the area from a subsurface investigation, believing the area was in fact "greenfield," a term related to or denoting previously undeveloped sites planned for either

operator struck and damaged a buried electrical cable located near the ATR perimeter fencing.

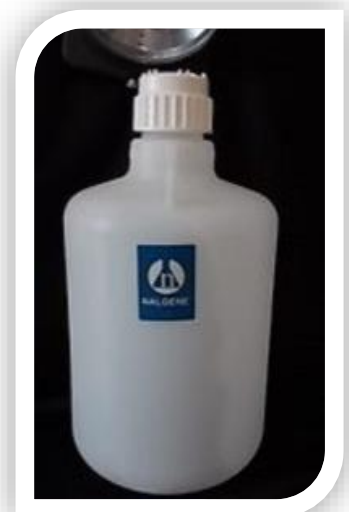
A program environmental lead Laboratory Space Coordinator and Waste Management personnel were following up on general action and performing an assessment of Waste Management Satellite Accumulation Areas (SAAs) at the Energy Innovation Laboratory (EIL). An empty container was observed inside of a flammable storage cabinet. The empty container was a 5 gallon Nalgene carboy with one large cap and a small vent cap, a label containing the words "Hazardous Waste" and a unique ID number.

The SAA inventory log was evaluated and indicated three entries for this 5 gallon carboy, totaling 650 mL of spent toluene. The container was inspected by the laboratory space coordinator and determined to be intact with the caps securely in place. Upon further inspection, it was discovered that one cap could be tightened with more effort for a better seal. Since the log sheet contained no details of the toluene being removed, transferred or emptied from the carboy, it was concluded the toluene waste may have evaporated from the carboy. It is not known if the cause of toluene evaporating was due to the incomplete sealing of the cap, the relatively small volume of the toluene versus the large headspace in the carboy, or an incompatibility between the plastic carboy container and the spent toluene waste. No malformation of the container was observed.

- Ensure the proper type of container is used for the waste type. Take into account the vapor pressure, volume and chemical constituents of the waste.
- Ensure the container lid/bungs are adequately secured.
- Disposition volatile waste chemicals in a timely manner.

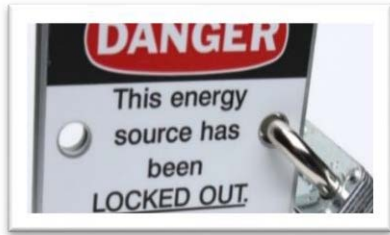
## FCF Inadequate Zero Energy Check during Maintenance

The MFC Utilities and Infrastructure Support division performed a lockout/tagout (LOTO) on the steam and

condensate system at the source of the hazard – a boiler in the Experimental Breeder Reactor (EBR) building. A week later, the Fuel Conditioning Facility

(FCF) performed local LOTOs on steam and condensate isolations to support maintenance efforts. Approximately three weeks later, it was discovered that zero energy checks performed on the LOTOs did not meet MFC management's expectations because, at the time of the check, there was no energy present to support validation of isolation.

- A zero energy check was credited without the ability to prove energy had been actively removed by the intended isolation point (impact of tagging downstream of off-line systems).
- Any changes to major systems under LOTO that affect multiple facilities need to be communicated and coordinated adequately to ensure common utilities are adequately isolated and controlled with LOTO.
- Isolation of a portion of a system that already has the hazardous energy removed must be monitored during work. Additionally, work must be stopped and boundaries must be re-verified prior to reintroduction of the hazardous energy at the boundary.

- Maintaining a questioning attitude can be challenging when directly observing work for which you are about to participate. Self-Checking and asking for a Peer Check can be helpful to mitigate error likely precursors and latent conditions.
- Frequent self-evaluation of working conditions is a good practice especially with changing conditions and/or overlapping or sequential work activities.

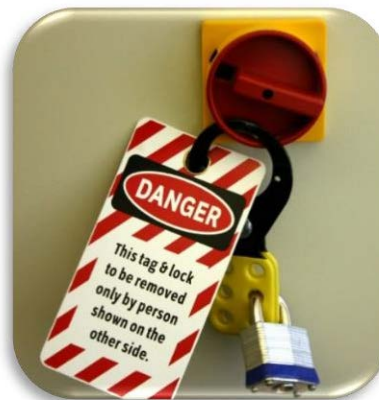
### Failure to Follow Lockout/Tagout Process during Quality Assurance Inspection at ATR

work order in hand and did not recognize that there was a LOTO in place for the job. The LOTO work group acceptance

had been completed for the QA work group but the QA inspector subsequently made this entry, and two more entries, without hanging a personal lock and tag.

Later that day, the inspector realized his mistake and reported the error to his

supervisor and to the ATR Shift Supervisor. The energy source had been isolated and controlled and no worker exposure occurred.

Managers should ensure that personnel have been properly briefed on the work they are tasked to perform. In addition, employees should maintain a questioning attitude and ensure they fully understand the hazards associated with the work they are doing.
