**IDAHO NATIONAL
LABORATORY
QUARTERLY
OCCURRENCE
ANALYSIS**

**DEEPER LEARNING THROUGH
EVENT ANALYSIS**

INL/EXT-18-44410 – 1st Quarter FY-18

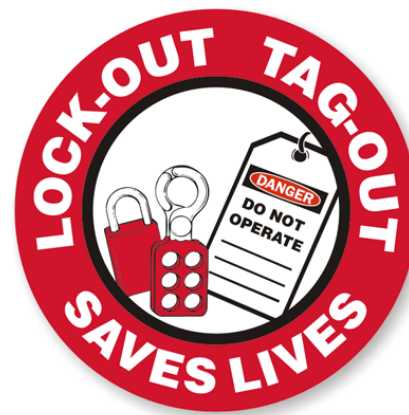
A Quality Assurance (QA) inspector failed to sign onto a LO/TO before entering a maintenance work area. The QA inspector was called to perform a fit-up inspection on a pressurizing-pump support stand. The QA inspector proceeded to the work location and bypassed checking in

Upon arriving at the work location, the QA inspector obtained the work order (WO), and without reviewing it, turned directly to the attached weld data sheet (WDS) and proceeded to perform the inspection. The QA inspector missed the LO/TO requirement when he bypassed Operations and did not review the WO and the associated LO/TO prerequisite instructions.

The QA inspector made several entries into the work area over the shift before realizing they needed to be on a LO/TO for the work evolution. Upon realizing the error, the QA inspector immediately exited the work area and contacted Operations and the QA supervisor.

ATR Operations quickly confirmed that the QA inspector had not hung a personal lock and danger tag for entry into the maintenance work area. The LO/TO work group acceptance had been completed on

- The QA inspector missed an opportunity to discuss work hazards and mitigations when he bypassed Operations. This conversation ensures hazards and hazard mitigations are known and understood prior to entry.

- Pre-job briefs are required in order to communicate specific information such as hazard and hazard mitigation, including LO/TO requirements. This ensures that the appropriate people are contacted, i.e., the job supervisor and Operations, prior to work.

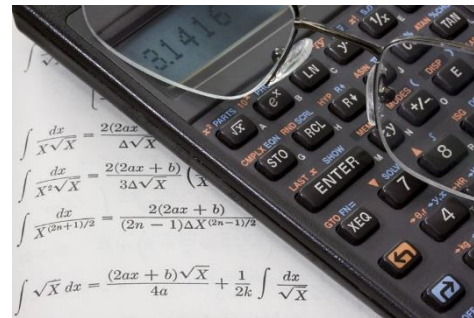
An engineer (Engineer No. 1) for the ATR questioned using nominal loop pressure to calculate the maximum allowable scram value for the inlet and outlet bulk-water temperature. The concern was that nominal loop pressure was not conservative enough because loop pressure could potentially drop below nominal without alerting operators to perform the required action until the low-pressure alarm set point was reached. This concern was brought to the attention of the Experiment Engineering technical lead, who began to search for documentation that supported the current calculation method. Following further discussion and a positive operability determination, a potential inadequacy in the safety analysis (PISA) was declared.

Interim controls were put into effect to ensure inlet pressure was maintained in the nominal control band with the

additional requirement that a manual scram be required if inlet pressure dropped below the bottom of the nominal control band for more than 5 minutes. There was no perceived sense of urgency to make changes to experiments not in the current cycle, but changes would be required for subsequent cycles. Changes to the ESA did not occur.

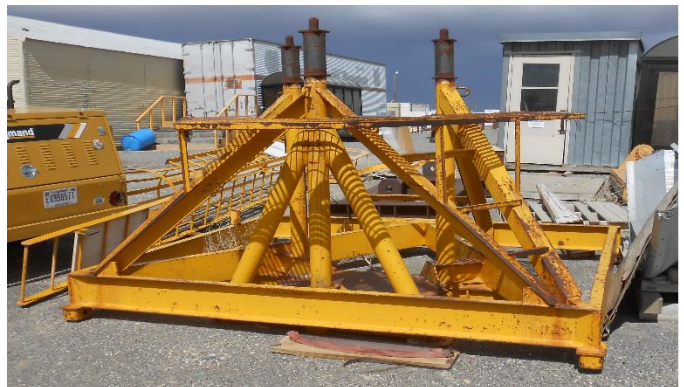
Modifications and paint removal were being performed on a spare cask stand at MFC in preparation for repurposing the stand. Radiological controls personnel were asked to free release the stand so it could be transported off-site for further work. While conducting surveys to support free release of the stand, health physics technicians located fixed contamination in one spot of the disassembled stand catwalk. There was no loose surface contamination detected in any area or on personnel. Items and tools associated with the cask work were surveyed and appropriately controlled.

- Accurate and complete records were not readily available to the system engineer. The cask stand was believed to have been used in the mid to late 1990s. It was placed in a laydown storage area around 2006 and has not been used since.
- There were no visible labels affixed to the stand to indicate the presence of fixed contamination or radioactive material, and the stand was not in an area marked for storage of radioactive material.
- Grinding and cutting on contaminated items requires Radiological Control coverage and a radiological work permit (RWP). While this event did not spread contamination, it potentially could have.

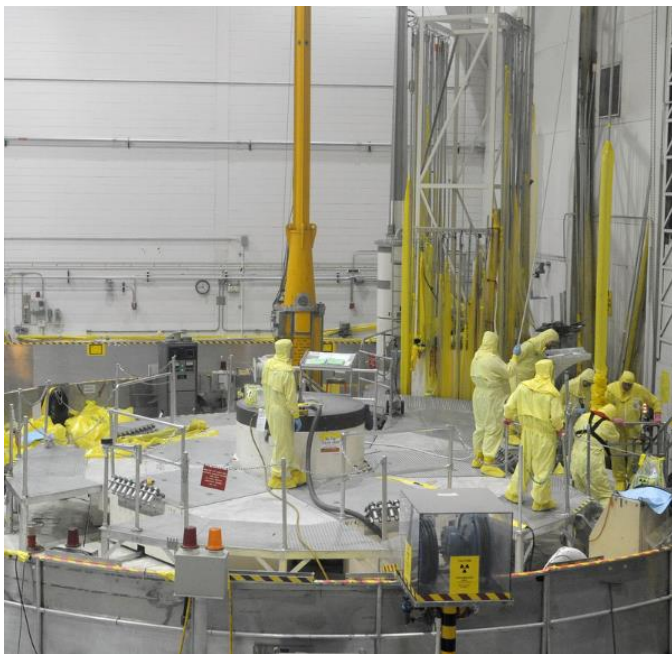
The definition of a core change in TSR-186 is, "the manual movement or manipulation of any component within the Core Reflector Tank with two or more FUEL ELEMENTS in the

reactor CORE. The manual movement of components (e.g., SAFETY RODS) using their normal drive mechanisms is not considered a CORE CHANGE, however, the movement of these components with their normal drive mechanism disconnected is considered a CORE CHANGE.” Additionally, the TSR-186, Administrative Control (AC) 5.3.2.1.D states, “during core changes other than through the reactor vessel refueling ports, an SRO certified for fissile material handling, shall directly supervise personnel performing the changes.”

For this particular evolution, the individual directing the work was working towards obtaining the Sample Handler Job Supervisor Qualification and was being observed by a job supervisor (JS) qualified as an on the job training (OJT) instructor. The OJT instructor was ultimately responsible for the work being done. At the point the test was being manually lowered, a note in the procedure required a senior reactor operator (SRO) to be present. The SRO was not present due to an oversight by the trainee and the JS. Not having the SRO present resulted in a TSR violation.

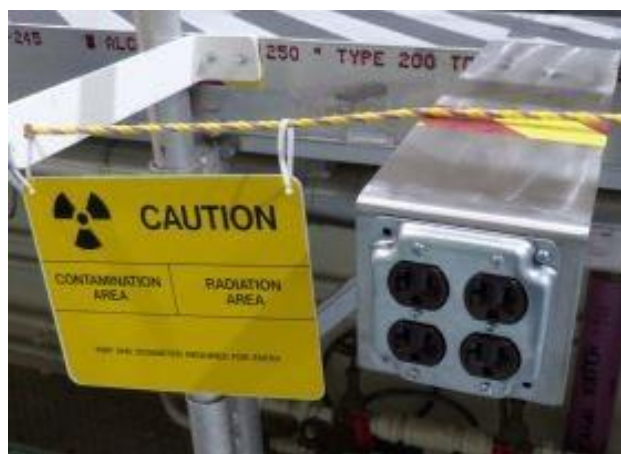
Best Practice: Innovative Power Outlet Brackets Save Time and PPE Cost

RadCon personnel saw a need to modify how power outlets were used in the ATR canal area. Previously, anybody who needed to plug into or unplug from an electrical outlet in the canal area would need to contact RadCon because the outlets were in a Contamination Area (CA). Entering the CA, required personal protective equipment (PPE) for each entry, to plug or unplug each piece of electrical equipment.

The BrigMar bracket made the outlets accessible outside of the CA. They worked with others to review, build, and approve the new bracket. There are now two BrigMar Brackets installed in the canal. One consists of outlets for power, the other is to connect cables to television monitors and computers. The new brackets will save time and the cost of PPE every year to plug and unplug equipment and monitors.

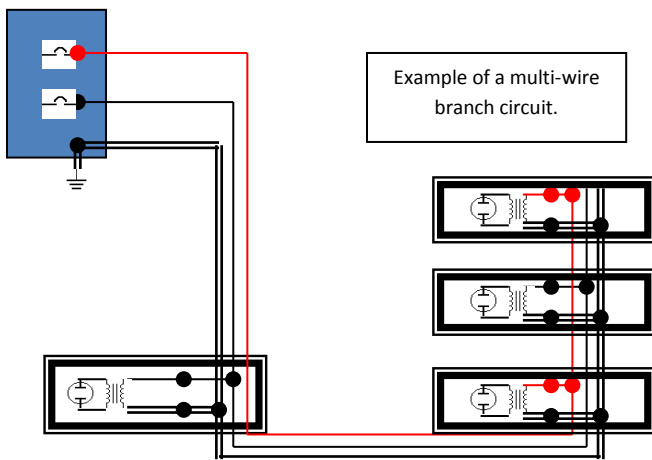
Work was being performed to replace a wall receptacle in the entrance of the HFEF; a LO/TO was required for this activity. A panel schedule for N-LP-R1C and HFEF's normal power drawing were used to develop the boundary for the LO/TO. A minor work package, "Troubleshoot and Repair an Entry Way 120 V Outlet," was approved for work, and a roundtable meeting of the work request was initiated. During the roundtable, there was no discussion about the potential for Edison circuits, although a discussion of this subject is required per MFC procedures.

The job began, and breaker 24 (powered by panel N-LP-R1C) was locked out. A zero energy check was performed, and work began to replace the outlet. The electrician wore appropriate PPE during performance of the zero-energy check and removed the rated gloves to replace the outlet.

A short time later the nuclear facility manager (NFM) noticed flickering of his computer (powered by Breaker 20) and notified the electrician, who was in the process of replacing the outlet. The electrician confirmed there was no power at the outlet. Work on the outlet was completed, and the outlet cover replaced. The electrician removed the LO/TO from breaker 24. Additional investigation discovered that Breaker 22, located directly above Breaker 24, was tripped and an administrative lock was placed on Breaker 22.

Later that afternoon, the NFM and electrician discussed the potential of an Edison circuit. Based on facility conditions, the recent replacement of panel N-LP-R1C and the circuit at the outlet not appearing to be an Edison circuit, the presence of an Edison circuit could not be confirmed.

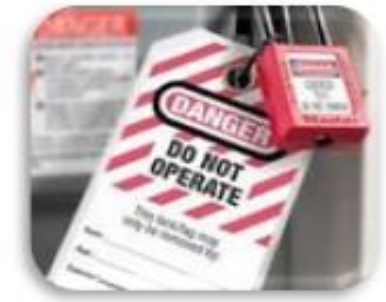
employee had performed work on the overhead door without first ensuring the mechanical motion of the door was prevented via LO/TO. No injuries occurred as a result of the noncompliance.

One week prior to discovery of the noncompliance, a carpentry superintendent questioned the need for a LO/TO related to work being performed on the overhead door. The REC-682 building specialist and a hazardous energy specialist verified the doors had been walked down and a hazardous energy map had been generated and communicated to the

superintendent. However, the building specialist did not communicate that the work was authorized to begin without a LO/TO. The building specialist assumed the carpentry superintendent would request that an escorted LO/TO briefing be held prior to beginning work. Several people, including the building specialist, could have performed the briefing.

Following completion of the work, the building specialist noticed none of LO/TO steps in the work order had been signed off. The specialist contacted the workers who performed the work and learned they had not performed a LO/TO because they believed they had maintained exclusive control of the equipment (door, motor, switch) via the overhead-door disconnect switch, located approximately 20 feet above ground level.

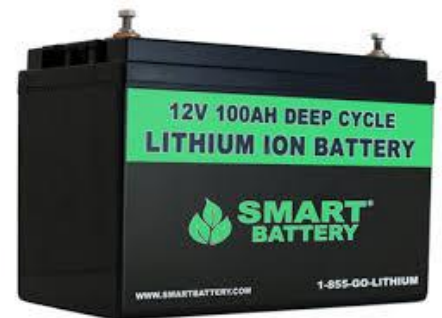
On October 17, 2017, a battery test engineer (BTE) for the Battery Test Center requested help from the laboratory space coordinator (LSC)

in trouble-shooting some anomalous readings on one of the test systems. The cells in question were in an

environmental chamber.

Initial inspection revealed melted foam and plastic in the cable entry port of the environmental chamber. Before proceeding with any further inspection, it was verified that all testing in that chamber was suspended and that there were no abnormal temperatures present. After conferring with the laboratory manager, and following direction in the Laboratory Instruction, the LSC proceeded with the inspection of the chamber. Upon opening the chamber, it was immediately obvious that at least one cell in the chamber had undergone thermal runaway and was almost completely consumed.

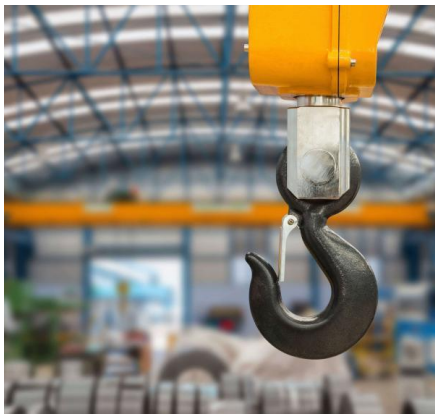
Hoisting and Rigging Concern at ATR Machine Shop

Following the installation of a new piece of equipment, a layout table in the machine shop required relocation. Machinists, using shop hoisting and rigging equipment, rigged the table top

and lifted it while the base was relocated. An experienced contractor observed the lift and expressed concerns regarding the sling configuration and sling protection being used.

Uphold a questioning attitude in the performance of pre-job rigging inspections. Remain vigilant in bringing attention to conditions that appear inconsistent with safety in the performance of job activities.

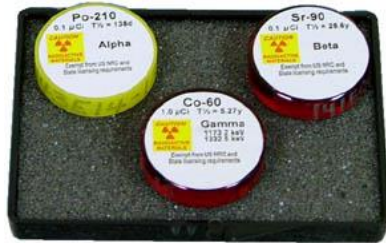
Leaking Radioactive Sealed Source

A leaking sealed radioactive source was identified in IRC building IF-603 lab B-5 during the semi-annual leak test. The source was labeled as "mixed nuclide alpha source."

Contamination levels were approximately 912 dpm/swab alpha. The source has been bagged and controlled. The area around the source and the counter where the source was used were surveyed, with no contamination detected.

Due diligence and routine surveys help to ensure contaminants are not spread outside the desired area.

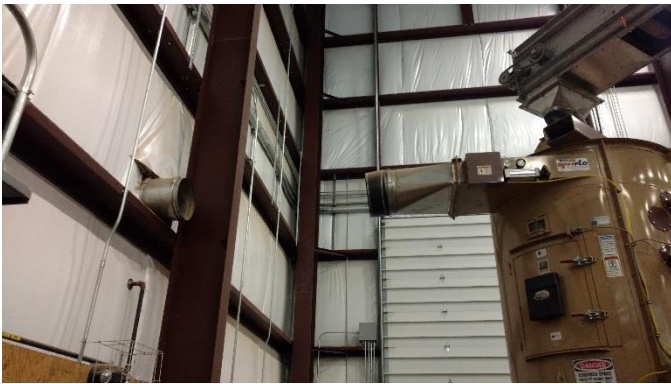
At some point between Friday, November 3, and Tuesday, November 7, the section of ducting became disconnected from the process equipment and fell to the floor. No one was

in the immediate vicinity when the section dislodged, and there was no damage to any equipment located in the facility.

The duct was attached at both ends with original-equipment-manufacturer rubber connectors and band clamps. It appears that the distance between the bulkhead connector and the pellet cooler had increased such that one end of the section became disconnected, causing the opposite end to also become disconnected and allowing the duct section to fall. The section fell approximately 12 feet to the floor below.

Prior to the ducting falling, high winds with sustained wind speeds of greater than 40 miles per hour and wind gusts reaching 58 miles per hour occurred. The metal building, to which the ducting was attached, was buffeted by these high winds for a number of hours. This likely caused the metal skin of the building to expand resulting in the bulkhead connectors moving apart and the ducting falling to the floor.

We all understand how dangerously strong winds can affect travel, but do we think about how those same winds can affect the buildings in which we work? Oftentimes, siding or roofing materials are dislodged due to high winds, but this event shows us that things can also occur inside the building. After exceptionally high-intensity wind events, cautiously enter buildings and inspect the area to ensure nothing has become dislodged or is posing a safety hazard.
