3D Reconstruction of M11A2 from the SELENIUM Experiment

B. D. Miller, M. Abir, A. Aitkaliyeva,
A. Leenaers, B. J. Hernandez,
W. Van Renterghem, S. Van den Berghe,
A. Winston, D. D. Keiser, Jr.

January 2017

**Idaho National Laboratory
Idaho Falls, Idaho 83415**

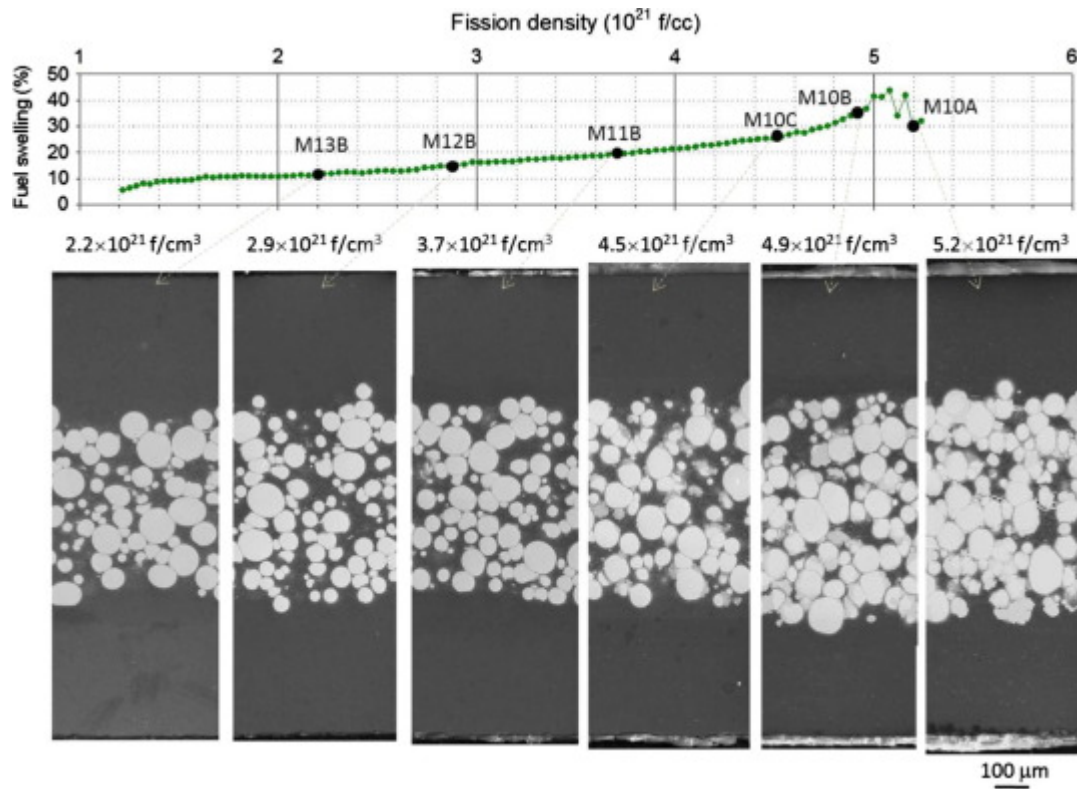
Using neutronics from the plate, various sections of the ZrN fuel plate were sectioned to study the irradiated microstructure behavior at various fission densities. Section M11 was obtained from a fission density around 4.0 to 4.5×10^{21} fiss/cm³. Figure 1 shows SEM micrographs that show the cross-section of the fuel at various fission densities (2). Figure 2 shows a diagram of where section M11 was sectioned into smaller sections. From Figure 2, section M11A2 was created and prepared for SEM and FIB analysis. The section was polished to a thickness of ~ 150 μ m with a mirror finish on one side. The section is ~ 2 mm in length. Basic SEM was performed on the section and some results will be seen in the SEM characterization section. The sample was decontaminated and shipped to the INL for FIB analysis.

Figure 1: SEM micrographs of various cross-sections from plate U7MD1231 (2).

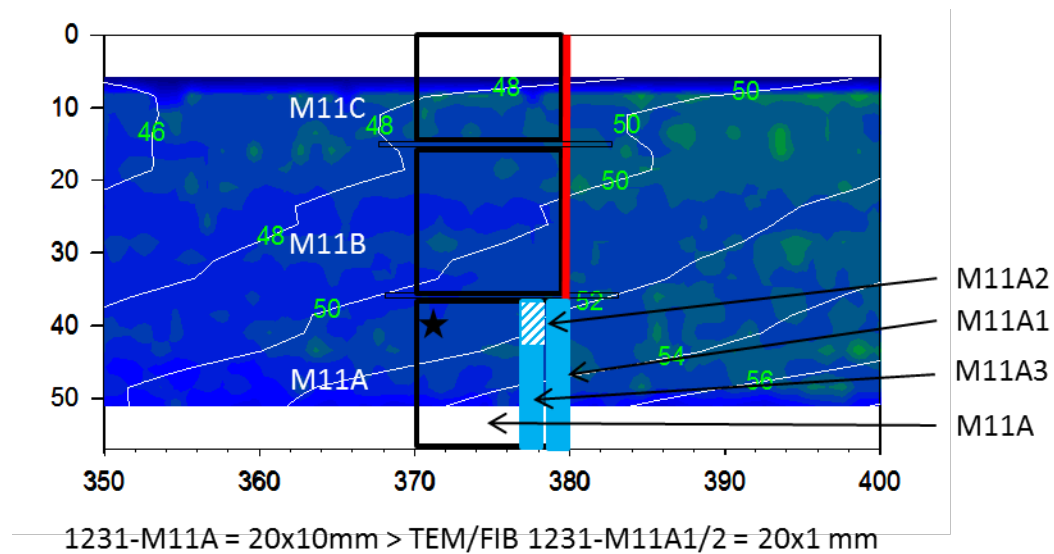
Figure 2: Cutting diagram of plate M11A2

Local irradiation conditions for M11A2 were determined using the cutting diagram seen in Figure 2. Locally, M11A2 saw a 52% ^{235}U burnup.

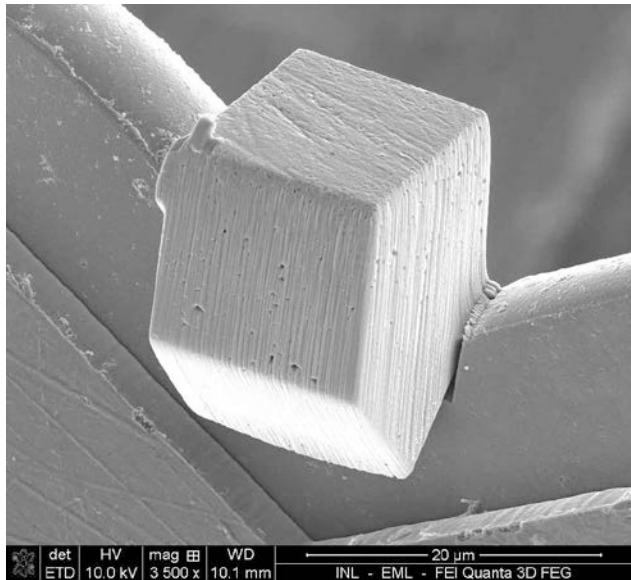
Figure 4: SEM micrograph showing an example of a cube on the copper grid.

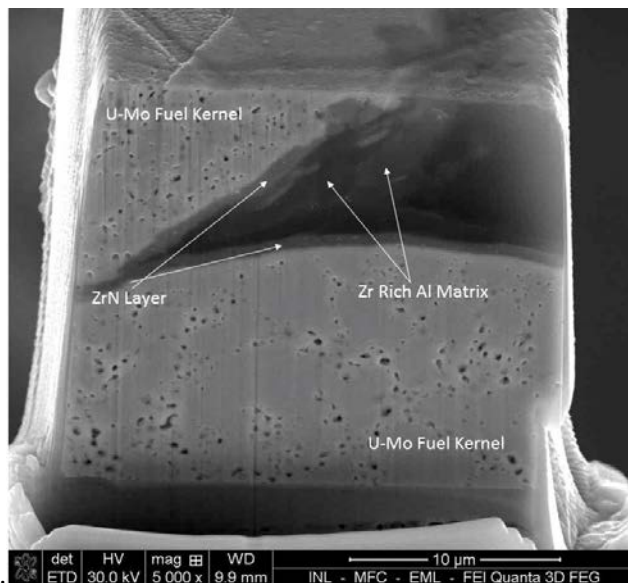
In attempt to find the “volcano” feature in the FIB, two separate cubes were created from the host sample. The first cube was sectioned in roughly 200 nm slices. This large sectioning distance was due to time constraints in the FIB. Figure 5 shows the starting slice for the 3D reconstruction. The starting useable area is 22 x 17.5 µm. Figure 6 shows various SEM micrographs of the FIB slices at different locations showing the evolution of “volcano” features in one of the M11A2 cubes.

Figure 5: SEM micrograph showing the starting condition of the sectioning process.

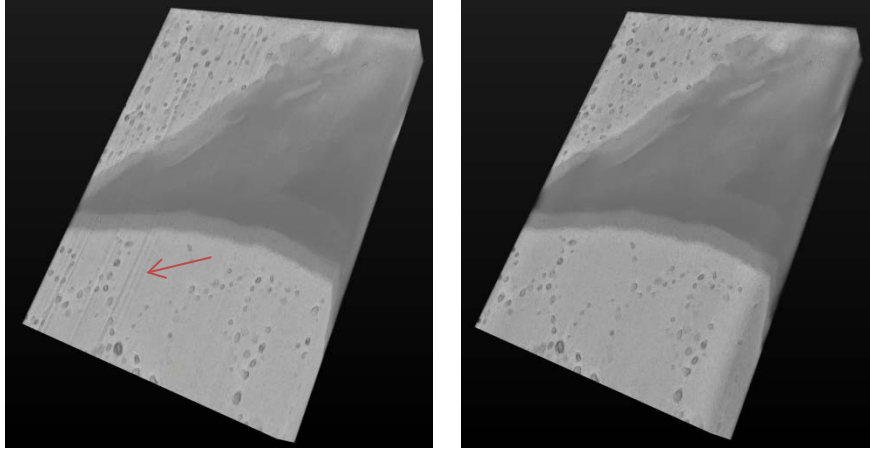
The major problem that makes DualBeam FIB/SEM images difficult to analysis is the milling artifact, which also known as curtaining or waterfall effect. The local variations, e.g. voids or cracks, on the surface structure, affect the sputtering rates of the ion beam, which eventually creates these artifacts. Sample preparation, milling parameters, such as low beam current may reduce the curtaining effects, however, these may significantly increase in processing time for image acquisition. Moreover, for a specific sample geometry and microstructure, the curtaining effect may be unavoidable. Therefore, image filtering is a very important step for 3D reconstruction. These effects can be better seen in Figure 8. The left micrograph shows volume of the fuel obtained by FIB/SEM images (55 slices, 200 nm thickness). The arrow shows the curtaining artifact on the image. The processed image does not contain curtaining artifacts.

Figure 8: Two micrographs showing the curtaining artifact (left) and the processed image (left) devoid of the curtaining artifact.
