FEASIBILITY OF USING NEUTRON TOMOGRAPHY TO EXAMINE
TMI-2 FUEL ASSEMBLIES (DRAFT)

Idaho National Engineering Laboratory

This report presents results of a feasibility study for using neutron tomography (NT) to examine TMI-2 fuel assemblies. A fuel assembly mockup was constructed to simulate many of the conditions that may exist in actual TMI-2 fuel assemblies and was examined with NT techniques. This study demonstrated that useful and reliable information could be obtained regarding fuel assembly configuration, particularly the location and condition of the fuel and control materials within the assembly.

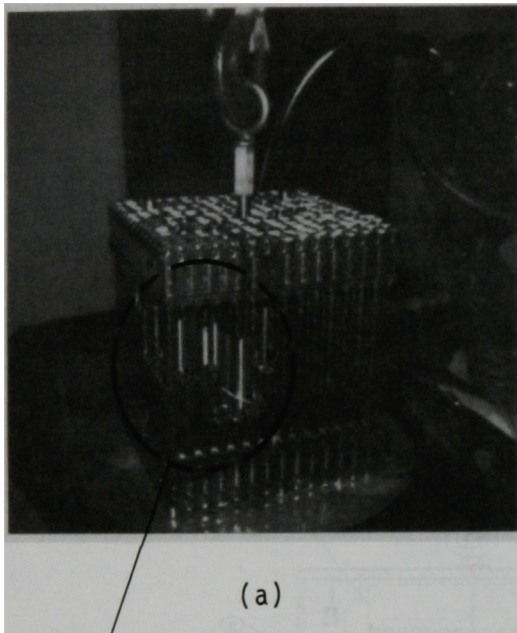
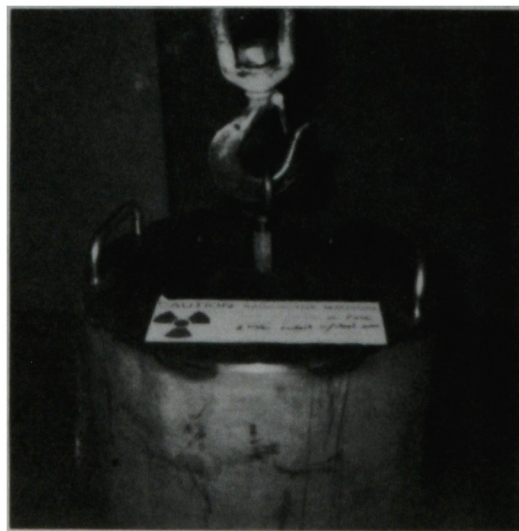
Simulated
damage
zone
(see Figure 2b)

Figure 2. Photographs of mockup of the TMI-2 fuel assembly: (a) overall view, (b) closeup of the simulated damage zone, (c) simulated shipping/storage canister containing the mockup.

Figure 1 (EG&G Drawing 418532) shows the detailed configuration of the fuel assembly mockup. Figure 2a shows the mockup after fabrication. Figure 2b shows a closeup of the simulated damage zone. Figure 2c shows the simulated shipping/storage canister. The mockup is located inside the canister.

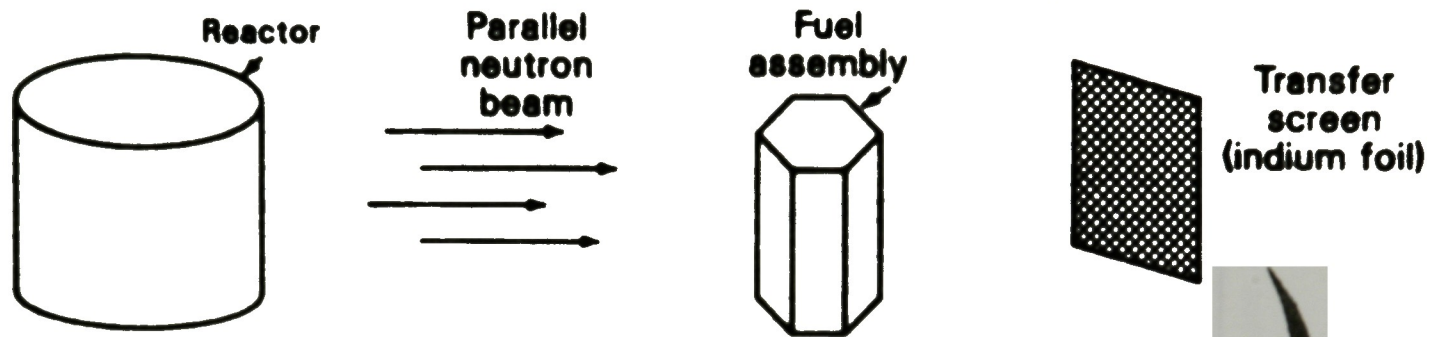
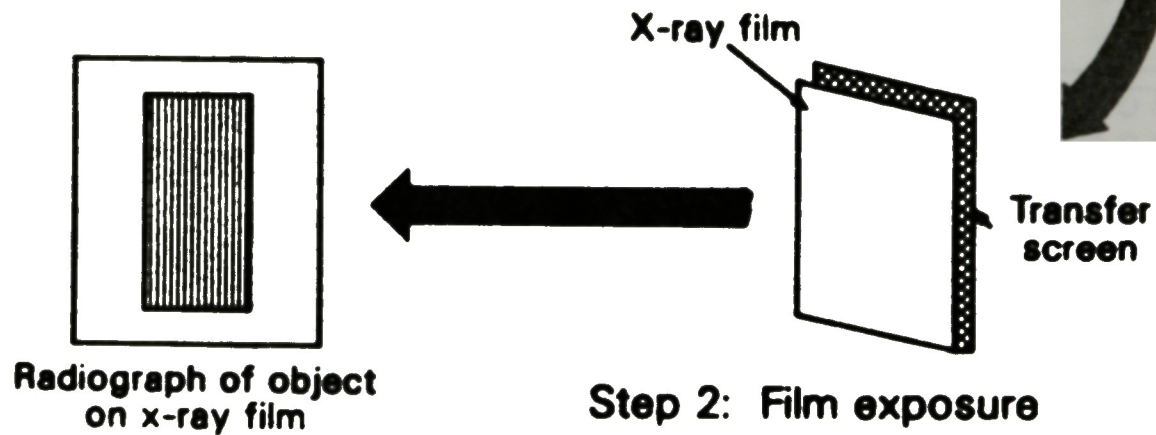
Step 1: Irradiation by neutron beam

Step 2: Film exposure

Figure 3. Schematic depicting the neutron radiography process.

Examination of a specimen by NT yields cross-sectional images of the specimen. These are generated nondestructively from numerous views of the specimen in the form of neutron radiographs. In each of the radiographs, the specimen is rotated to present a unique angular view. The data contained in these radiographs are digitized for entry into a computer. Computer processing of the data yields the cross-sectional images. The examination technique can be viewed as a two-step process. The first step is the acquisition of the neutron radiographs. The process is depicted in Figure 3. The specimen is illuminated with a parallel beam of neutrons. Neutrons that penetrate the specimen impinge on a thin indium foil, creating a radioactive image of the specimen on the foil. The activated foil is removed from the beam and allowed to decay while in close contact with photographic film. This results in the transfer of the specimen image onto photographic film. The specimen is rotated radially to another preset angular position and the radiography process repeated. The angular rotation between each radiograph is called an increment. For purposes of NT, the process is repeated numerous times at equal increments until the specimen has been rotated through 180 degrees. The second step in NT, illustrated in Figure 4, is computer processing of the data contained in the neutron radiographs. The data (variations in the film density) are digitized by scanning each radiograph using a high resolution microdensitometer or similar digitizing device. The data are entered into a computer which manipulates the data using a mathematical reconstruction algorithm. The end result is a series of computer-generated reconstructions of cross-sectional images of the specimen. Cross-section images can be generated through the specimen at almost any angle and view. In addition, by using various filtering and color schemes in the computer, it is possible to accentuate or highlight different specimen materials by their unique neutron absorption characteristics, making identification of materials such as control rods, stainless steel, UO_2 , and water much easier.

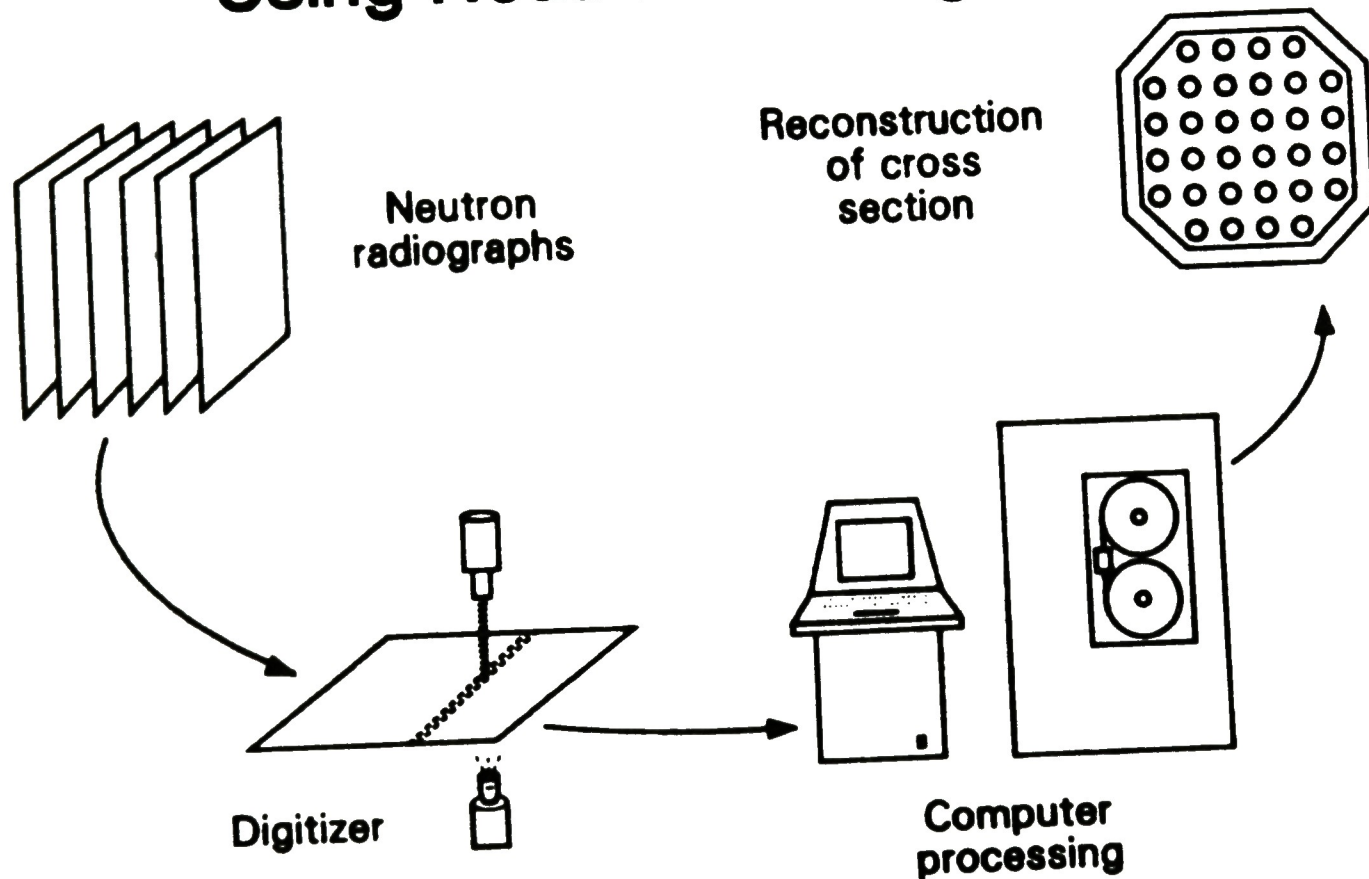
Figure 4. Schematic depicting the tomographic reconstruction process.

Ninety views of the TMI-2 assembly mockup were acquired for this study. The views were collected at two-degree increments. Cross-sectional images were generated from these 90 views as well as from smaller subsets. The smaller subsets contained 75, 60, 45, and 30 views. Interpolation was involved in generating the sets with 75 and 60 views. The two smaller sets were obtained by simply subsampling the original 90-view set.

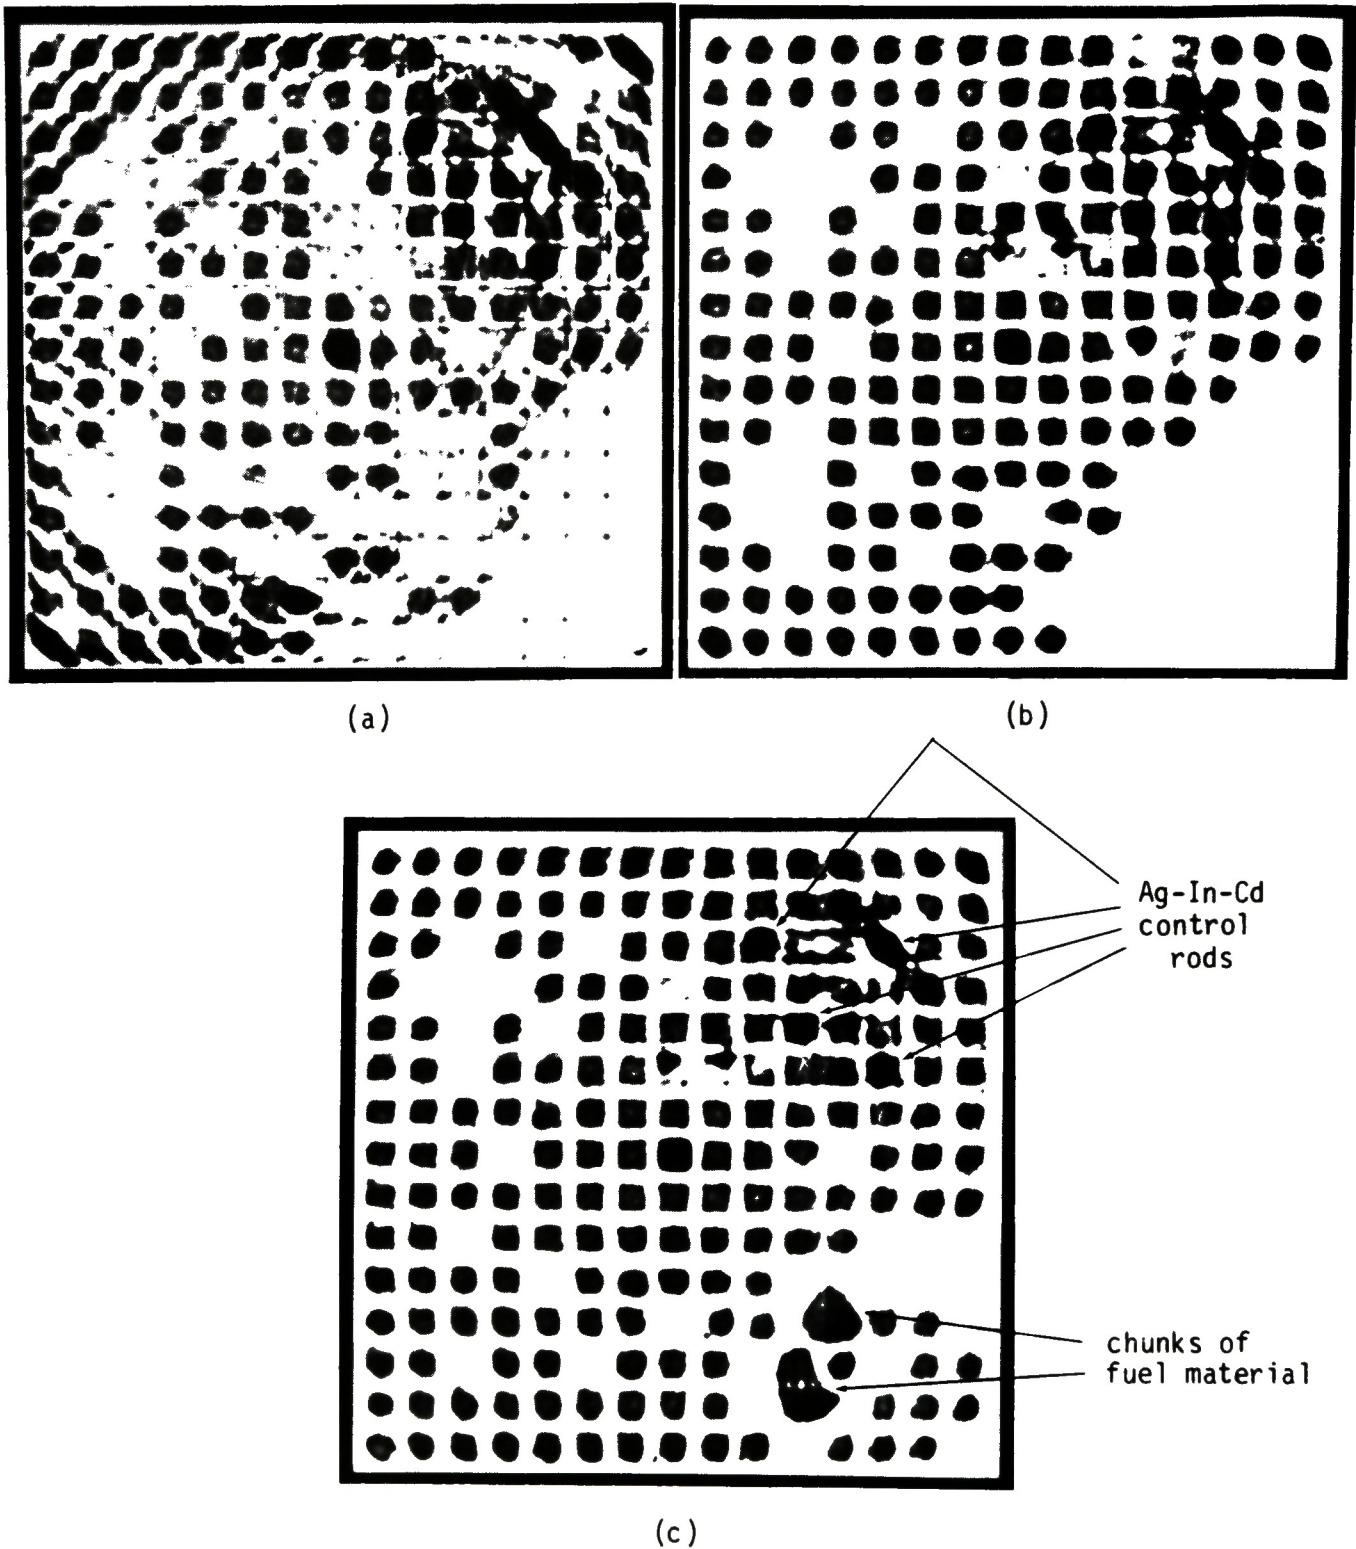
Figure 5. Transverse reconstructions using 90 views (a) within the upper spacer grid, (b) 11.2 cm below the top spacer grid, and (c) showing irregularly shaped molten chunks of previously molten core internal materials.

In the upper spacer grid region (Figure 5a), most of the fuel rods are present and arranged in a regular grid pattern. There are a few missing rods, empty cladding, and empty guide tubes in this grid. There is also a few control rods and water-filled rods. As discussed above, the zircaloy elements

are not reliably visible in the reconstructions. The transverse reconstructions reveal the remaining features with only a fair degree of reliability. The axial reconstructions provide a much better view. The transverse cross-sectional reconstructions are affected adversely by the great amount of detail (greater bandwidth) in the planes containing the spacer grid. Neutron scattering caused by the spacer grid may also have had an adverse effect.

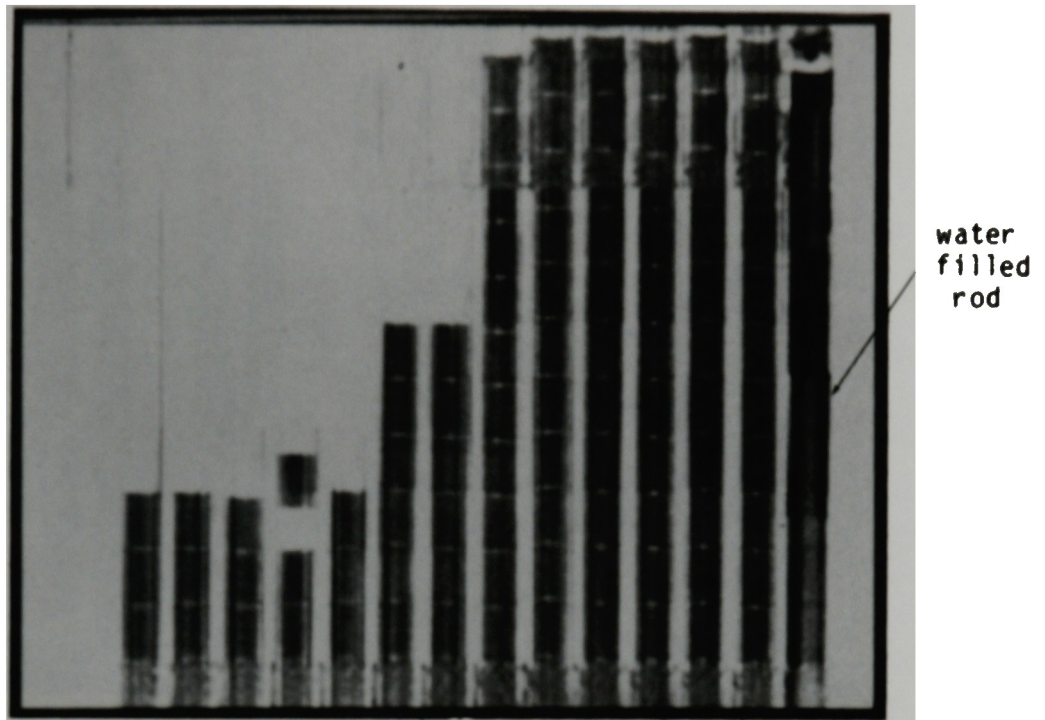
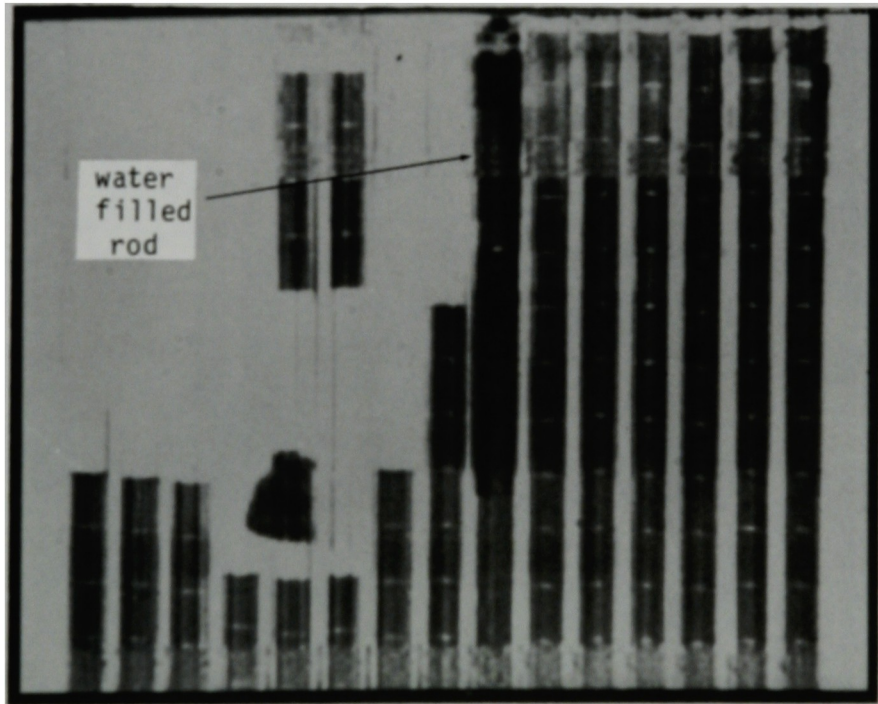
Figure 6. Axial reconstructions using 90 views (a) Row 1 of the TMI-2 assembly mockup and (b) Row 2 of the TMI-2 assembly mockup.

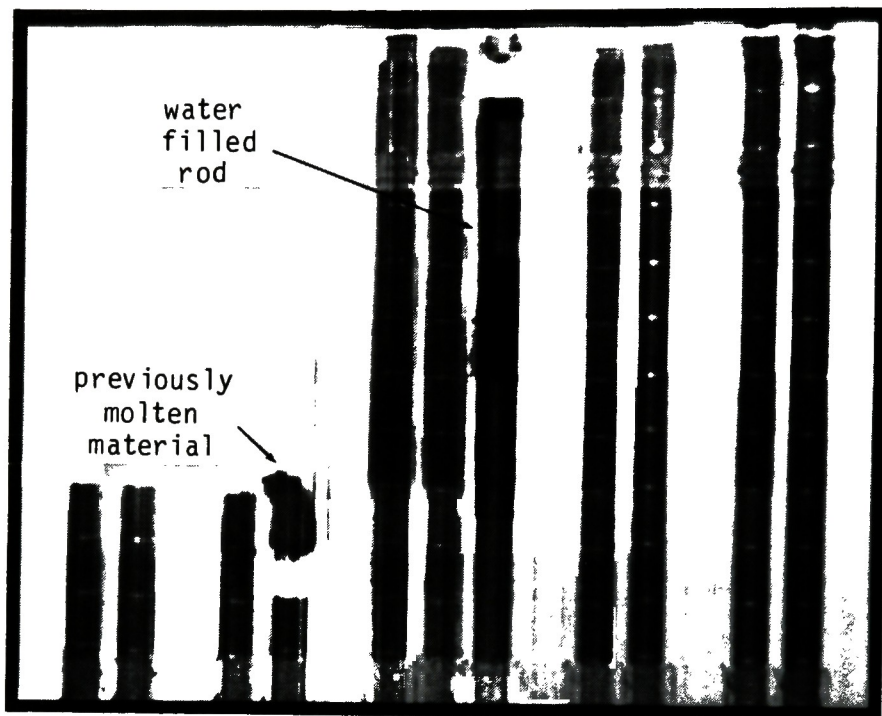
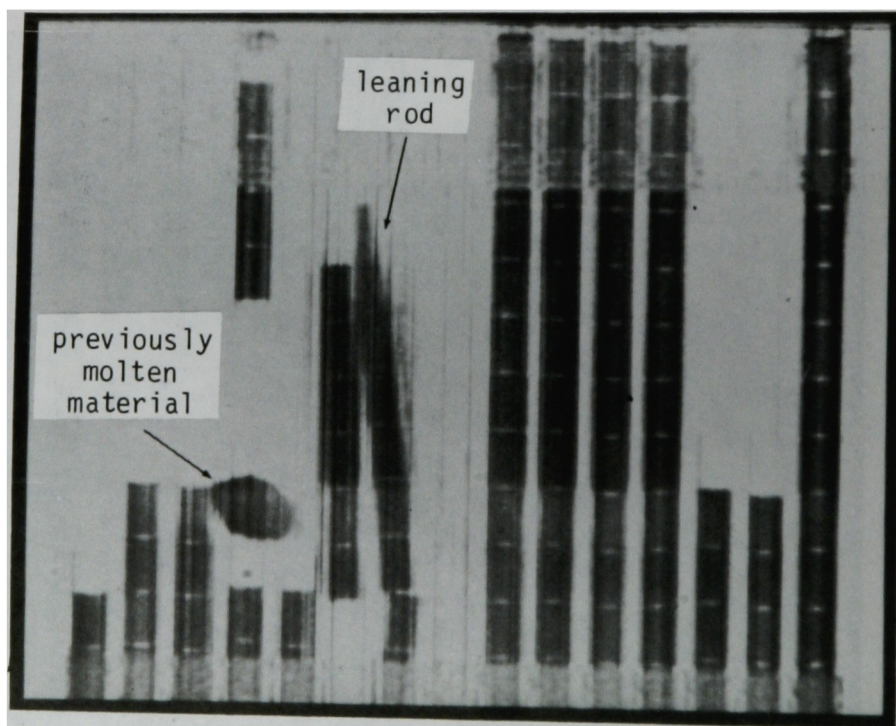
Figure 7. Axial reconstructions using 90 views (a) Row 3 of the TMI-2 assembly mockup and (b) Row 4 of the TMI-2 assembly mockup.

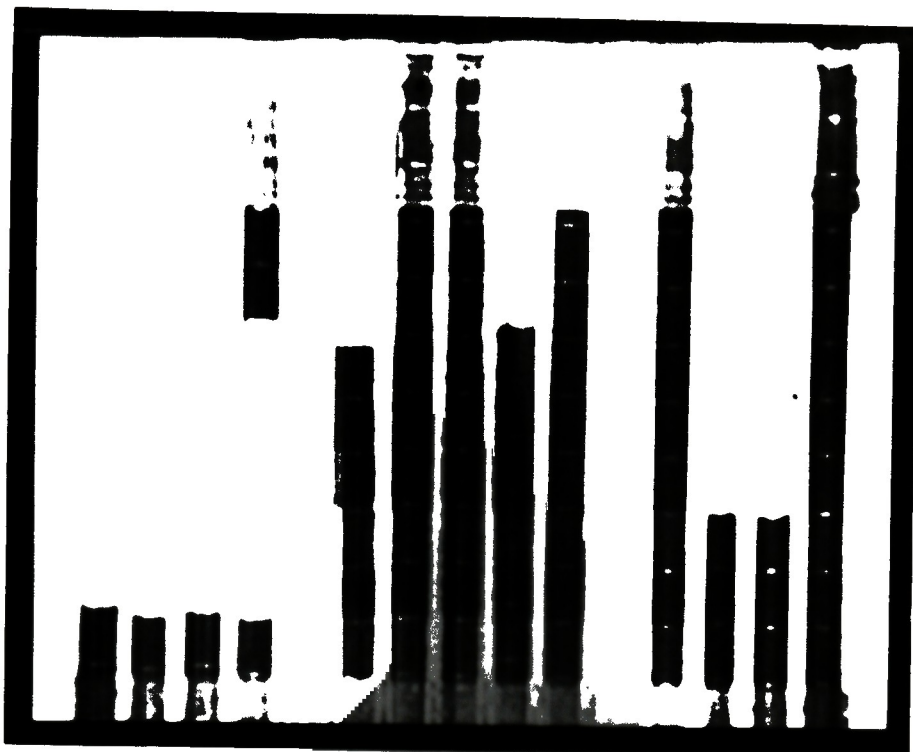
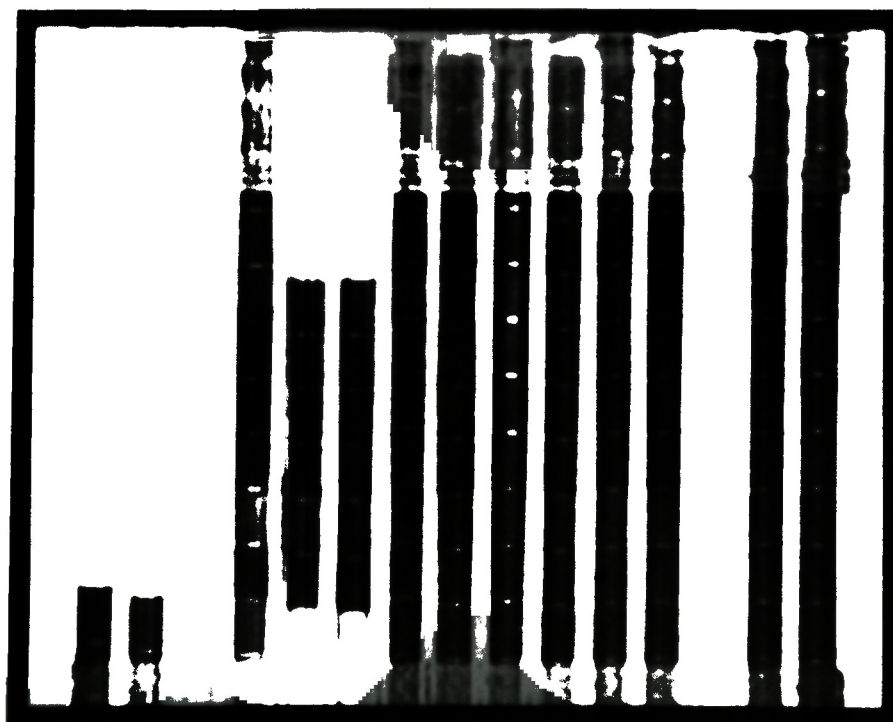
Figure 8. Axial reconstructions using 90 views (a) Row 5 of the TMI-2 assembly mockup and (b) Row 6 of the TMI-2 assembly mockup.

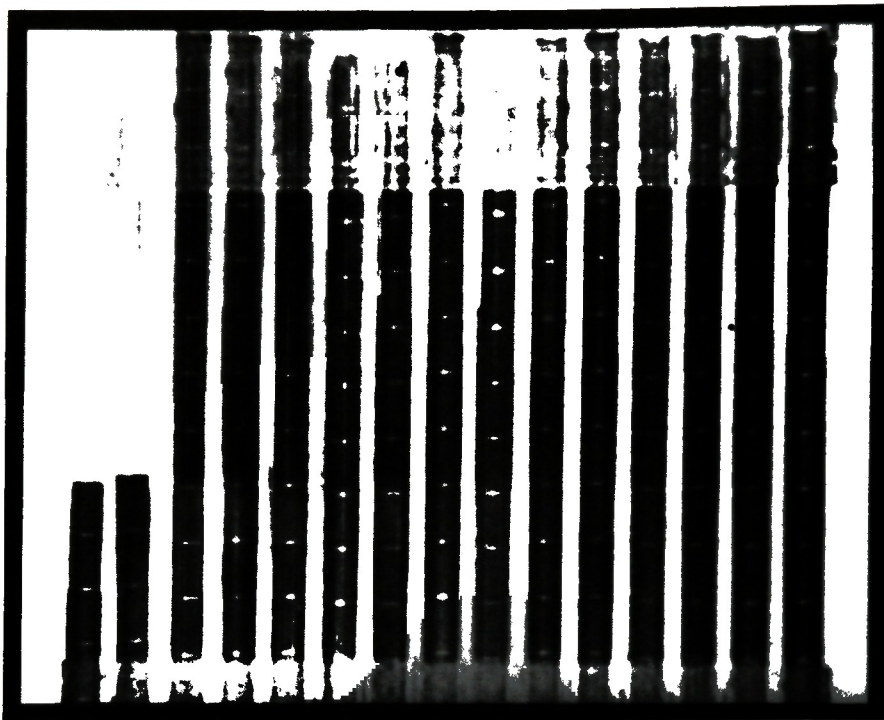
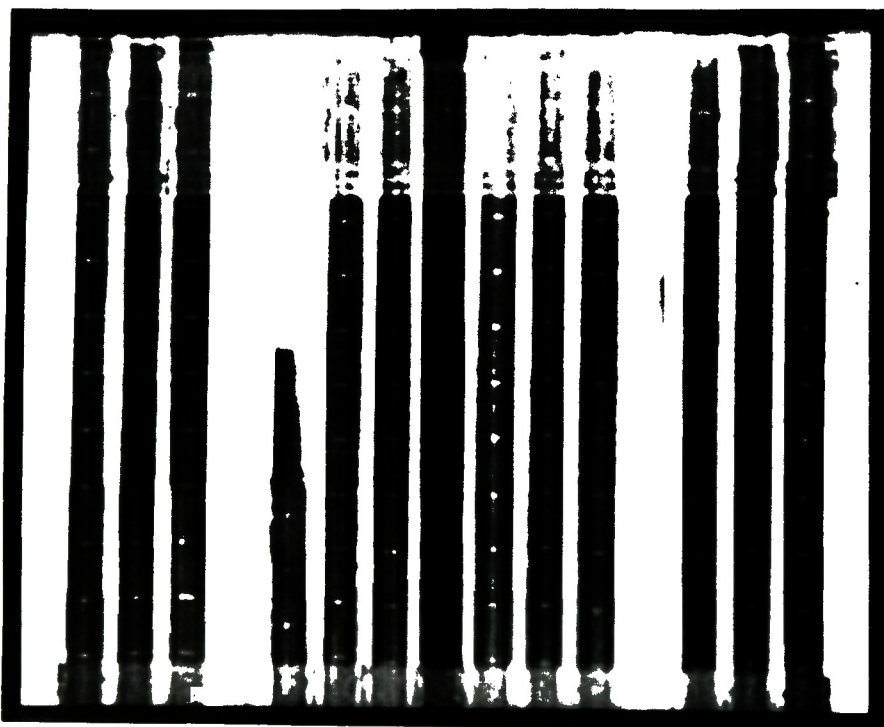
Figure 9. Axial reconstructions using 90 views (a) Row 7 of the TMI-2 assembly mockup and (b) Row 8 of the TMI-2 assembly mockup.

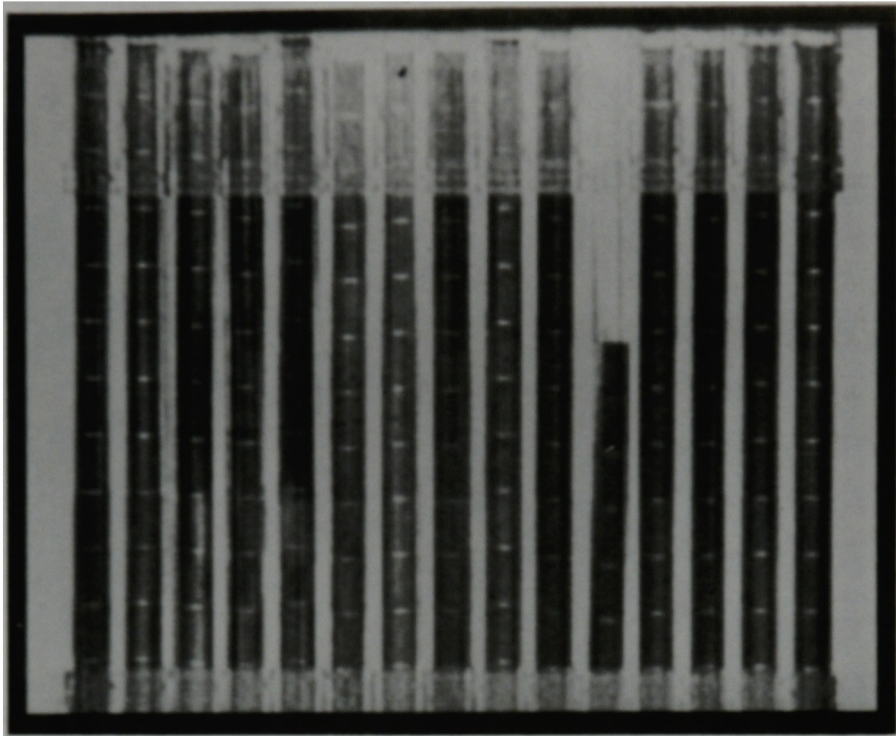
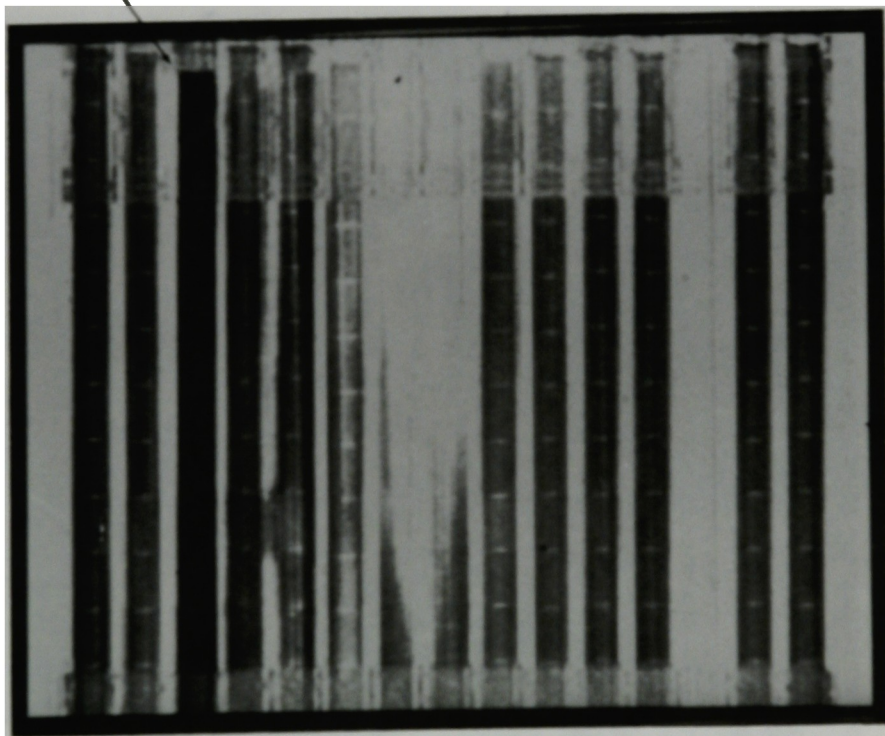
Ag-In-Cd
control rod

Figure 10. Axial reconstructions using 90 views (a) Row 9 of the TMI-2 assembly mockup and (b) Row 10 of the TMI-2 assembly mockup.

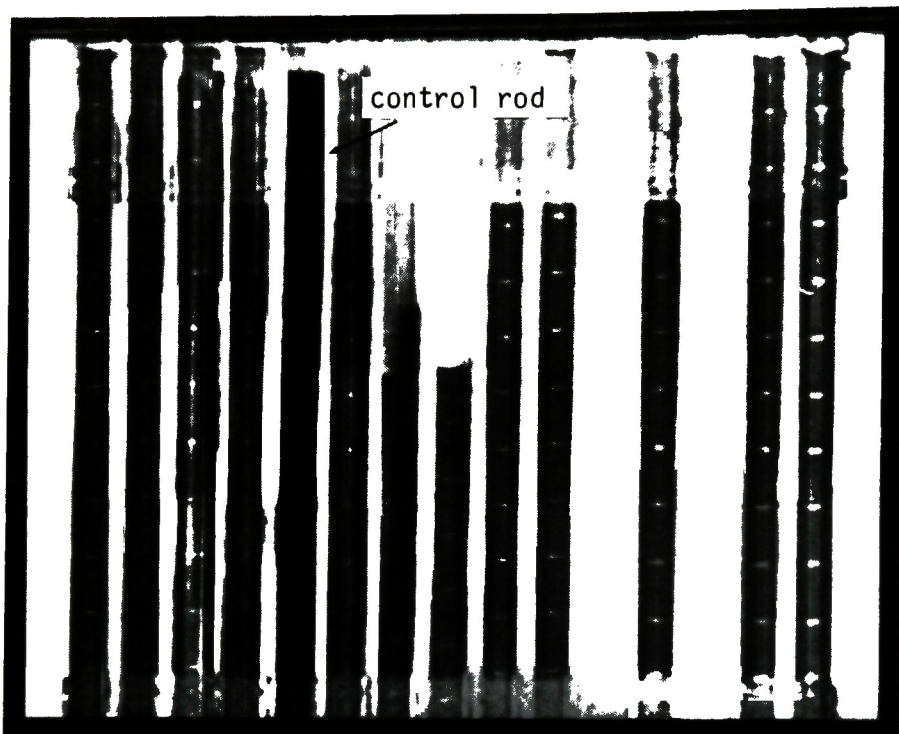
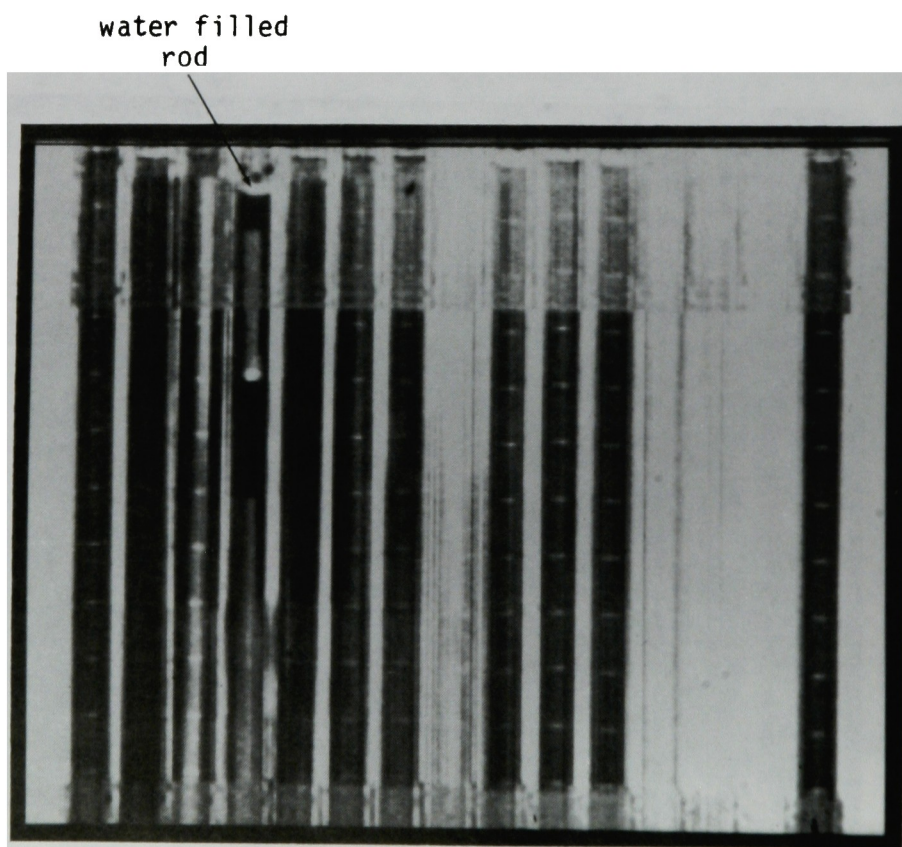
Figure 11. Axial reconstructions using 90 views (a) Row 11 of the TMI-2 assembly mockup and (b) Row 12 of the TMI-2 assembly mockup.

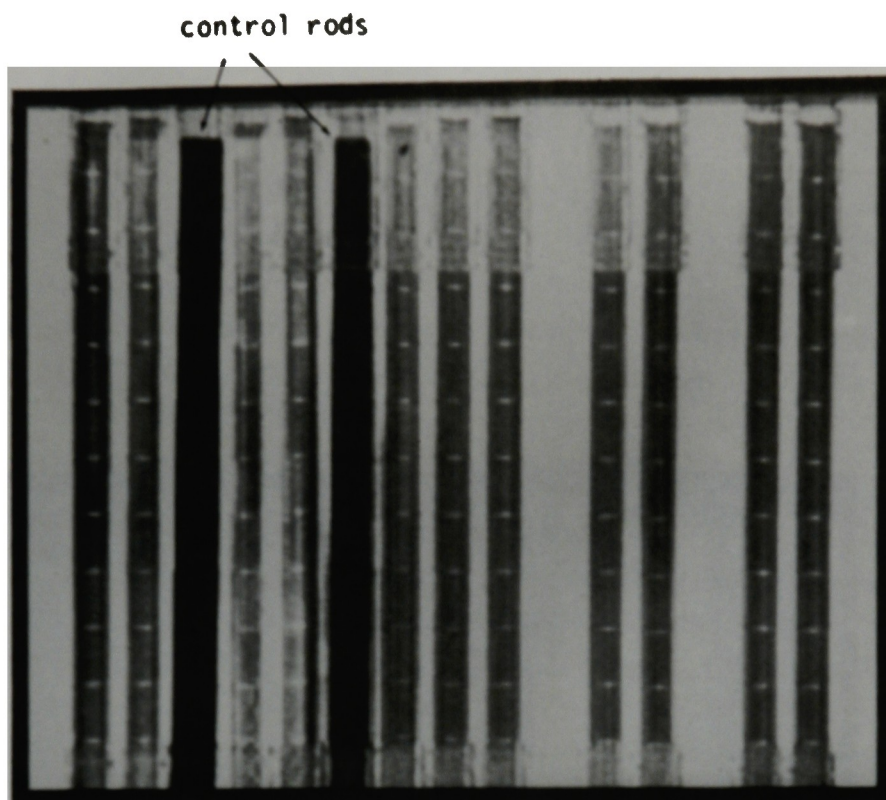
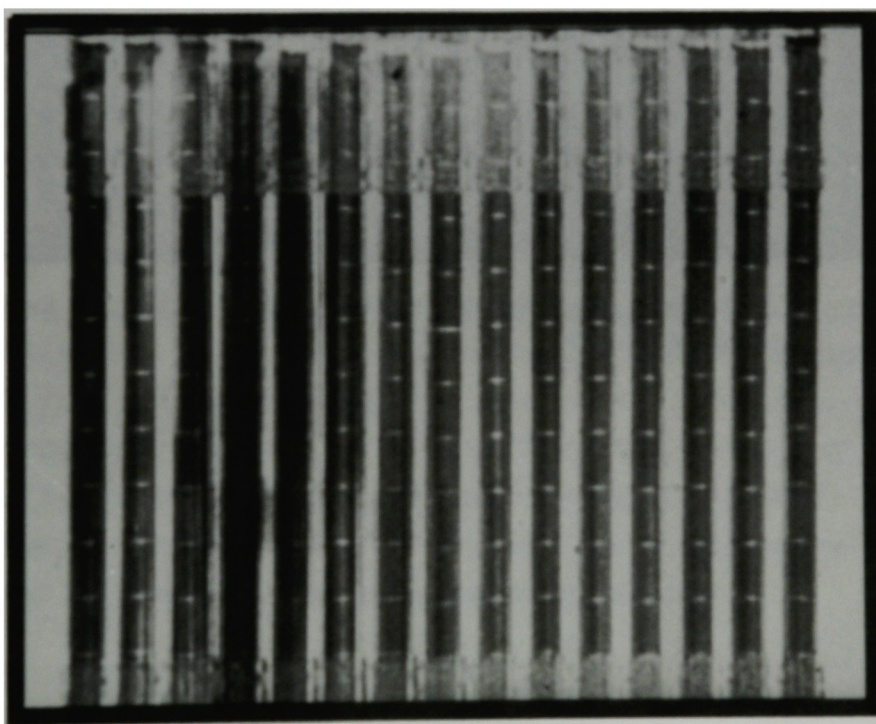
Figure 12. Axial reconstructions using 90 views (a) Row 13 of the TMI-2 assembly mockup and (b) Row 14 of the TMI-2 assembly mockup.

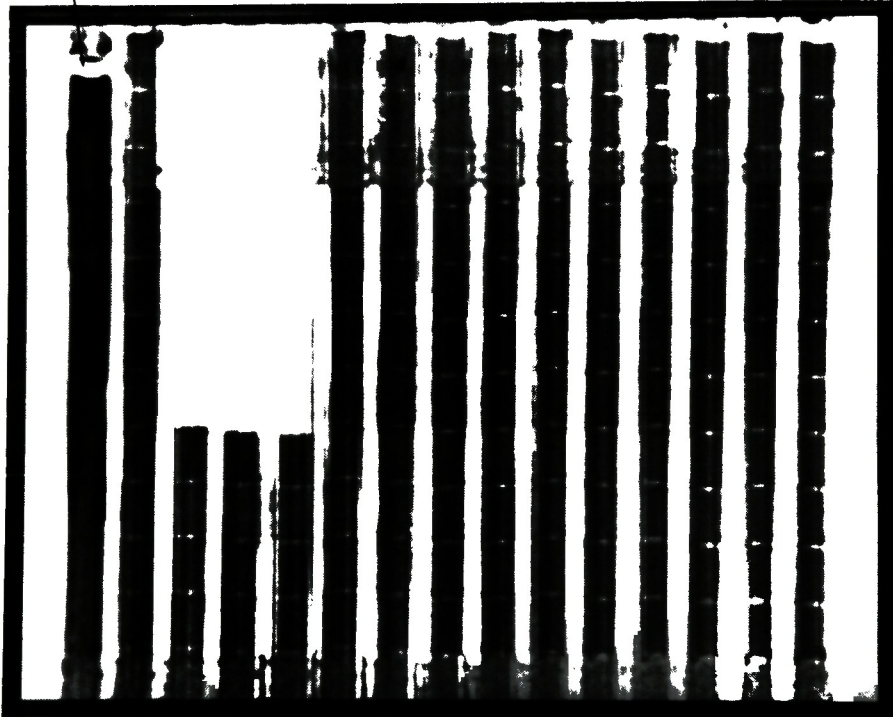
water filled
rod

Figure 13. Axial reconstruction using 90 views for Row 15 of the TMI-2 assembly mockup.

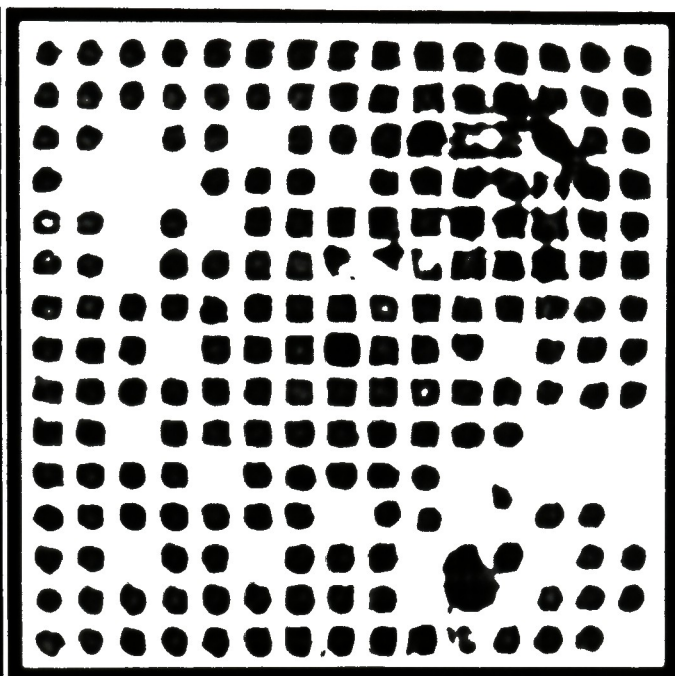
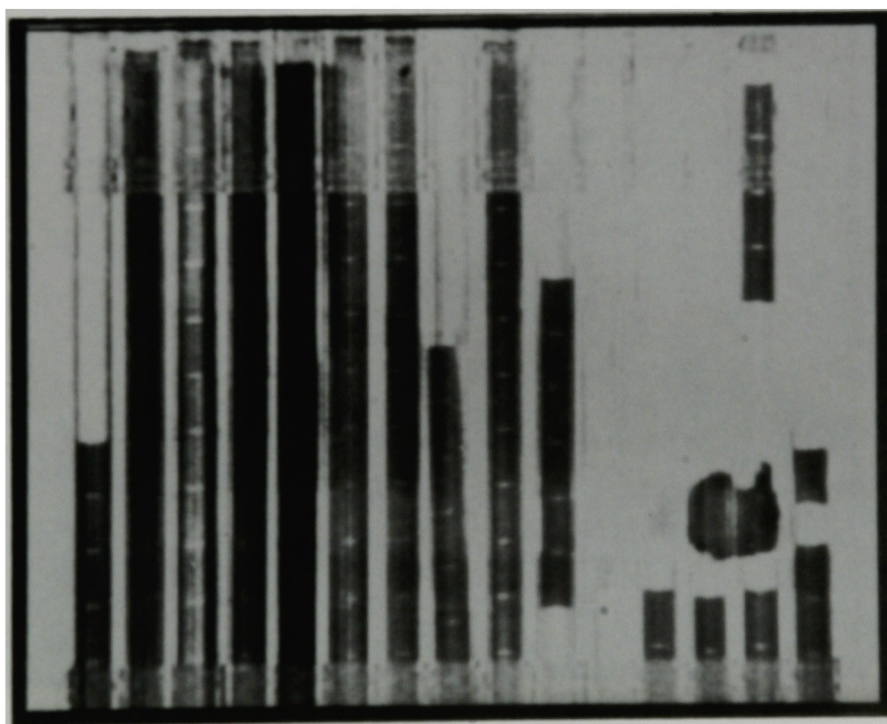
Figure 14. Reconstructions using 90 views (a) within the upper spacer grid, (b) 14.4 cm below the top of the spacer grid, and (c) Row E, axial view.

Cross-sectional reconstructions were computed using 75, 60, 45, and 30 views. Interpolation was necessary to generate 75 and 60 views from 90. No interpolation was required to pick 45 and 30 views from the original 90 as they are integer subsets of the 90 views (2 and 3). Figures 14 through 18 show comparisons of the same cross sectional views using 90, 75, 60, 45, and 30 views, respectively.

The accuracy and resolution of the reconstructed images decreases as the number of views is reduced. The resolution of the transverse cross-sectional images is roughly proportional to the number of views used. The axial cross sections are less sensitive to the number of views, but still suffer some impairment when the number is reduced.

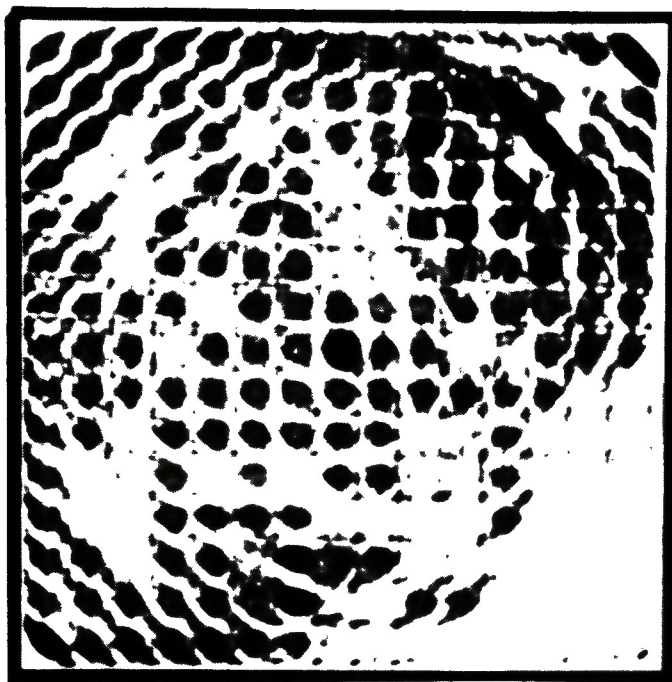
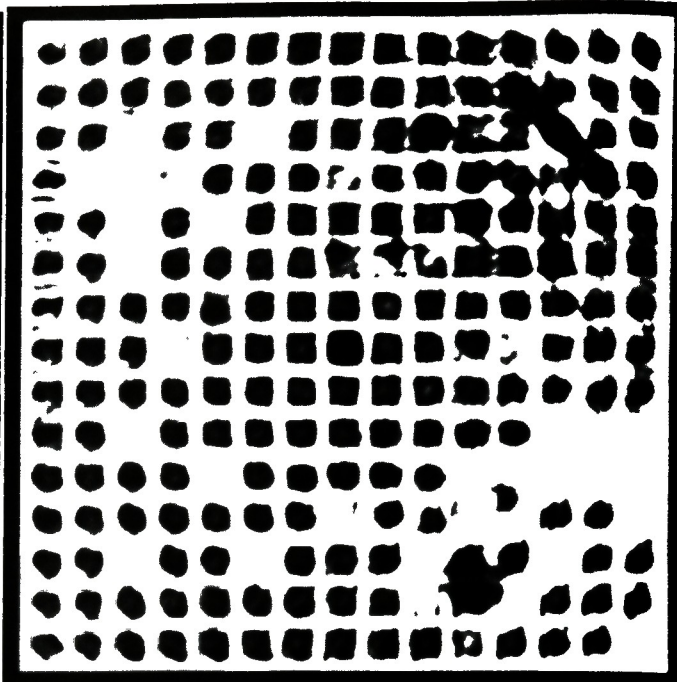
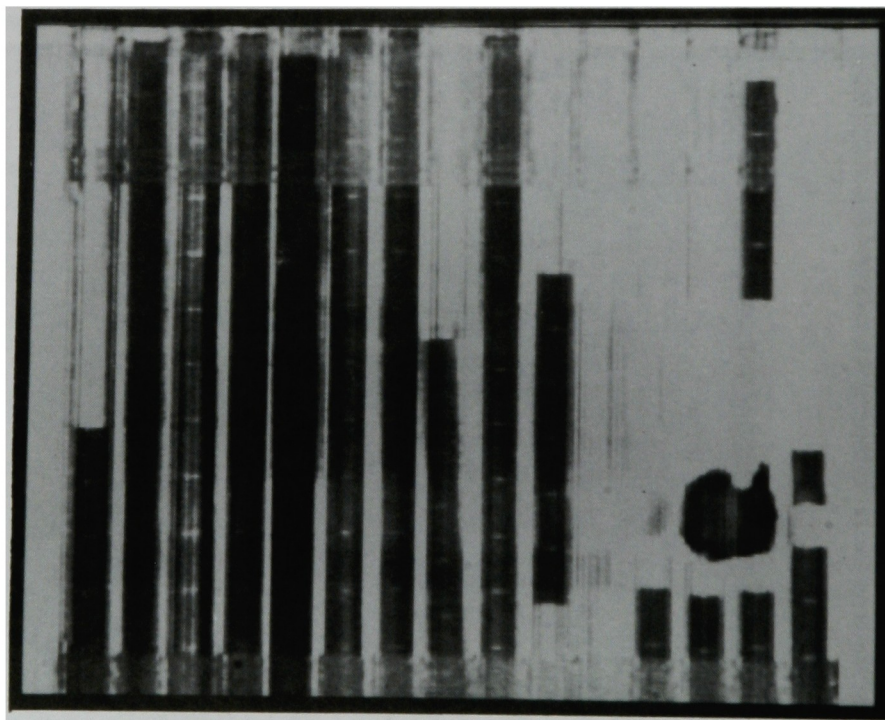
Figure 15. Reconstructions using 75 views--same cross sections as Figure 14 (a) within the upper spacer grid, (b) 14.4 cm below the top of the spacer grid, and (c) Row E, axial view.

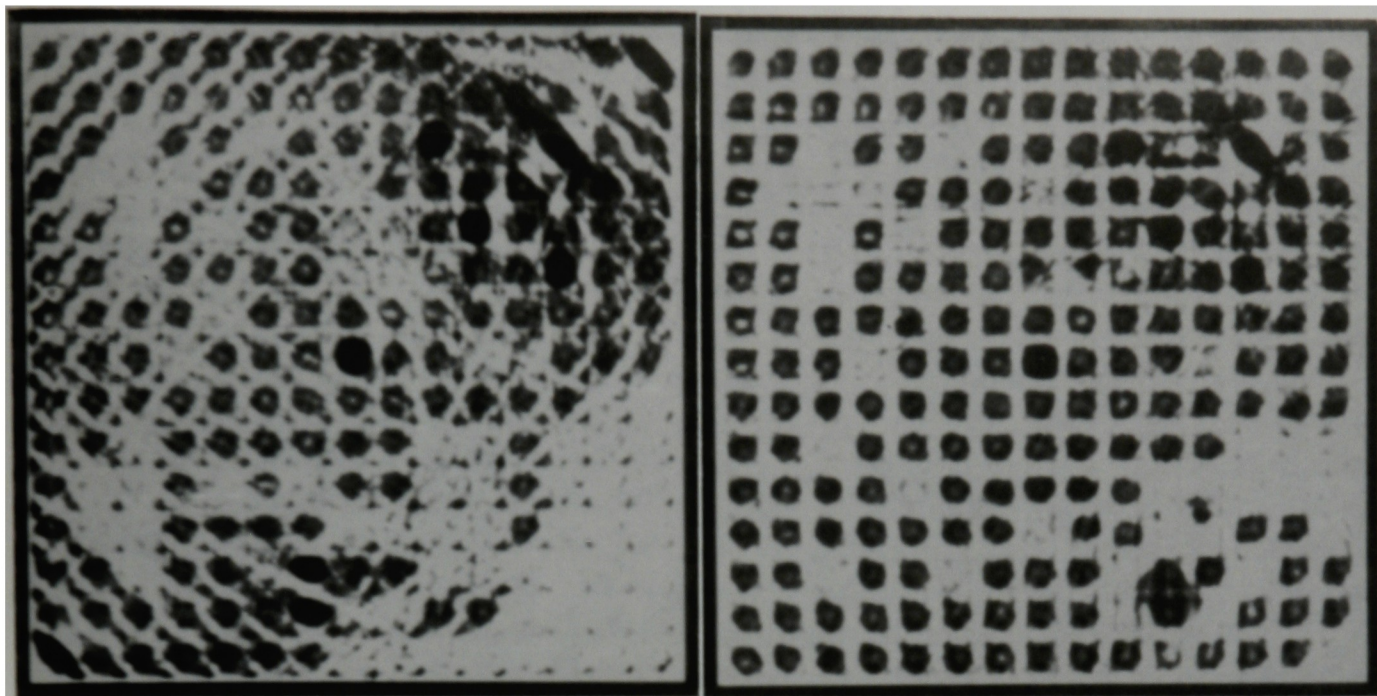
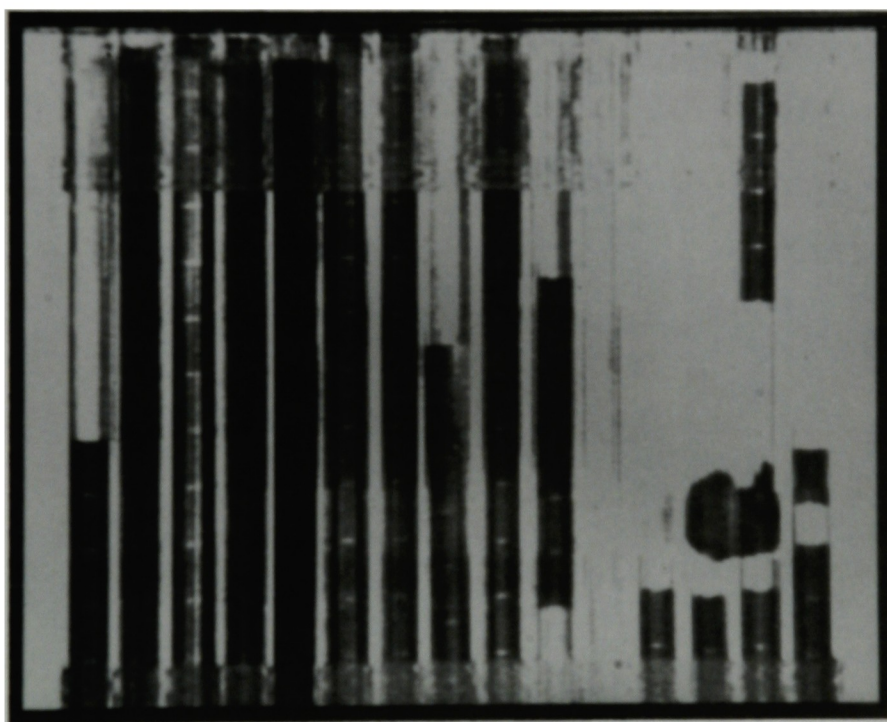
Figure 16. Reconstructions using bU views--same cross sections as Figure 14 (a) within the upper spacer grid, (b) 14.4 cm below the top of the spacer grid, and (c) Row E, axial view.

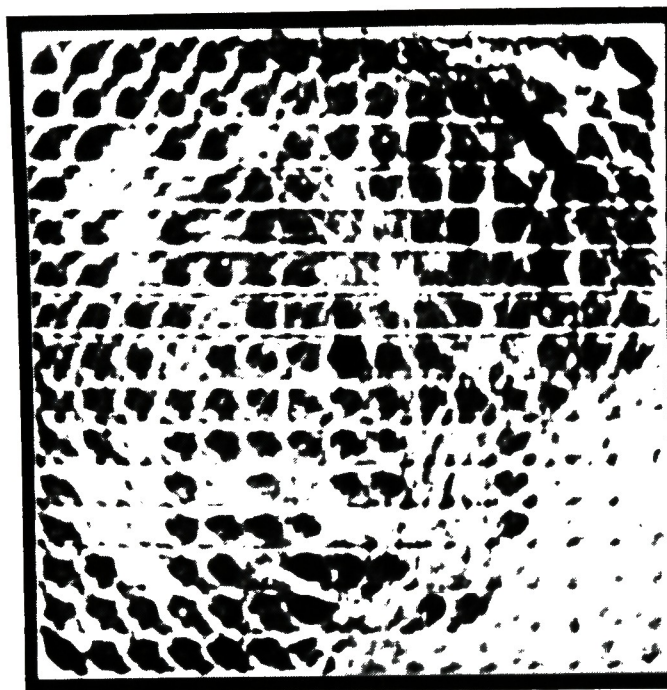
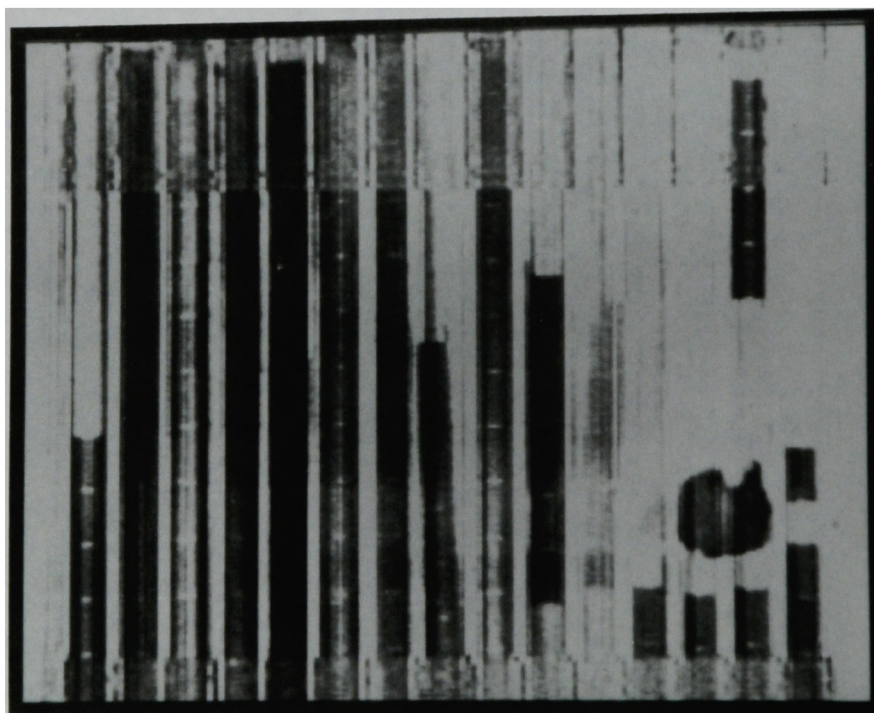
Figure 17. Reconstructions using 45 views--same cross sections as Figure 14 (a) within the upper spacer grid, (b) 14.4 cm below the top of the spacer grid, and (c) Row E, axial view.
