FEASIBILITY OF USING NEUTRON TOMOGRAPHY TO EXAMINE
TMI-2 FUEL ASSEMBLIES (DRAFT)

Idaho National Engineering Laboratory

This report presents results of a feasibility study for using neutron tomography (NT) to examine TMI-2 fuel assemblies. A fuel assembly mockup was constructed to simulate many of the conditions that may exist in actual TMI-2 fuel assemblies and was examined with NT techniques. This study demonstrated that useful and reliable information could be obtained regarding fuel assembly configuration, particularly the location and condition of the fuel and control materials within the assembly.

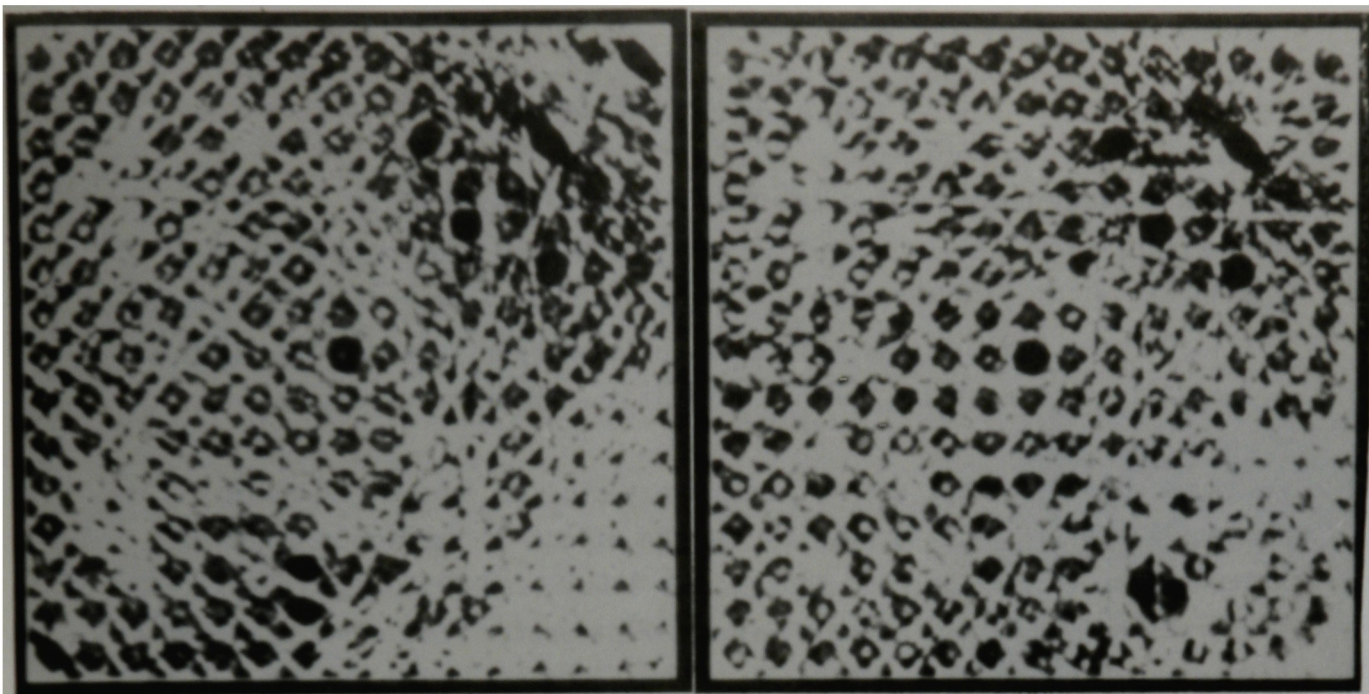
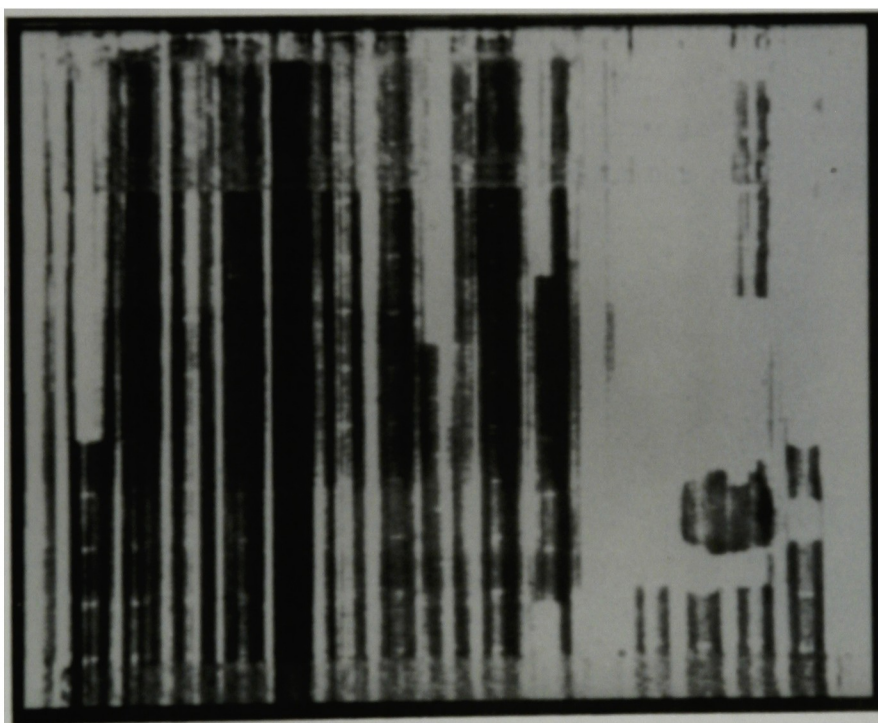
Figure 18. Reconstructions using 30 views--same cross sections as Figure 14 (a) within the upper spacer grid, (b) 14.4 cm below the top of the spacer grid, and (c) Row E, axial view.

Cross-sectional reconstructions were computed using 75, 60, 45, and 30 views. Interpolation was necessary to generate 75 and 60 views from 90. No interpolation was required to pick 45 and 30 views from the original 90 as they are integer subsets of the 90 views (2 and 3). Figures 14 through 18 show comparisons of the same cross sectional views using 90, 75, 60, 45, and 30 views, respectively.

The accuracy and resolution of the reconstructed images decreases as the number of views is reduced. The resolution of the transverse cross-sectional images is roughly proportional to the number of views used. The axial cross sections are less sensitive to the number of views, but still suffer some impairment when the number is reduced.
