Dissolution Testing of a Metallic Waste Form in Chloride Brine

Scientific Basis for Nuclear Waste Management

D. E. Janney

November 2006

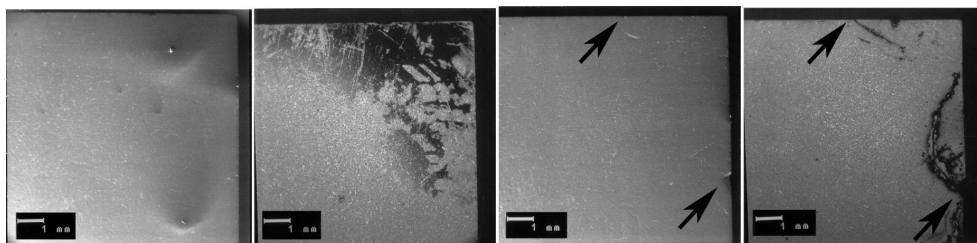
Although most of the surface area of the pH 3 coupon appear similar in pre- and post-test low-magnification SEM images, back-scattered electron (BSE) images show thin corrosion products extending inward from three corners on one side of the sample (left half, Figure 1). Several areas with localized linear or gently curving areas of corrosion products intersect the edges of the sample (right half, Figure 1). Examples of steels and intermetallics in the original eutectic microstructure are indicated by “S” and “I” in some figures.

Figure 1. pH 3 coupon. Scale bars: 1 mm. a: Pre-test SE image showing corner of sample. B: Post-test BSE image of area in Fig. 1a. c: Pre-test SE image showing corner of opposite side of sample. D: Post-test BSE image of area in Fig. 1c.

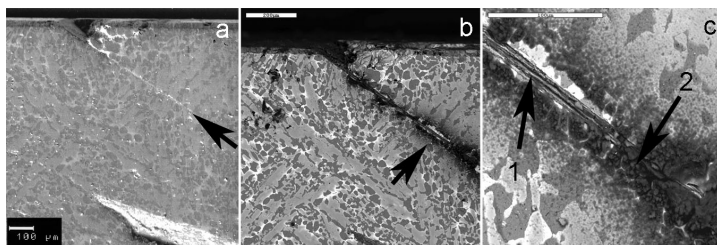
Figure 2 shows the area indicated by the arrow at the top of Figure 1d. Figure 2a was taken before the test, and shows an unidentified linear feature intersecting the edge of the sample at a

notch. Figure 2b shows the same area after the test, with a line of corrosion products following the original linear feature. Figure 2c, a higher magnification view of the area indicated by the arrow in Figure 2b, shows a line of longitudinally grooved corrosion products below the sample surface, surrounded and in some cases covered by porous corrosion products on the sample surface.

Figure 2. pH 3 coupon. a: Pre-test SE image, scale bar: 100 μm . Arrow shows linear feature. b: Post-test image of the same area, scale bar: 200 μm . c: Area shown by arrow in part b, scale bar: 100 μm . Numbers indicate locations of EDX spectra 1 (material below sample surface) and 2 (material above surface) in Table I.

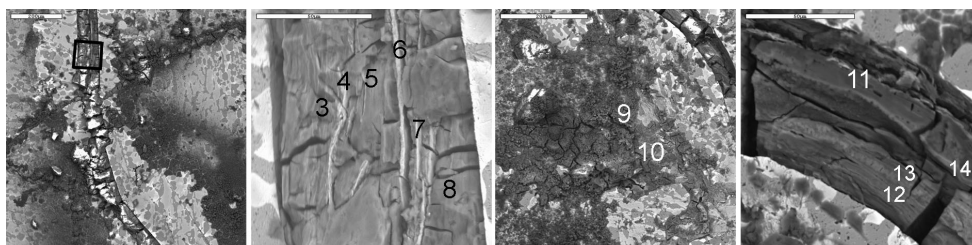
Figure 3 shows details of two broader bands of corrosion products, both of which occur in channels extending below the sample surface. Edges of the channels are sharp and cut across phase boundaries in the original eutectic microstructure. The material inside each channel has a complex structure with layers approximately parallel to the edges of the channel. Spectra 4, 6, and 7 (Fig. 3b) are from three approximately parallel, light-colored layers, while Spectra 3, 5, and 8 (Fig. 3b) and 11-14 (Fig. 3d) are from darker areas. Spectra 9 and 10 are from surface corrosion products adjacent to a channel.

Figure 3. Post-test BSE images, pH 3 coupon. a) Section of curving dark area at right of Figure 1d, scale bar: 200 μm . b. Area shown by box in part a, scale bar: 50 μm . c. Section of a curved dark area and adjacent surface deposits, scale bar: 200 μm . d: Section of curved dark area just above field of view in part c, scale bar: 50 μm . Numbers indicate locations of EDX spectra in Table I.

Table I. Compositions from EDX spectra in Figures 2-4, normalized to 100 at% (“L” indicates material in channels that appears light in BSE images, “D” indicates dark-colored material in channels, and “S” indicates material on the sample surface)

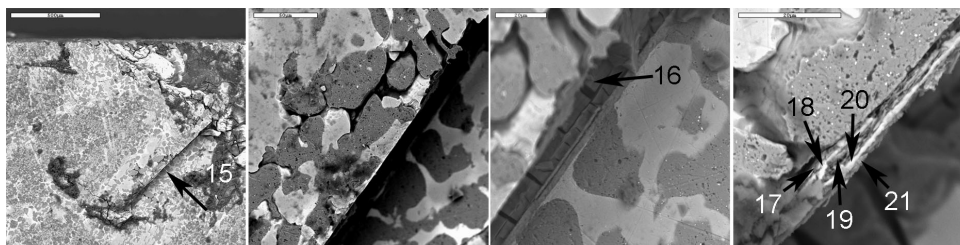
Figure 4 shows a tilted, approximately triangular area that has been partially lifted above the rest of the sample surface. Spectrum 15 is from corrosion products on the sample surface near the wedge, and 16 is from material below the sample surface adjacent to the uplifted edge of the wedge. Although Spectra 18-21 are currently above the surface of the majority of the sample, they are below the surface of the wedge. Because their morphologies and compositions resemble those of materials in channels, they are interpreted as material that formed below the surface and was raised when the wedge was lifted.

Recessed areas in the uplifted wedge in Figure 4 suggest that the intermetallic materials and materials along grain boundaries are absent. Steel phases in these areas show extensive pitting. Although the pre-test images do not offer conclusive proof, it seems unlikely that sharp edges and pits such as those visible here could be retained while the sample was ground with 1200-grit paper, and the recessed areas and pits probably formed during the immersion tests.

Figure 4. Post-test BSE images, pH 3 coupon. a) Partially uplifted wedge-shaped area, scale bar: 500 µm. b. Area shown by arrow in part a, scale bar: 50 µm. c. Layered materials at sample surface (upper right portion of Fig. 4c), scale bar: 20 µm. d: Layered materials attached to edge of uplifted wedge, scale bar: 20 nm. Numbers indicate locations of EDX spectra in Table I.

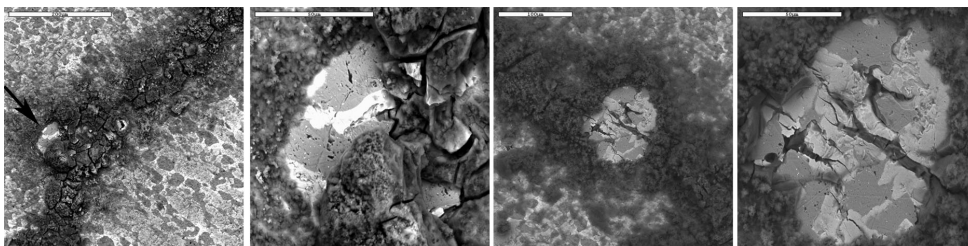
Most of the corrosion products visible on the pH 4 coupon appear as highly porous materials above the sample surface. The underlying material can be seen in a few areas where the corrosion products appear to have broken away. Figure 5 shows one such area, which has recessed areas in intermetallic materials and along grain boundaries. Sharp edges on the recessed areas again suggest that they formed during the immersion tests. Corrosion products in sharp-edged channels extending below the sample surface were also observed where the porous corrosion products had broken away.

Figure 5. Post-test BSE images, pH 4 coupon. a: Line of corrosion products on sample surface, scale bar: 200 μm . b: Area indicated by arrow in Fig. 6a, scale bar: 50 μm . c: Hole in line of corrosion products on sample surface, scale bar: 100 μm . d: Central part of Fig. 5c, scale bar: 50 μm .

EDX data from the pH 4 coupon are almost entirely from corrosion products above the sample surface, and consist primarily of Cr and Fe in varying proportions. Although the highest concentration of U is ~17% (comparable to the maximum reported in uncorroded waste forms with 11% U [1, 2]), correlations between it and other elements are less clear than in the pH 3 coupon. The single spectrum collected from material below the sample surface is from the central part of Fig. 5d and shows ~30% Cr, 57% Fe, 6% Ni, 3% Zr, 2% Mo, and 1% U.
