Uranium Casting Materials Development: HfN Testing Summary

January 2017

**Prepared for
TerraPower, LLC
Under CRADA 13CR13
Under DOE Idaho Operations Office
Contract DE-AC07-05ID14517**

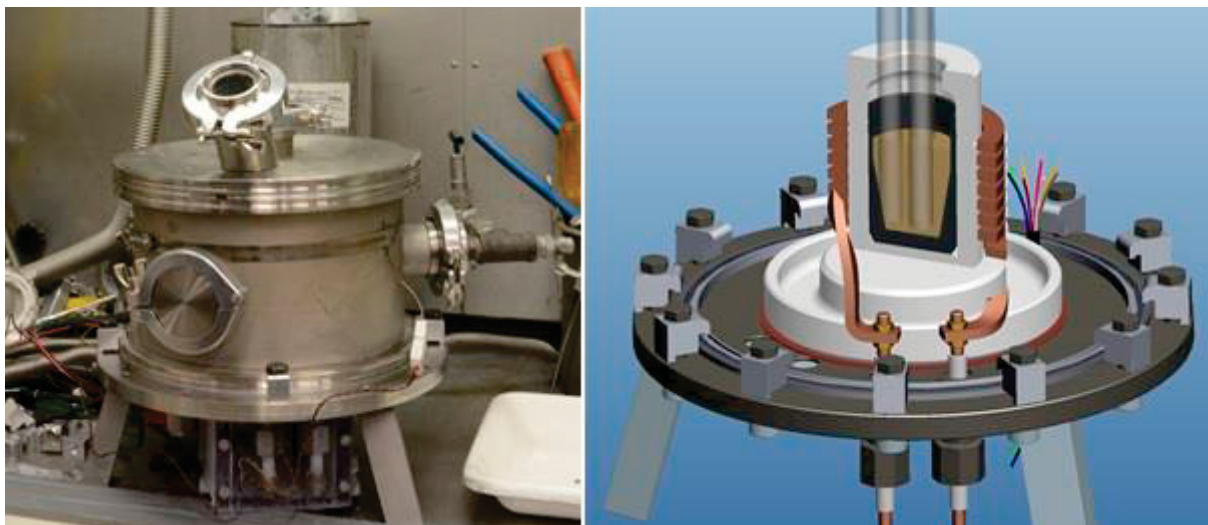
Figure 1. BCS-II shown in the fume hood (left) and internal cut-away schematic showing basic internal components (right).

Dip testing was carried out using the Benchtop Casting System-II (BCS-II) vacuum induction melting and casting furnace. The BCS-II is an induction heated furnace which utilizes Y_2O_3 coated graphite crucibles. Figure 1 shows the BCS-II in the fume hood and cut-away schematic showing the basic internal components. Although, the furnace was slightly reconfigured to perform the dip testing. Uranium and zirconium or pre-alloyed feedstocks were loaded into the crucible at a ratio to provide a final alloy having 10% zirconium, by mass. Uranium rods 0.5" diameter cut to various lengths, SPM# 182-60-1174, were used and the zirconium feedstock was excess zirconium obtained for EBR-II fuel fabrication in the form of thick machine turnings. A graphite dipping fixture was designed to hold the coated samples. A sketch of the fixture used for the first and fourth test is shown in Figure 2. The fixture was machined from graphite, with a threaded connection to a graphite rod that was fed out of the furnace for manual insertion into or out of the melt. Coated coupons were fastened to the fixture through refractory metal screws, also shown in the sketch. The center pillar shown on the fixture was included to ensure a consistent depth of dip from test to test. The second and third tests utilized a single graphite rod with a threaded connection that connected to the coated coupon without depth control. For each dip test the furnace was heated to 1450°C and the sample dipped into the molten melt for 1 minute, then the furnace was allowed to cool. Following cooling the samples and melted charge were examined.

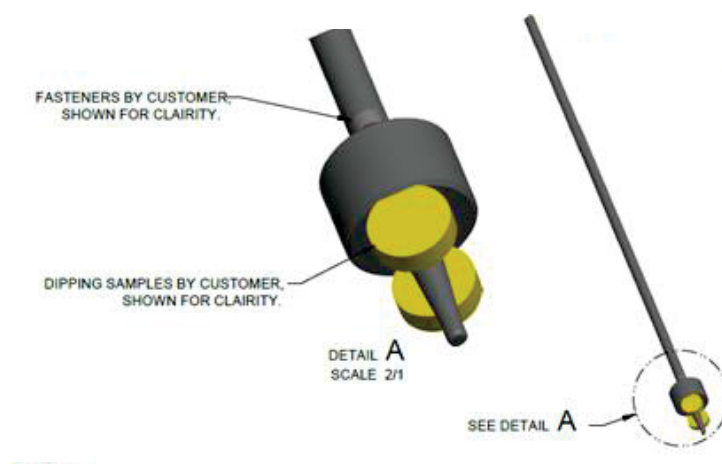
Figure 2. Dipping fixtures used for the first two dip tests.

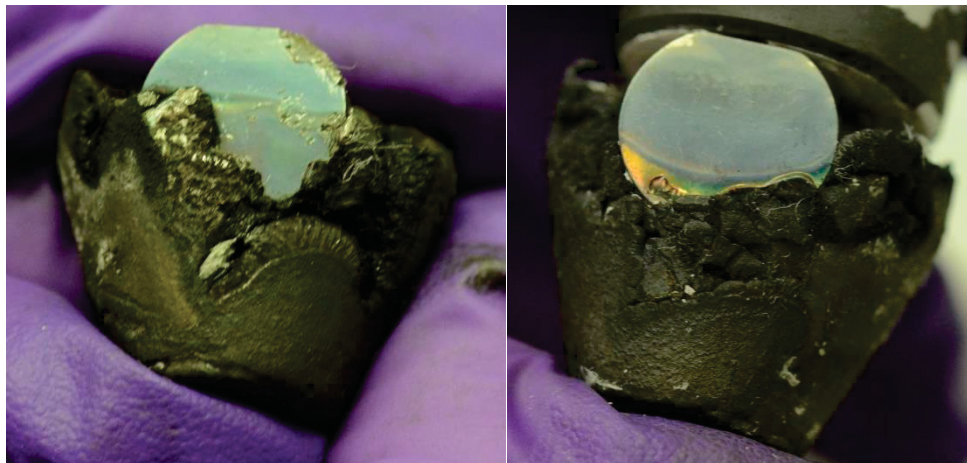
Figure 3. Result of the first dip test HfN-1 (left) and HfN-2 (right).

Figure 3 shows the resulting ingot and samples from the first dip test. Figure 4 shows the heating profile from the test. The samples were dipped when the furnace reach approximately 1550°C. The furnace started to cool after the samples were inserted and then was heated again settling at approximately 1450°C. The total time the samples were exposed to the melt was approximately 18 minutes. The figure clearly shows that the ingot was heavily oxidized despite being evacuated and purged with argon several times and being run under a dynamic vacuum. The ingot showed indications that the individual zirconium and uranium feedstocks did not fully melt and coalesce. The coated sample was held tightly in the ingot and could not be removed. However, due to the extensive oxidation of the melt there is concern whether

the coupon was in actual contact with the molten material or rather the oxide shell. Some damage can be seen on sample HfN-1, although the damage is above the melt and is most likely mechanical damage caused during subsequent handling and efforts to remove from the ingot. HfN-2 shows less mechanical damage; however, an interaction layer can be seen just above the fuel line. Further microstructural investigation of the samples was not performed because the melt did not fully coalesce.

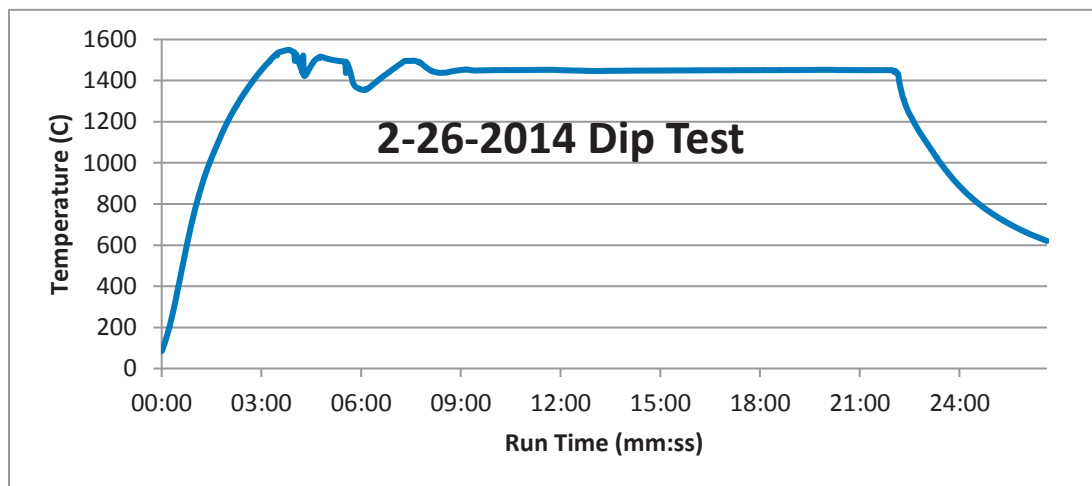
Figure 4. Heating profile of the first dip test.

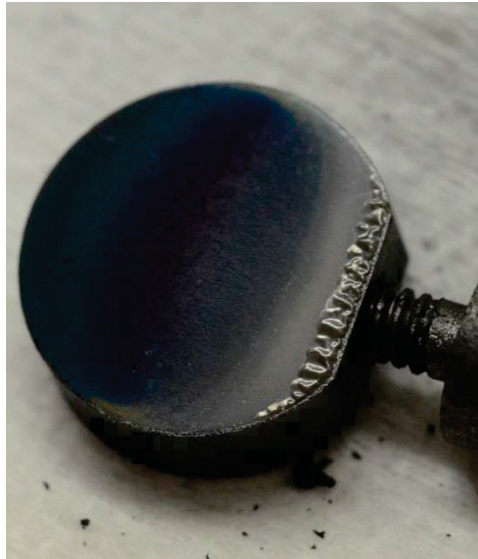
Figure 5. Resulting sample from the second dip test. Notice the coating degradation along the right side of the figure.

Based on this test, the next test used a pre-alloyed U-10Zr button as feedstock. The heat cycle was similar; however, to allow more time for any off gas to be removed from the system by the vacuum the heat up rate was much slower. The charge was brought up to 1450°C and the test coupon dipped. In order to conserve samples the dipping fixture was changed to a single sample. The pre-alloyed button used was fabricated using the arc melting process, which results in a well-mixed alloy. The sample was dipped and removed from the melt and examined. The resulting sample is shown in Figure 5. From the appearance of the sample, it appears that either the sample was not inserted into the crucible deep enough to make

contact with the molten pool or because of the heavy oxide layer which was present on the melt full contact was not achieved. However, although there was no obvious melt/coupon interaction, the coating does show signs of degradation from either oxidation or the thermal cycle or a combination of both.

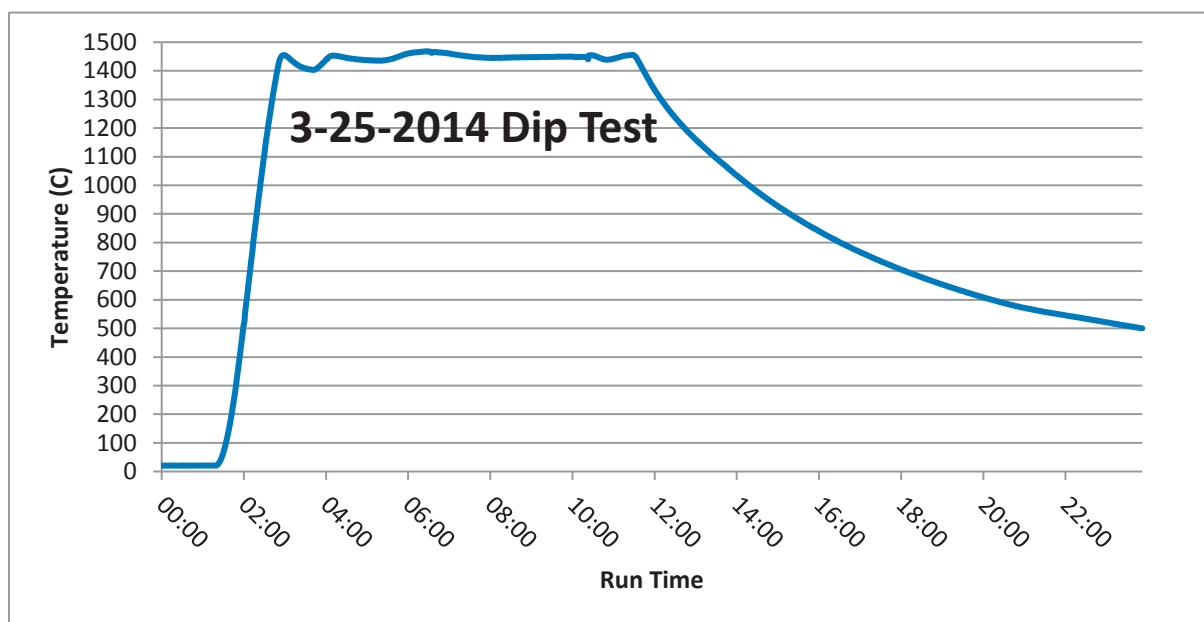
Figure 6. Heating profile showing rapid ramp rate to decrease time alloyed for oxidation.

Due to the excessive oxidation seen in the previous two tests, the third test used a much faster heating rate in order to achieve the 1450°C melt temperature with as little time to oxidize as possible. The heating profile is shown in Figure 6. In this test, the entire sample was immersed in the melt. The resulting disc and heel are shown in Figure 7. The resulting heel appears to be fully melted and consolidated with no remaining uranium or zirconium shells visible. The sample also appears to have no visible damage due to exposure to the melt; however, the fuel material adhered tightly to the sample and could not be removed.

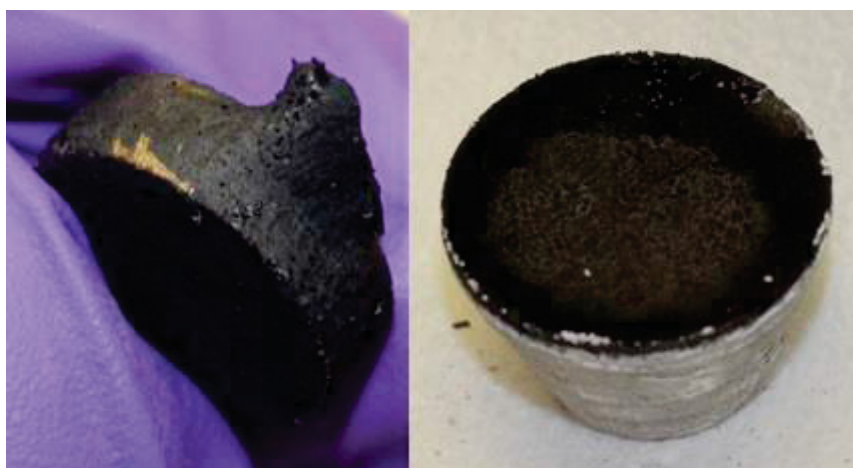
Figure 7. Resulting sample from the third dip test (left) and the third dip test heel showing no undissolved zirconium or oxide shells (right).

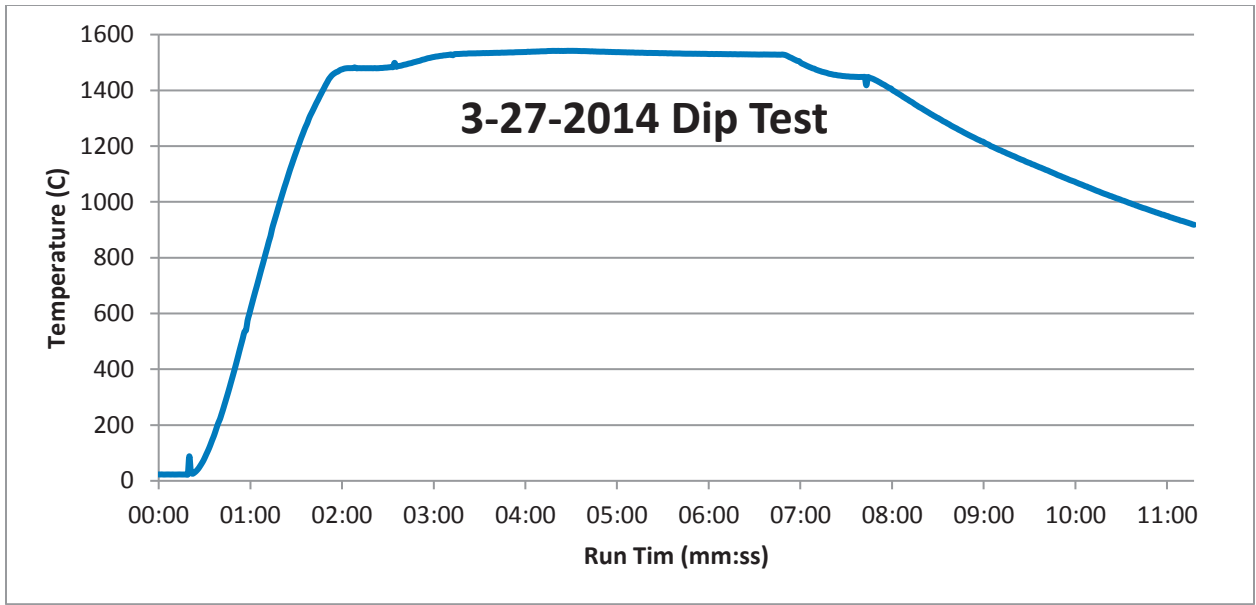
Figure 8. Thermal profile resulting from the fourth and final dip test, which used two samples dipped simultaneously.

Because of the success of the third dip test a final test was performed with the original fixturing which contained two HfN coated specimens. This final dip test again used a high heating rate in order to reduce the amount of time for additional oxidation. The thermal profile is shown in Figure 8. Once 1450°C was reached the temperature was held for approximately 5 minutes before the samples were dipped into the melt, exposed for 1 minute and withdrawn. The test went well with approximately half of the discs being coated with the fuel alloy. The resulting test samples, resulting heel, and dipping fixture are shown in Figures 9–11. Visual examination of the coated samples showed the sample to be fully intact and partially covered with the alloy, with some signs of oxidation as well. The adhering material appeared firmly attached to the specimens and could not be removed through scraping. The samples were sectioned through the center axis and mounted for metallographic inspection; however, due to programmatic priorities, the inspections did not take place.

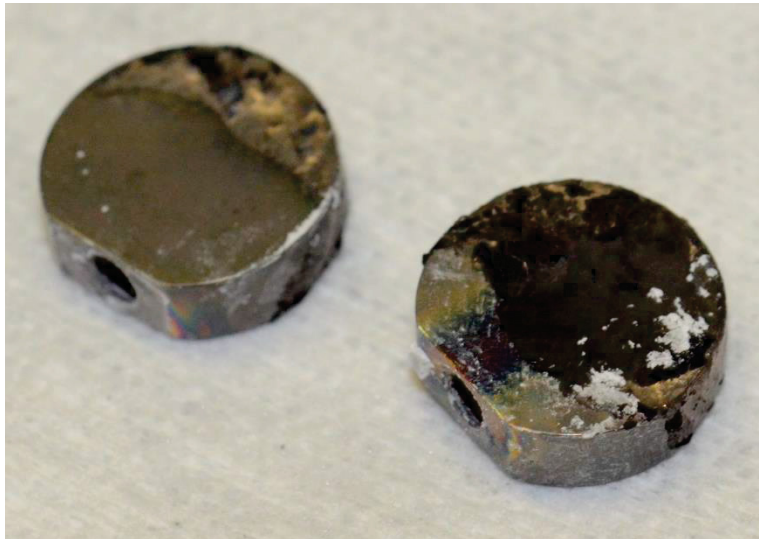
Figure 9. Resulting discs from the fourth dip test.

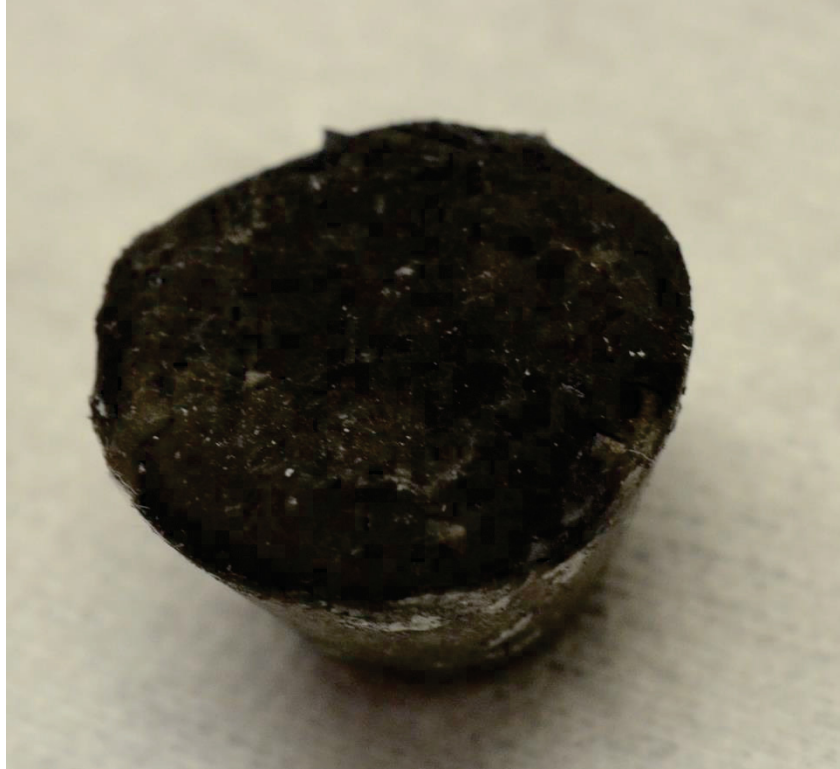
Figure 10. Resulting heel from the fourth dip test.

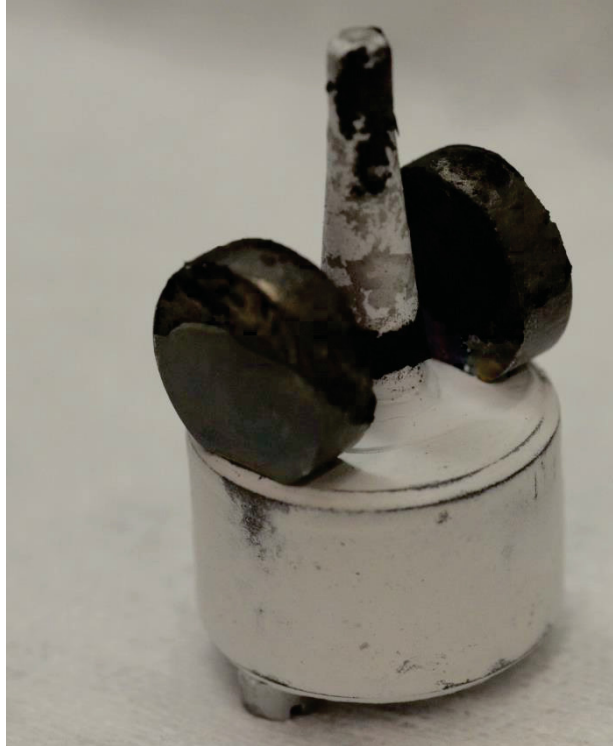
Figure 11. Resulting samples connected to dip fixturing.
