Natural Language Processing-Enhanced Nuclear Industry Operating Experience Data Analysis: Causal Learning and Inference

Sai Zhang

May 2, 2023

Idaho National Laboratory, USA

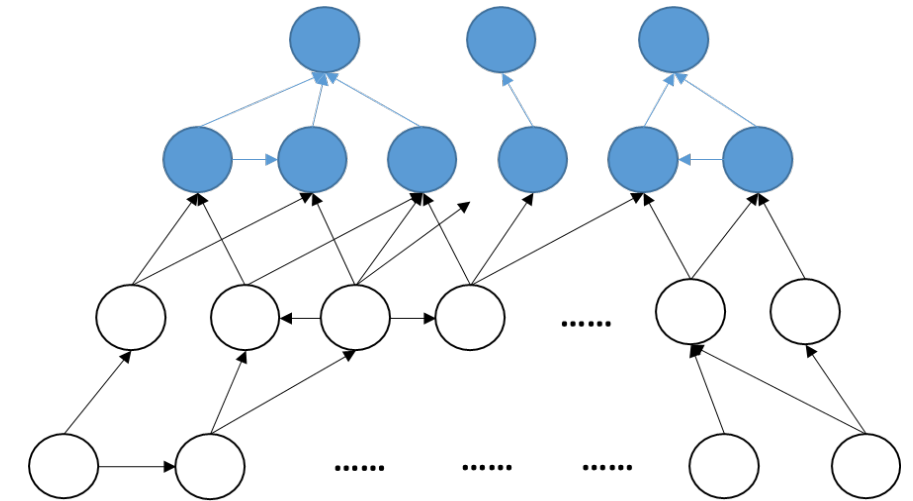
NLP-
Enhanced
Analysis

Output: directed acyclic graph

Input: free-text event report

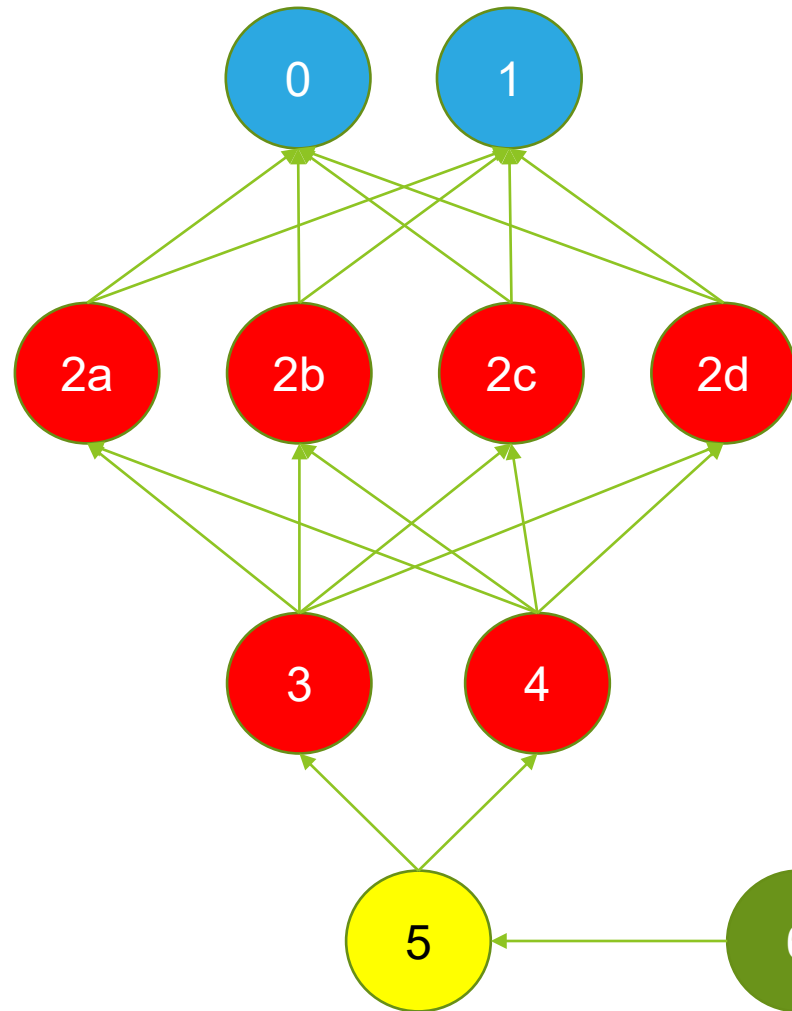
Results (One Event Report)

0. An acrid odor in control room

1. Entry into a 24-hour shutdown action statement

6. Steam dump control relay coil failure

8. Relay coil age being beyond the vendor recommended life

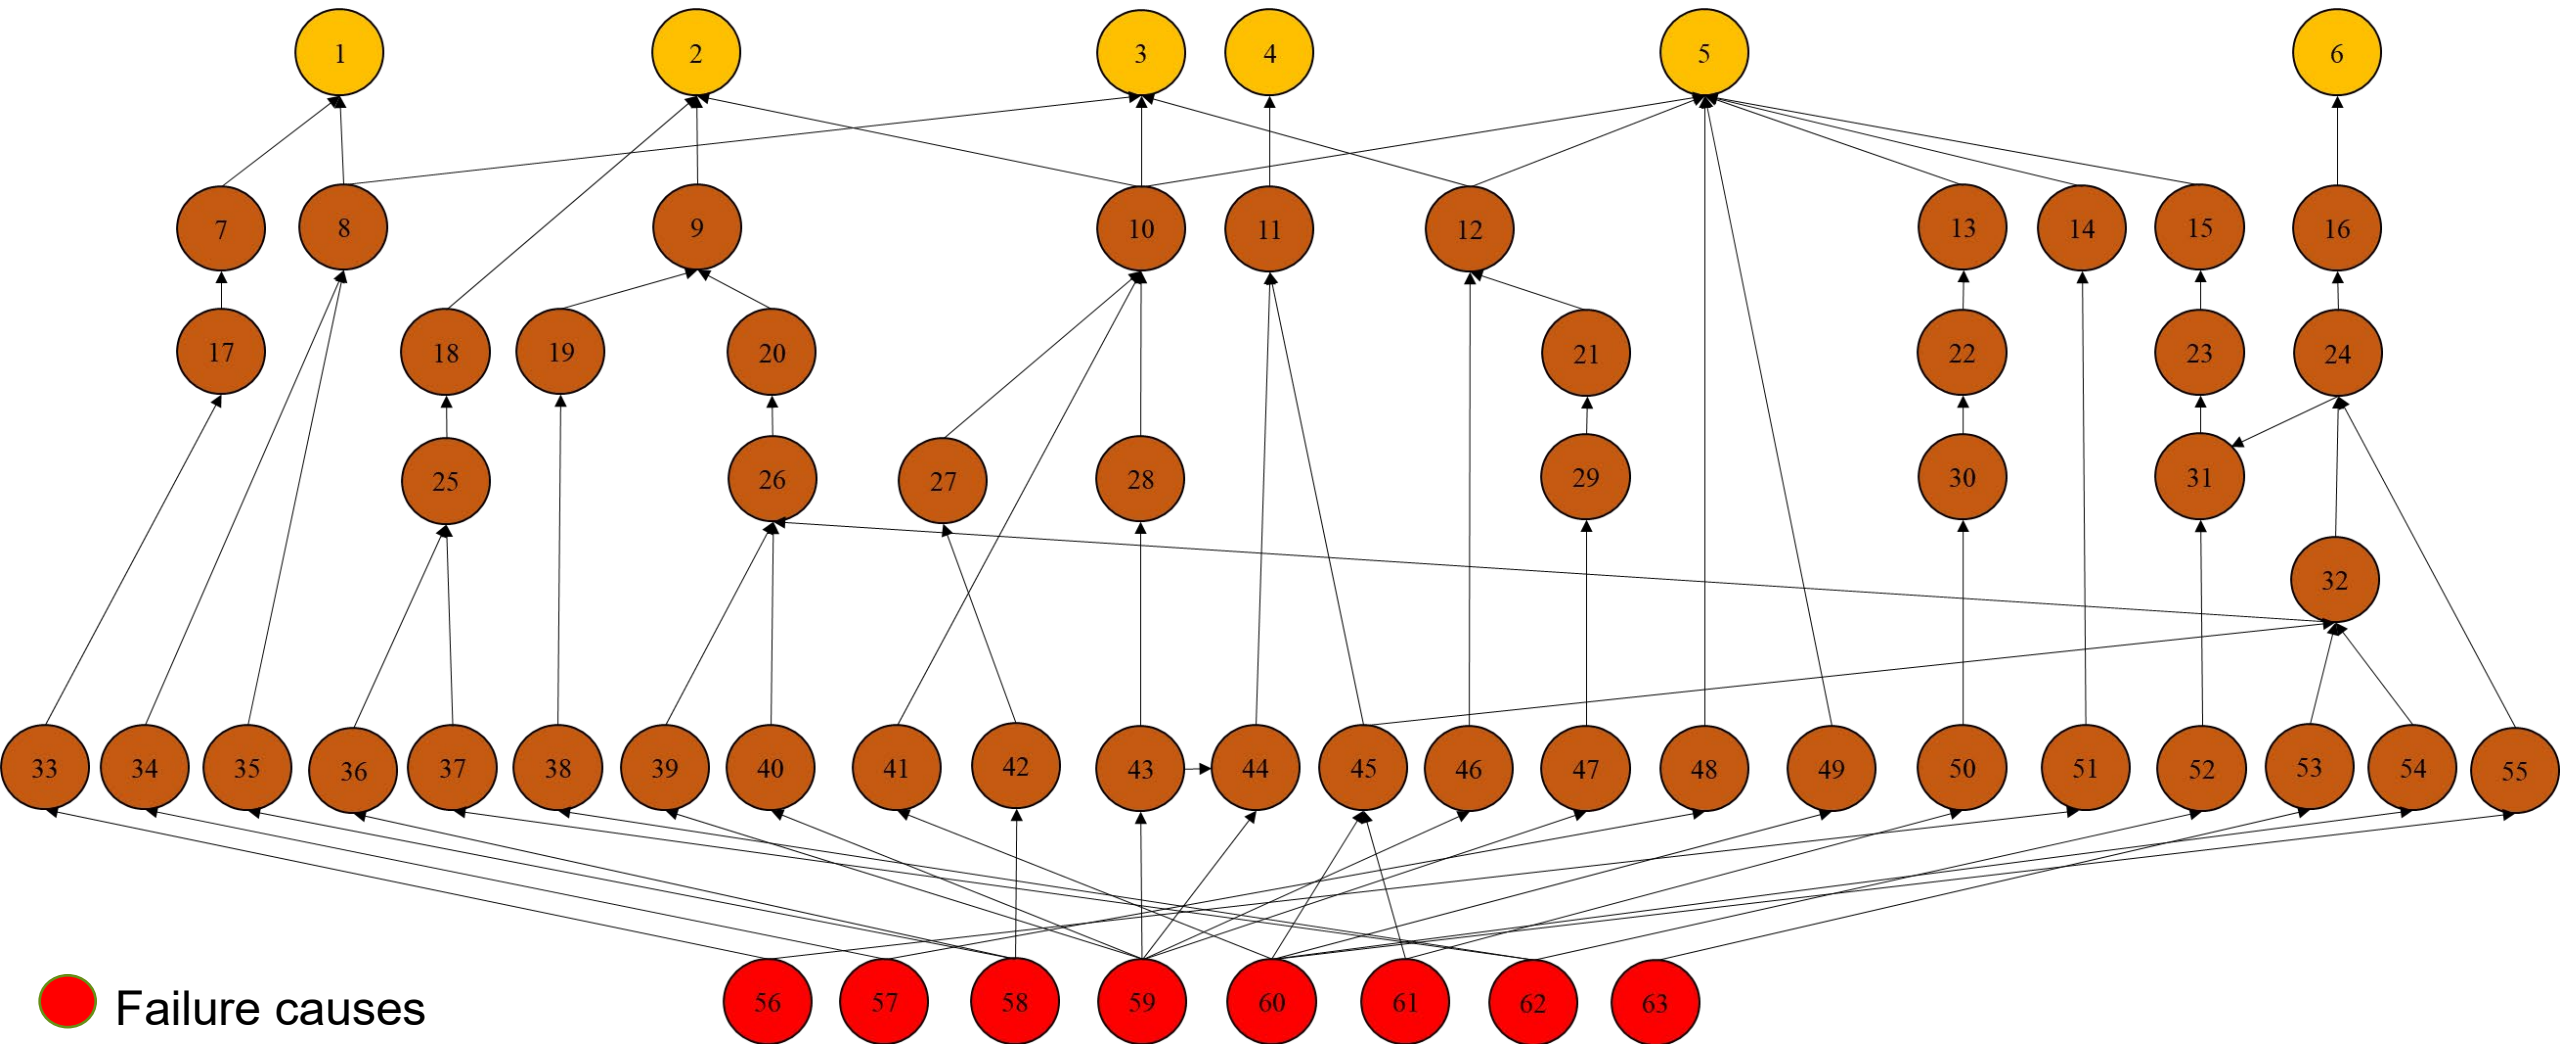
Results (Twenty Event Reports)

● Failure causes

● Failure modes

- Developed an NLP tool to extract and aggregate causal relations from multiple reports
 - Input: event narratives
 - Output: a causal network representing failure initiations and propagations
