DROP TESTS OF THE THREE MILE ISLAND KNOCKOUT CANISTER

Published January 1987

Oak Ridge National Laboratory Oak Ridge, Tennessee 37831 operated by Martin Marietta Energy Systems, Inc. for the Department of Energy Under DOE Contract No. DE-AC05-74OR21400

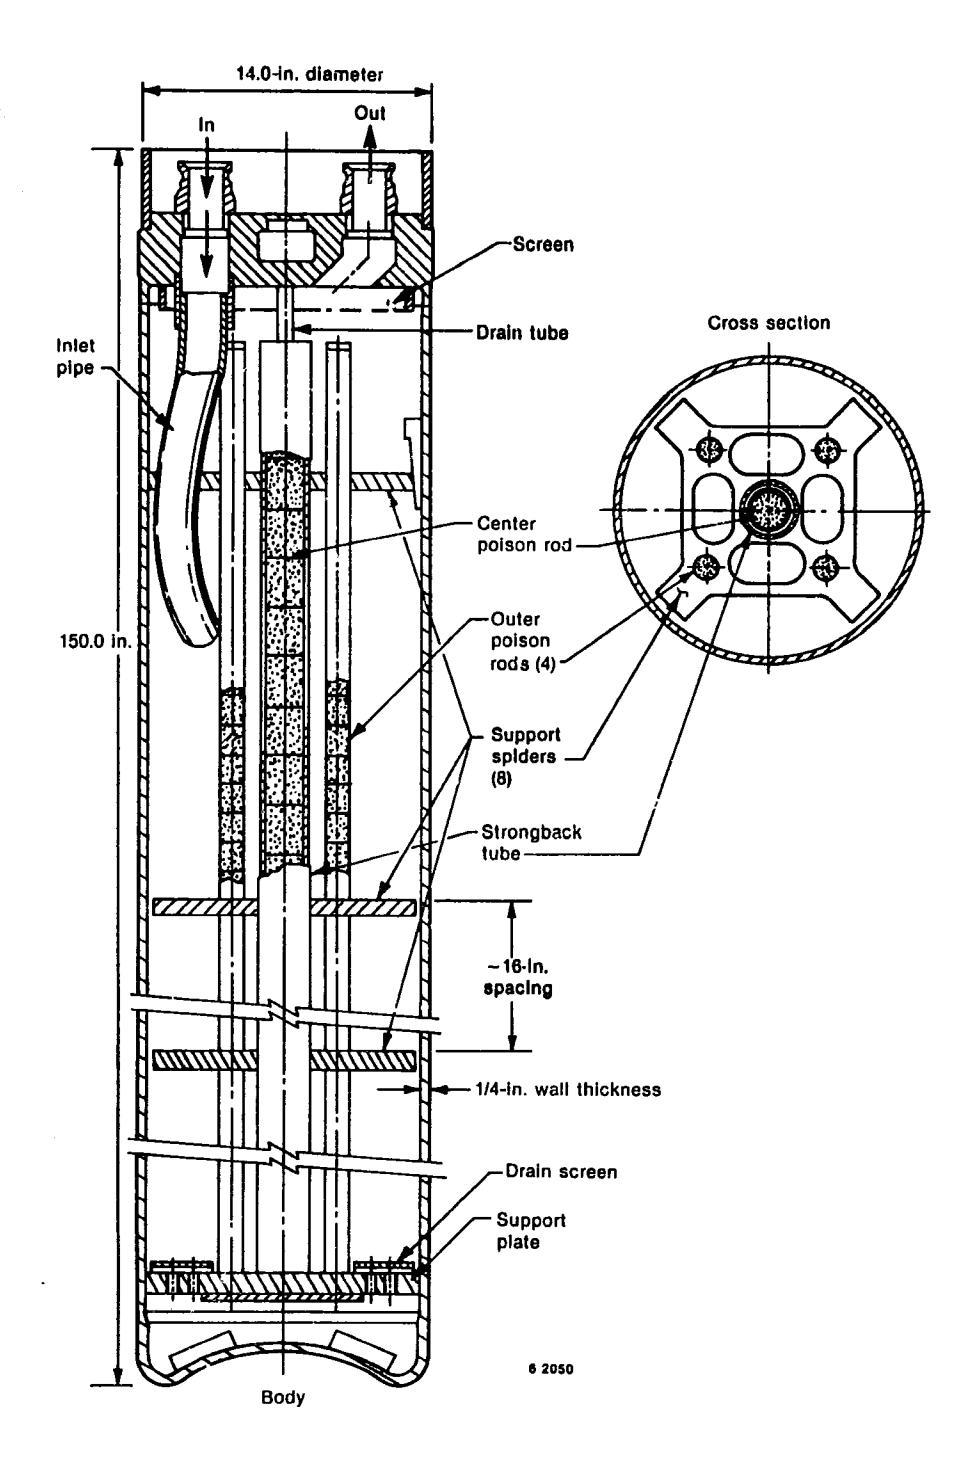
Fig. 2.1. Knockout defueling canister.

The knockout canister (Fig. 2.1) is one of three types of defueling canisters that have been designed to implement the removal and storage of fuel debris from the damaged TMI-2 reactor. The three canisters, called the fuel, knockout, and filter canisters, all use a 35.6-cm-0.D. (14-in.-0.D.), 0.64-cm-wall (0.250-in.-wall) pipe made of 304L stainless steel as the outer shell. In each type, the lower head is a reversed dish made of 0.45-cm (0.375-in.)-thick 304L stainless steel. The upper head of the knockout canister is a flat plate closure that is welded to the shell. The thick, metal plate upper heads are made of 10.1-cm (4-in.)-thick 304L stainless and contain penetrations for hydraulic loading and dewatering. The head has a recess machined into the center for interfacing with the handling grapple. The penetrations in the upper head are fitted with quick-disconnect couplings using a nucleargrade pipe sealant during attachment to the top head. A skirt on the upper head extends 10.1 cm (4 in.) beyond the top to protect the disconnect fittings. The total length of the knockout canister is 380 cm (149.75 in.).

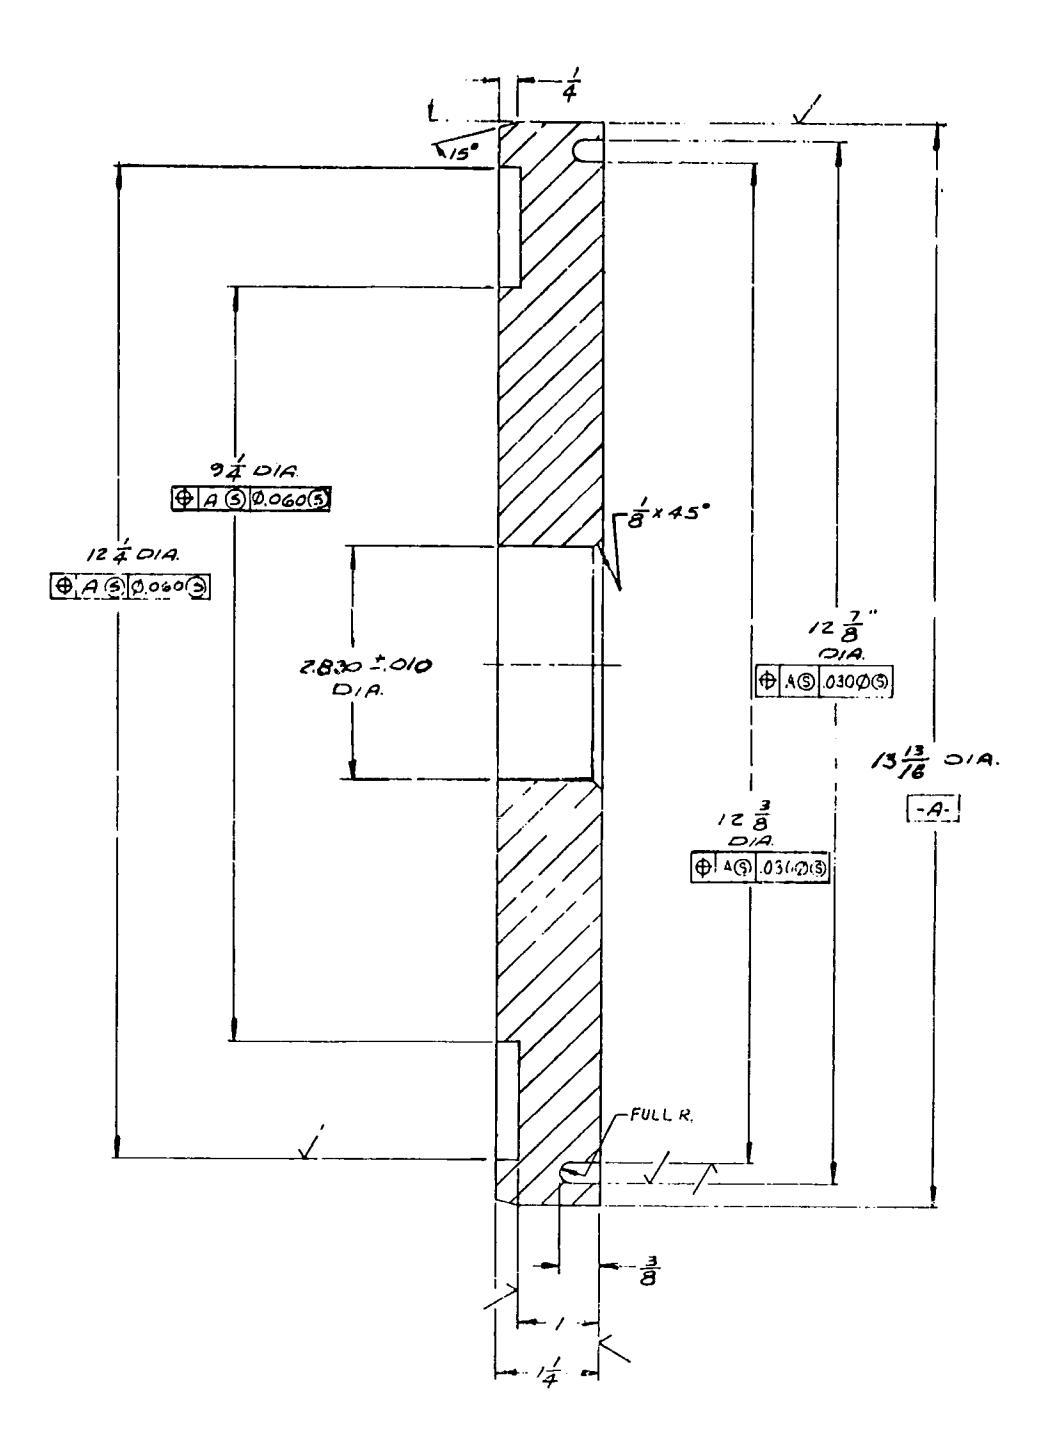
Fig. 2.2. Lower support plate for internal poison rod assembly. Source: Engineering drawing No. 1150950E, Babcock & Wilcox, Lynchburg, Virginia, 1984.

The internal assembly (Fig. 2.2) is supported from a 3.175-cm (1.25-in.)-thick lower support plate and is positioned at the top of the canister by welded chock blocks at the upper support plate. An absorber array of four outer rods around a central rod is located in the canister for criticality control. The outer rods are 3.34 cm (1.315 in.) in

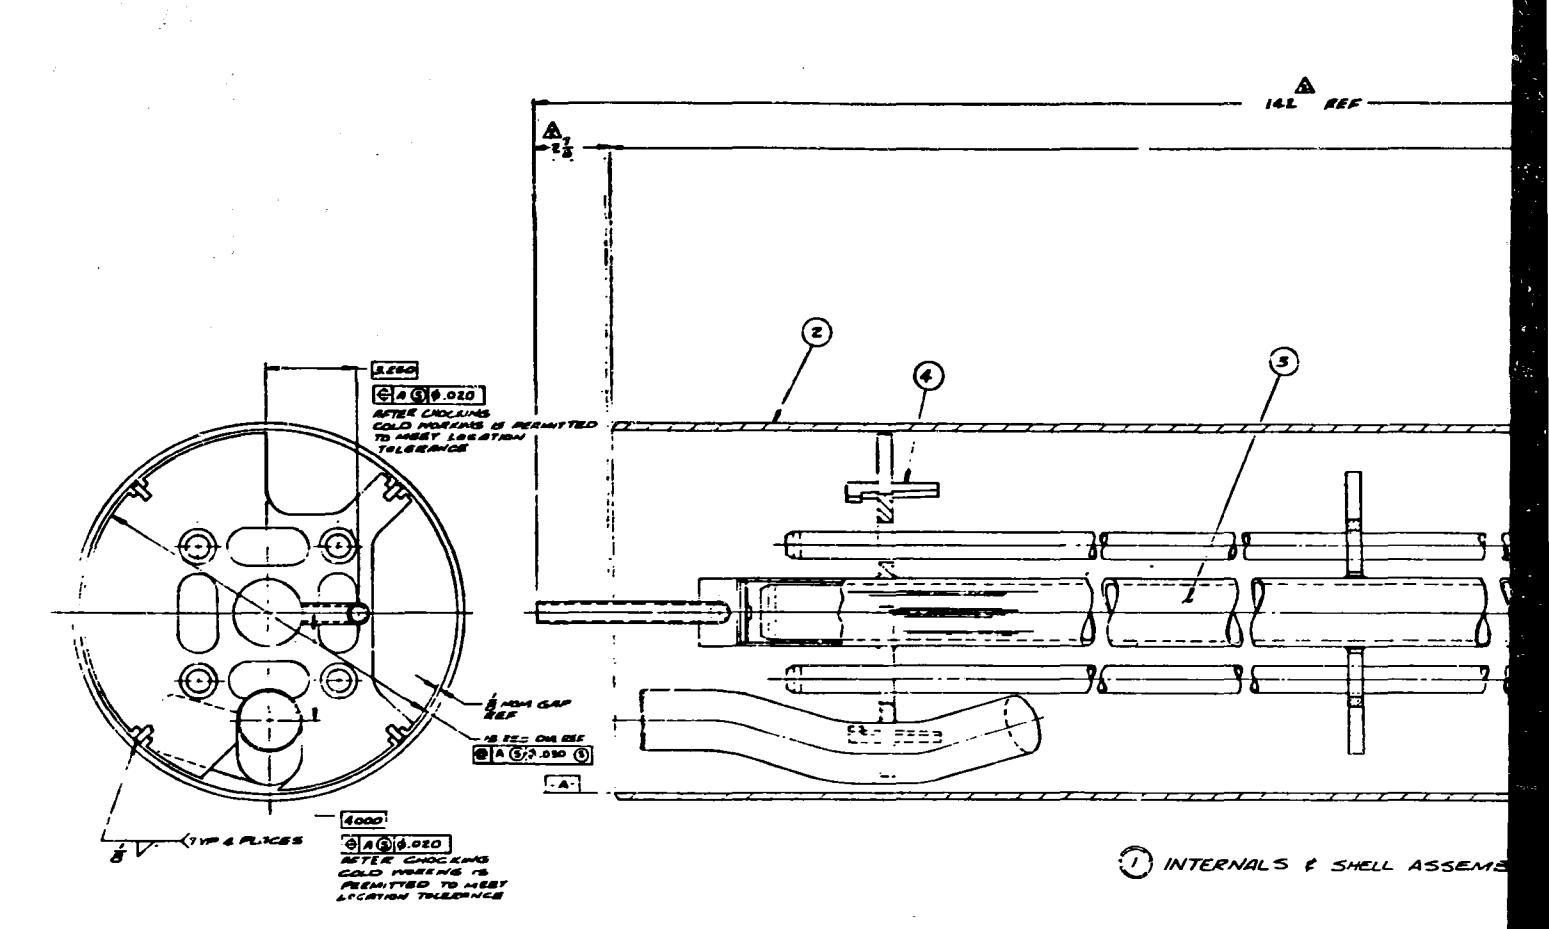
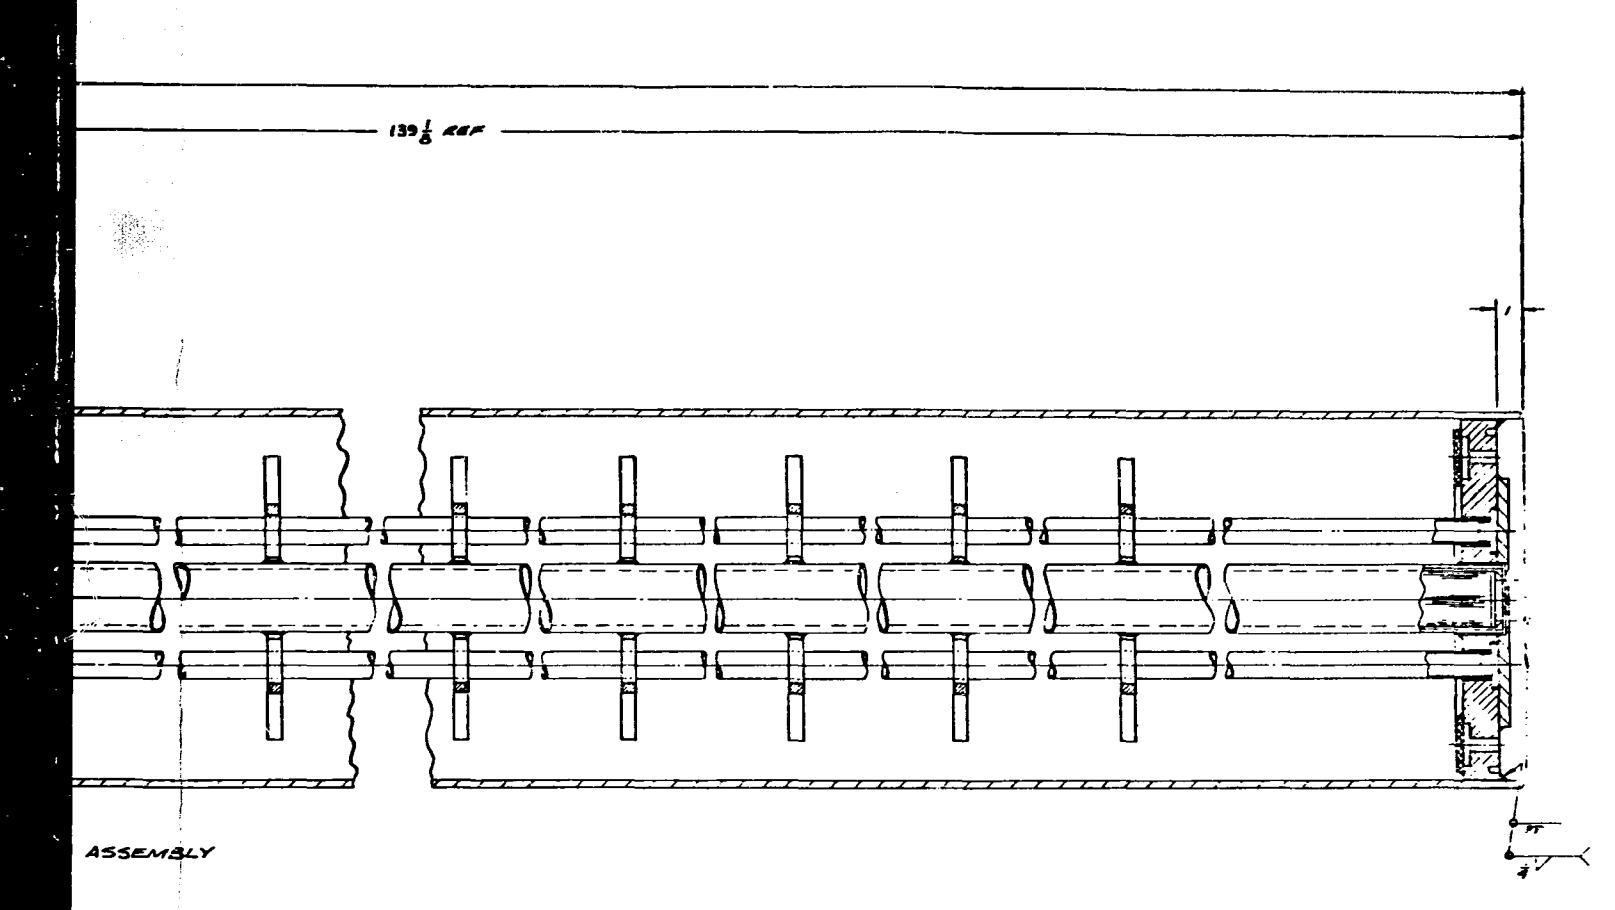
Fig. 2.3. Central absorber rod a canister. Source: Engineering drawin Lynchburg, Virginia, 1984.

r rod array for knockout defueling drawing No. 1154034F, Babcock & Wilcox,

diameter and have a 6.0-mm (0.25-in.) wall tube filled with neutronabsorbing B4C pellets. The central absorber rod is comprised of a 7.30-cm (2.875-in.)-diam strong-back tube with a 7.9-mm (0.312-in.) wall. Inside this tube is a 5.39-cm (2.125-in.) rod with a 1.6-mm (0.063-in.) wall filled with the B4C pellets. Seven intermediate support plates cradle the rods along their lengths and have a 3.0-mm (0.125-in.) radial clearance to the shell (Fig. 2.3). All support parts are constructed of 304L stainless steel, whereas the tubes containing the B4C pellets are made of 316L stainless steel.

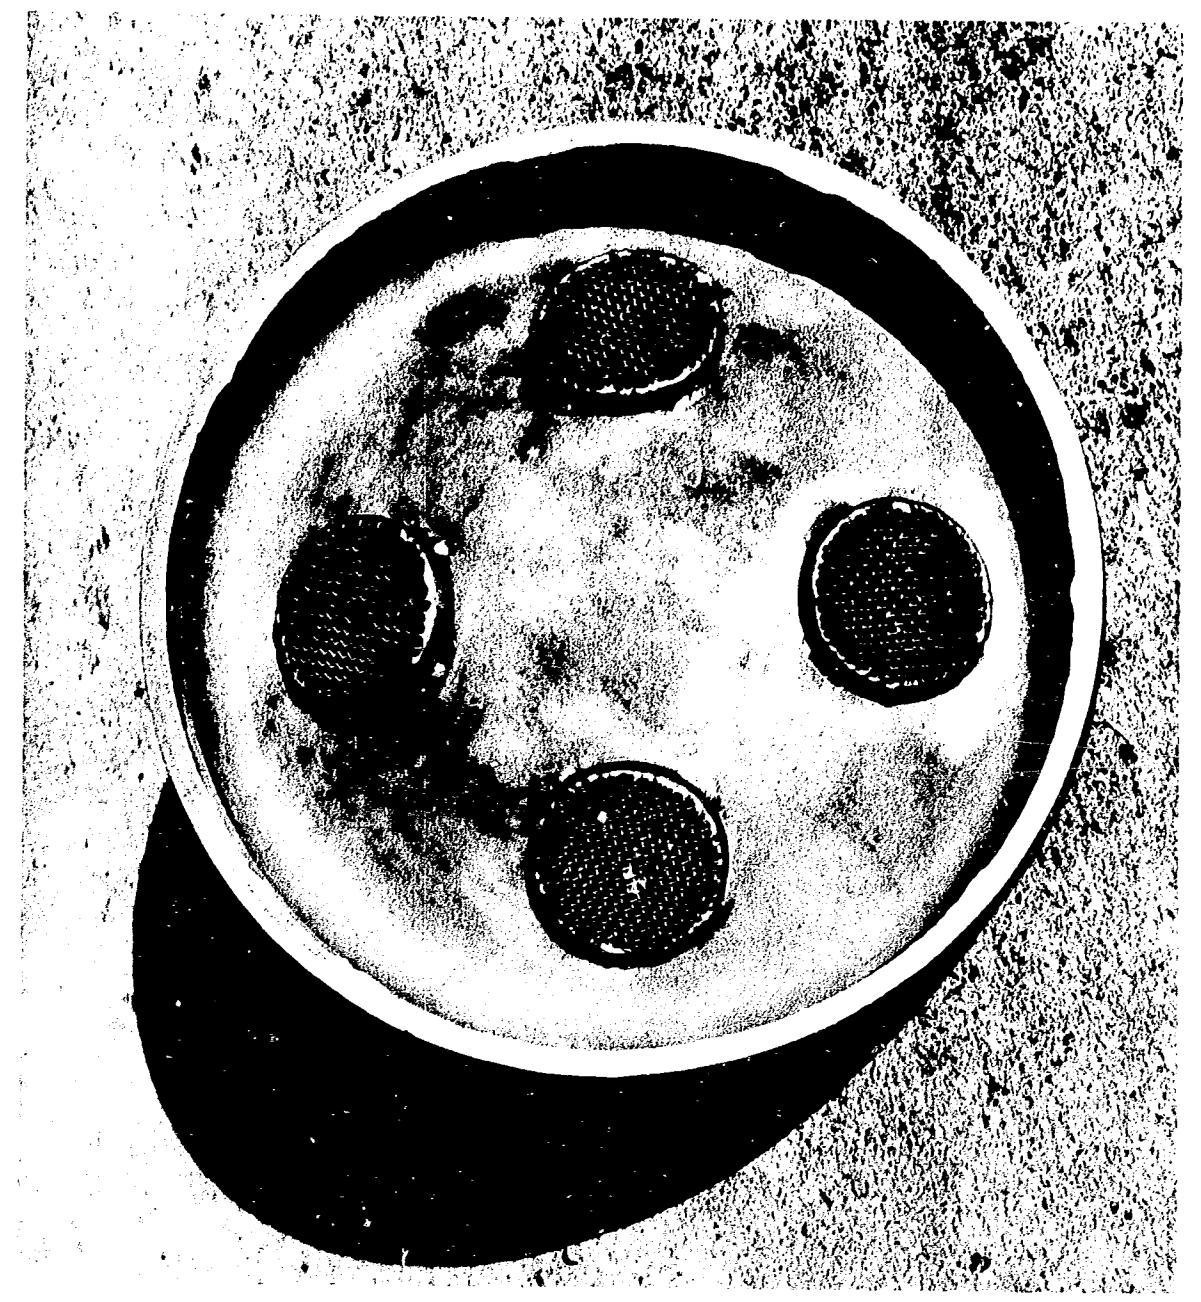
Fig. 2.4. Catalyst packets in lower head.

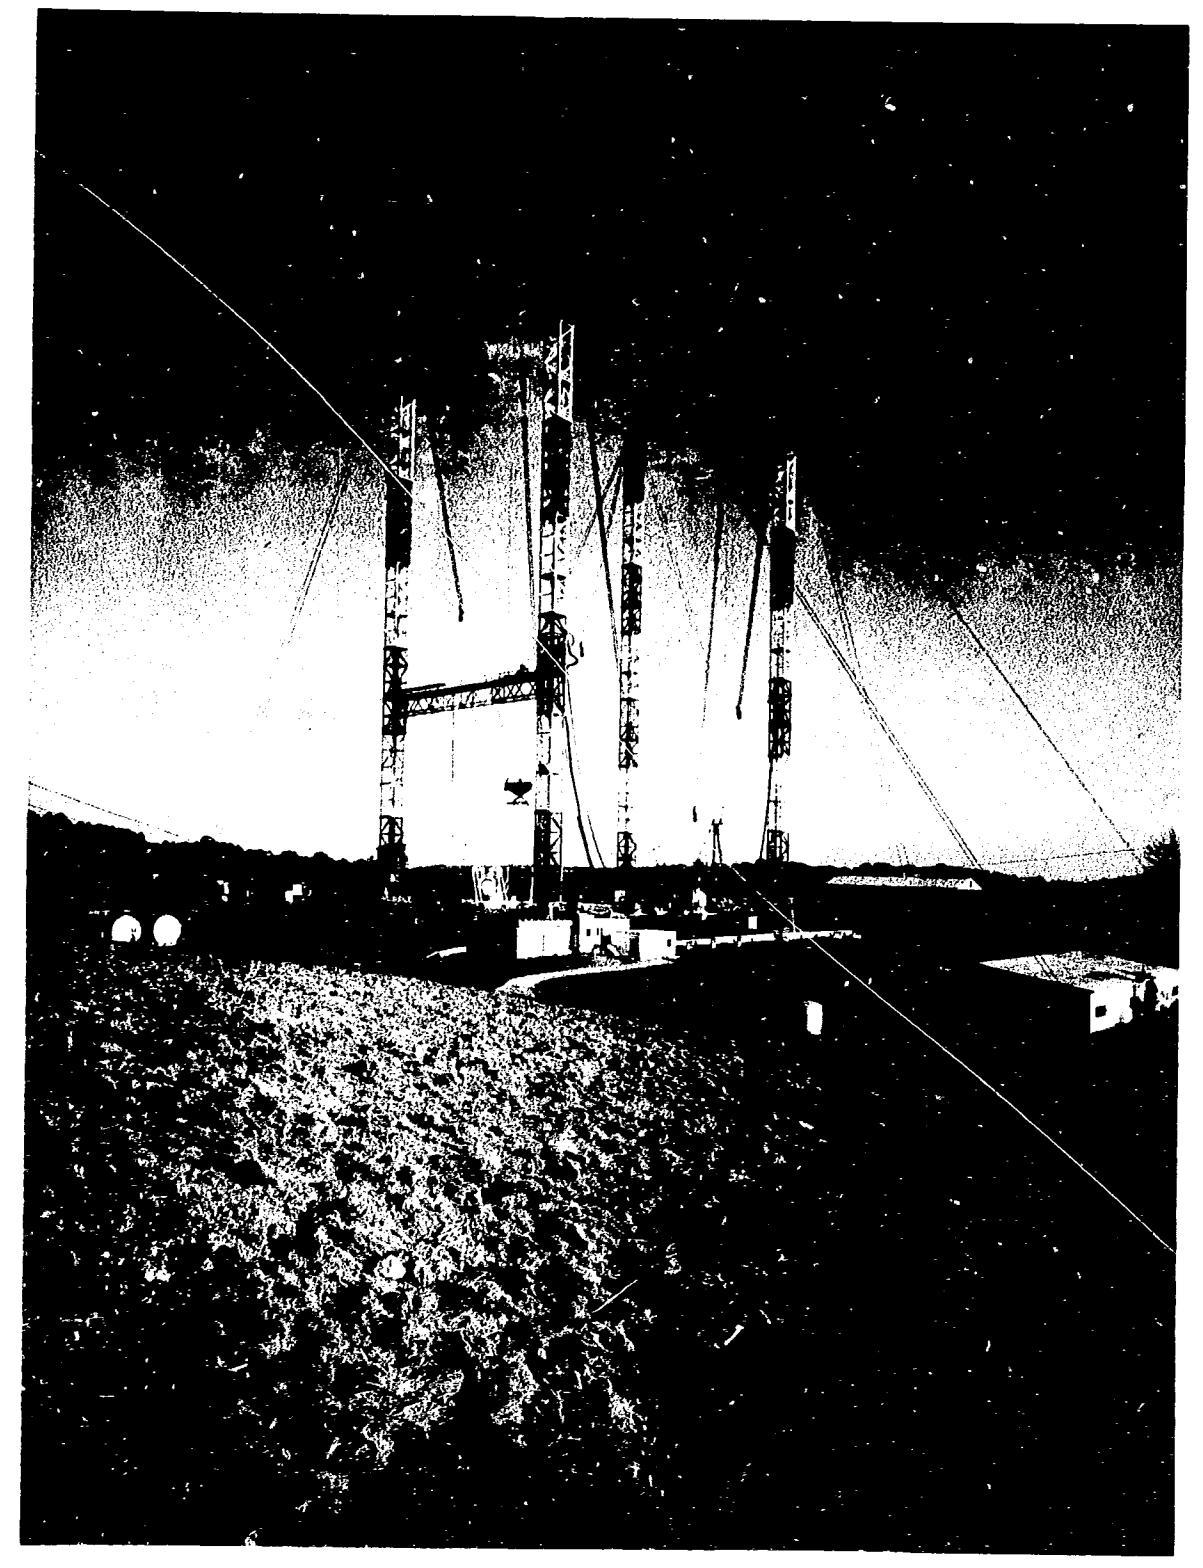
Fig. 3.1. ORNL Drop Test Facility.

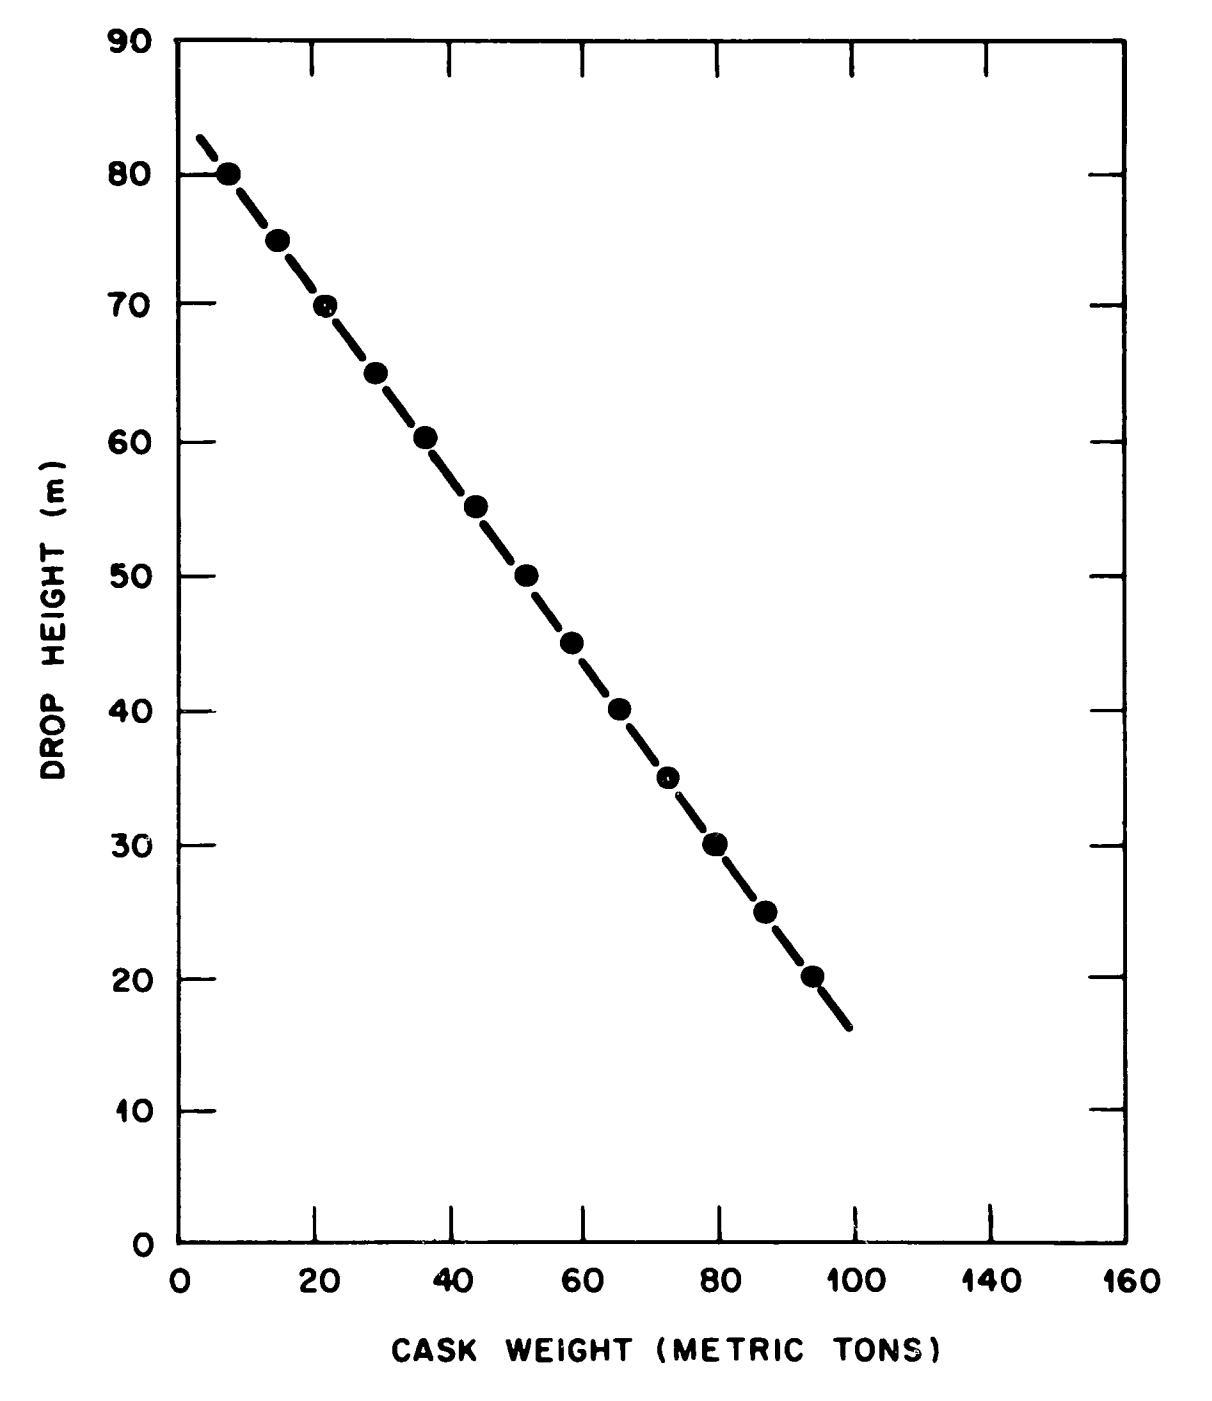
Fig. 3.2. Engineering assessment data for cask weight vs drop height at the ORNL Drop Test Facility.

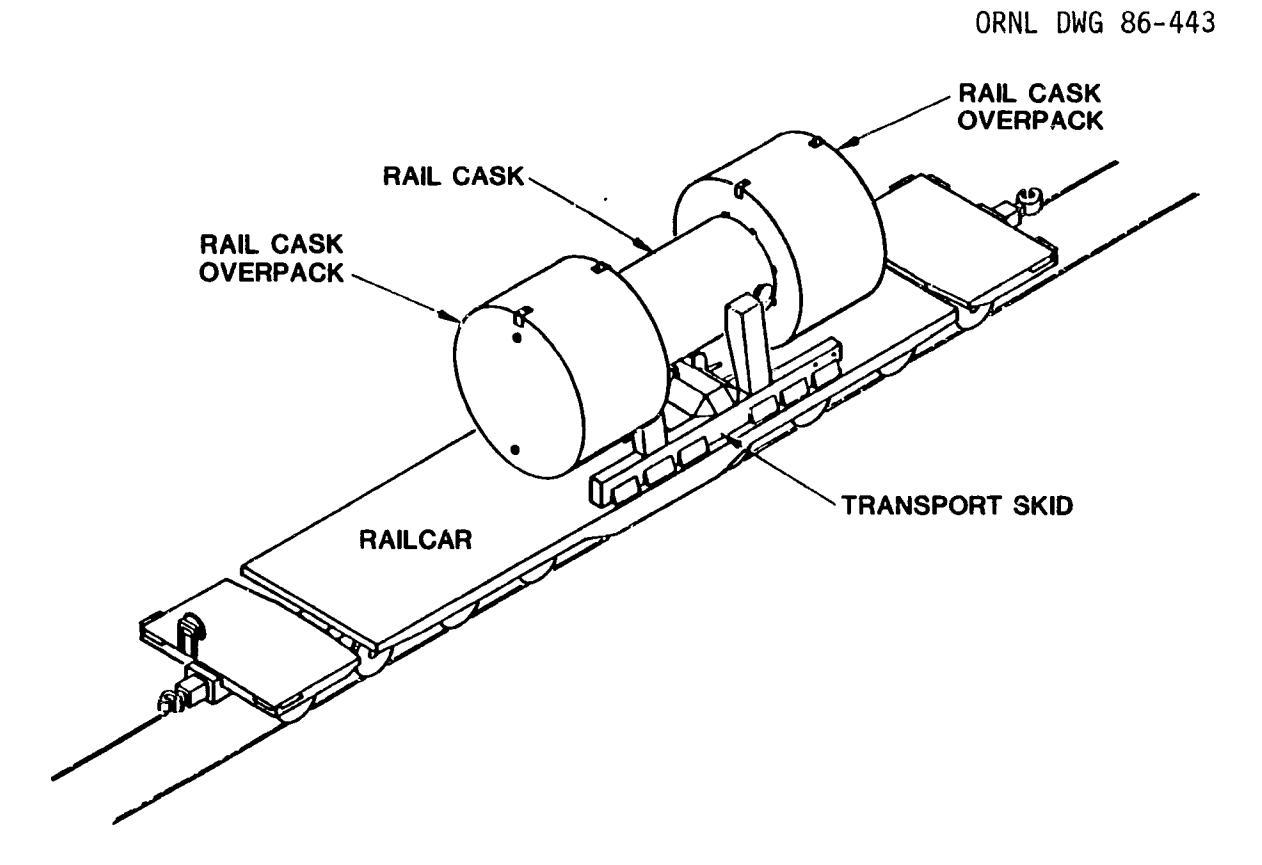
Fig. 4.1. NuPac 125-B rail shipping cask on transport skid.

The shipping cask (Fig. 4.1) has impact limiters of urethane foam on each end to afford protection to the cask and canisters. The CSVs were prepared with foam impact limiters of similar crush strength and density (Figs. 4.2 and 4.3) to duplicate this protection. Tests were conducted on small sections of the foam, to make certain that the properties were within the range of the values calculated to limit the deceleration forces to those specified in the test plan.

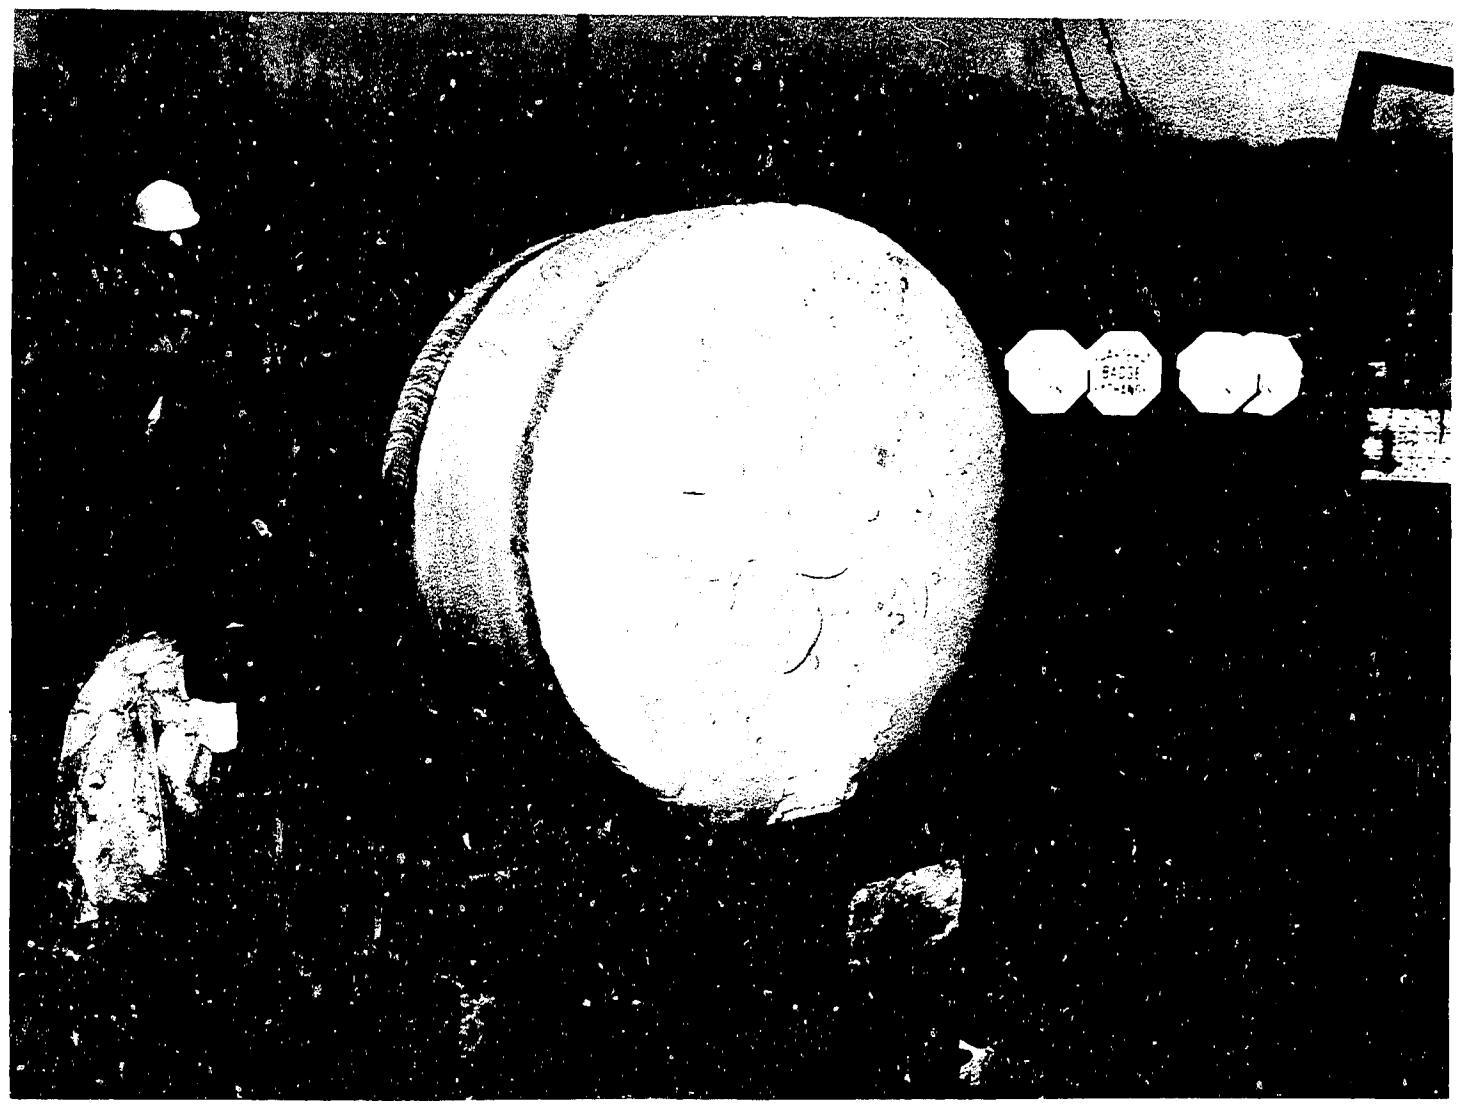
Fig. 4.2. Impact limiter of high density foam on cask simulation vessel.

An impact limiter was designed and constructed for each of the drop tests. The required area and thickness of foam needed to restrict the impact loads on the canister were calculated using an in-house program on an IBM personal computer. Since the area of impact would be much

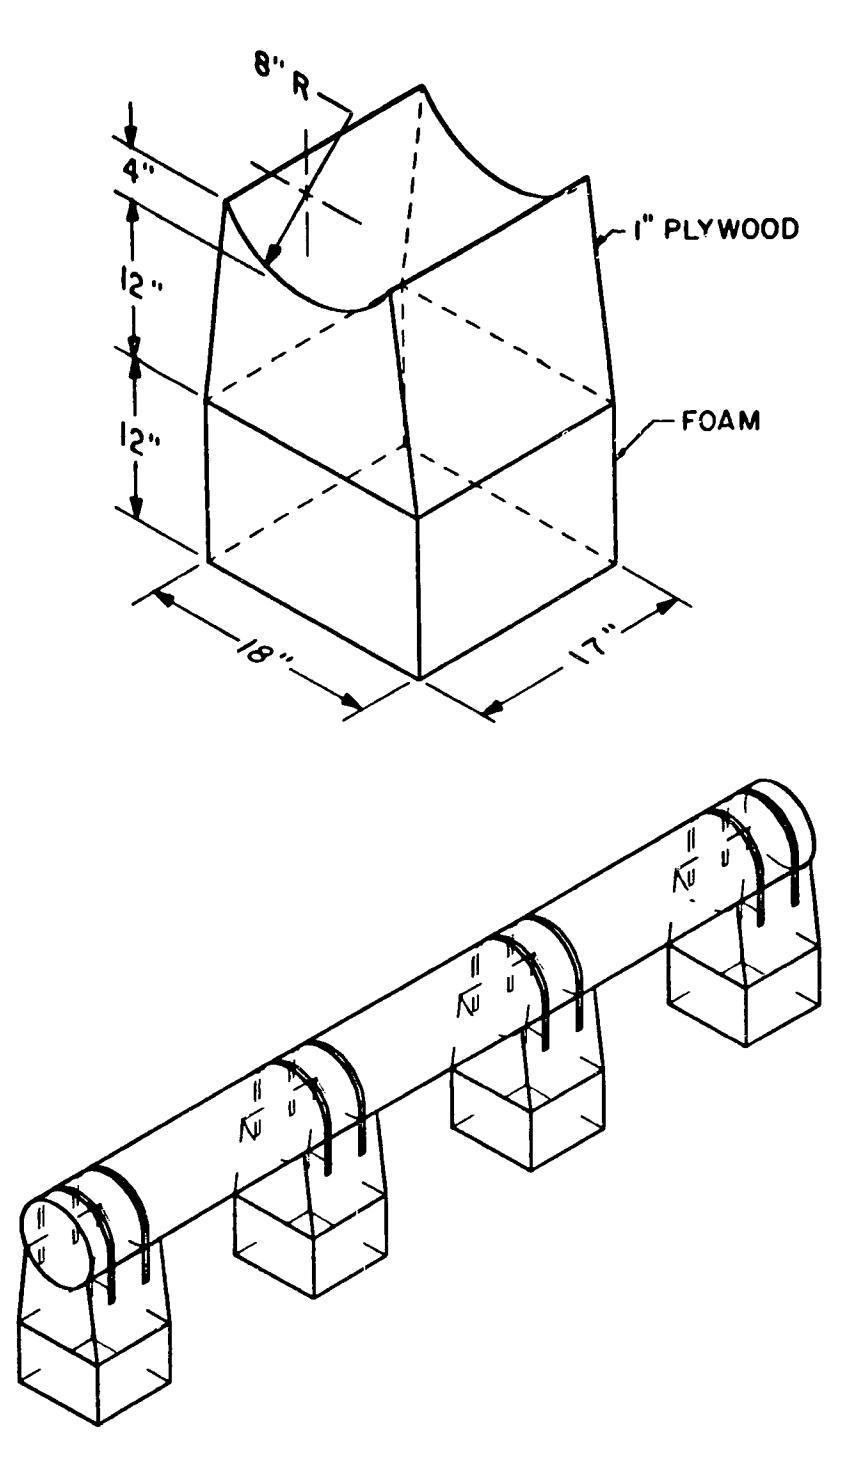
Fig. 4.4. Schematic of impact limiters for various horizontal drop tests.

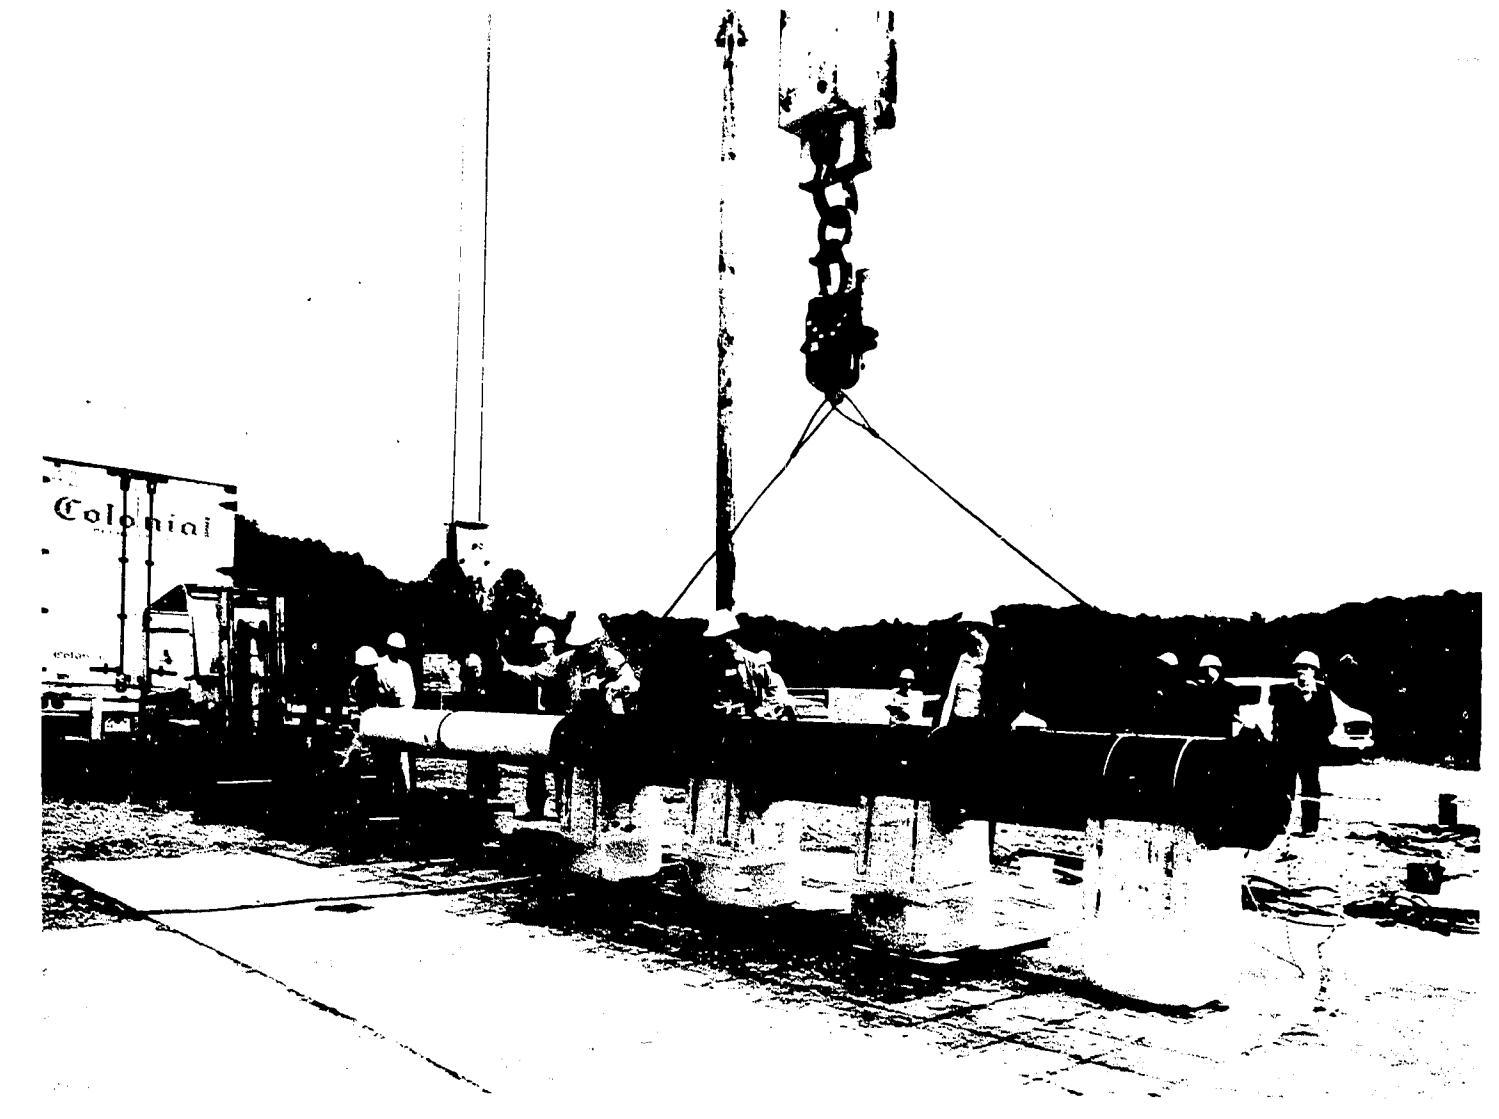
Fig. 4.5. Cask simulation vessel with impact limiters spaced equally along horizontal length.

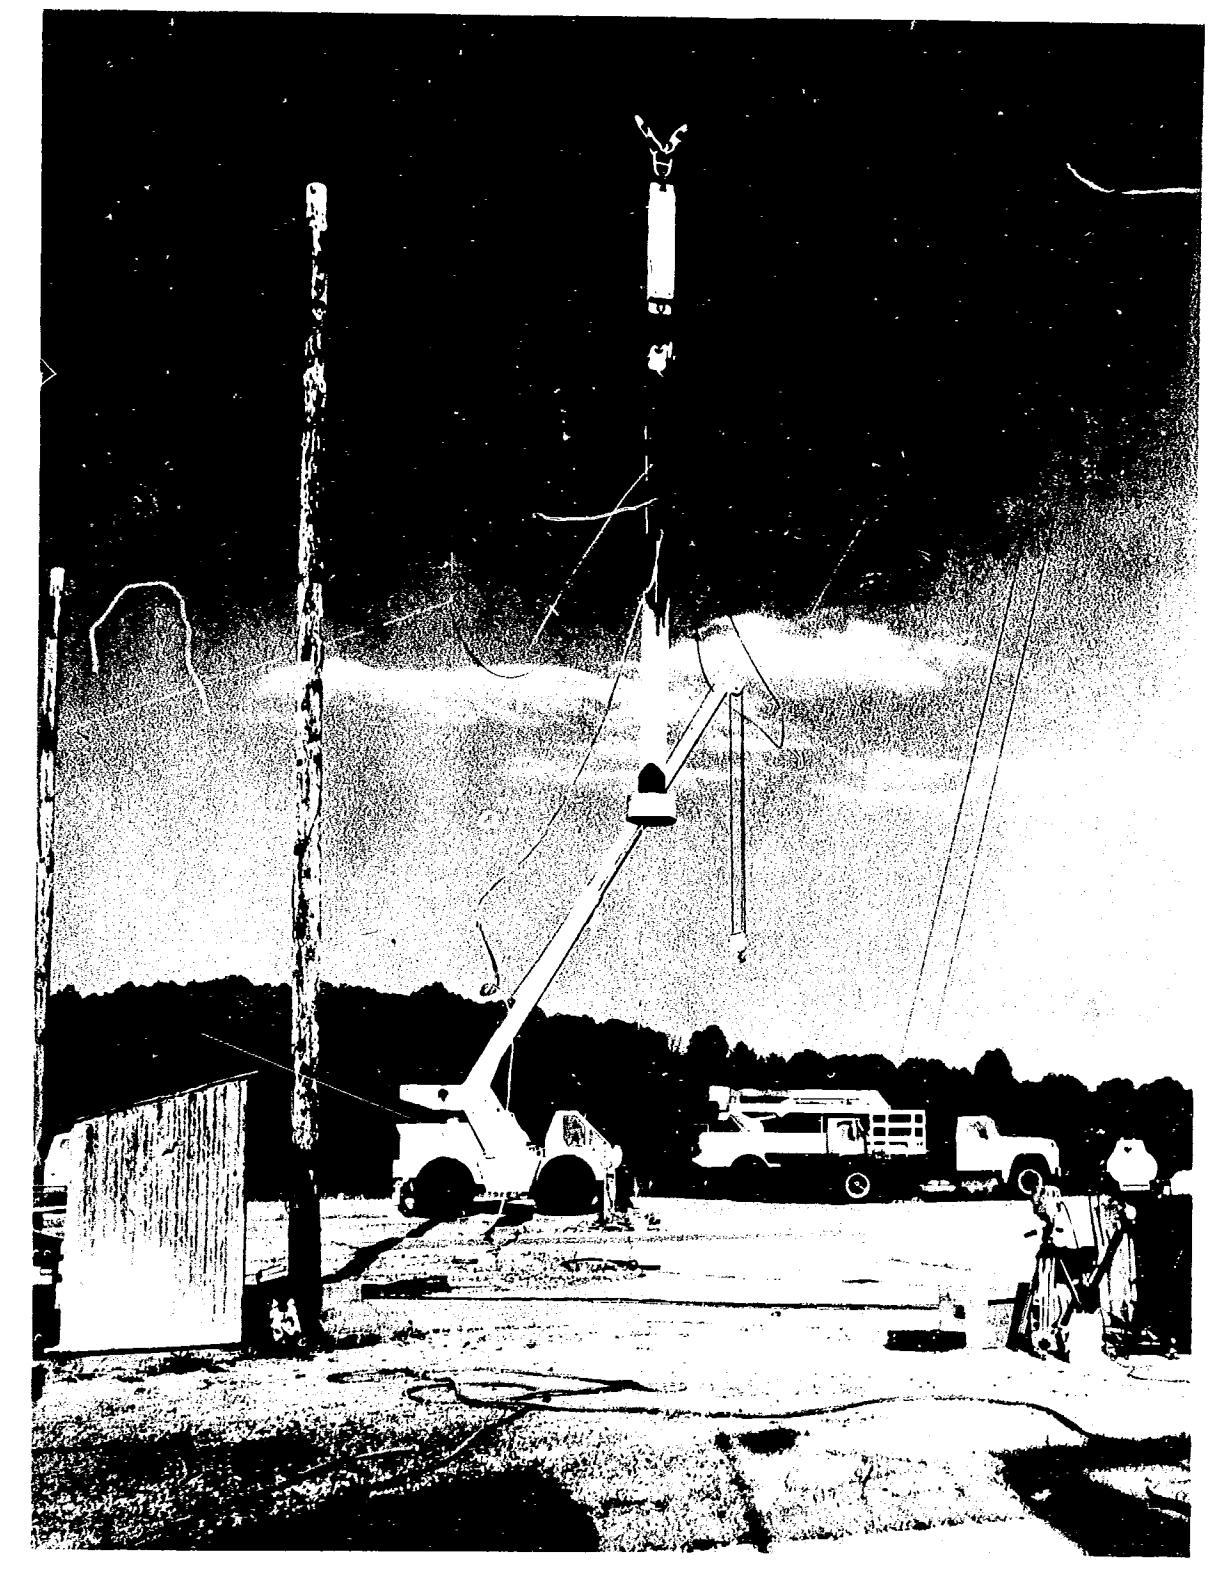
Fig. 5.2. Vertical drop testing of the knockout defueling canister.

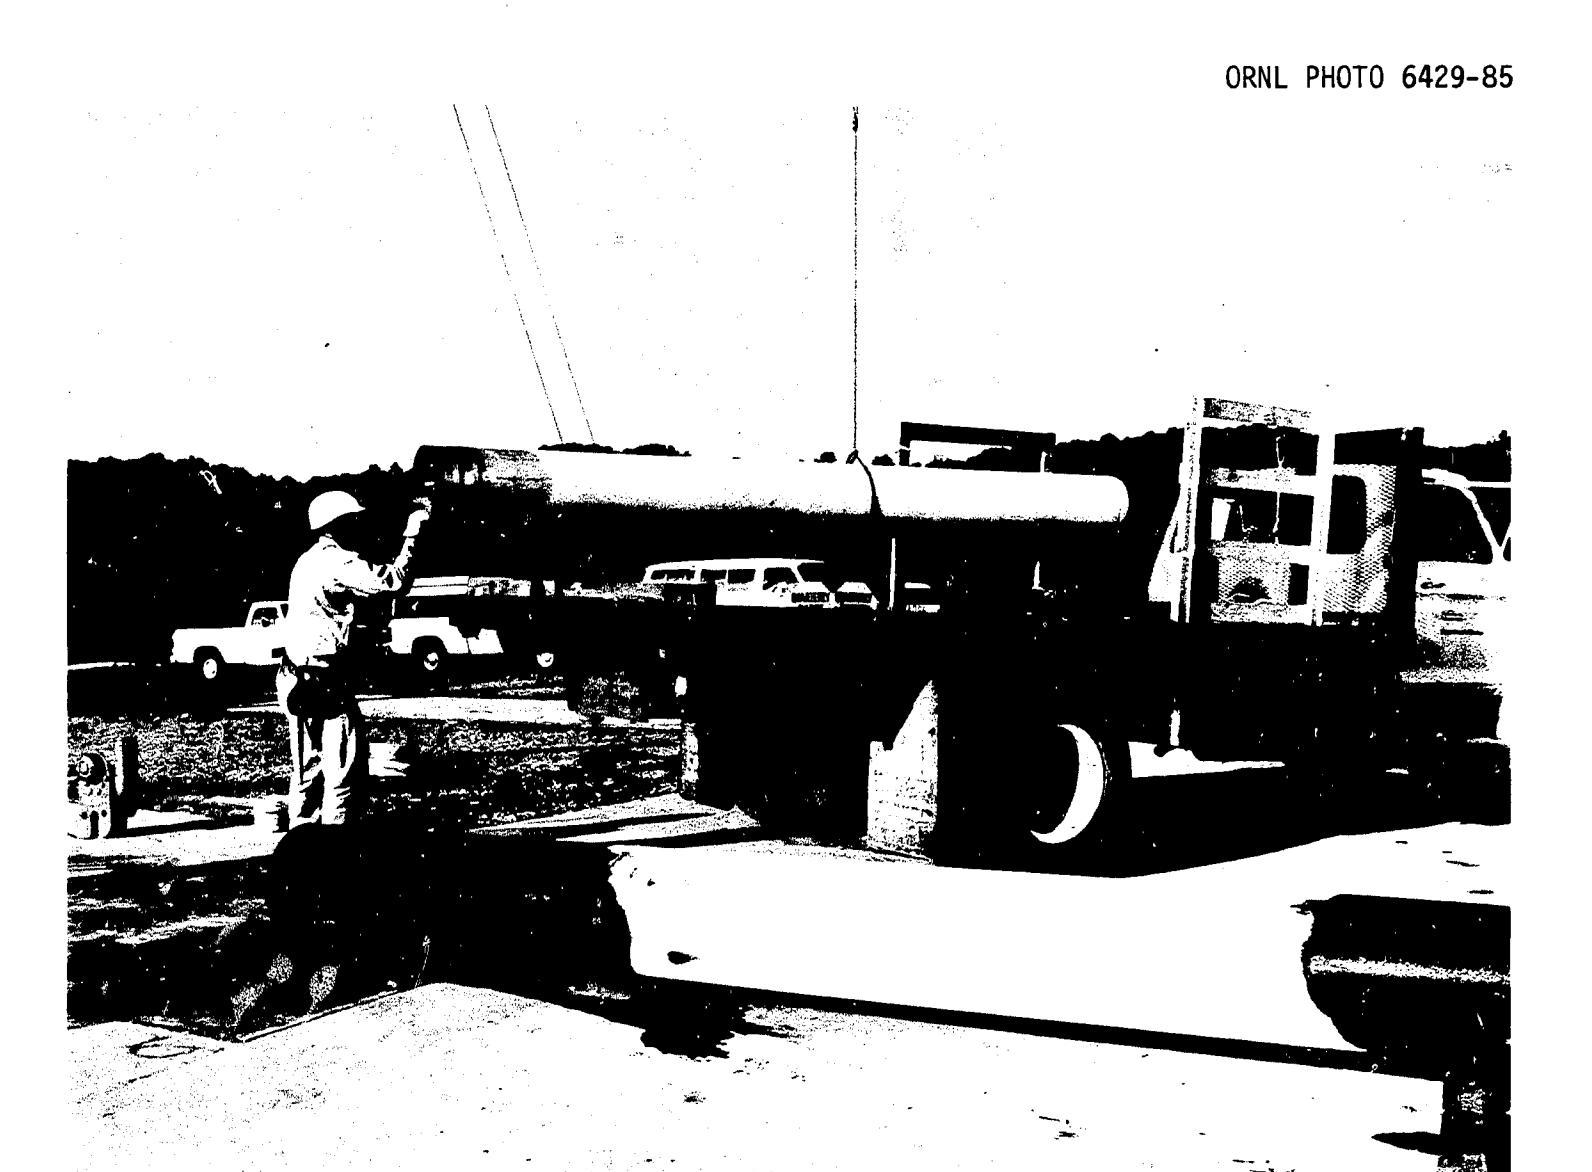
Fig. 5.3. Knockout defueling canister after first vertical drop test.

A visual examination of the canister after it was removed from the CSV following the vertical drop test indicated that no external damage resulted from the test (see Figs. 5.3 and 5.4). One of the caps placed on each of the fittings prior to the test fell off during the impact, but, even with this cap removed, no leakage from the fittings was detected. A canister pressure reading of 214 kPa, absolute (31 psia), was taken by means of the inlet plug. This higher internal pressure was attributed to the increase in temperature inside the canister, which resulted from its exposure in ambient air at a temperature of $\sim 21^{\circ}C$ ($\sim 70^{\circ}F$).
