DROP TESTS OF THE THREE MILE ISLAND KNOCKOUT CANISTER

Published January 1987

Oak Ridge National Laboratory Oak Ridge, Tennessee 37831 operated by Martin Marietta Energy Systems, Inc. for the Department of Energy Under DOE Contract No. DE-AC05-74OR21400

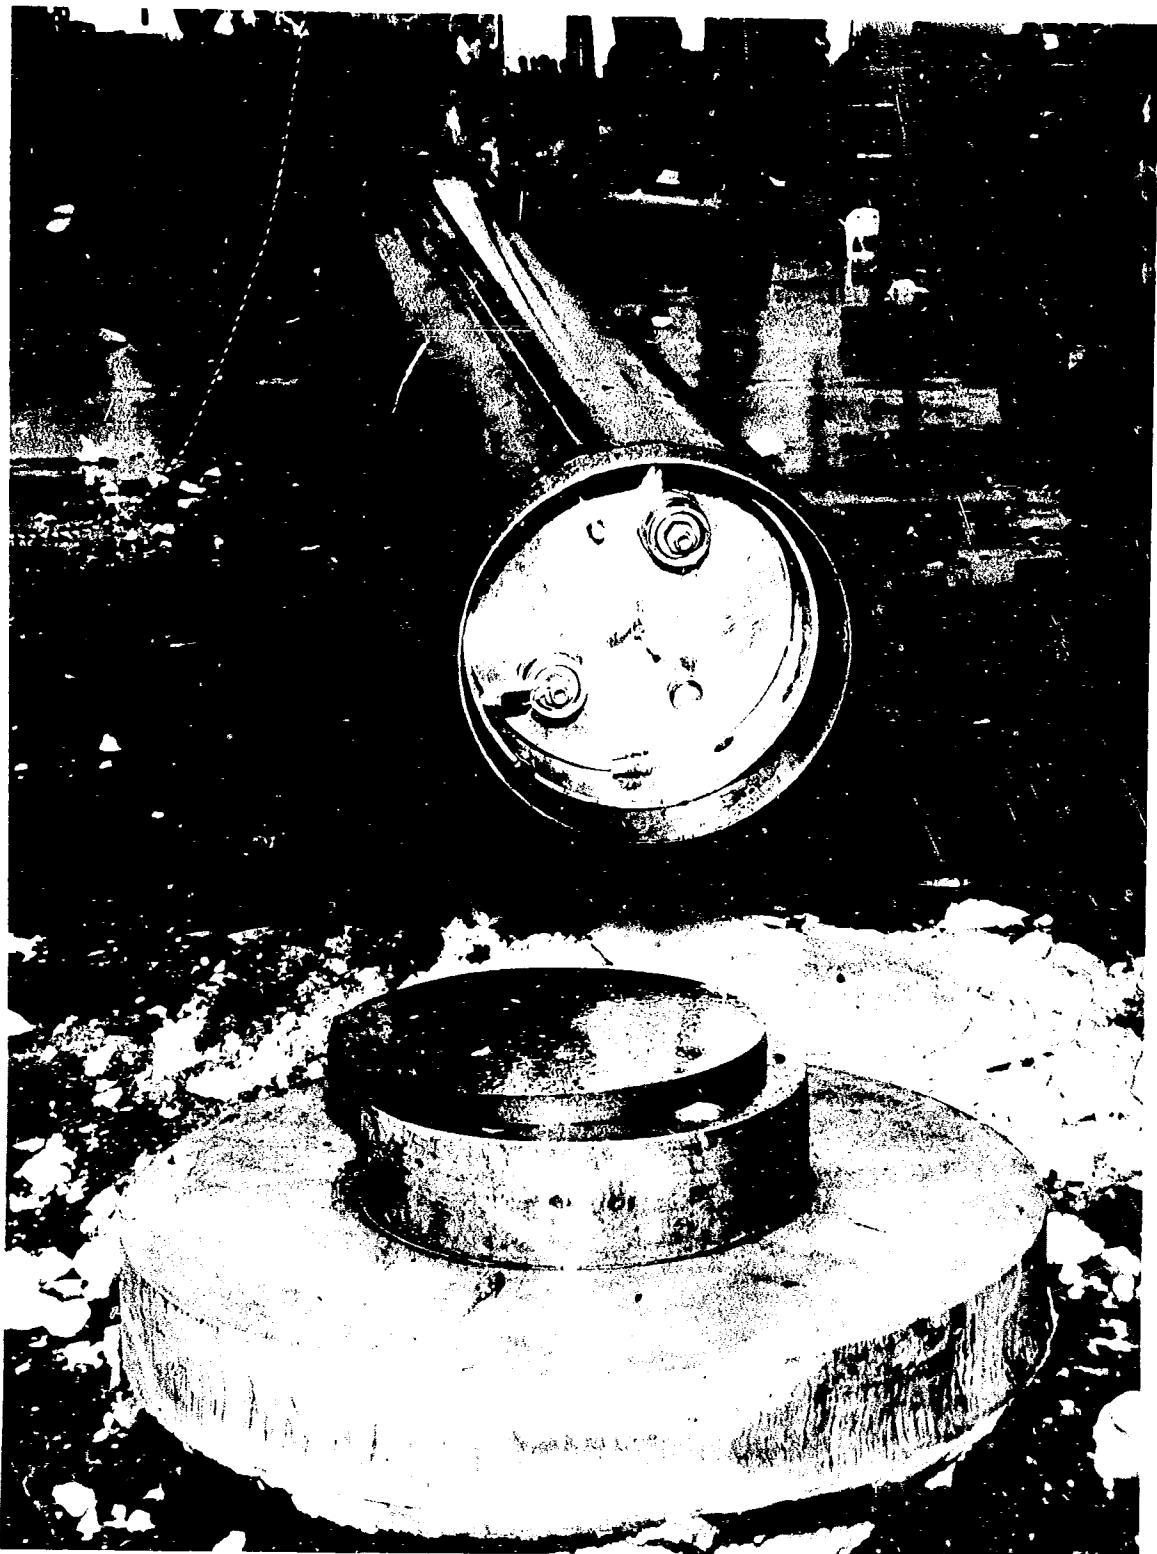
Fig. 5.4. Impact end of knockout defueling canister after first vertical drop test.

A visual examination of the canister after it was removed from the CSV following the vertical drop test indicated that no external damage resulted from the test (see Figs. 5.3 and 5.4). One of the caps placed on each of the fittings prior to the test fell off during the impact, but, even with this cap removed, no leakage from the fittings was detected. A canister pressure reading of 214 kPa, absolute (31 psia), was taken by means of the inlet plug. This higher internal pressure was attributed to the increase in temperature inside the canister, which resulted from its exposure in ambient air at a temperature of $\sim 21^{\circ}C$ ($\sim 70^{\circ}F$).

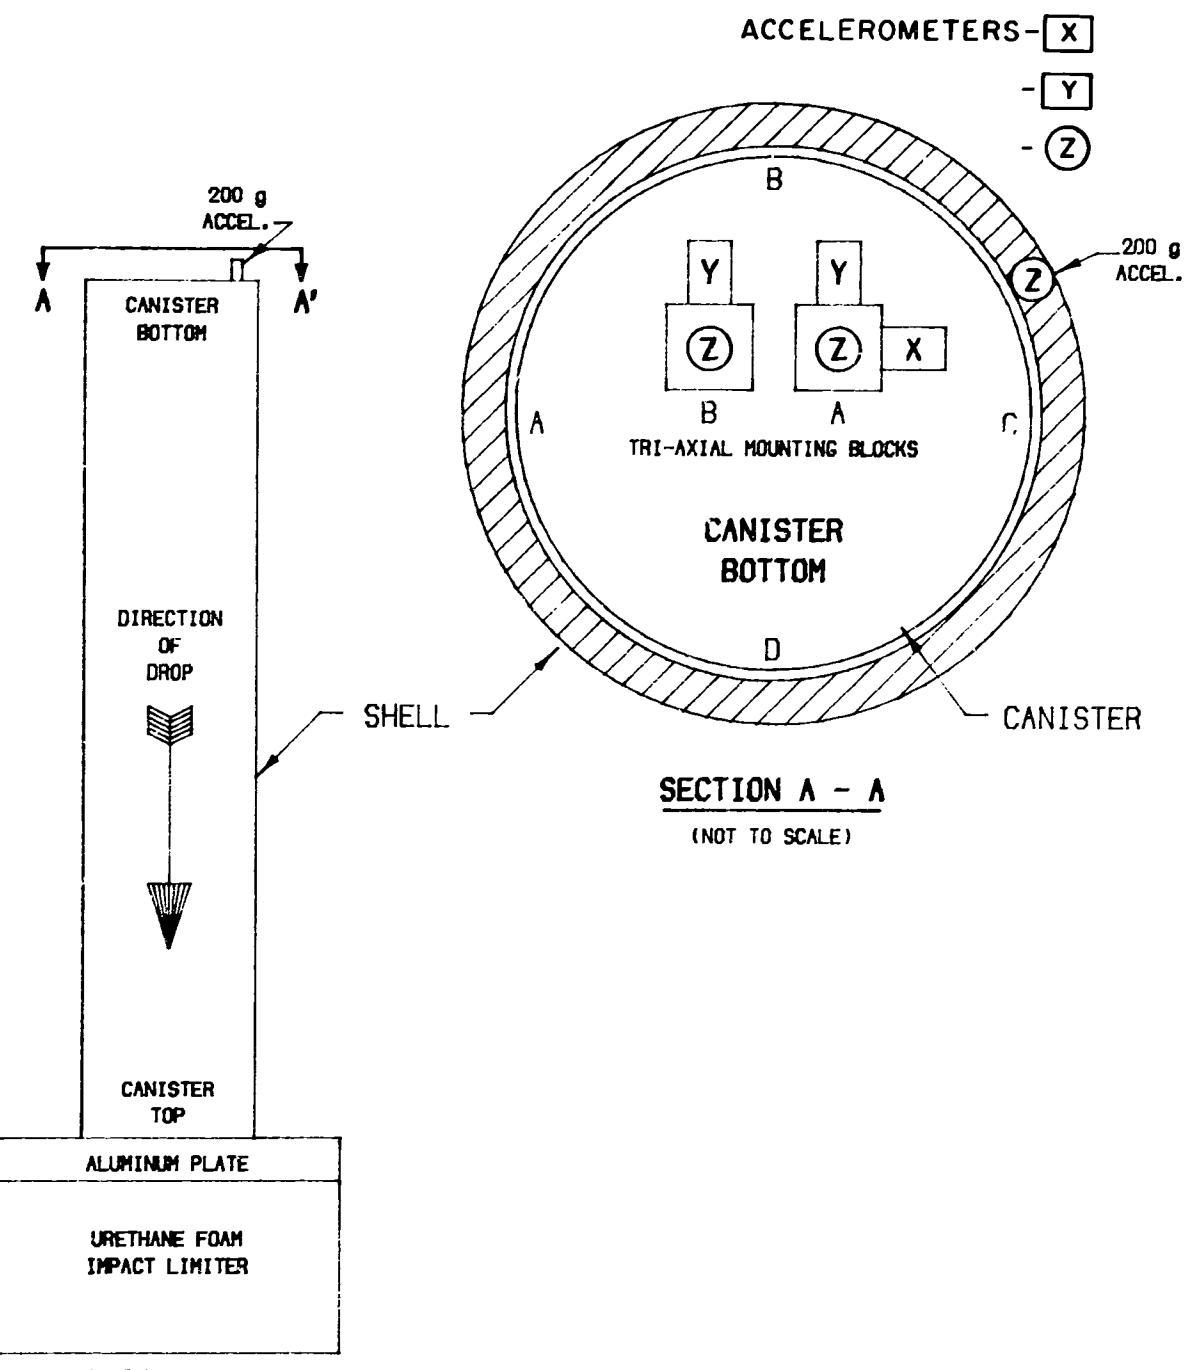
Fig. 5.5. Schematic diagram of knockout canister showing locations and orientation of accelerometers. Horizontal accelerometers mounted at X and Y; vertical accelerometer at Z.

In ORNL DWG 86-529 (in Appendix B), note that the tops of the positive peaks in the data plot are flattened, which indicates that the range of this accelerometer was exceeded. However, these data were from a low-range (-100 to +100 g) accelerometer that was added to the shell when the Z accelerometer on Block A (see Fig. 5.5) was determined to be defective.

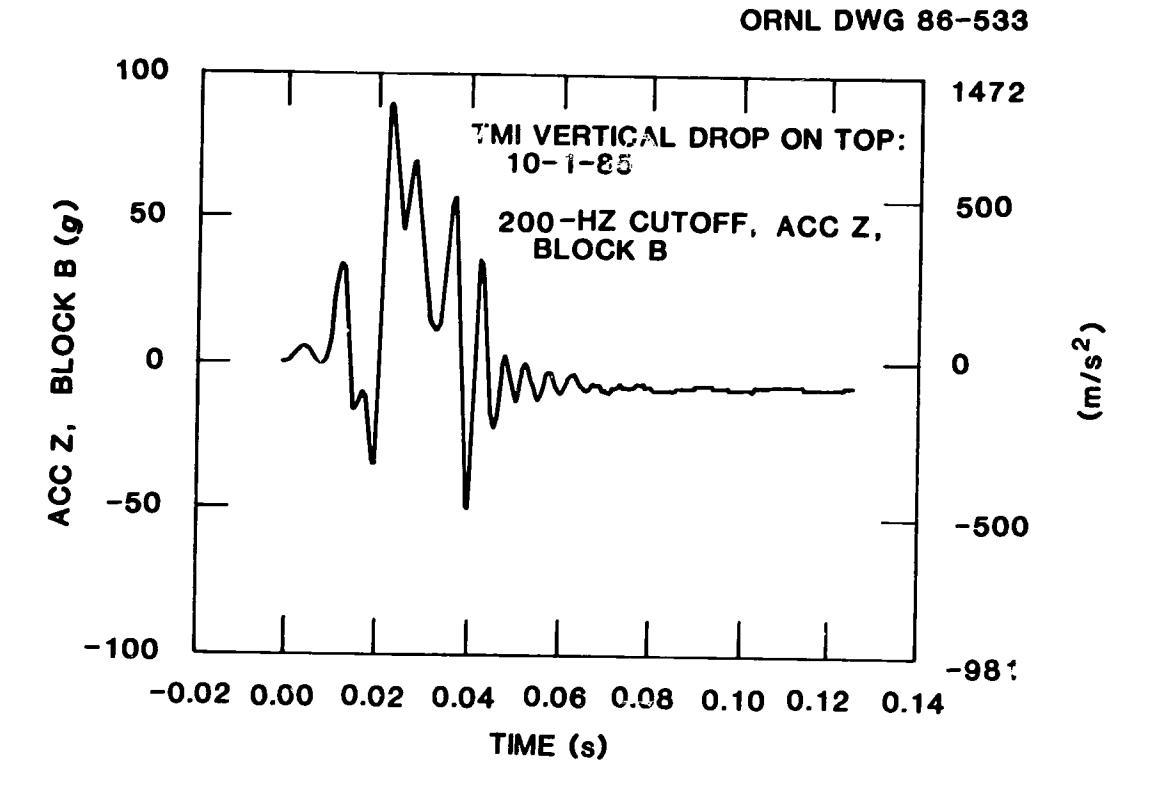
Fig. 5.6. Plot of output from vertical accelerometer mounted on block B in knockout defueling canister during vertical drop test.

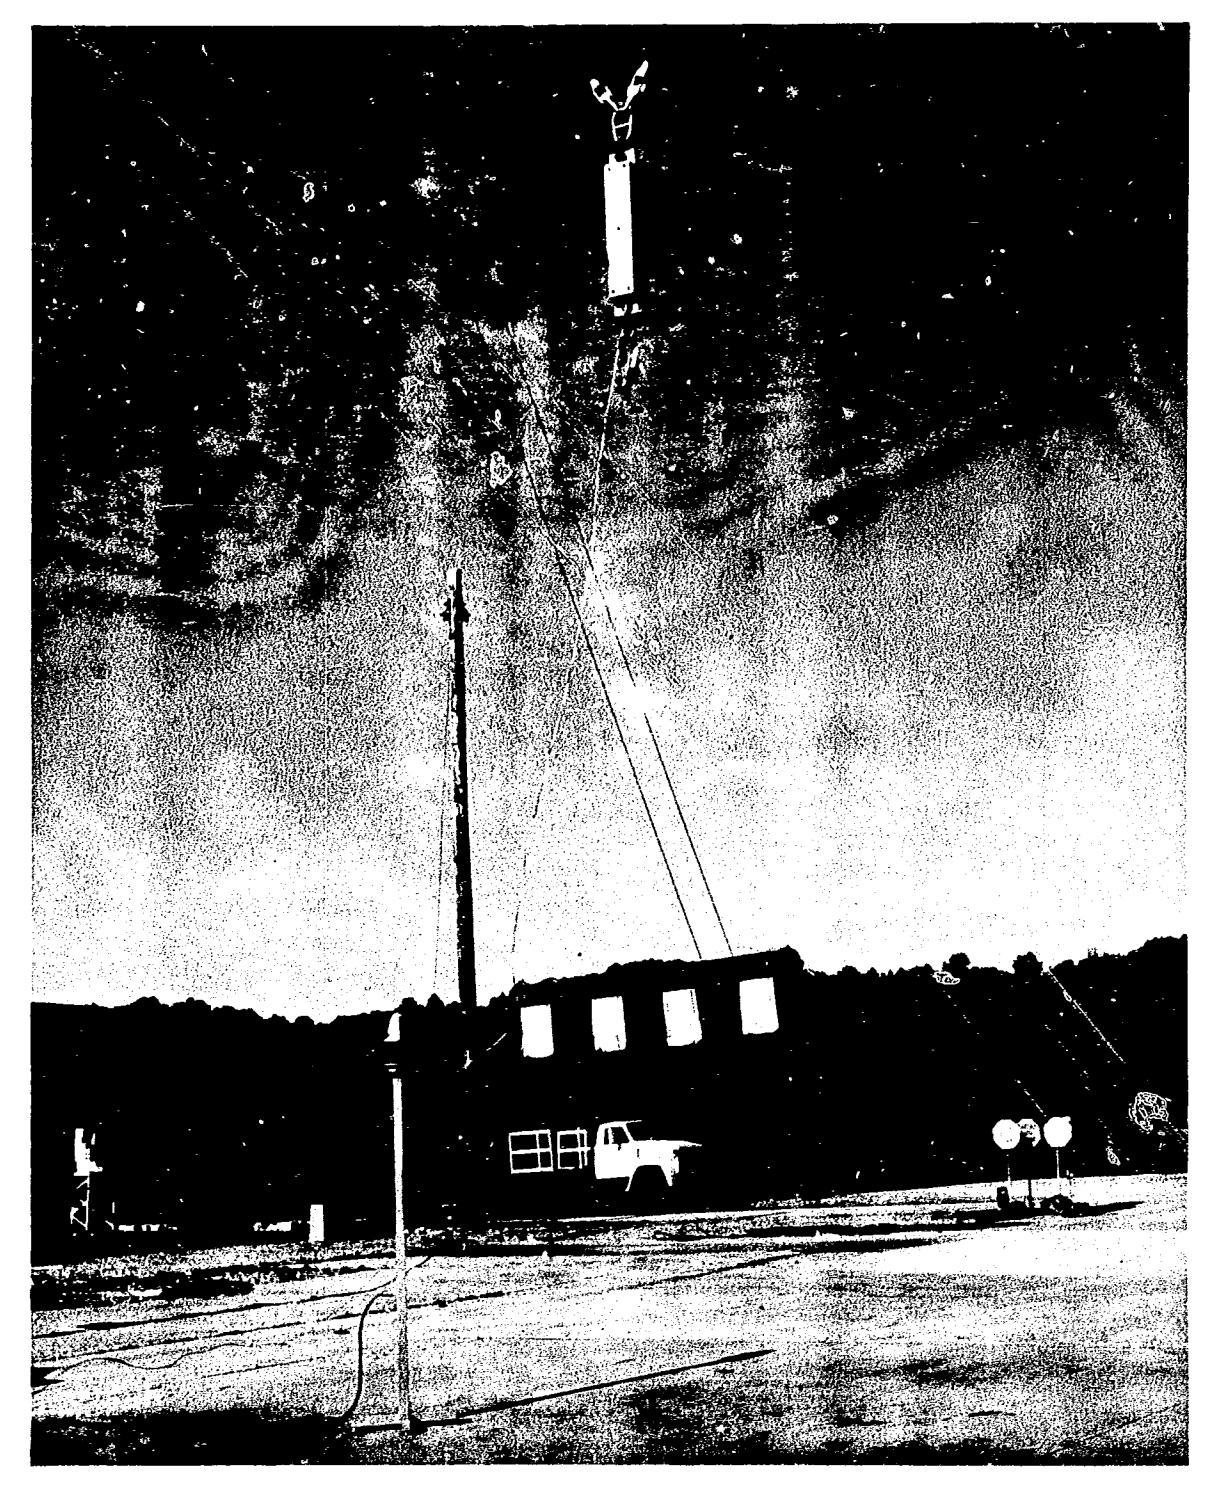
Fig. 6.2. Horizontal drop test of knockout defueling canister.

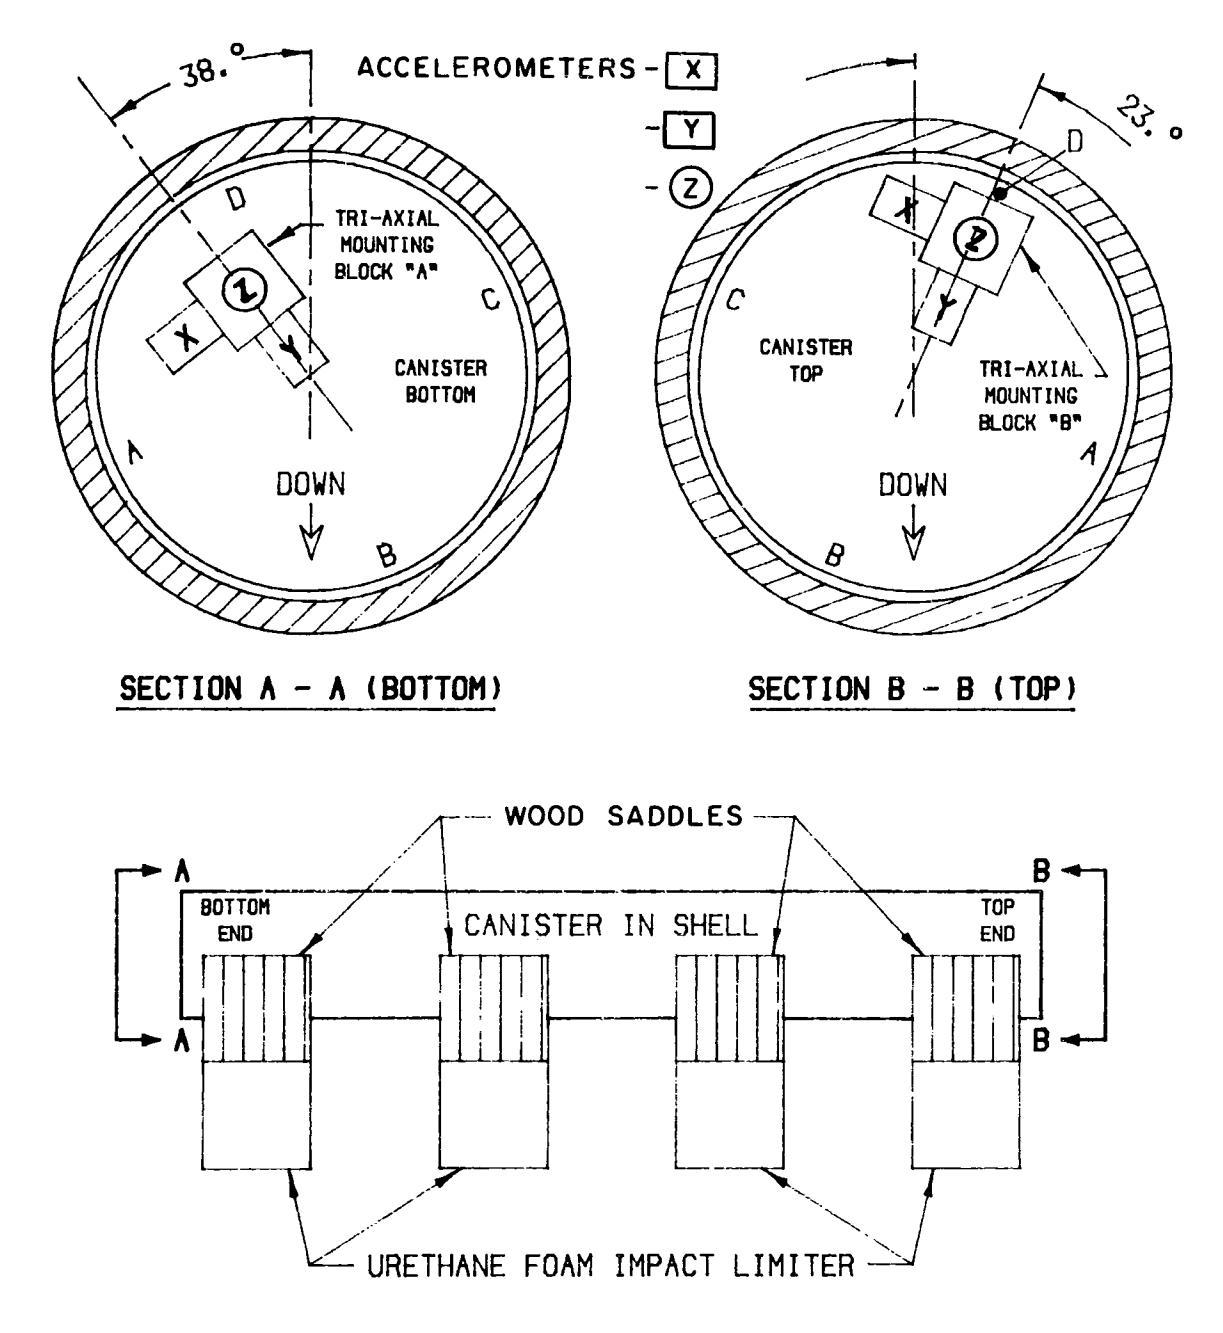
Fig. 7.2. Schematic diagram of knockout canister showing location and orientation of accelerometers.

Instrumentation installed for the first horizontal drops included six accelerometers mounted on triaxial blocks located at the ends of the canister, as shown in Fig. 7.2. The block located at the bottom of the canister was attached by bolts to a plate welded to the canister bottom, and the block located at the top was attached by bolts to a plate epoxied to the top of the canister. The ranges of the vertical (y) accelerometers used in this drop were -200 to +200 g, and the ranges of those installed in the horizontal (x and z) axes were -100 to +100 g. The general instrumentation scheme was the same as depicted in Fig. 4.6 for the vertical drop test.

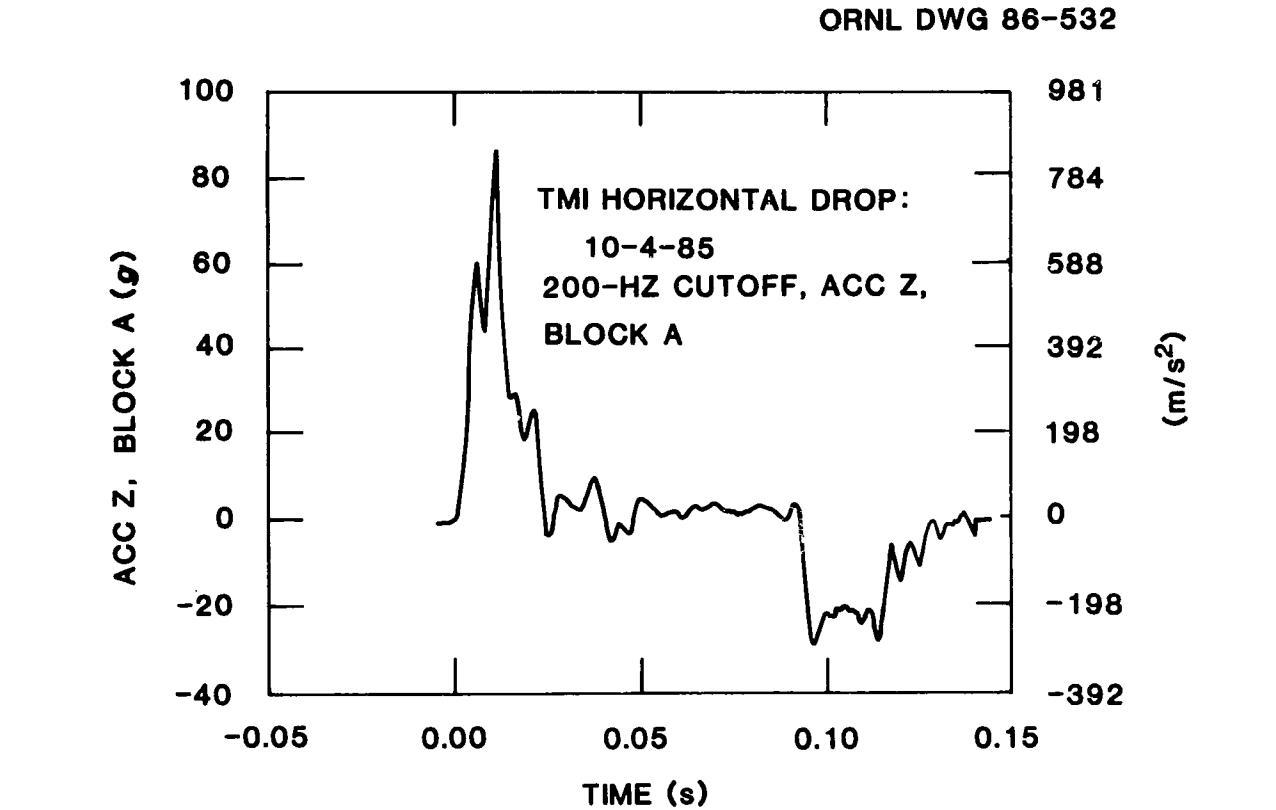
Fig. 7.3. Plot of output from vertical accelerometer mounted on bottom of knockout defueling canister during horizontal drop test.

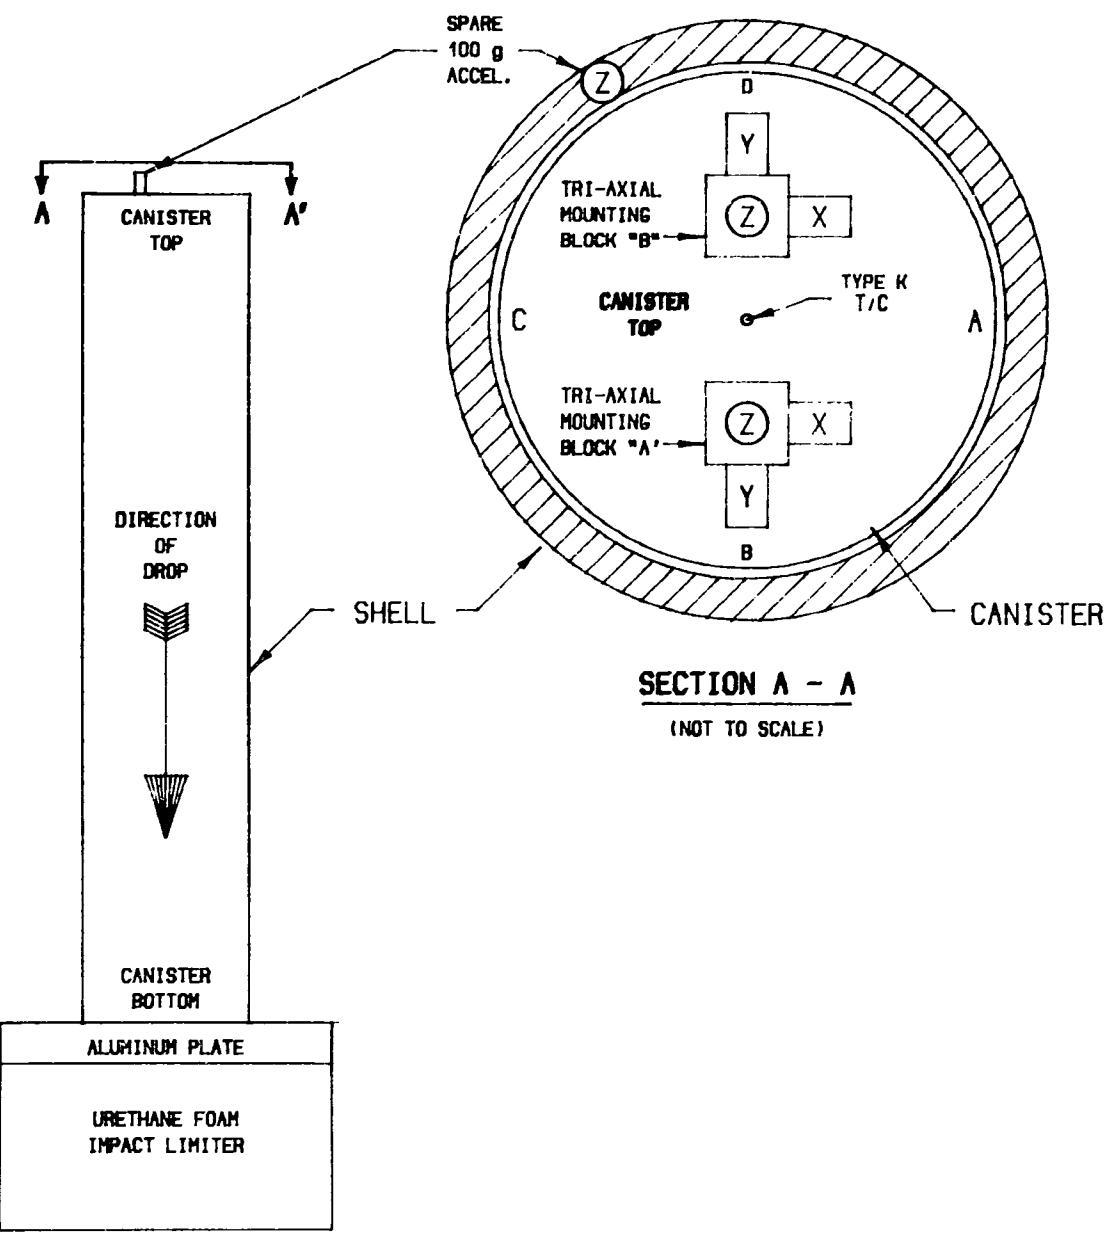
Fig. 9.1. Schematic of knockout defueling canister bottom showing the vertical (z), and horizontal (x,y) accelerometers locations.

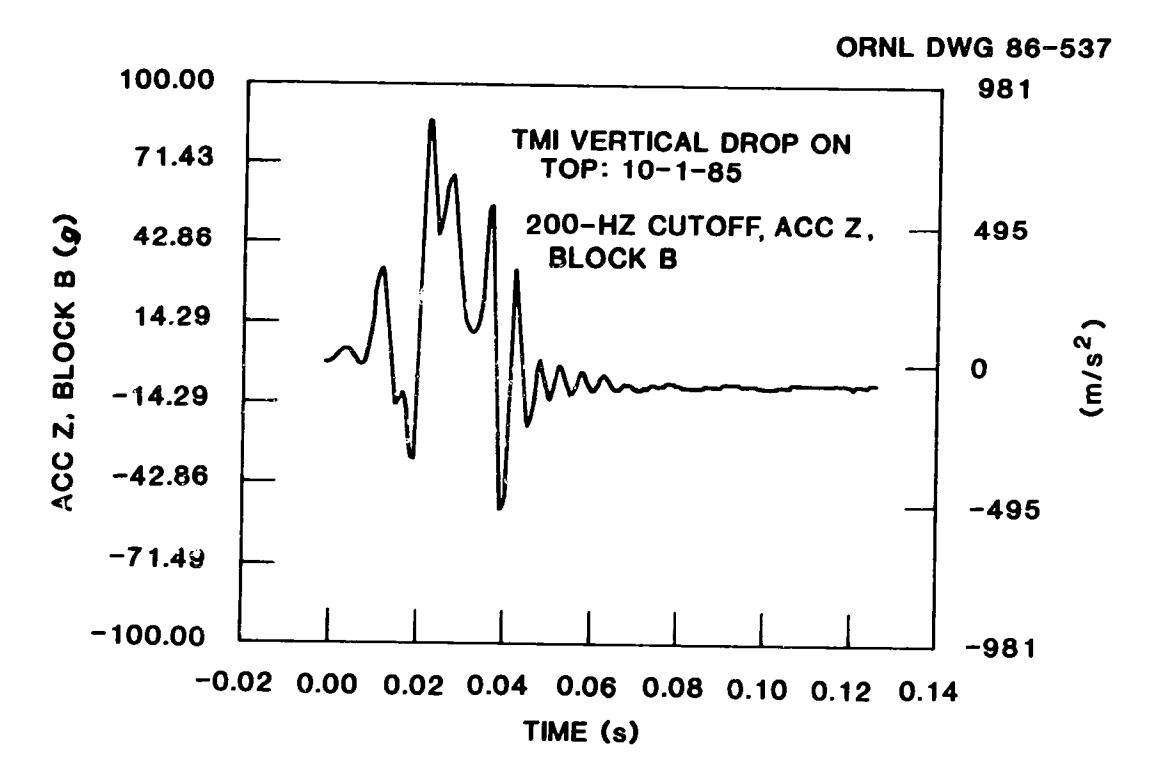
Fig. 9.2. Plot of output from vertical accelerometer mounted in the knockout defueling canister during the vertical drop test.

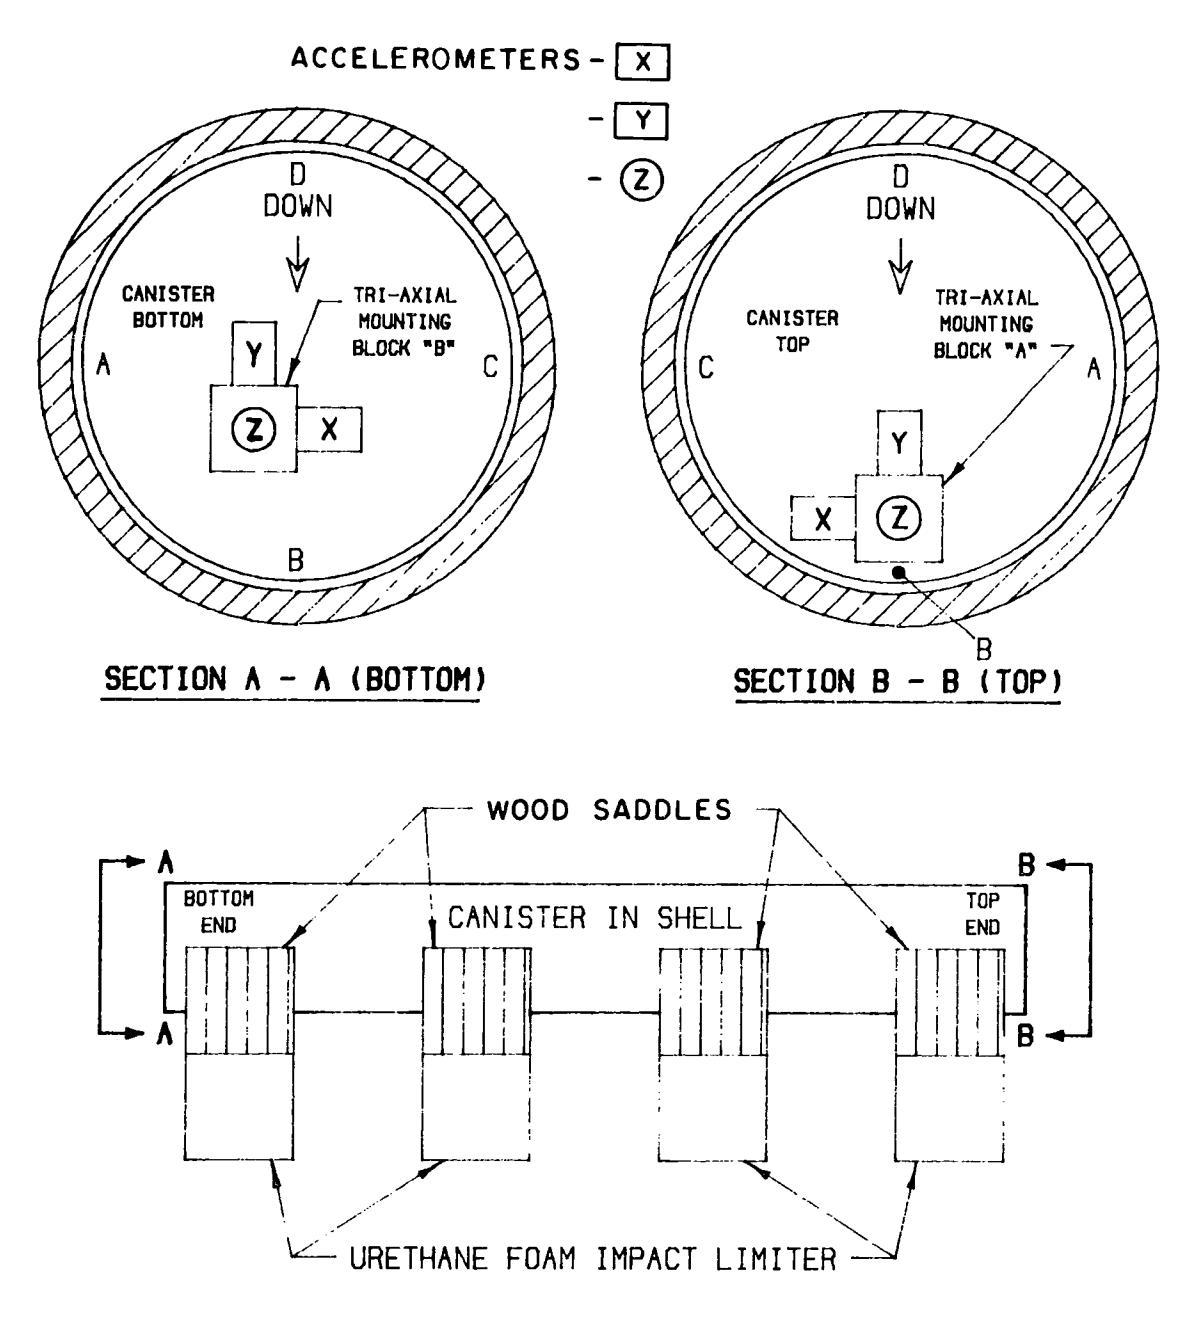
Fig. 11.1. Schematic of knockout defueling canister showing locations of accelerometers during the horizontal drop test with internal torque.

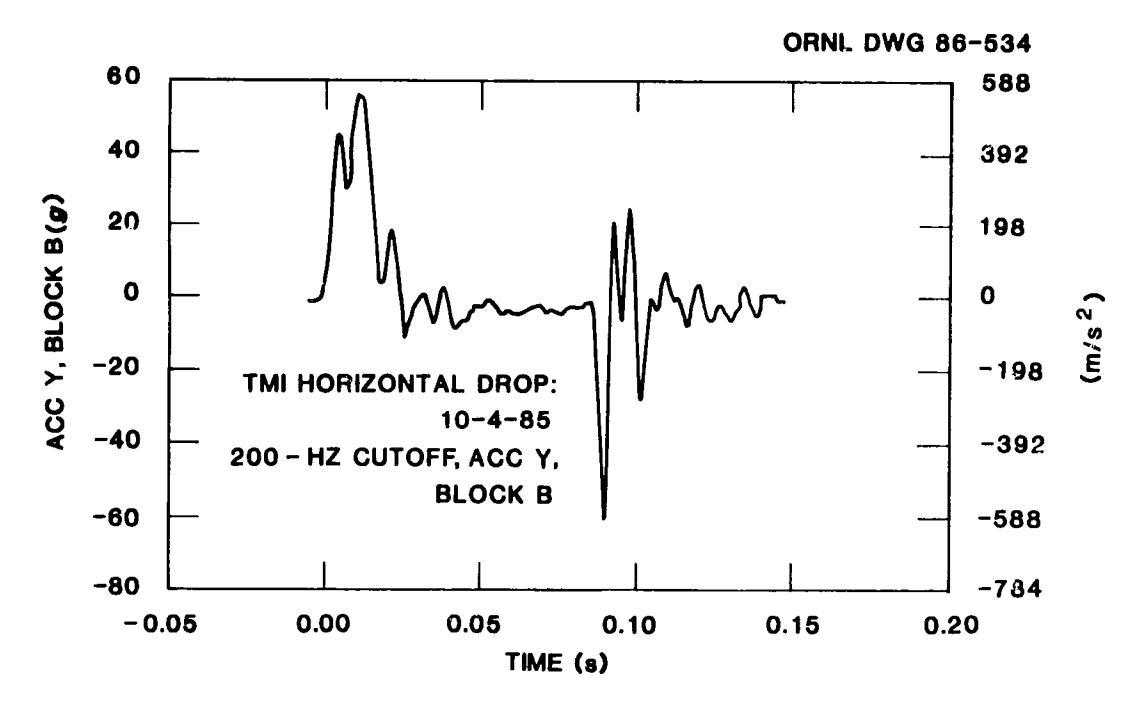
Fig. 11.2. Plot of output for vertical accelerometer of knockout defueling canister during a horizontal drop test. Data has been corrected for a 22° angle of rotation during drop.

During its descent, the canister rotated about its horizontal axis through an angle of approximately 22°. The plot of the vertical acceleration data (Fig. 11.2) has been corrected for this rotation. Plots of the horizontal components of acceleration for this drop test (found in Appendix B) have not been corrected for this rotation.

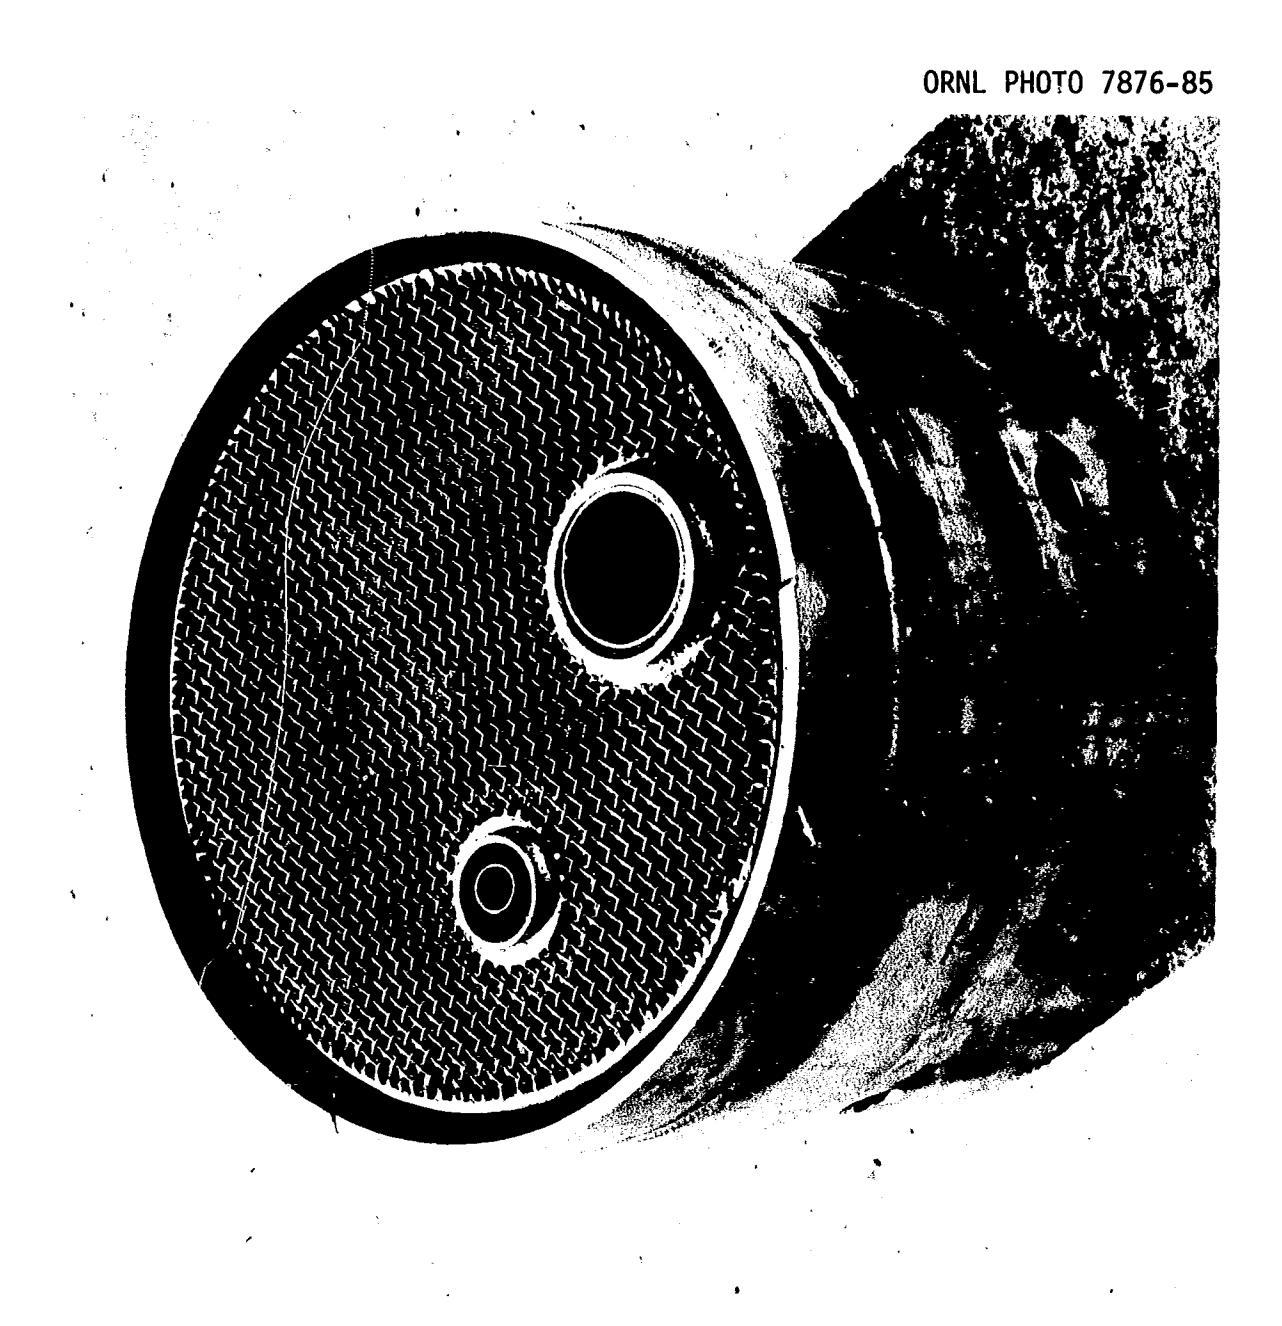
Fig. 12.1. Top head of the knockout defueling canister after all of drop tests.

the bottom head and the top head were cut from the shell (Figs. 12.1 and 12.2, respectively). The next step in the disassembly was to cut a section from the shell's circumference, ~5 cm (~2 in.) above the bottom of the support plate (Fig. 12.3) and remove the inner assembly (Fig. 12.4). The entire assembly was easily extracted from the outer shell, indicating no significant permanent damage to any of the poison rods or support plates had occurred.

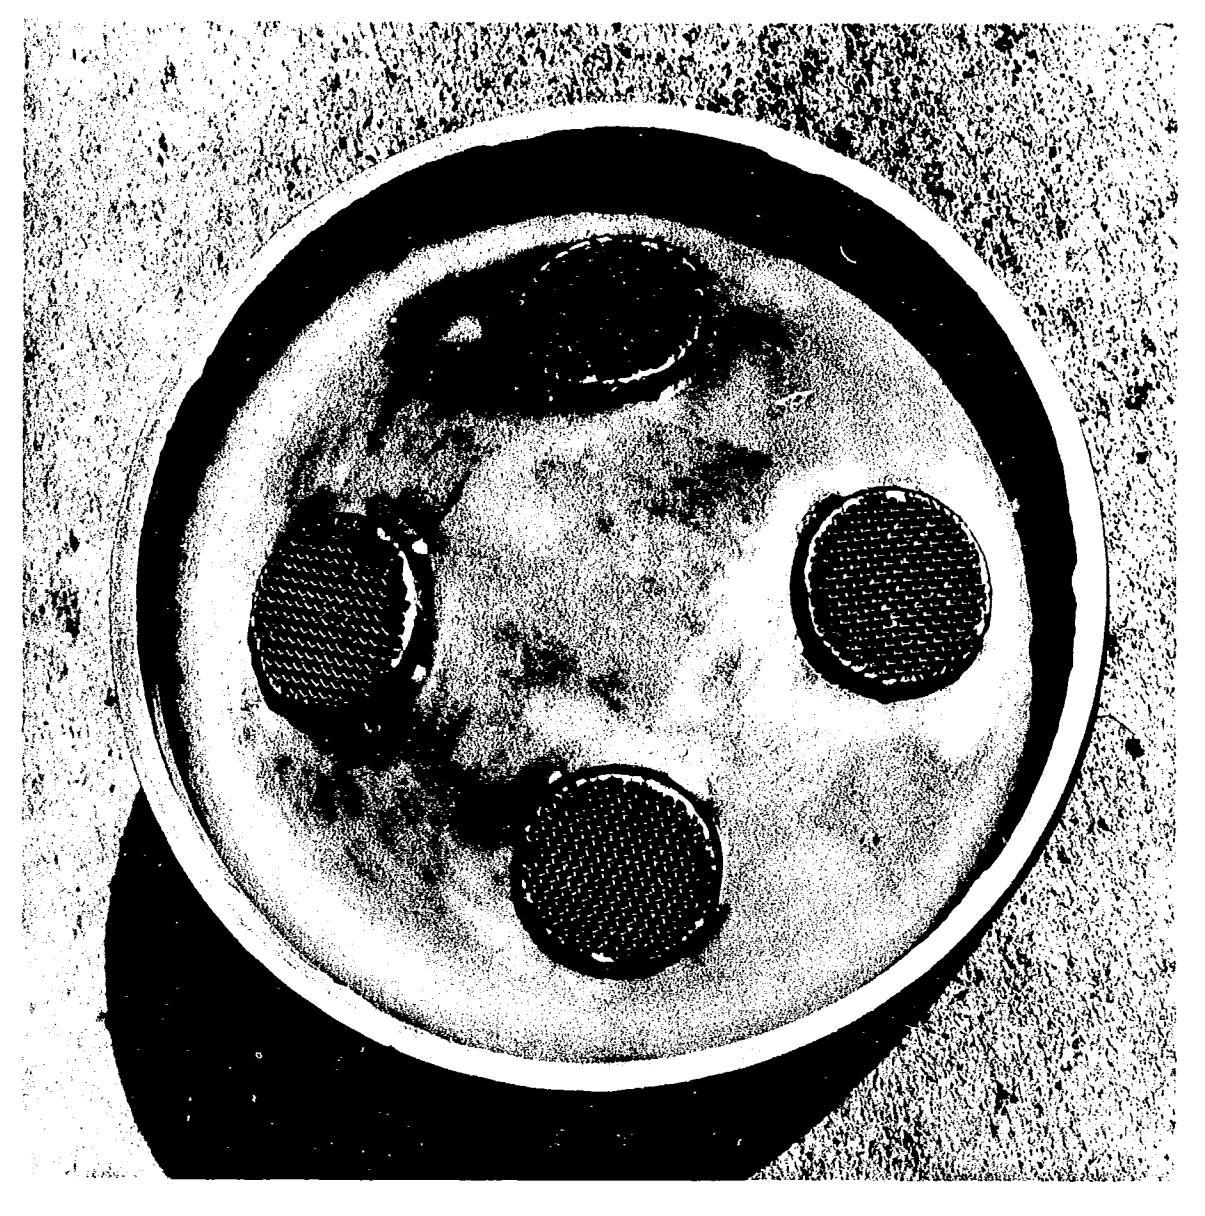
Fig. 12.2. Bottom head of the knockout defueling canister after all of the drop tests.

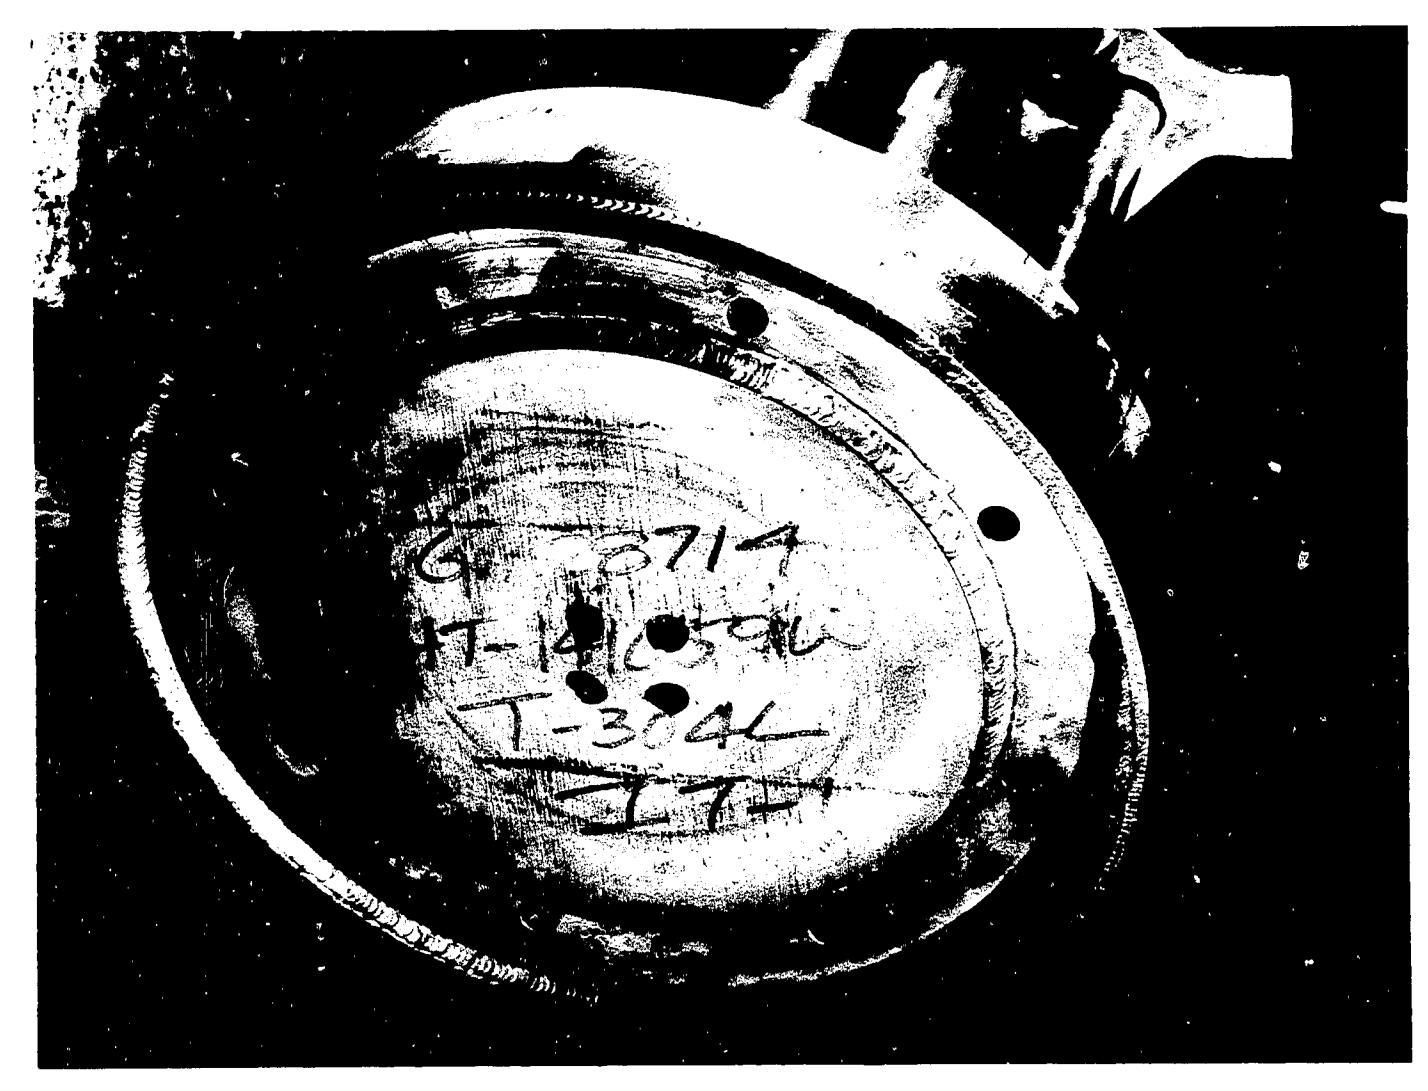
Fig. 12.3. Cross section removed from the knockout defueling canister showing the lower support plate that holds absorber rod in position.

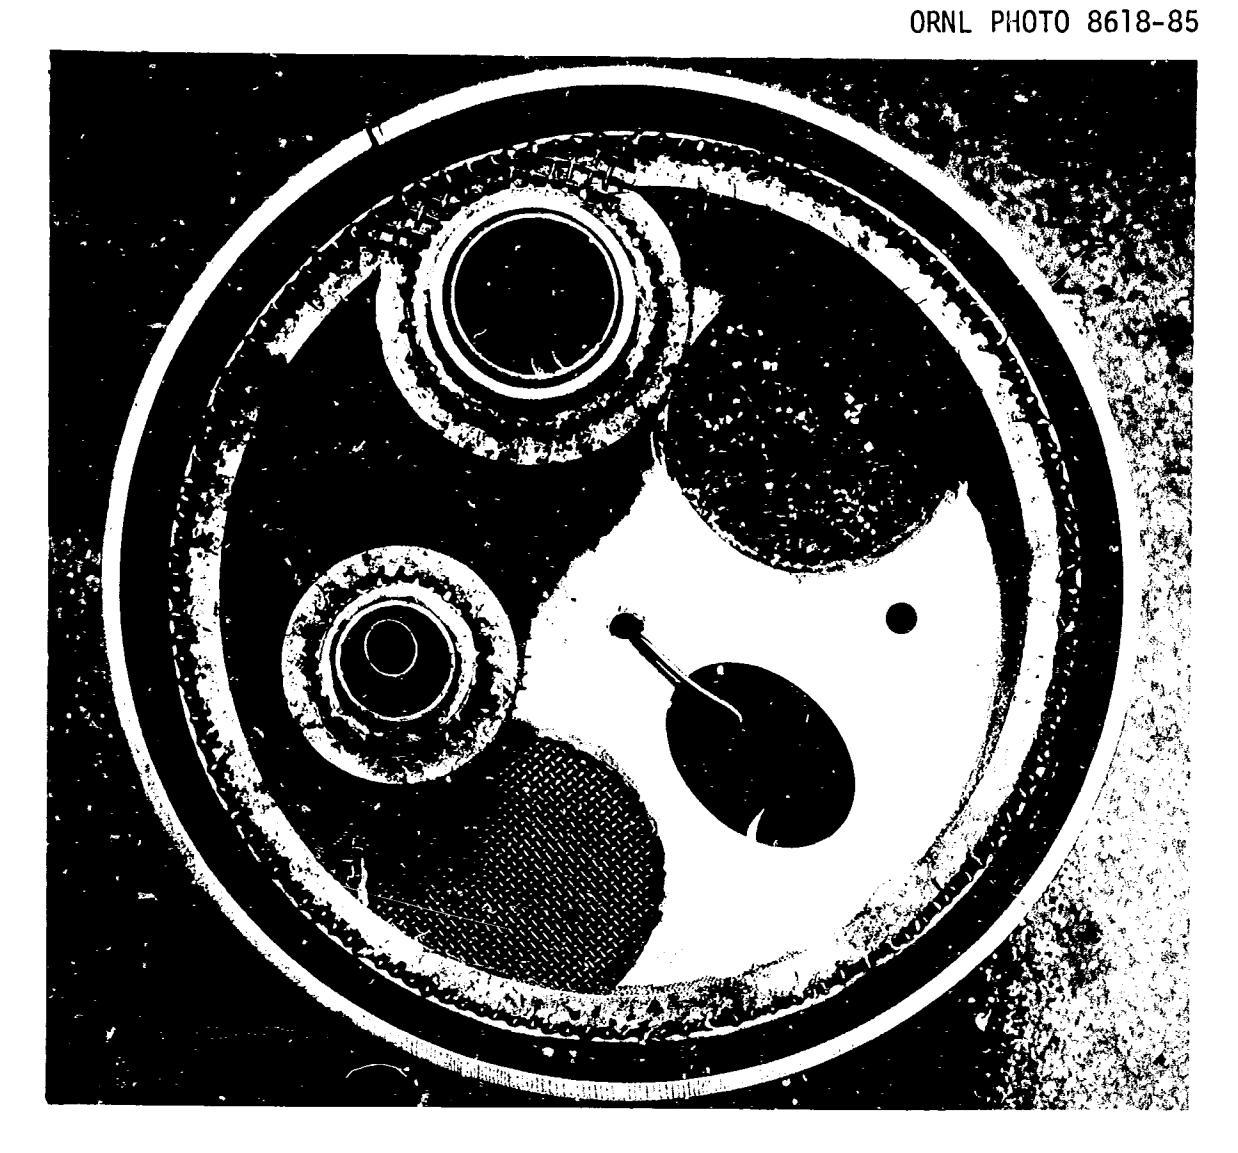
Fig. 12.5. Knockout defueling canister top head showing O_2-H_2 recombiner packets. Screen has been removed from a packet.

The stainless steel screens covering the recombiner pellets were removed to allow examination of the pellets (see Figs. 12.5 and 12.6). This inspection revealed that the recombiner material was undamaged and that the screens adequately contained the pellets within the designed containers in both the bottom and top heads.

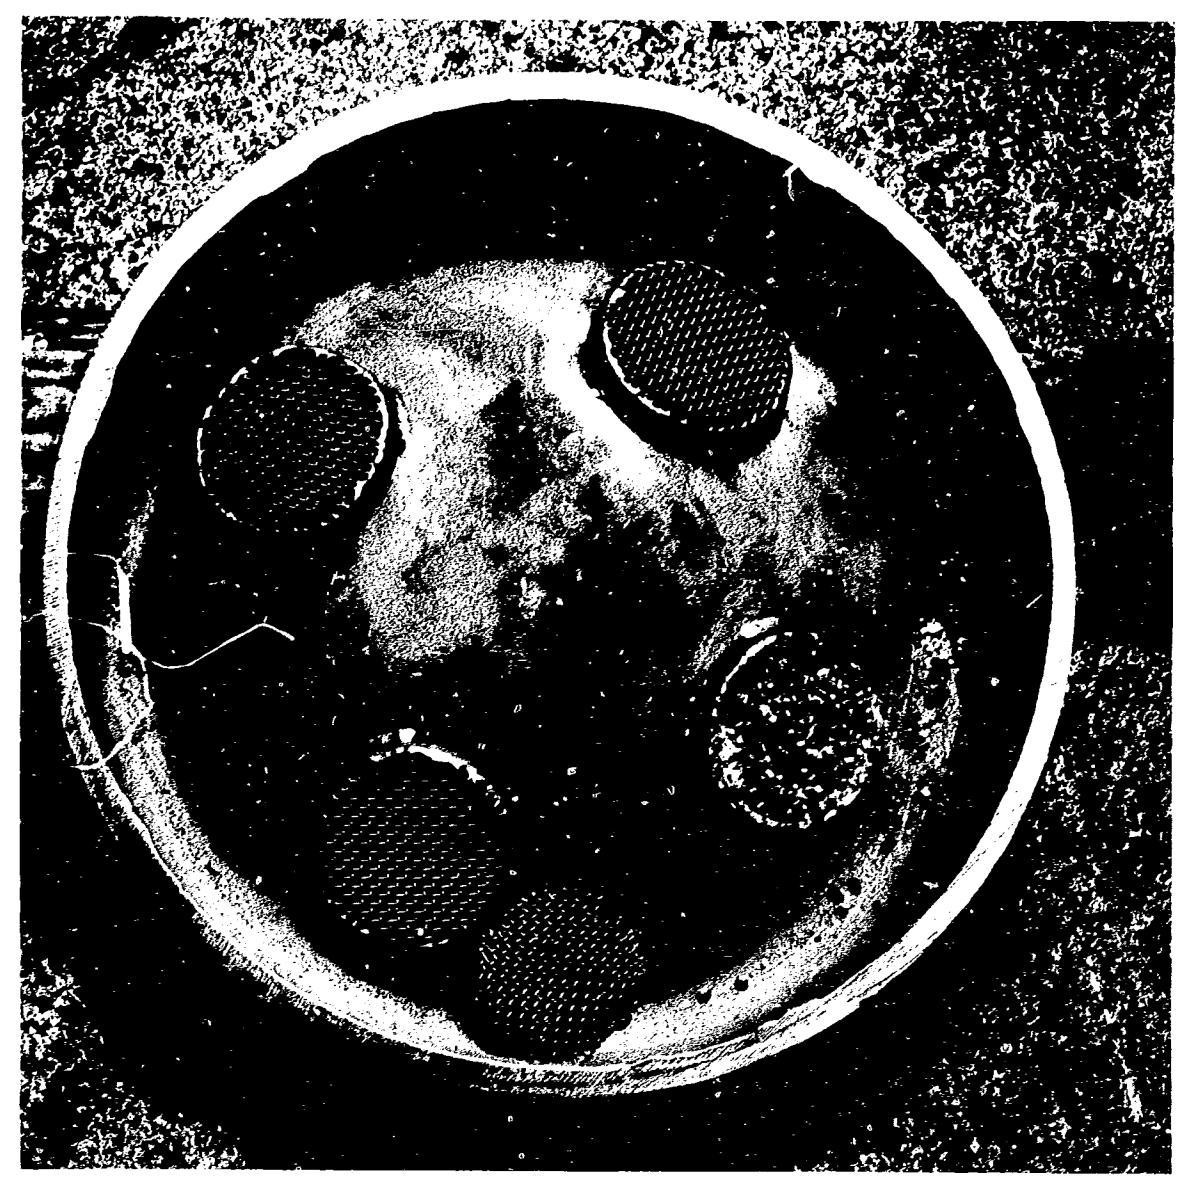
Fig. 12.6. Knockout defueling canister bottom head showing packets of O_2-H_2 recombiner pellets. Screen has been removed from one of the packets.
