DROP TESTS OF THE THREE MILE ISLAND KNOCKOUT CANISTER

Published January 1987

Oak Ridge National Laboratory Oak Ridge, Tennessee 37831 operated by Martin Marietta Energy Systems, Inc. for the Department of Energy Under DOE Contract No. DE-AC05-74OR21400

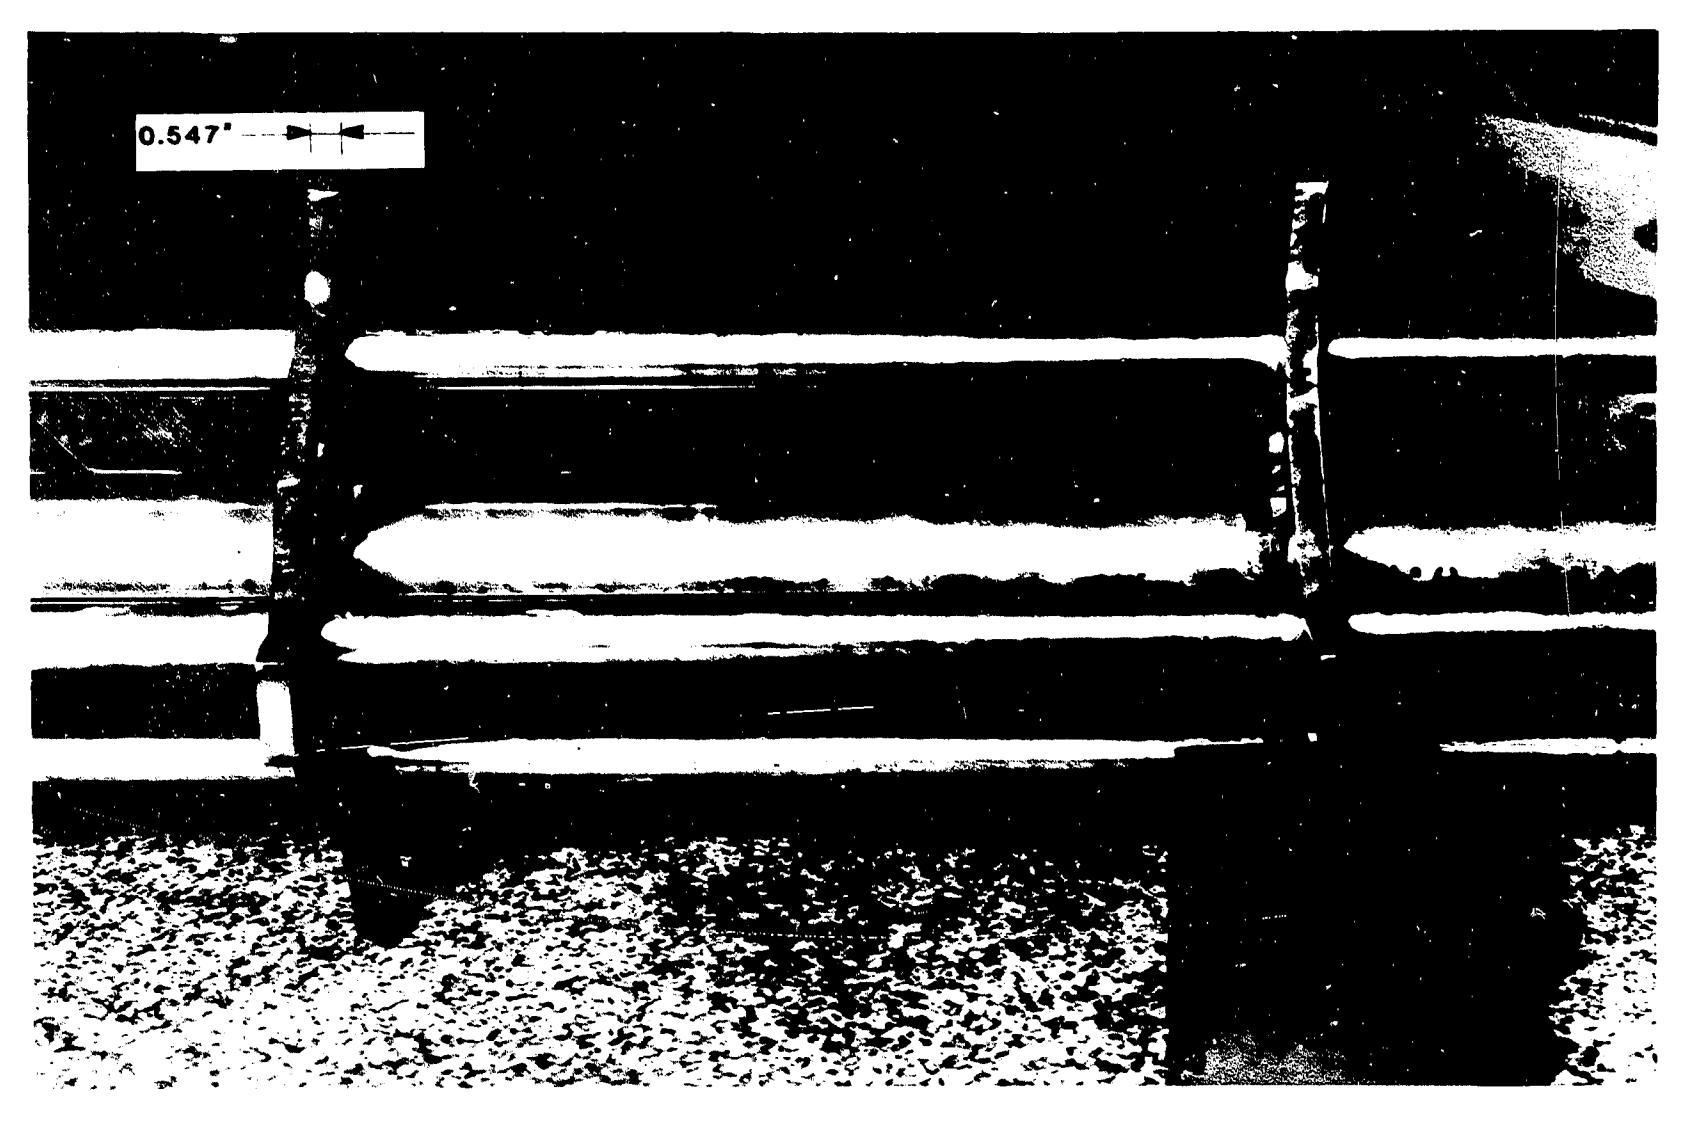
Fig. 12.8. Internal support spider showing displacement resulting from the drop tests.

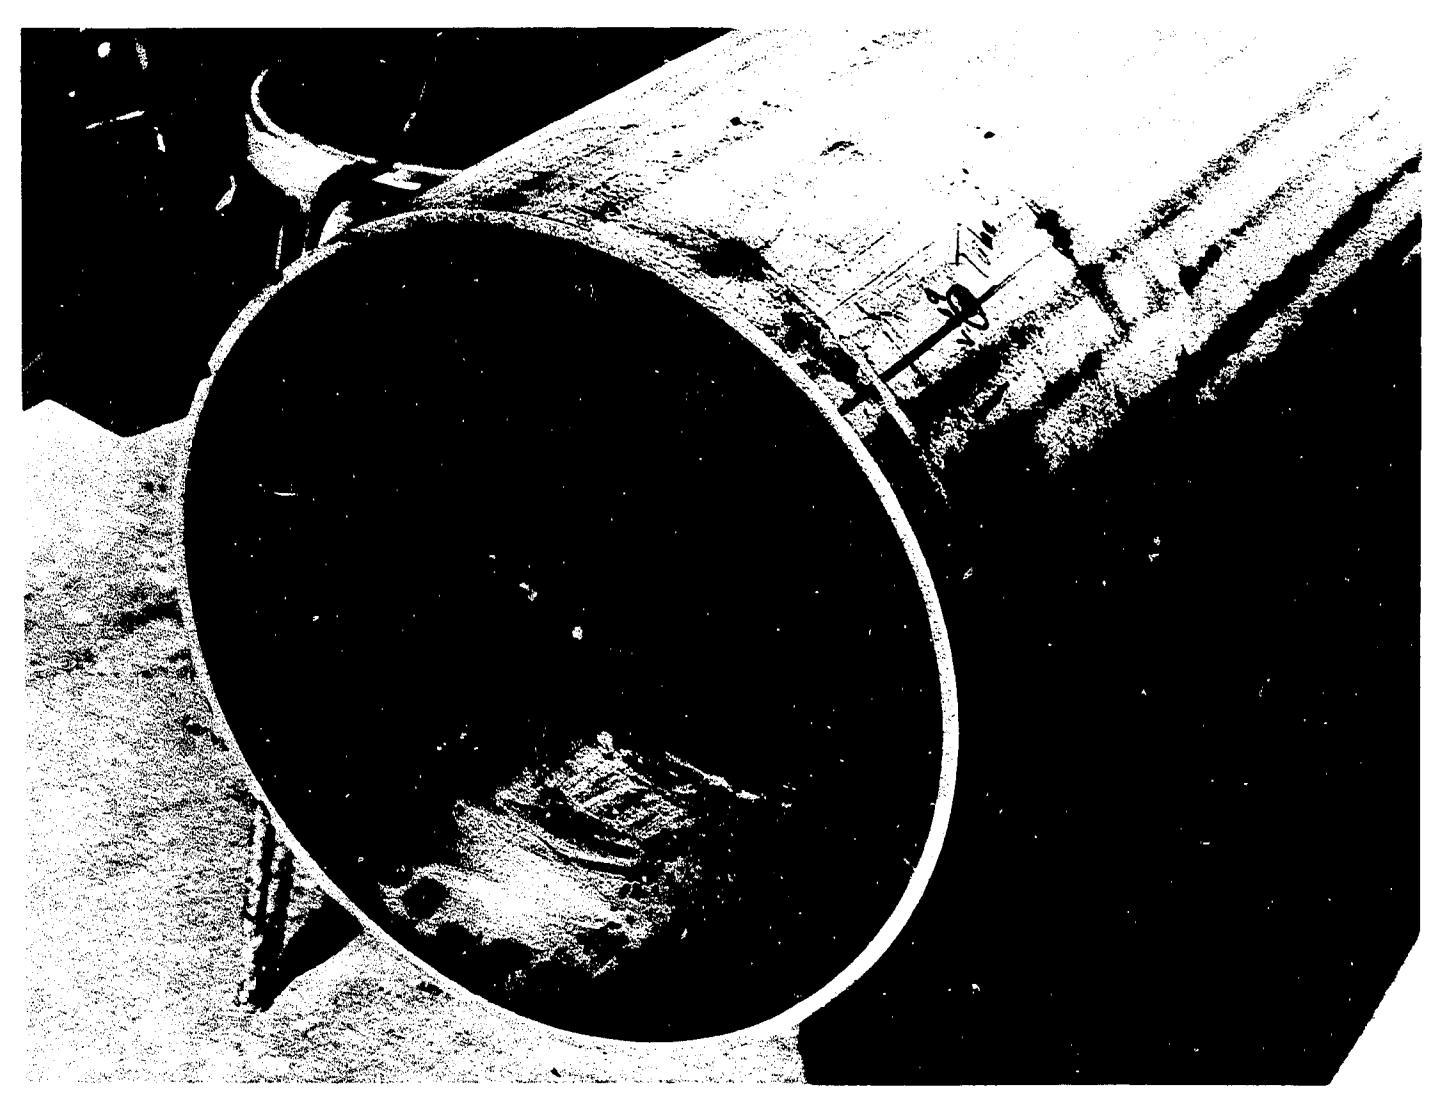
Fig. 12.9. Deformation in the wedges that hold the inner assembly in position resulting from the drop tests.

were welded in place to position the inner assembly inside the top of the canister shell (Fig. 12.9).

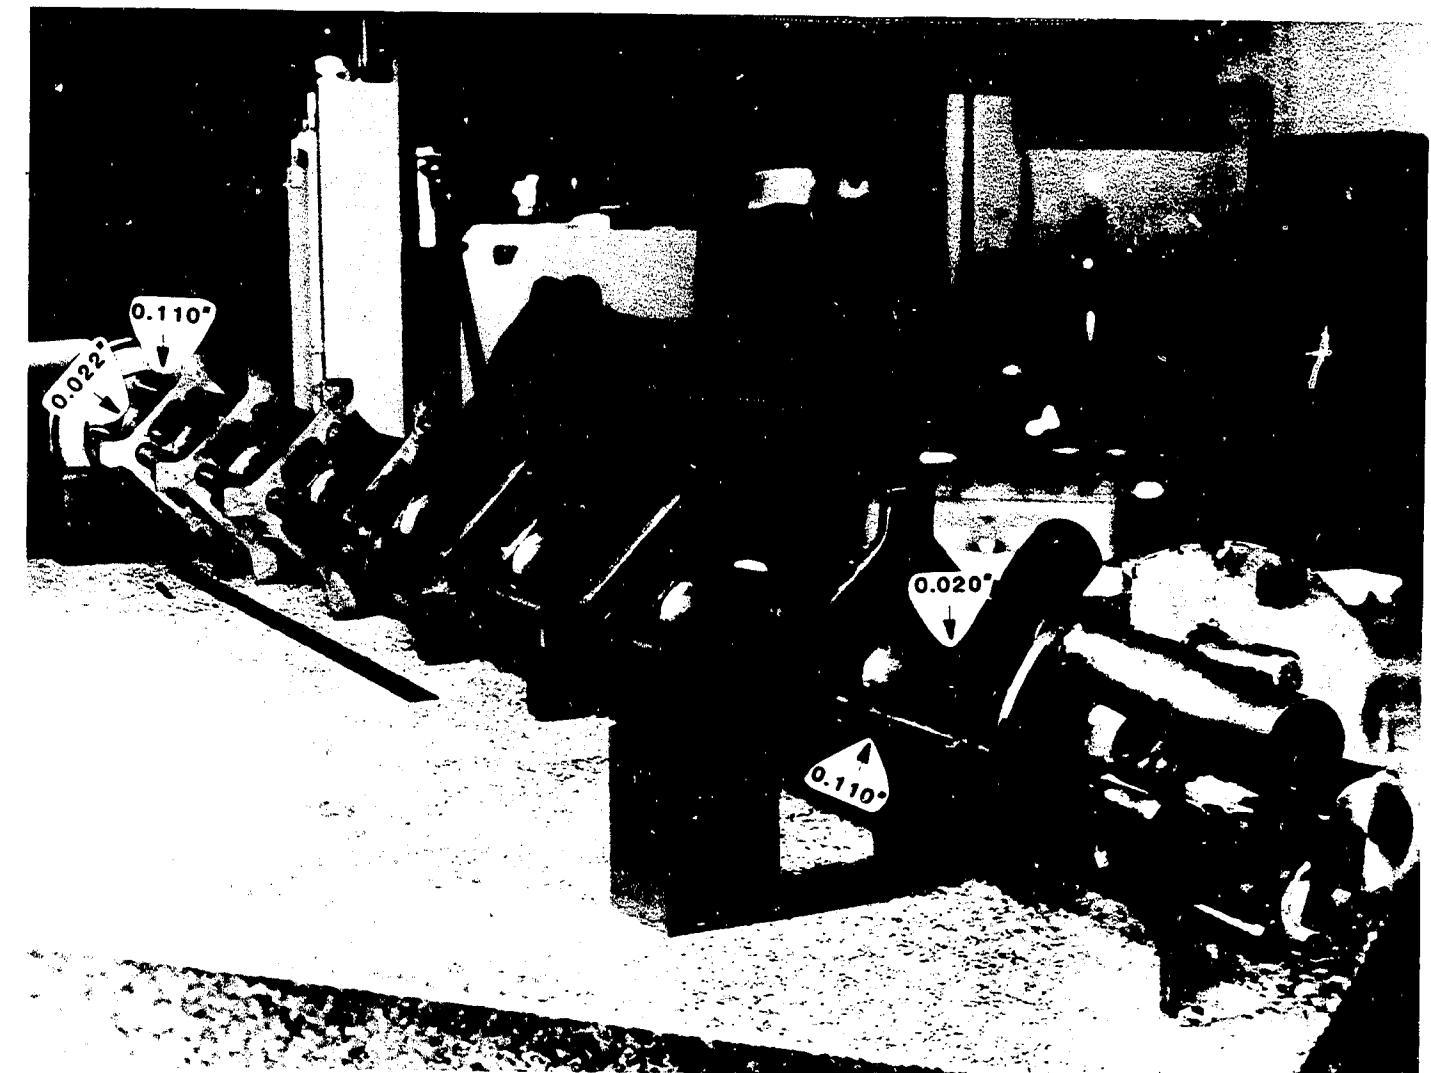
Fig. 12.10. Inner assembly with typical displacement of the poison rods marked on the photograph.

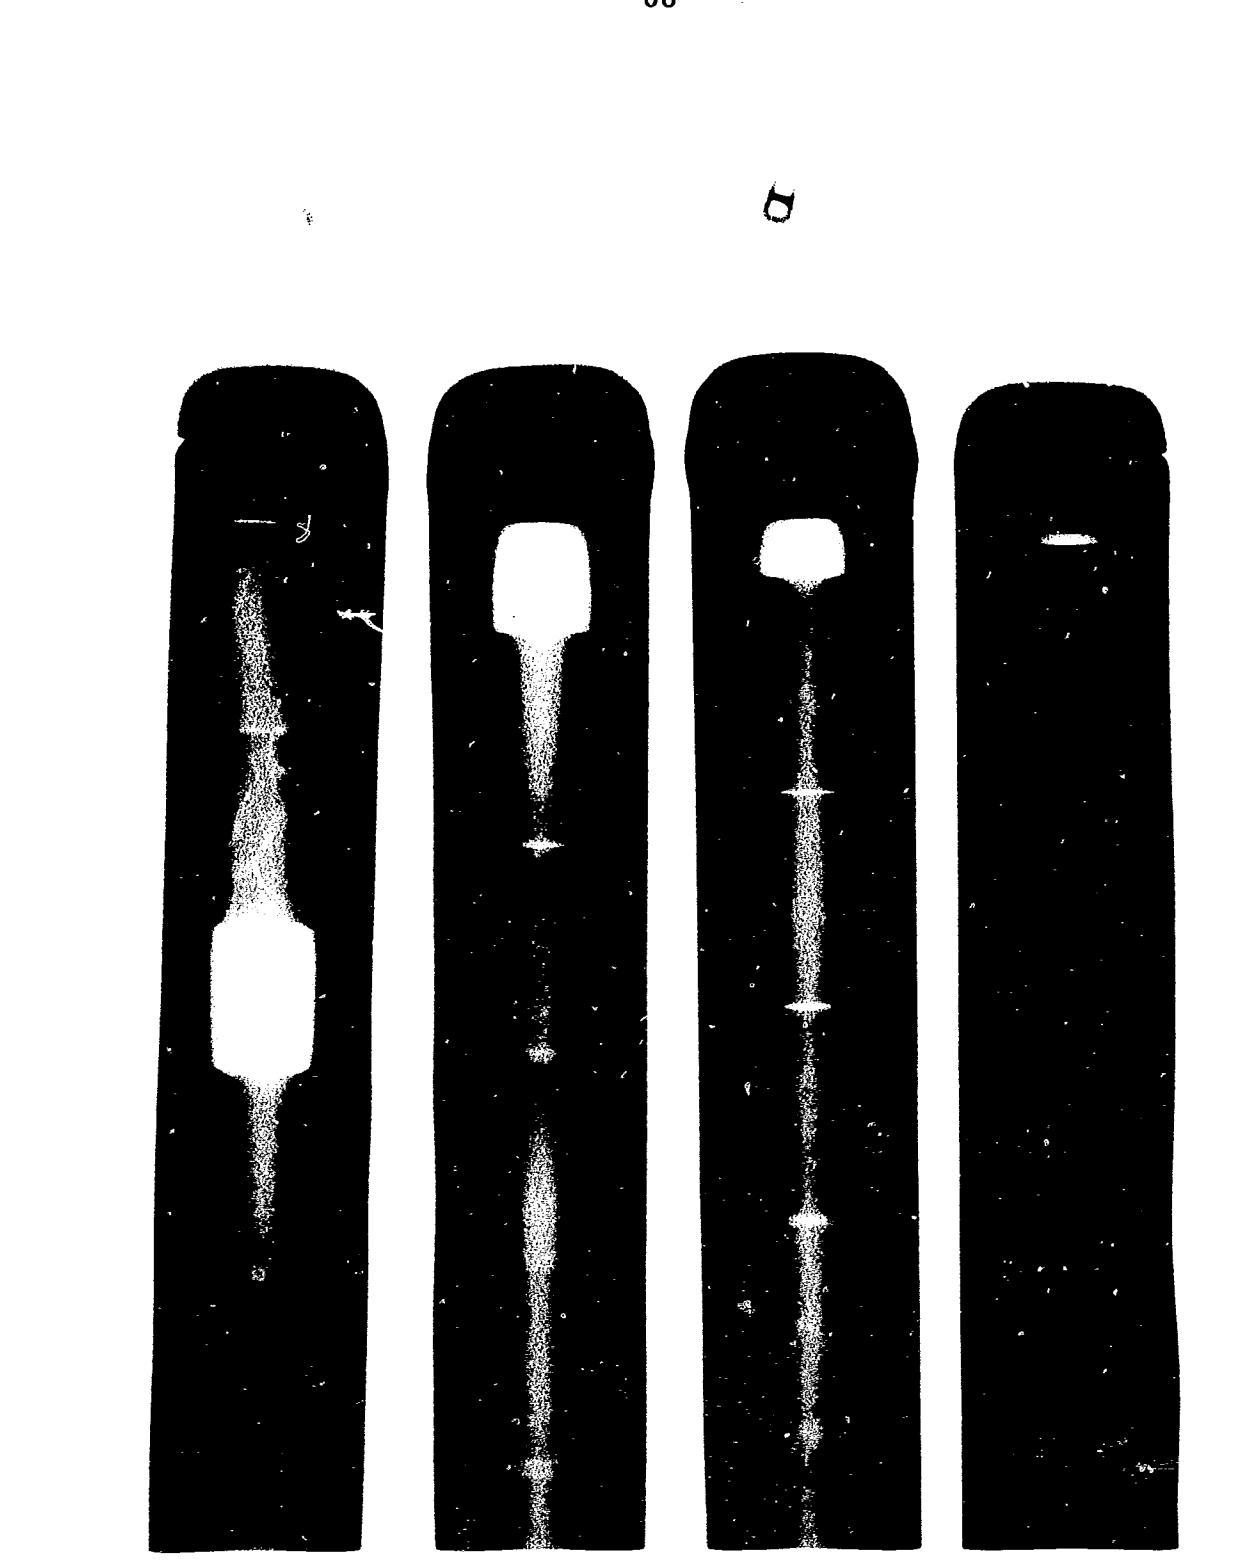
Fig. 12.11. X-ray photograph of the absorber rods after the drop tests. The dark spaces are vacancies resulting from cracked pellets.

pellets in tube B had cracked, causing the stack within the tube to be ~10 mm (~0.45 in.) shorter than its original length (Fig. 12.11). The broken pellets generally remained in pieces, thus contributing to the overall criticality control. The pellets in the remaining tubes were still in pristine condition, with no void space in the end when the tube was placed upright.

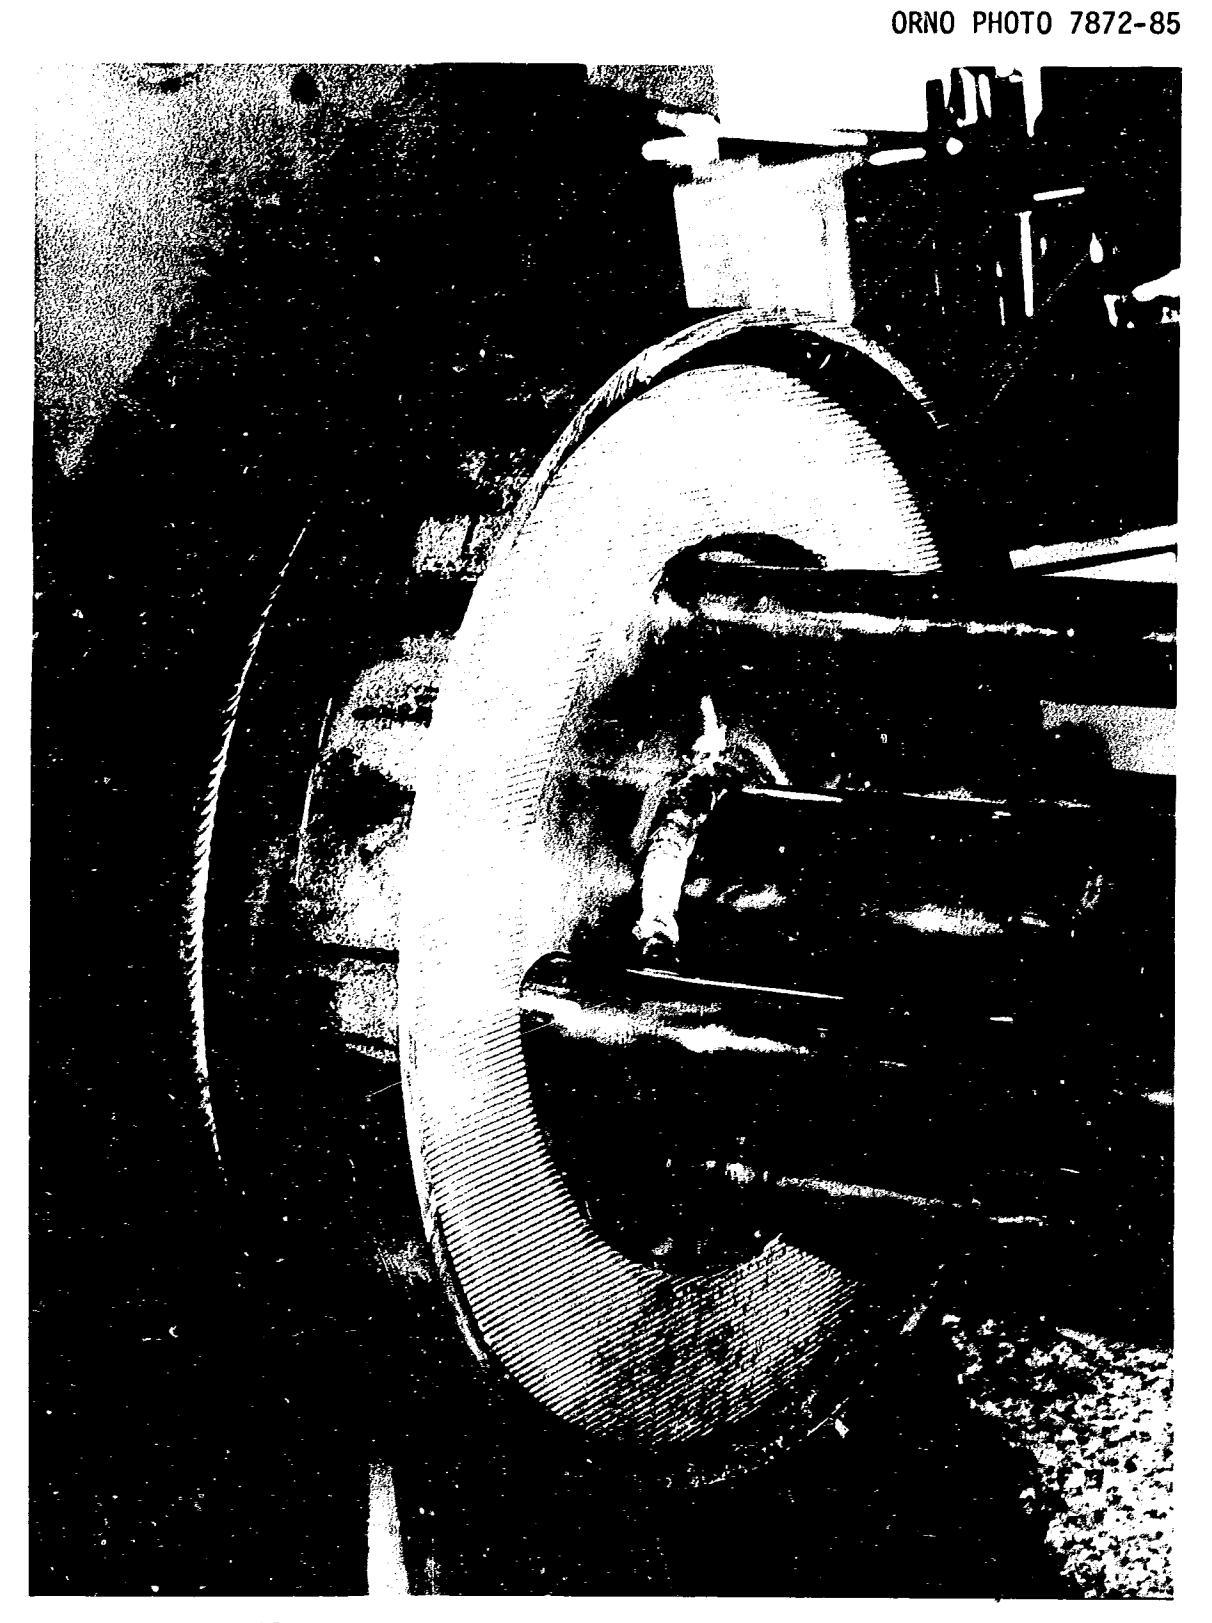
Fig. 13.1. Top surface of the lower support plate of the knockout defueling canister after drop testing.
