# ***TMI-2: Lessons Learned by the U.S. Department of Energy***

*A Programmatic Perspective*

# **TMI-2 LESSONS LEARNED BY THE U.S. DEPARTMENT OF ENERGY— A PROGRAMMATIC PERSPECTIVE**

**R.C. Schmitt  
H.W. Reno**

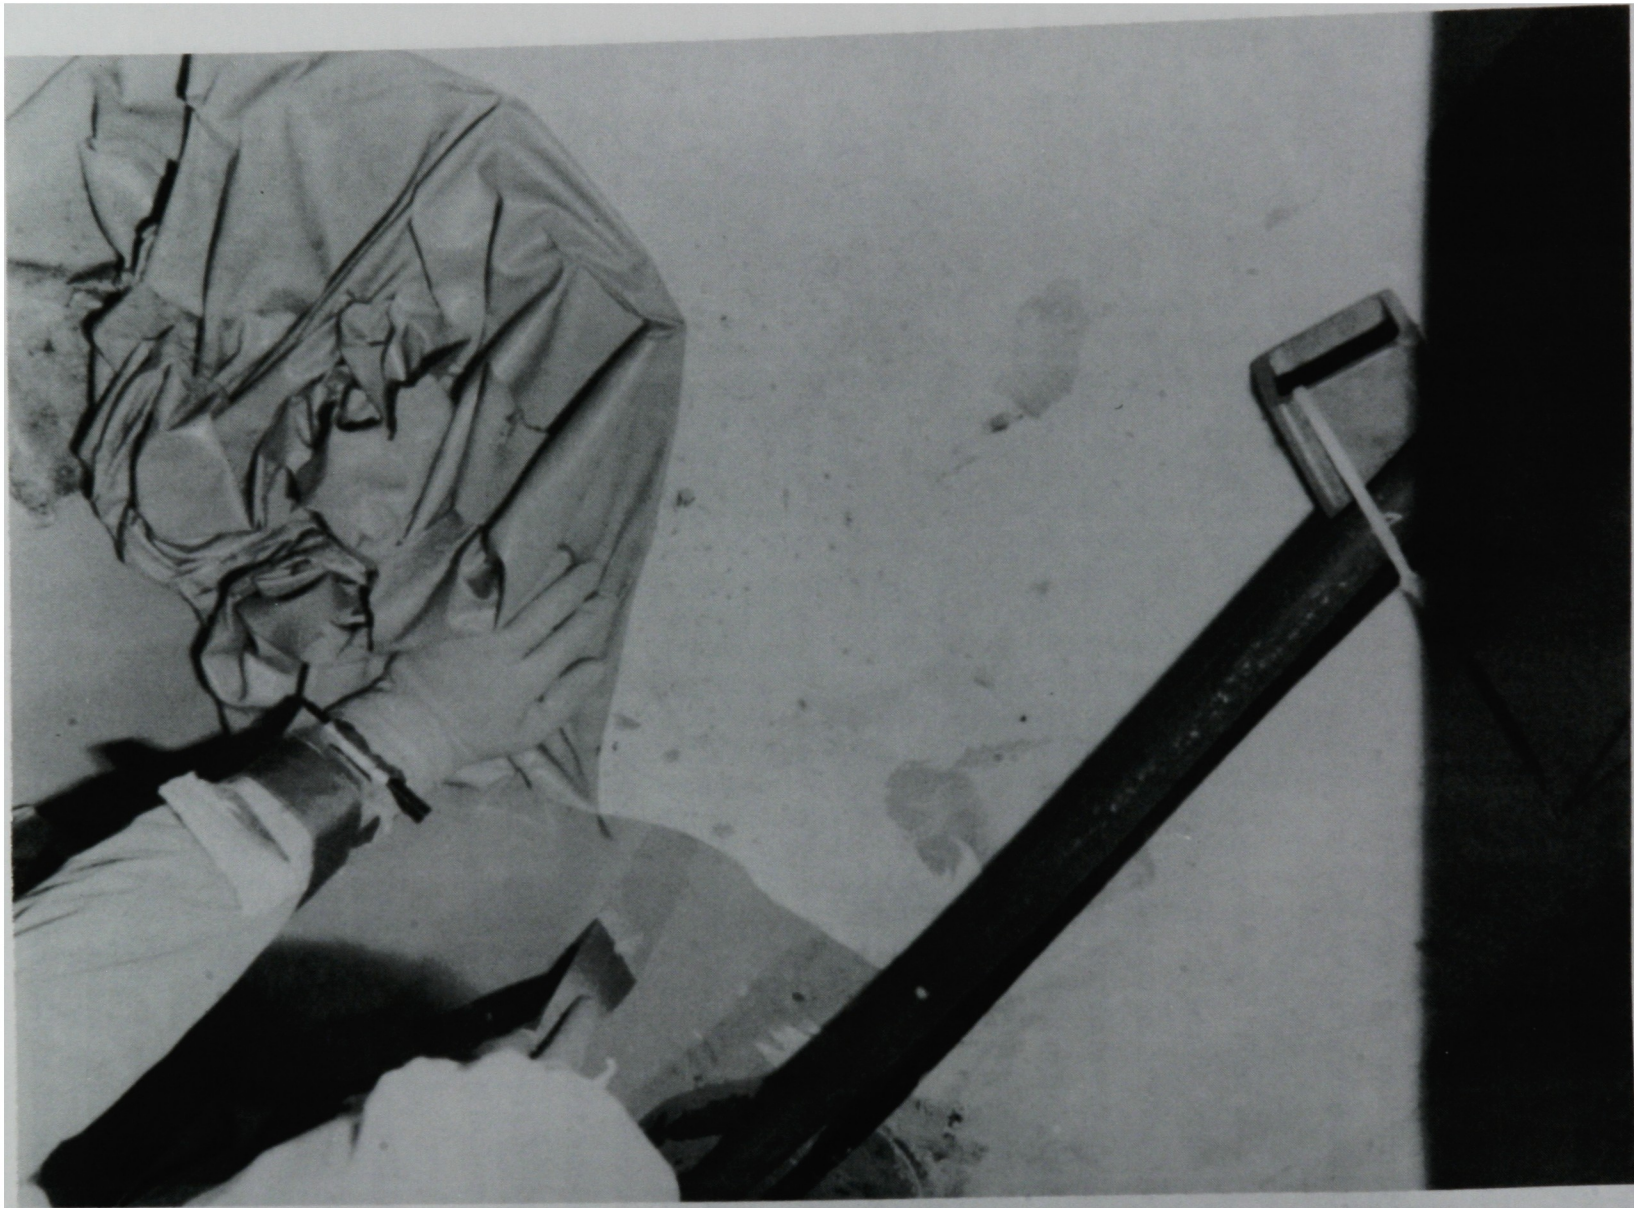
Figure 4. TMI-2 worker removing strippable coating from concrete floor.

Strippable coatings were used on contaminants fixed on painted surfaces, lodged in concrete pores and cracks, and on some pieces of equipment. A self-stripping coating was used at TMI-2. As the coating dried, it cracked and peeled away from the surface; it was then swept up or vacuumed.

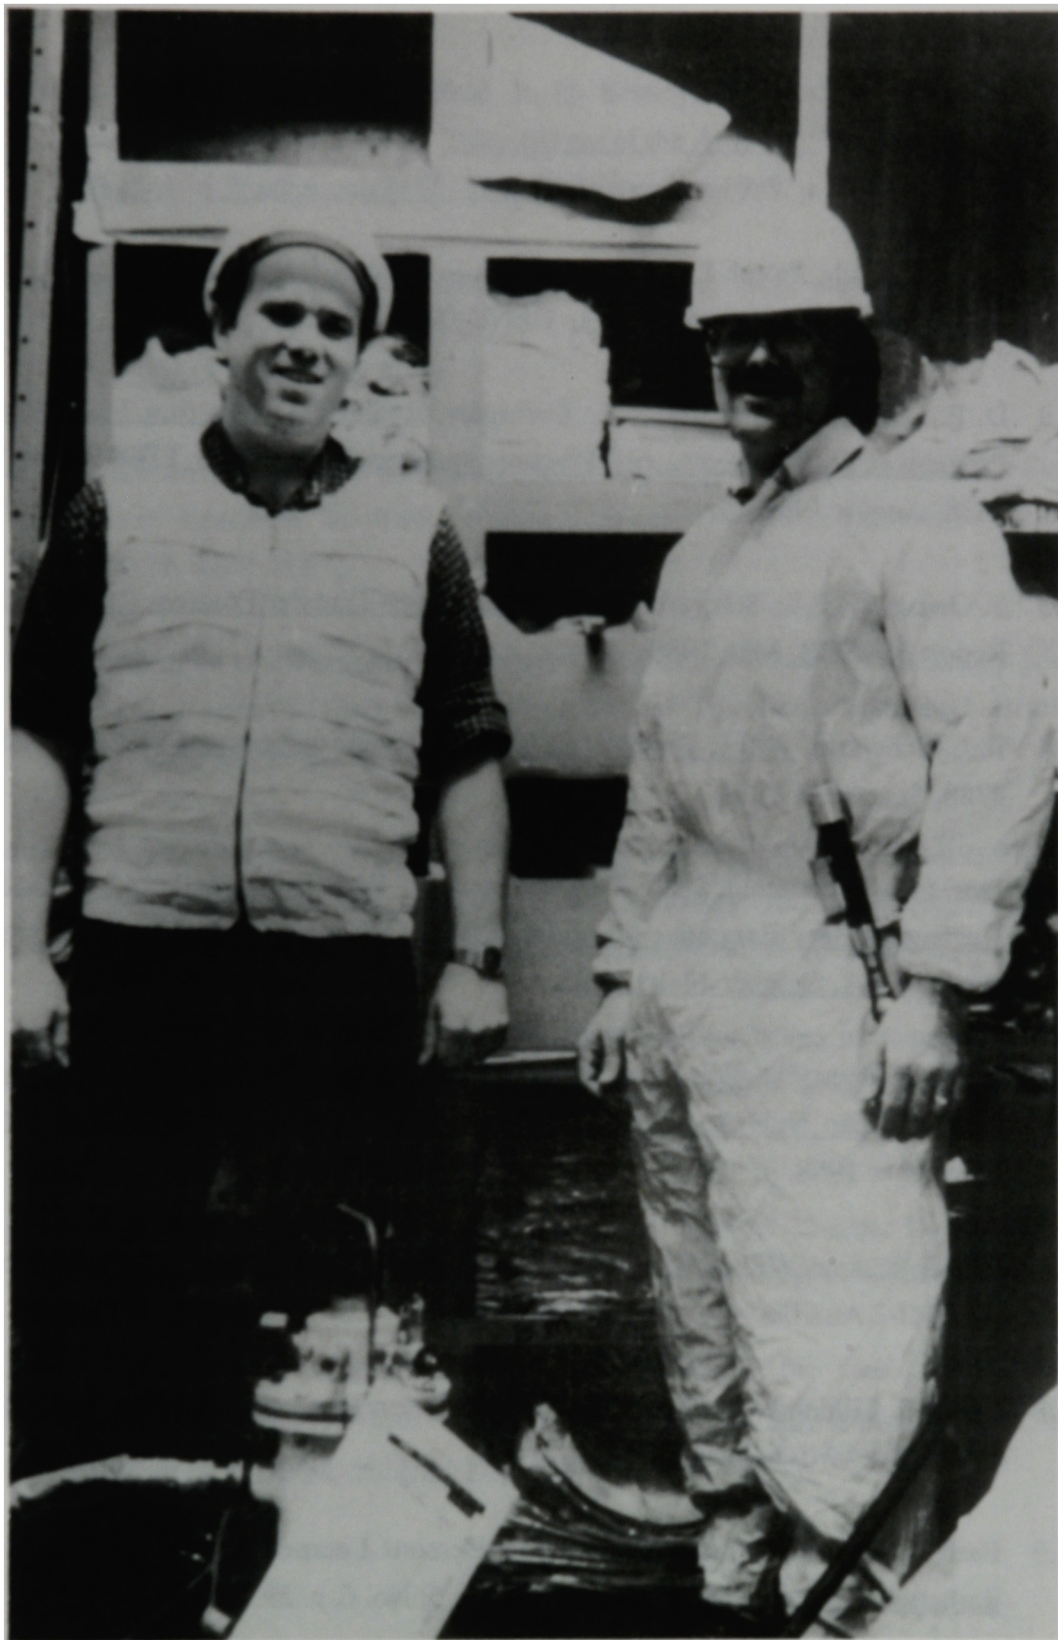
Figure 13. Ice vest (left) and vortex tube cool suit used at TMI-2.

Body cooling garments were considered after encountering problems with the Vortex tubes. Three types of body cooling garments were investigated: the Cool Vest™ and the Cool Head™ (which use circulating water tubes in the garment to remove body heat), and the frozen water garment. At TMI-2, the first two garments were found to be difficult to decontaminate, expensive, and their pumps required regular maintenance. Greater success was achieved with simple, easy to maintain frozen water garments. The frozen water garment, or ice vest, is a tight-fitting vest worn under protective clothing. It has 60 small pockets to hold ice packets with a total capacity of ~8 lbs of ice. The ice serves as a heat sink for metabolic heat produced by the body; the heat dissipates as the ice melts. While the heat sink provided by the ice packets is limited, workers in the high heat environment wearing the garments doubled their stay times. Prepared garments and additional ice packets were kept in a freezer in the worker dress-out area. Ice packets were regularly replaced since they often would break in use. The garments were laundered with other uncontaminated protective clothing. Ice vest use was carefully planned because substantial melting occurred if there were delays between the dress up period and entry into the work area. Work times also were monitored because once the ice melted the garment's weight added to the worker's heat stress burden. Liquid nitrogen was used to quick-freeze the water packets to save time, but this practice was discontinued because the ice packets were so cold that worker frost bite was a danger. (Reference: 4.4, 4.5, 4.8, 4.17)

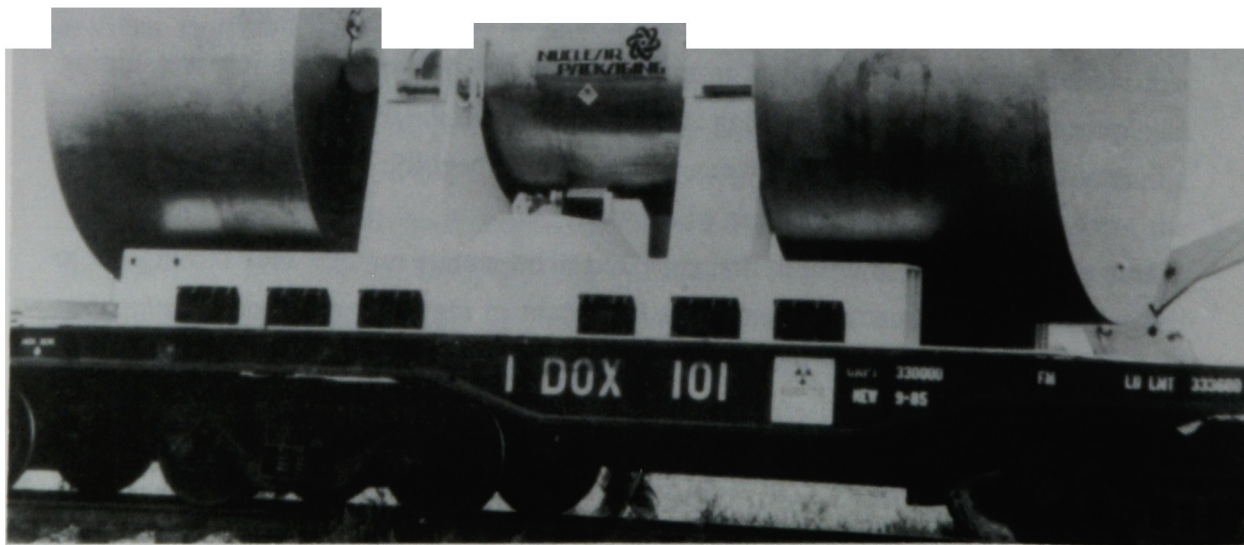
Figure 18. Exploded view of NuPac-125B rail cask and photo of cask on railcar.

- using welded instead of epoxied joints in the aluminum honeycomb internal impact limiter, thus eliminating the need for constant repair;
- inserting a small diameter tube through the center of each lower impact limiter to pump residual water from the cavity, instead of removing the impact limiter, thereby reducing maintenance time;
- using uncoated stainless steel cables as lanyards instead of vinyl-coated steel aircraft cables corrected the problem that was causing the lanyard loop to open;
- adding tapered lead-in collars around each bolt hole alleviated the time-consuming process encountered in installing attachment bolts for the overpacks;
- revising procedures to greatly extend the useful wheel life of the railcars as a result of early identification of excess wheel wear.
