# **U. S. Department of Energy Three Mile Island Research and Development Program 1989 Annual Report**

**U.S. DEPARTMENT OF ENERGY  
THREE MILE ISLAND  
RESEARCH AND DEVELOPMENT PROGRAM  
1989 ANNUAL REPORT**

**July 1990**

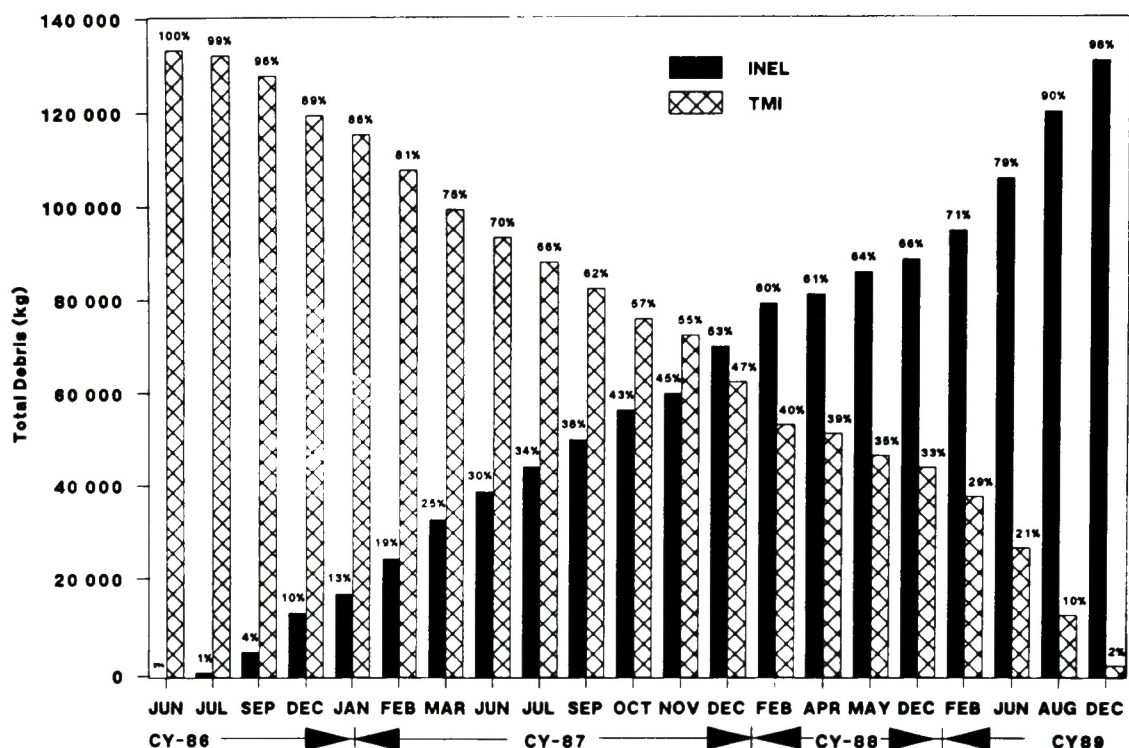
**Figure 1.** Location of TMI-2 core debris—Three Mile Island versus Idaho National Engineering Laboratory.

Figure 1 shows the percentage of TMI-2 core debris that has been transferred from Three Mile Island for storage at the INEL. The figure shows that approximately 98% of the core debris was transferred to the INEL by the end of 1989. This amount accounts for approximately 131,836 kg of the original TMI-2 core debris, which was estimated to be 134,945 kg.

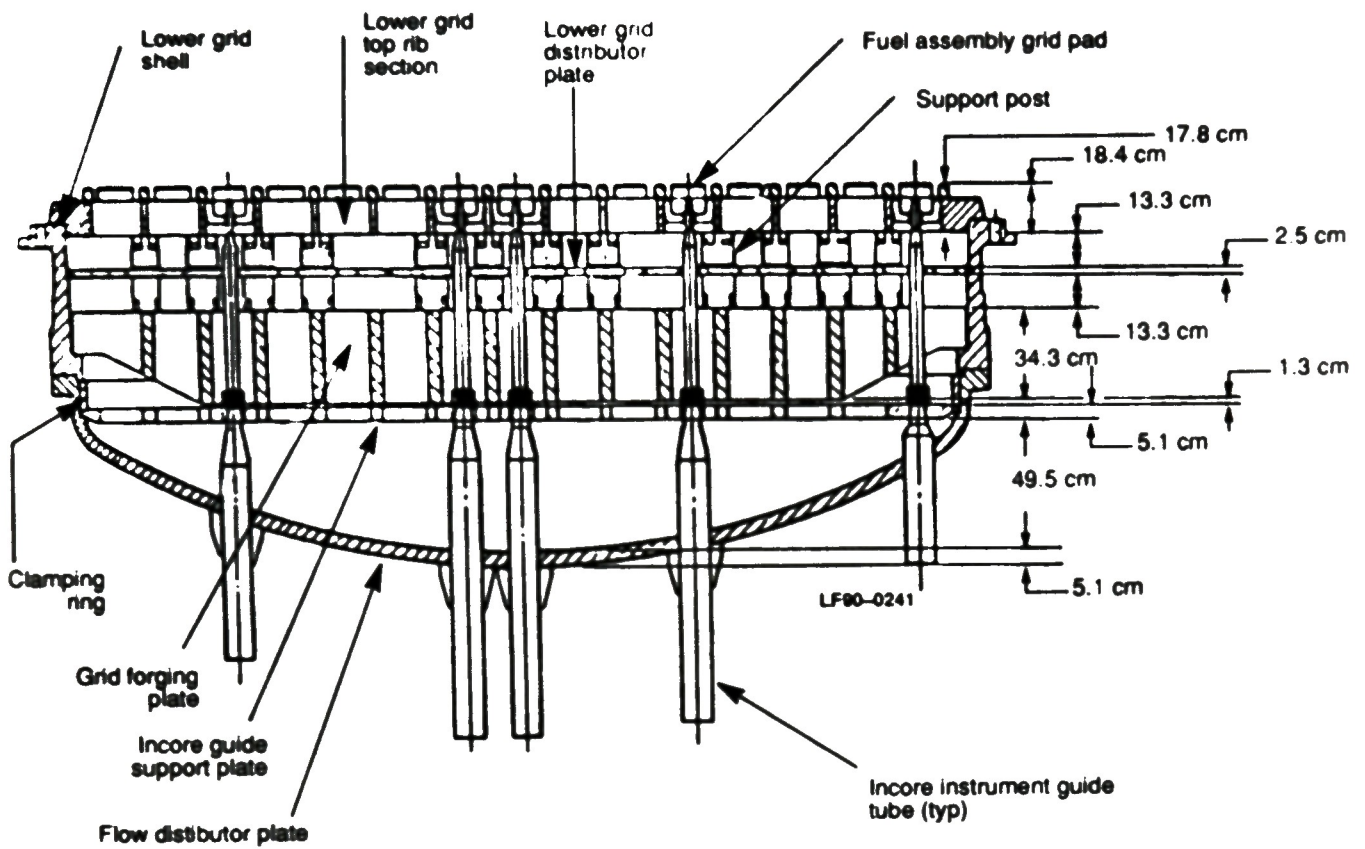
**Figure 3.** TMI-2 lower core support assembly.

The LCSA consists of a series of five interconnected, stainless steel plates (see Figure 3). The plates, from top to bottom, are: (a) lower grid rib section, (b) lower grid distributor plate, (c) lower grid forging plate, (d) incore guide tube support plate, and (e) the flow distributor head plate.

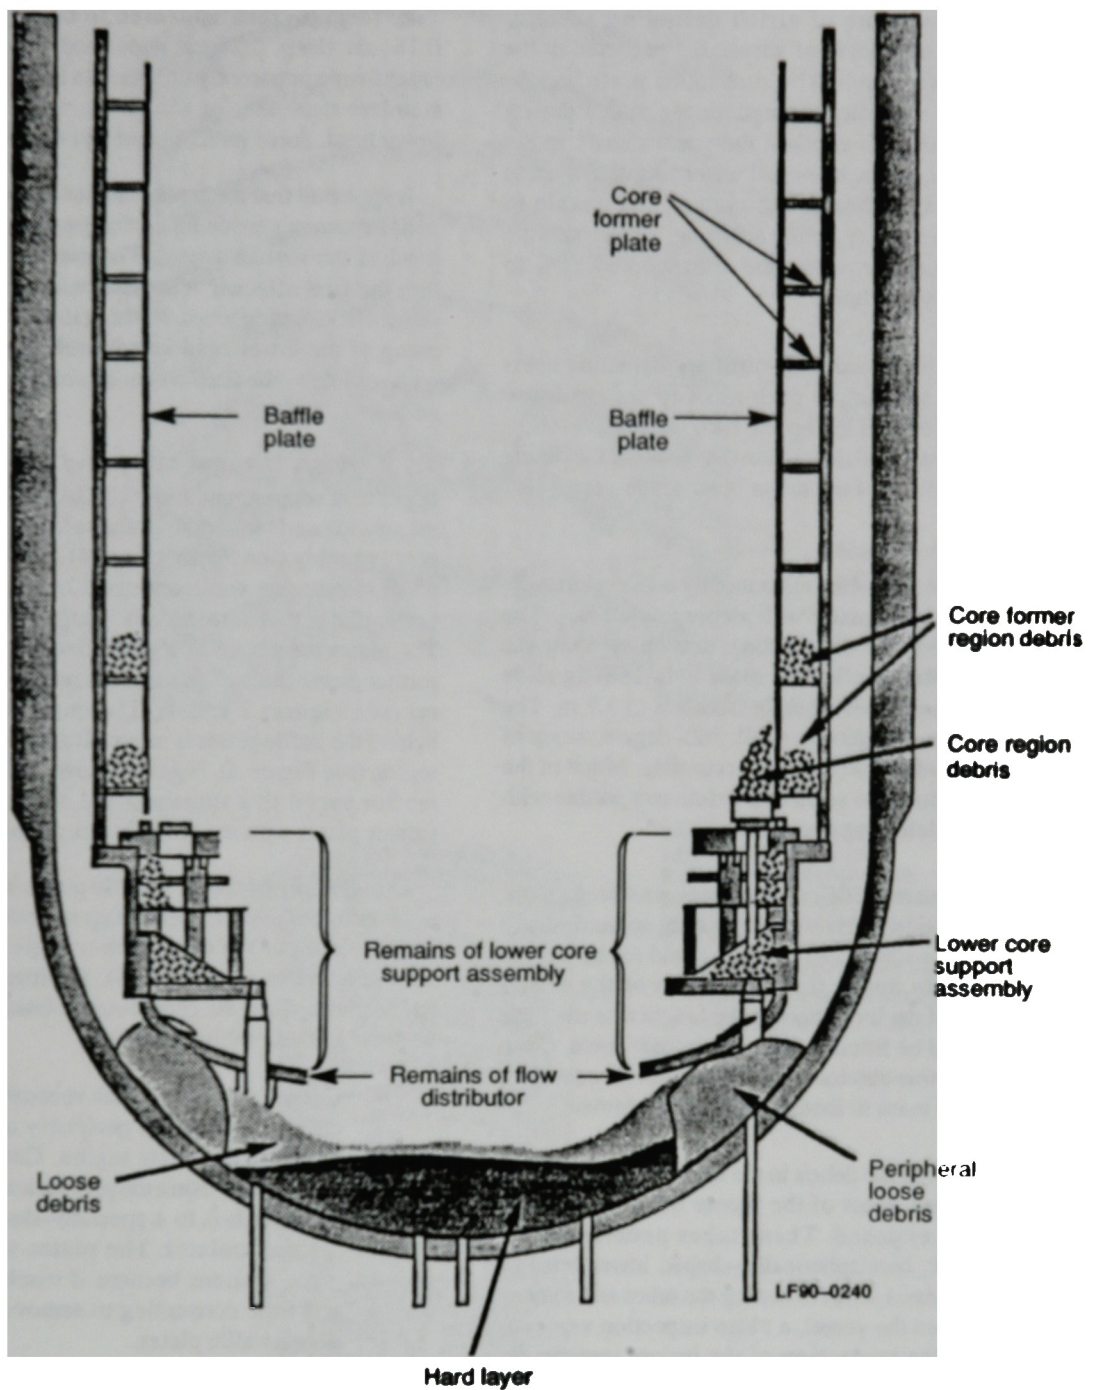
**Figure 4.** Illustration showing the configuration of the TMI-2 reactor vessel and the location of core debris after the lower core support assembly was removed.

Figure 4 illustrates the remains of the flow distributor head plate, the peripheral remains of the LCSA, and the configuration of the lower region of the reactor vessel after the LCSA was disassembled and removed from the reactor vessel.

Pick-and-place and midi-airlifting defueling operations were alternately performed to collect loose debris prior to breaking up the hard-packed, resolidified mass of material, located in the center of the debris bed at the bottom of the lower head of the vessel (see Figure 4).
