## INTERIM REPORT ON THE TMI-2 PURIFICATION FILTER EXAMINATION

### Idaho National Engineering Laboratory

Filters from the purification/makeup system of the Three Mile Island Unit 2 Reactor were examined after the March 28, 1979, accident to determine the character of the debris transported to the filters. The general condition of the filters is presented. Material was removed from the filters and examined. The elemental and radionuclide makeup of the debris is discussed. Distribution of particle size and shape is presented for some of the material examined. This is an interim report. When the investigation is completed, another report summarizing all of the data will be issued.

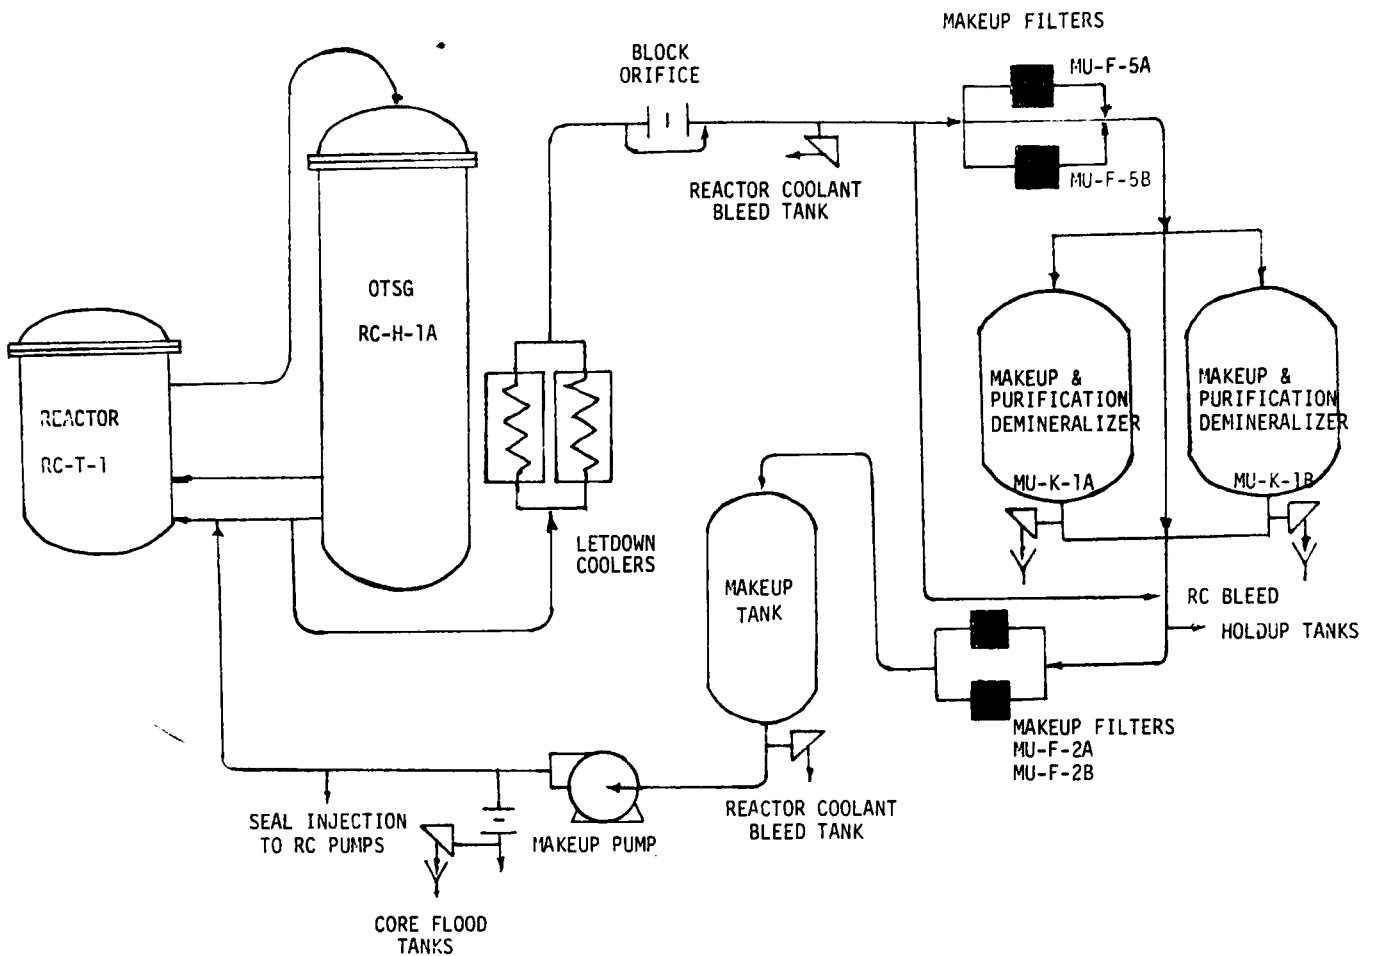
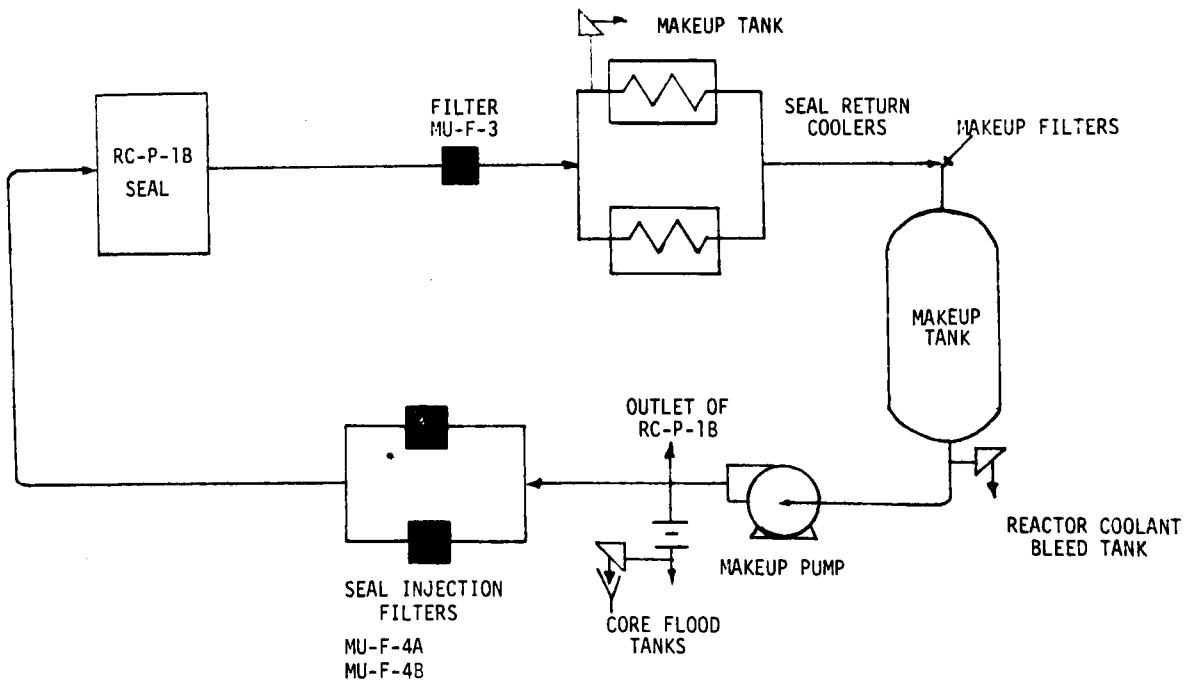
Figure 1. Schematic of the purification/makeup filter system in the TMI-2 reactor.

The TMI-2 purification/makeup system purifies and recirculates reactor coolant and supplies water to the reactor coolant primary pump seals. A fraction of the primary coolant water is diverted from the primary coolant cold leg through the purification/makeup system and back into the cold leg. A simplified schematic of the system is shown in Figure 1. The flow leaves the cold leg through letdown coolers and a block orifice. At this point, some of the flow may be diverted to reactor coolant bleed tanks. The flow then travels through Filter MUF-5A and/or -5B, one of two purification/makeup demineralizer tanks, Filter MUF-2A and/or -2B, and into a makeup tank. Either one or both of the MUF-5 and -2 filters, and the demineralizer tanks, can be valved into the line or by-passed completely. Some of the flow from the makeup tank is diverted through two seal injection filters (MUF-4A and -4B) and then to cool the reactor coolant primary pump seals. The flow through the pump seals then proceeds through another filter (MUF-3), through seal return coolers, back to the makeup tank, and then back to the primary coolant cold leg.

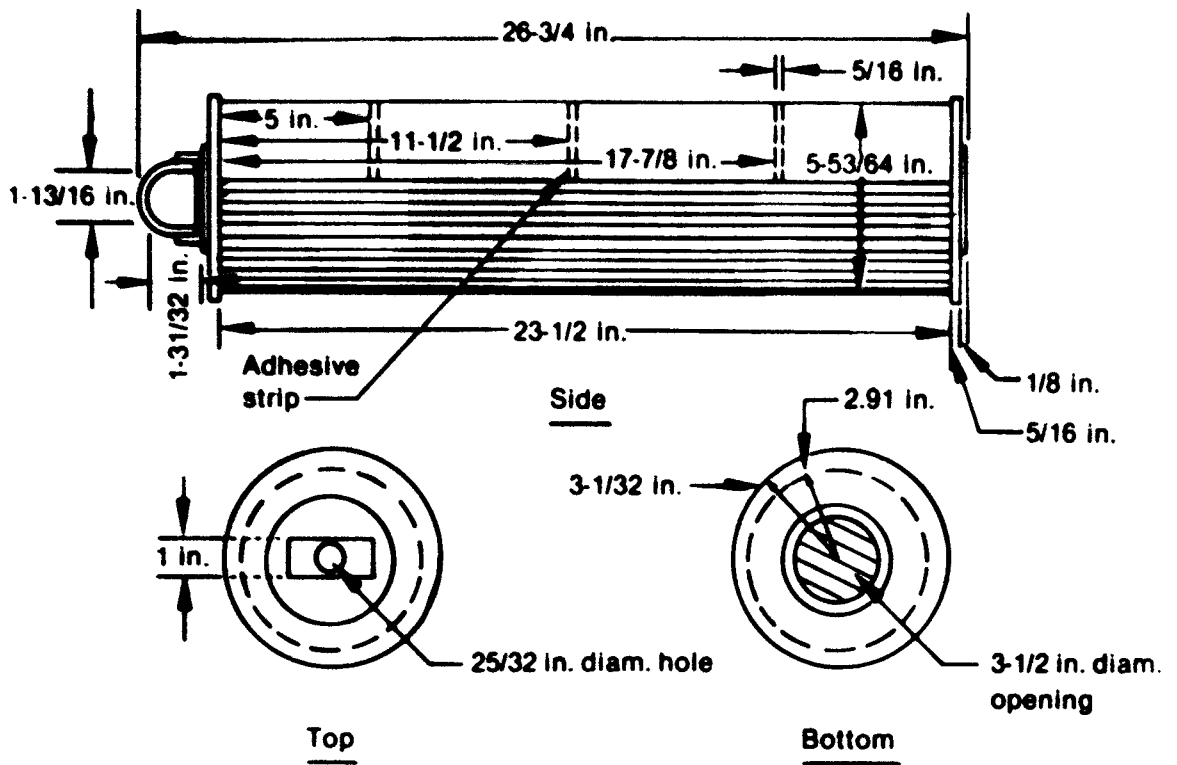
Filters MUF 5B, 2A and 2B

Figure 2. Schematic of the TMI-2 purification/makeup filters.

Three large (~0.6 m long) and two short (~0.3 m long) purification/makeup filters were received at the EG&G Idaho hot cells in April of 1982. The long filters (MUF-5B, -2A, and -2B) were located in the system upstream of the makeup tank. The short filters (MUF-4A and -4B) preceded the injection to the primary pump seal. Each filter had a cylindrical perforated stainless steel backing covered by pleated paper. The pleated paper on the large filters was composed of a minimum of four layers of

paper. The outer paper layer was a treated composite of cellulose and glass fiber cardboard type paper, and the multiple inner layers were thin and fine grained. The smaller filters were composed of a perforated stainless steel backing covered with only one layer of treated cellulose cardboard type paper. The filters are illustrated in Figure 2.

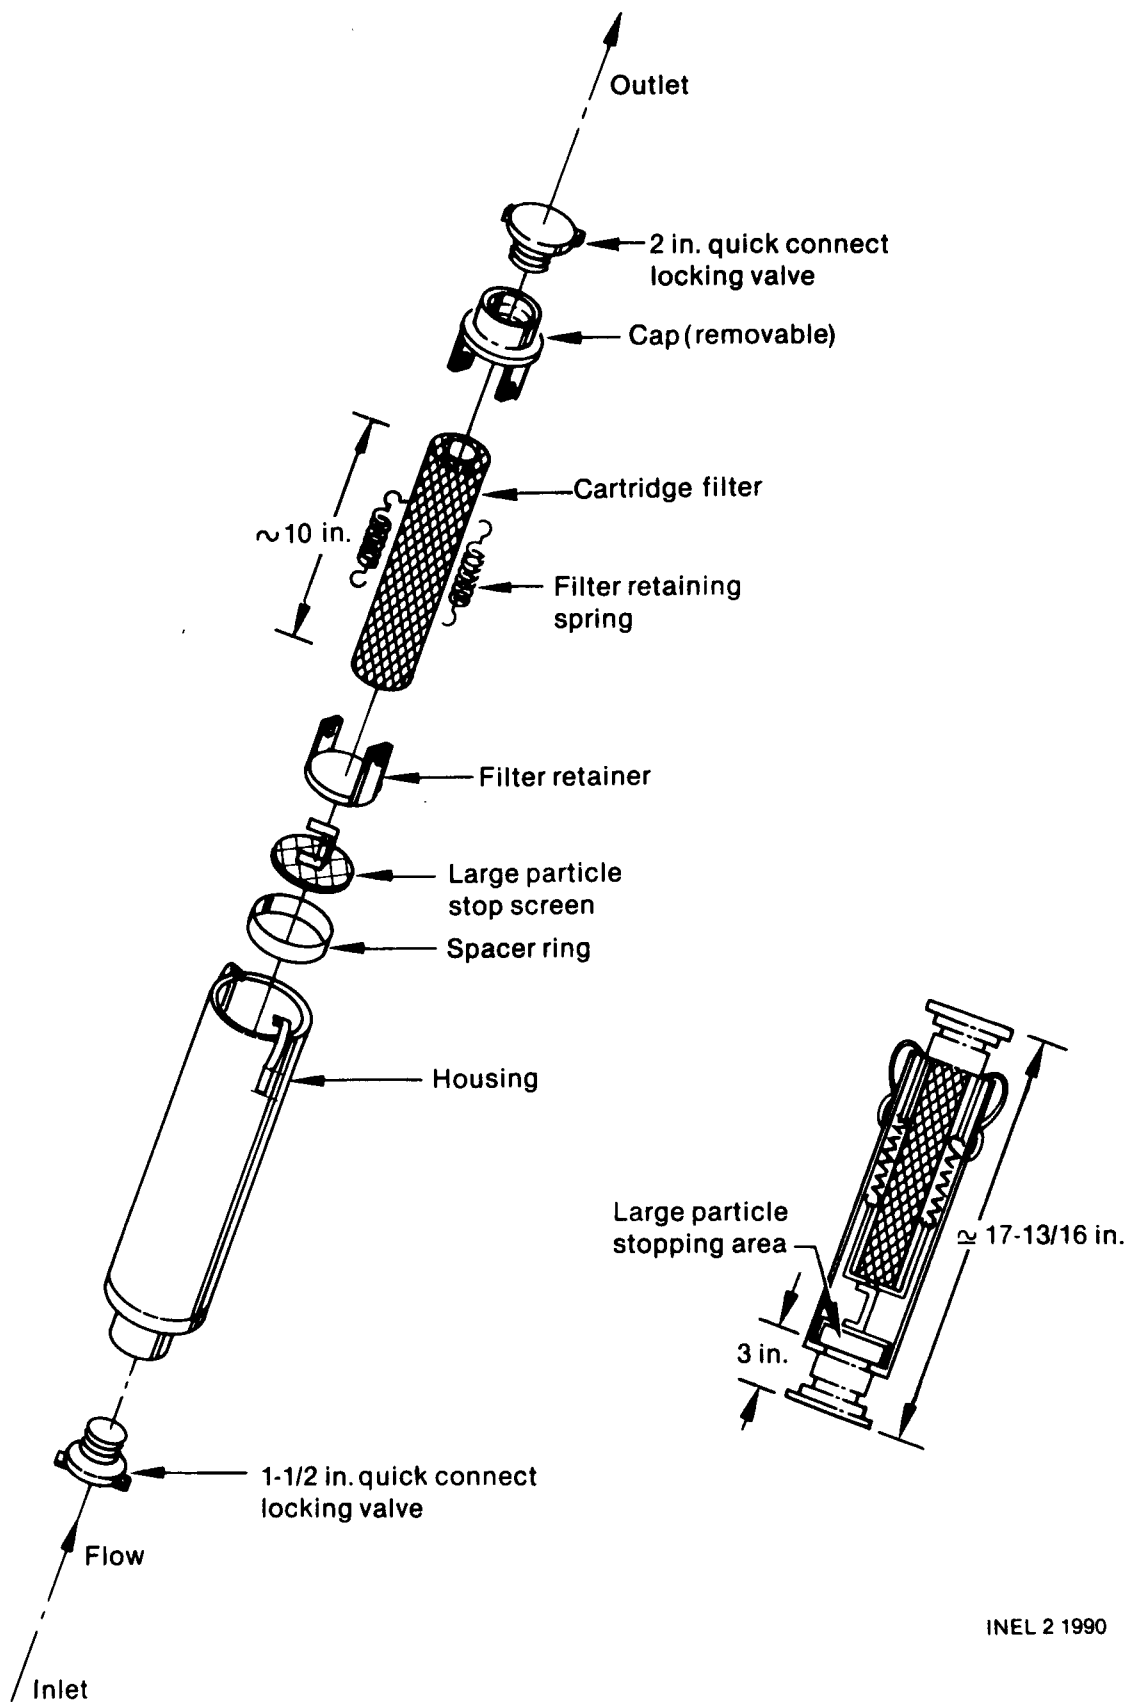
Figure 3. Schematic of the TMI-2 vacuum filter.

In addition to the purification/makeup system filters, eight vacuum cartridge filters were used to vacuum loose debris out of the filter housings after the system filters were removed. These filters were also sent for examination. The vacuum filters were enclosed in metal canisters and sealed on both ends by spring closed caps, as illustrated in Figure 3.

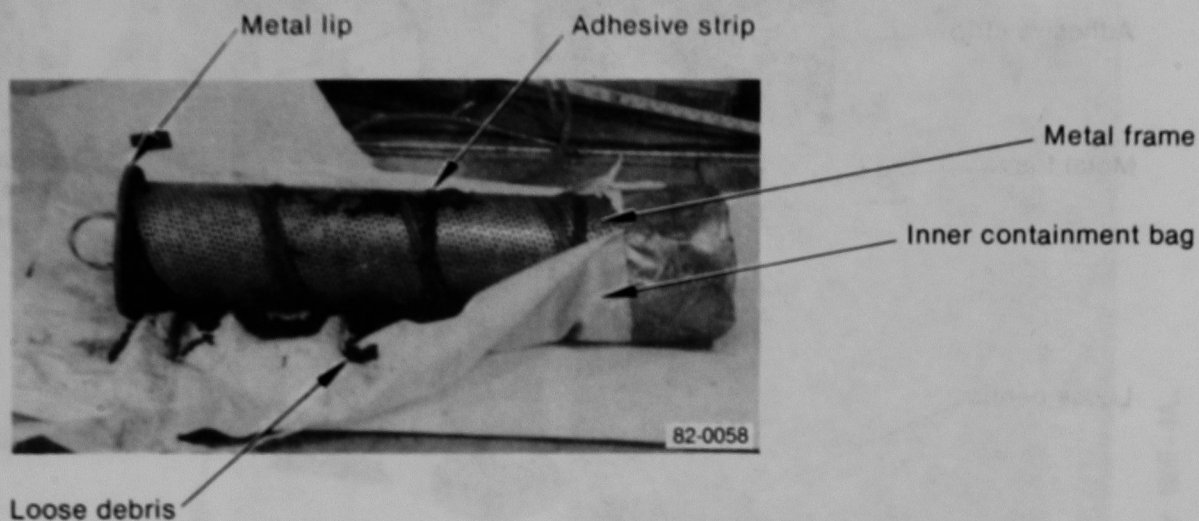
Figure 4. Purification/makeup Filter MUF-5B.

The physical condition of Filters MUF-5B, -2A, -2B, -4A, and -4B when they were removed from their containment bags is illustrated in Figures 4 through 8, respectively. As Figures 4, 5, and 6 illustrate, there was little filter paper or debris left on the steel frames of the three large filters. However, Filter MUF-4A (Figure 7) was received with almost all the filter paper and debris still on the metal filter frame. This filter was scanned to determine the concentrations of gamma-emitting isotopes on the filter. Figure 9 shows the results of the gross gamma scan of Filter MUF-4A. Much of the gamma-emitting debris was on one end. Figure 10 shows a gamma spectrum of the filter at about mid-height. The primary radioactive elements were Cs, Sb, Ru, and Ce/Pr; the activation elements were Ag, Mn, and Co. The filter paper was very friable and debris and paper fell off as the filter was handled. Also, the top half of the metal filter frame was collapsed, as shown in Figure 7. There was no indication on the filter paper that the filter had been crushed during shipping. Thus, a pressure differential during use at TMI probably caused the filter to collapse. This may have occurred after the filter had been loaded with debris. Nearly all of the filter paper and debris was scraped from the filter. The MUF-4A filter paper and debris weight was 82.7 g.

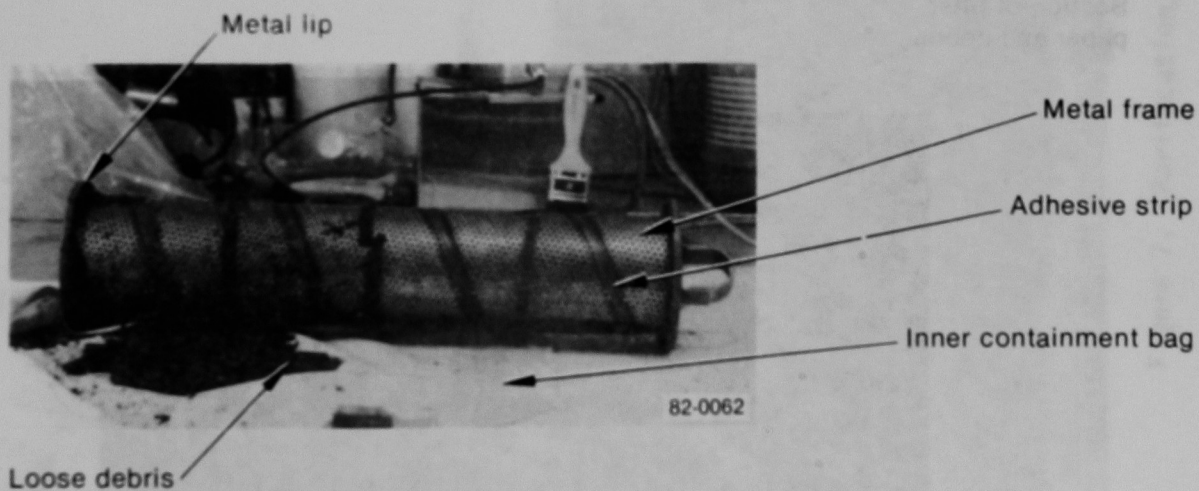
Figure 5. Purification/makeup Filter MUF-2A.

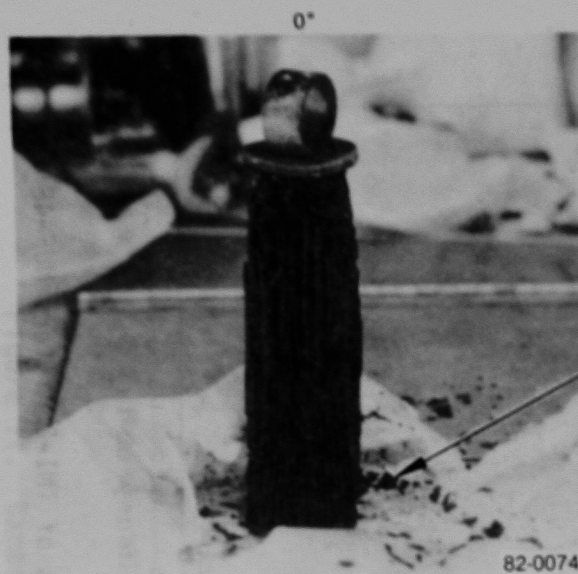
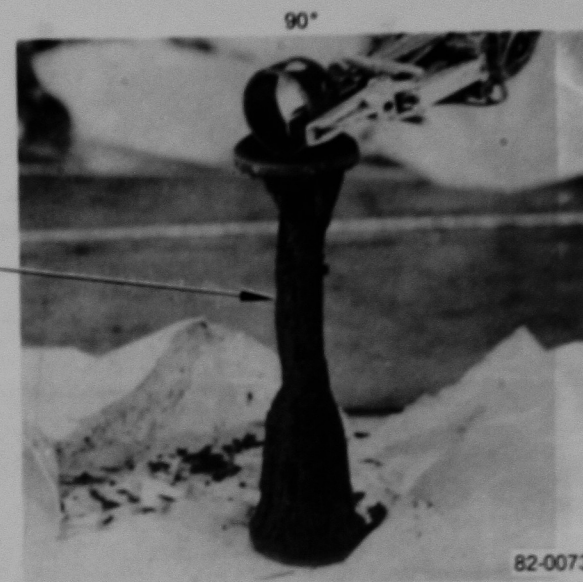
Figure 6. Purification/makeup Filter MUF-2B.

Loose debris

Collapsed region

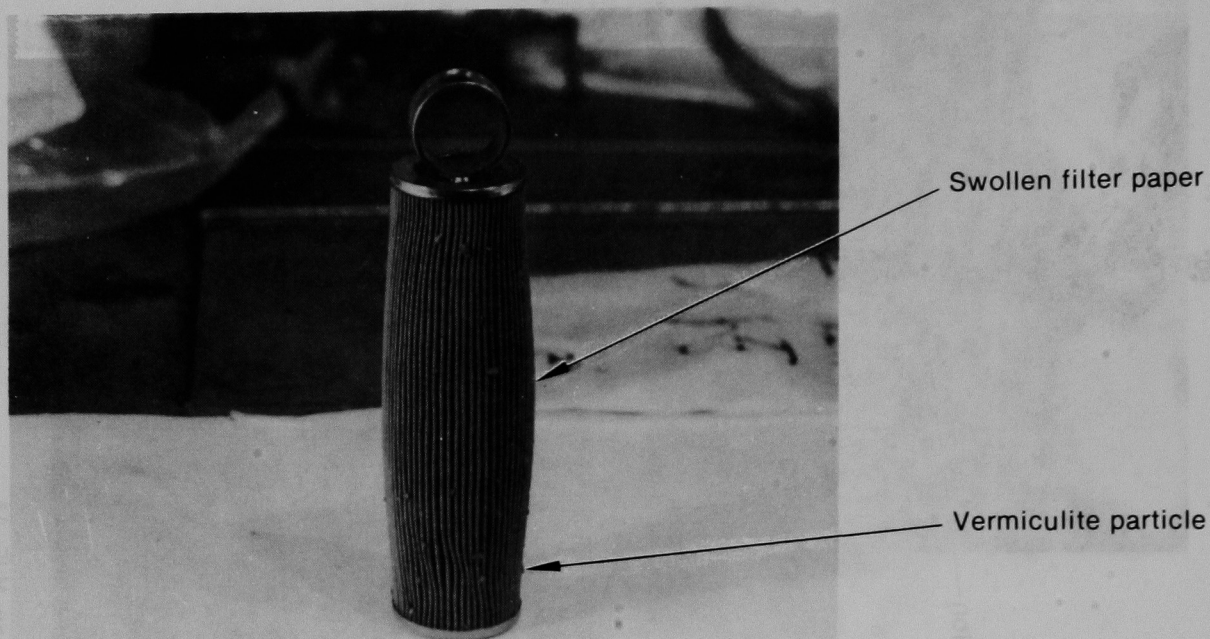
Figure 8. Purification/makeup Filter MUF-4B.

Short purification Filter MUF-4B was also received intact. However, it was not loaded with the dark debris found on all the other filters, and the filter paper was swollen, as shown in Figure 8. The filter contained cesium and cobalt, as indicated by the gamma spectrum shown in Figure 11. Cesium was the major fission product on the filter. The gross gamma scan of Filter MUF-4B is shown in Figure 9, along with the MUF-4A scan. Although the gamma intensity of Filter MUF-4B was much lower than the gamma radiation

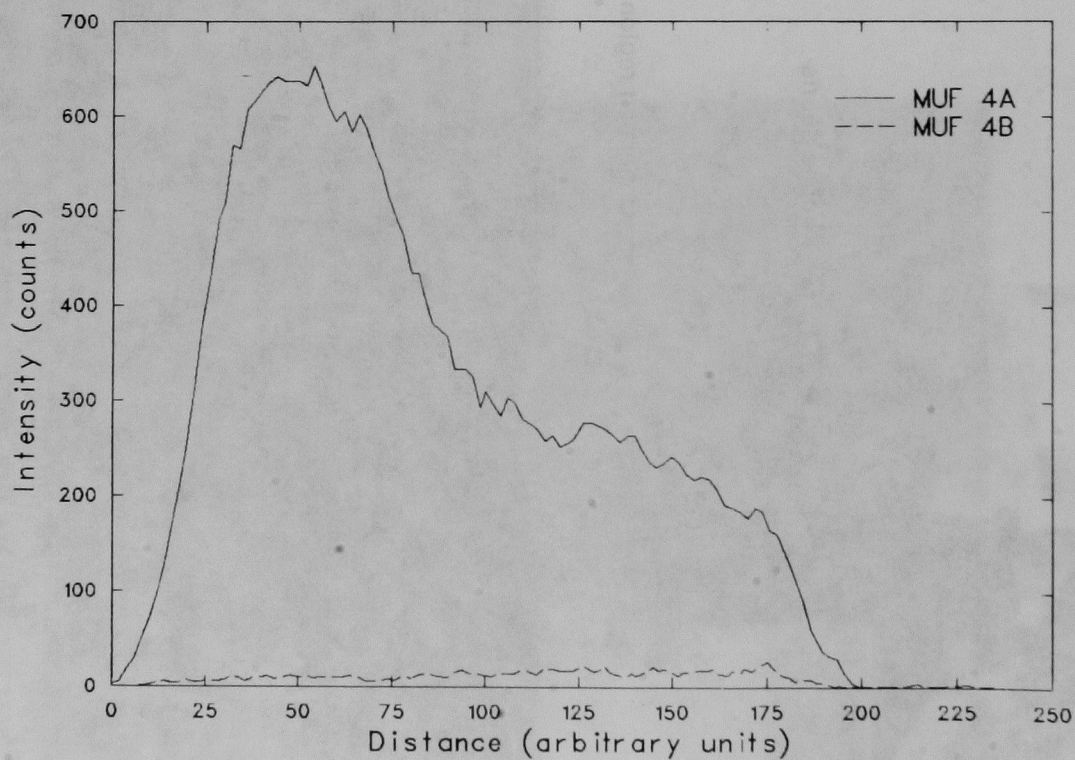
Figure 9. Gross gamma radiation profiles of TMI-2 Filters MUF-4F and -4B.

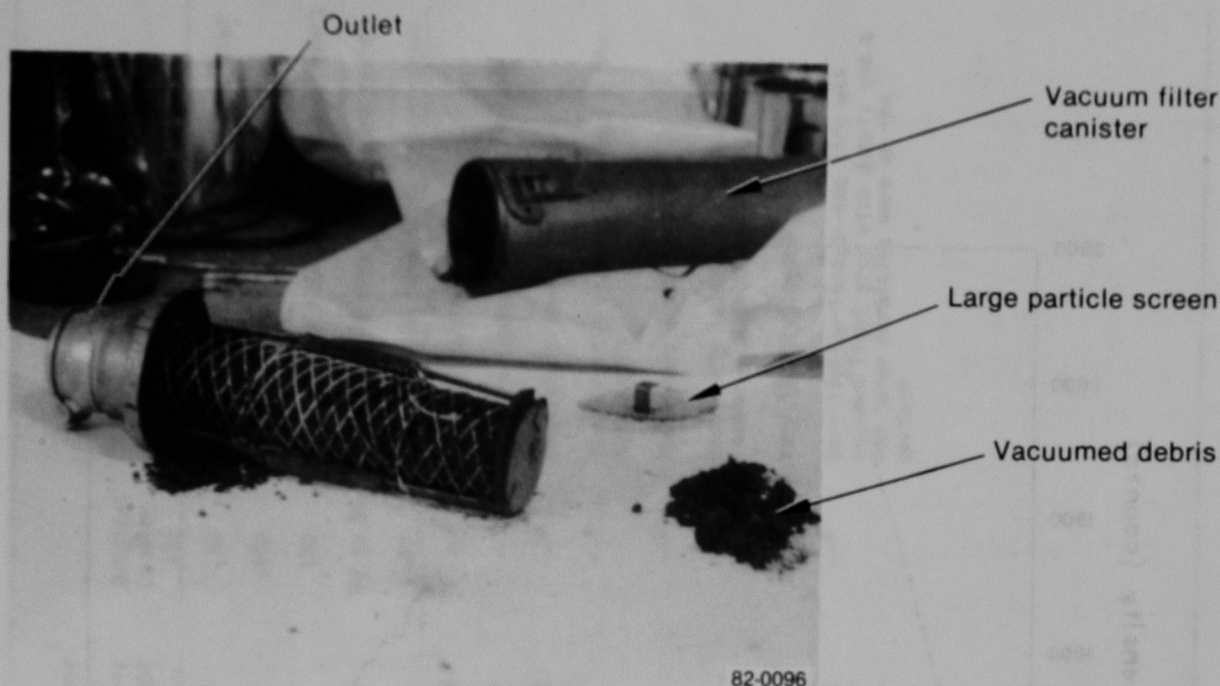
Figure 12. Vacuum Filter VAC-MUF-2A-1.

The eight vacuum filters received at the EG&G Idaho hot cells were opened, gamma scanned, and repackaged for archive storage. A typical vacuum filter after removal from the metal canister is shown in Figure 12. The radioisotope loading on these filters and on the MUF-4A and -4B purification filters is described in Table 3.

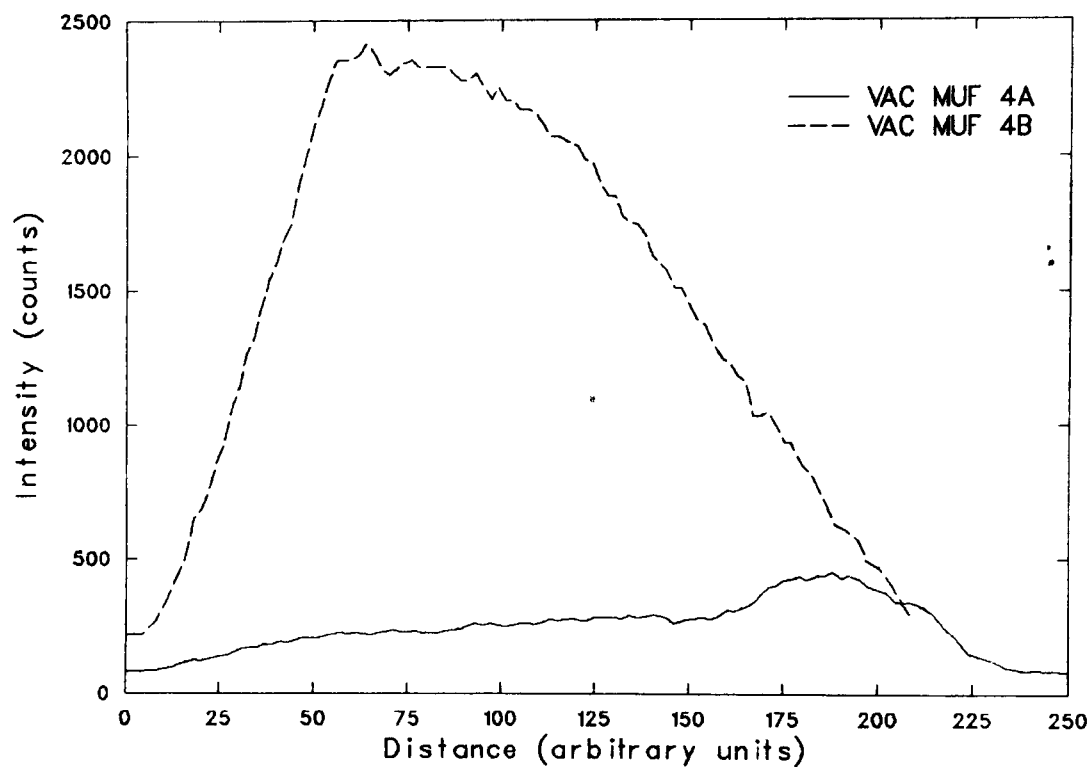
Figure 13. Gross gamma scans of vacuum Filters VAC-MUF-4A and -4B.

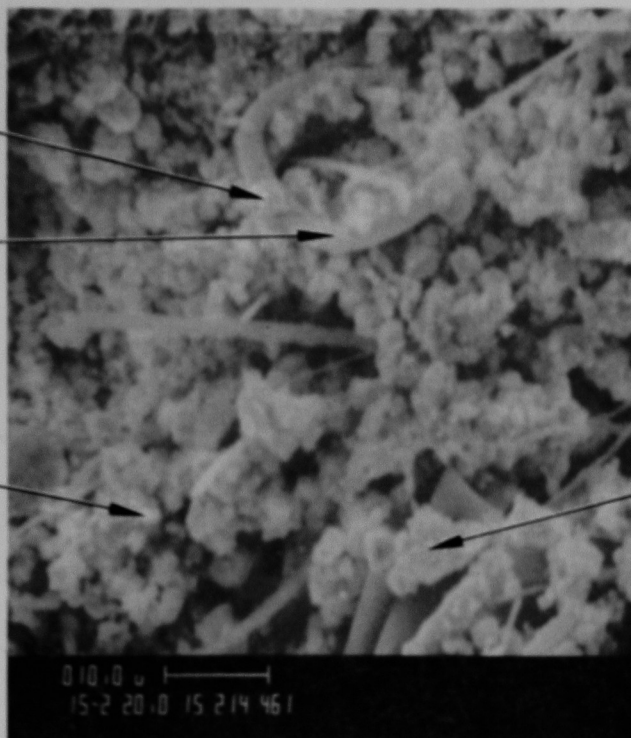
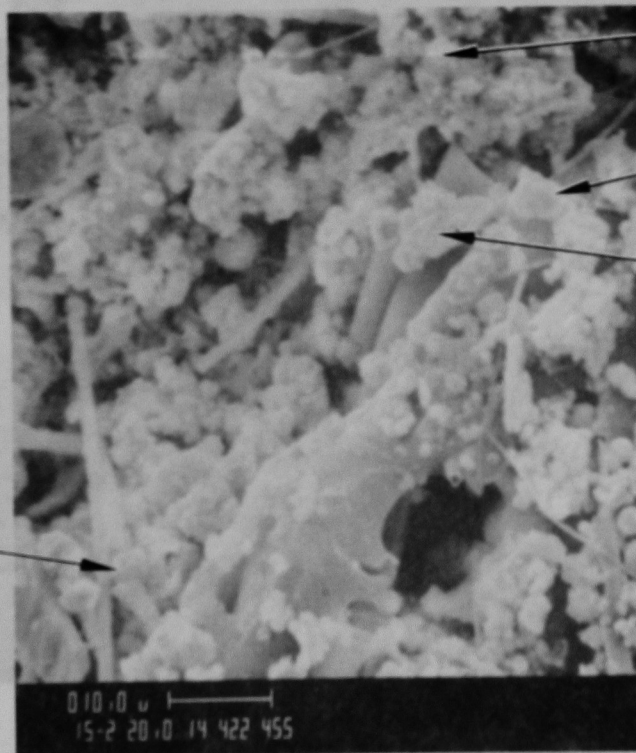
Prominent  
elements  
Fe, Ni

Prominent  
element Zr

Prominent  
element Ni

Prominent  
element Ag

Figure 14a,b. Typical filter MUF-58 debris.

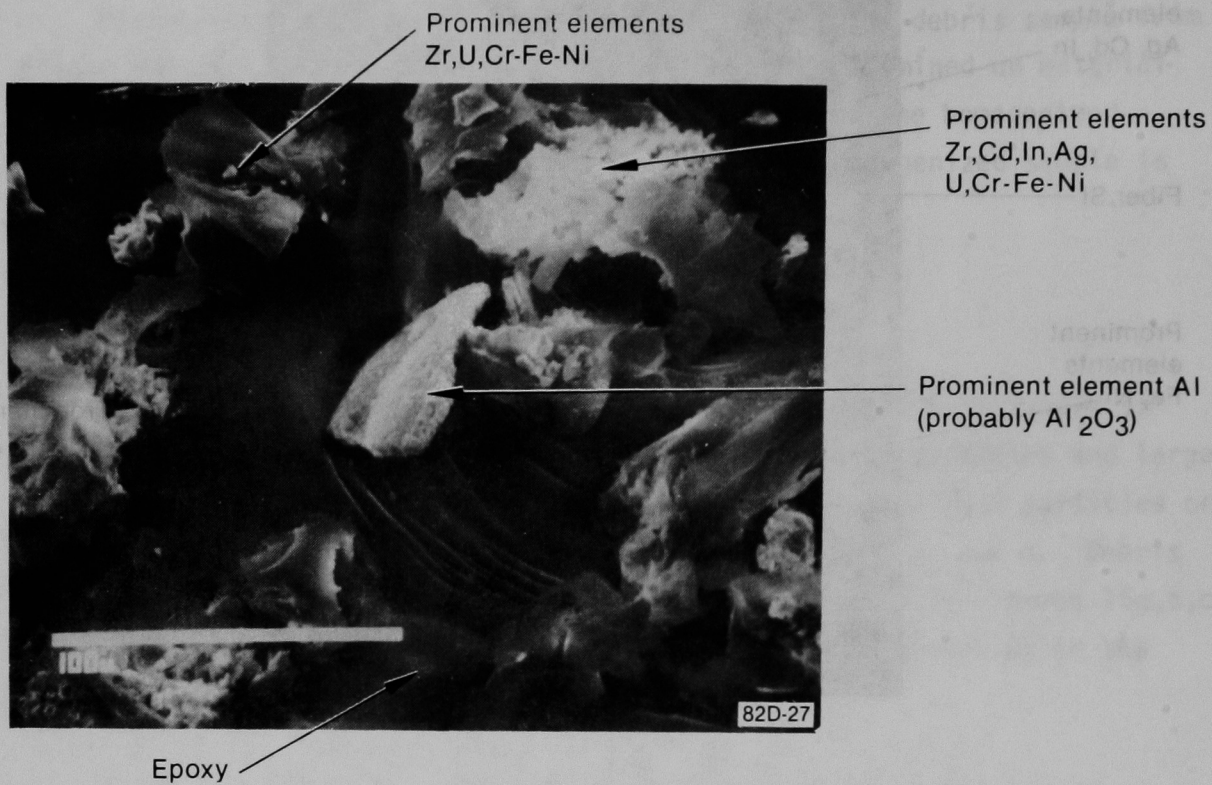
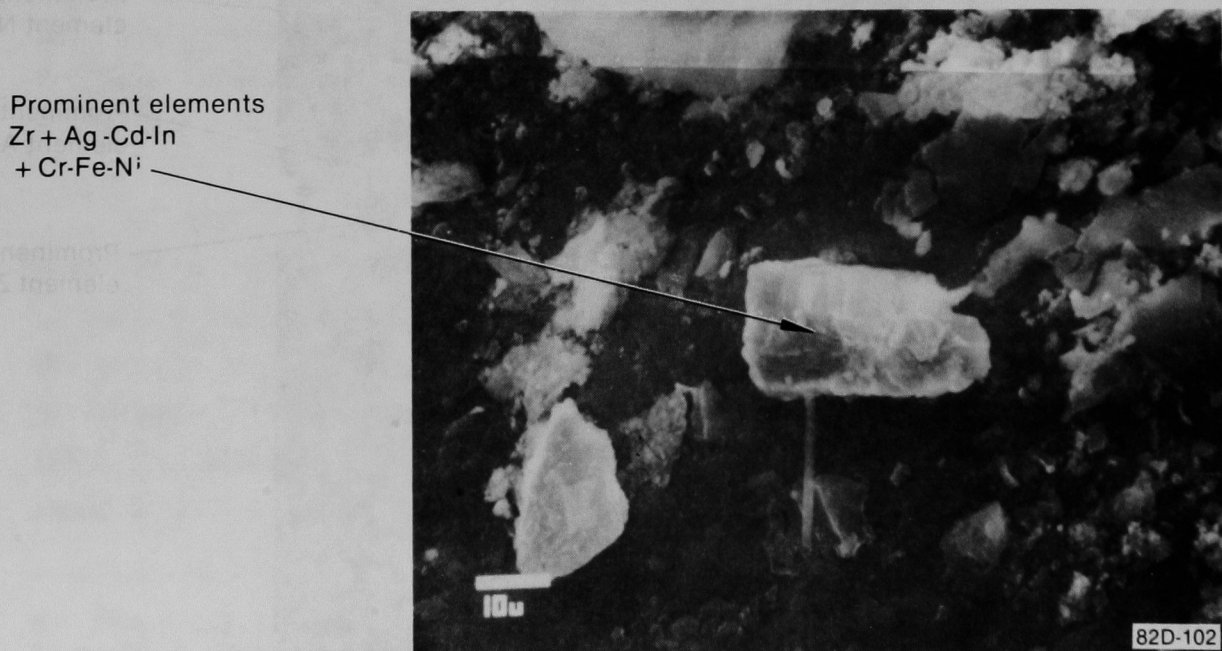
Figure 15a,b. Particles from Filter MUF-5B.

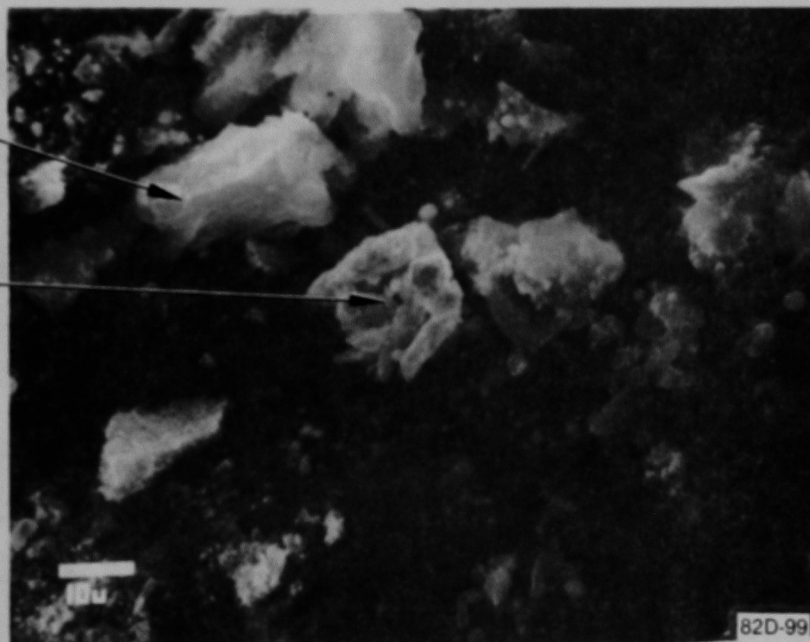
Prominent elements  
poison material

Prominent element U  
( $\text{UO}_2$  or  $\text{U}_3\text{O}_8$ )

Figure 15c. Particles from Filter MUF-5B.

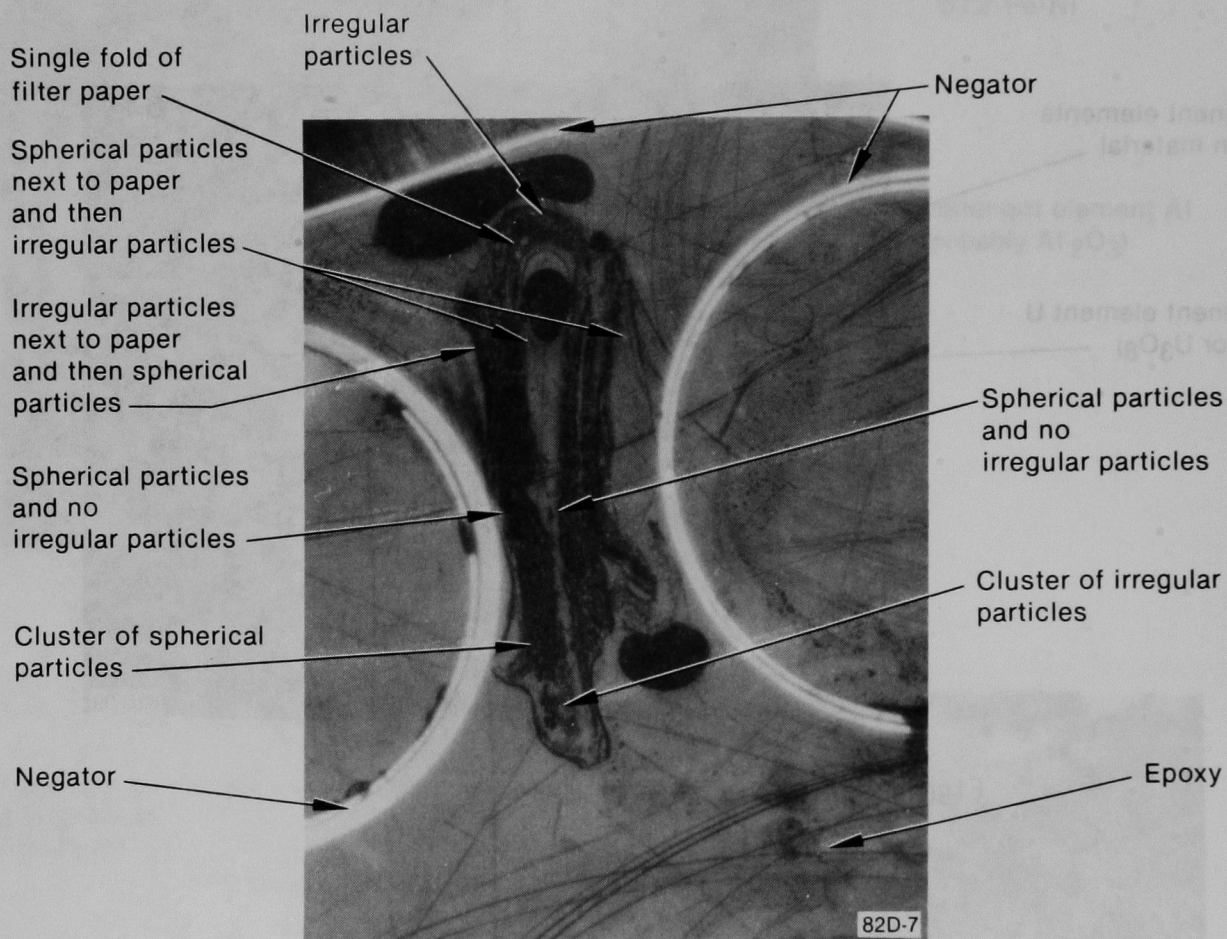
Figure 16. Cross section of a single fold of Filter MUF-5B paper.

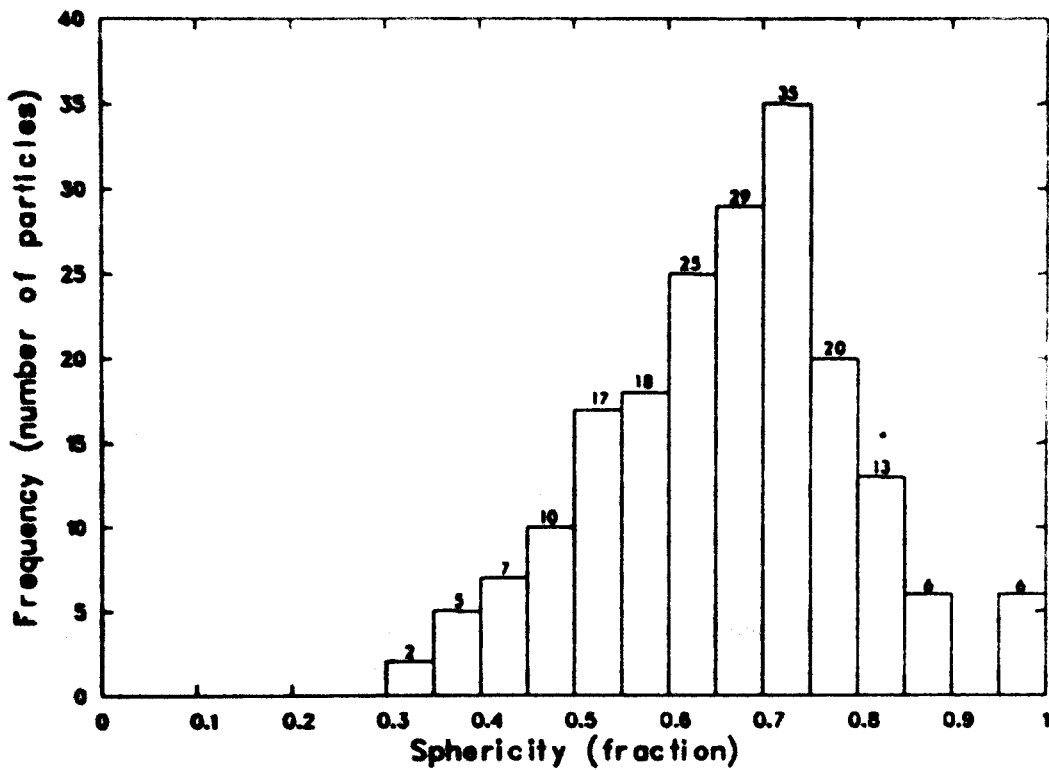
Figure 17. Sphericity distribution of particles from Filter MUF-5B.

The spherical or nearly spherical particles were probably control rod material (silver and/or cadmium). That is, the EG&G Idaho analyses indicated that the particles had X-ray peaks at energies characteristic of silver and cadmium. The spherical particles also had a mean diameter  $<2\text{ }\mu\text{m}$  instead of the  $\sim 6\text{ }\mu\text{m}$  estimated for all particles. Thus, there may be a correlation between size, shape, and composition. A shape-size-composition relation was also suggested in the ANL-E analyses. The ANL-E analyses also indicated that the numerous spherical particles seem to be control rod materials, and in some cases the spherical particles appeared to be pure silver or cadmium. Zirconium particles were generally found as either large rectangular pieces or small flakes, and steel bearing particles were generally found as small rectangular particles.

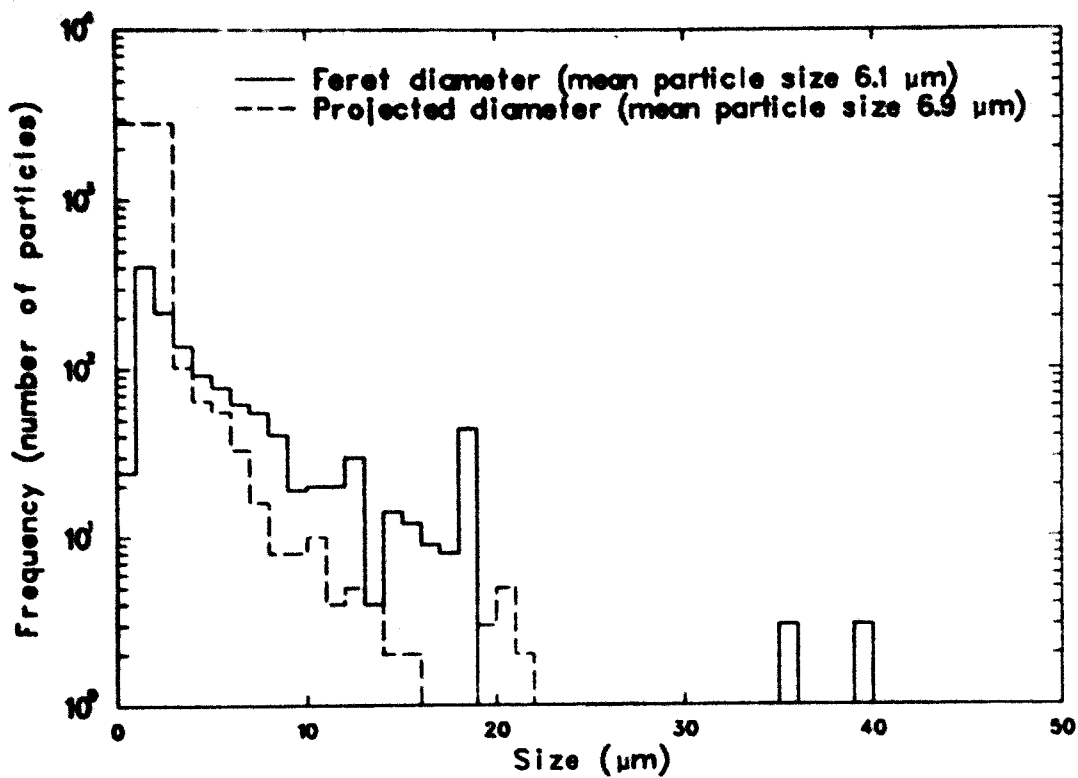
Figure 18. Size distribution of particles from Filter MUF-5B.

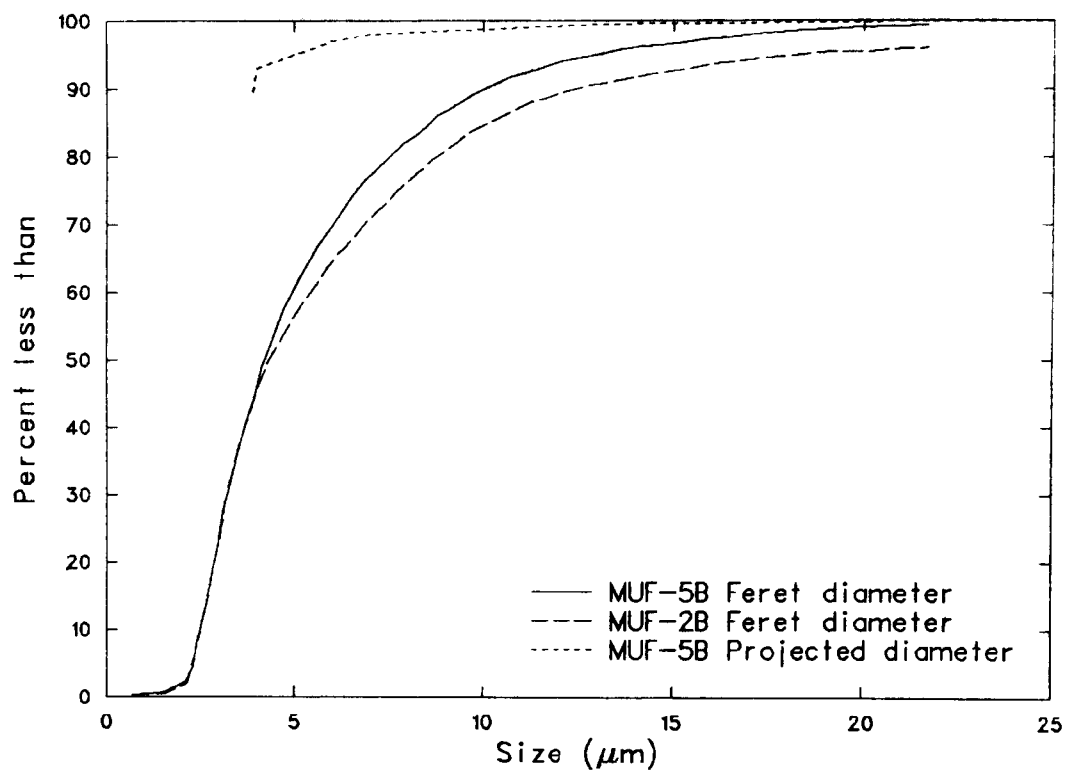
Figure 19. Cumulative particle size distribution from Filters MUF-5B and 2A

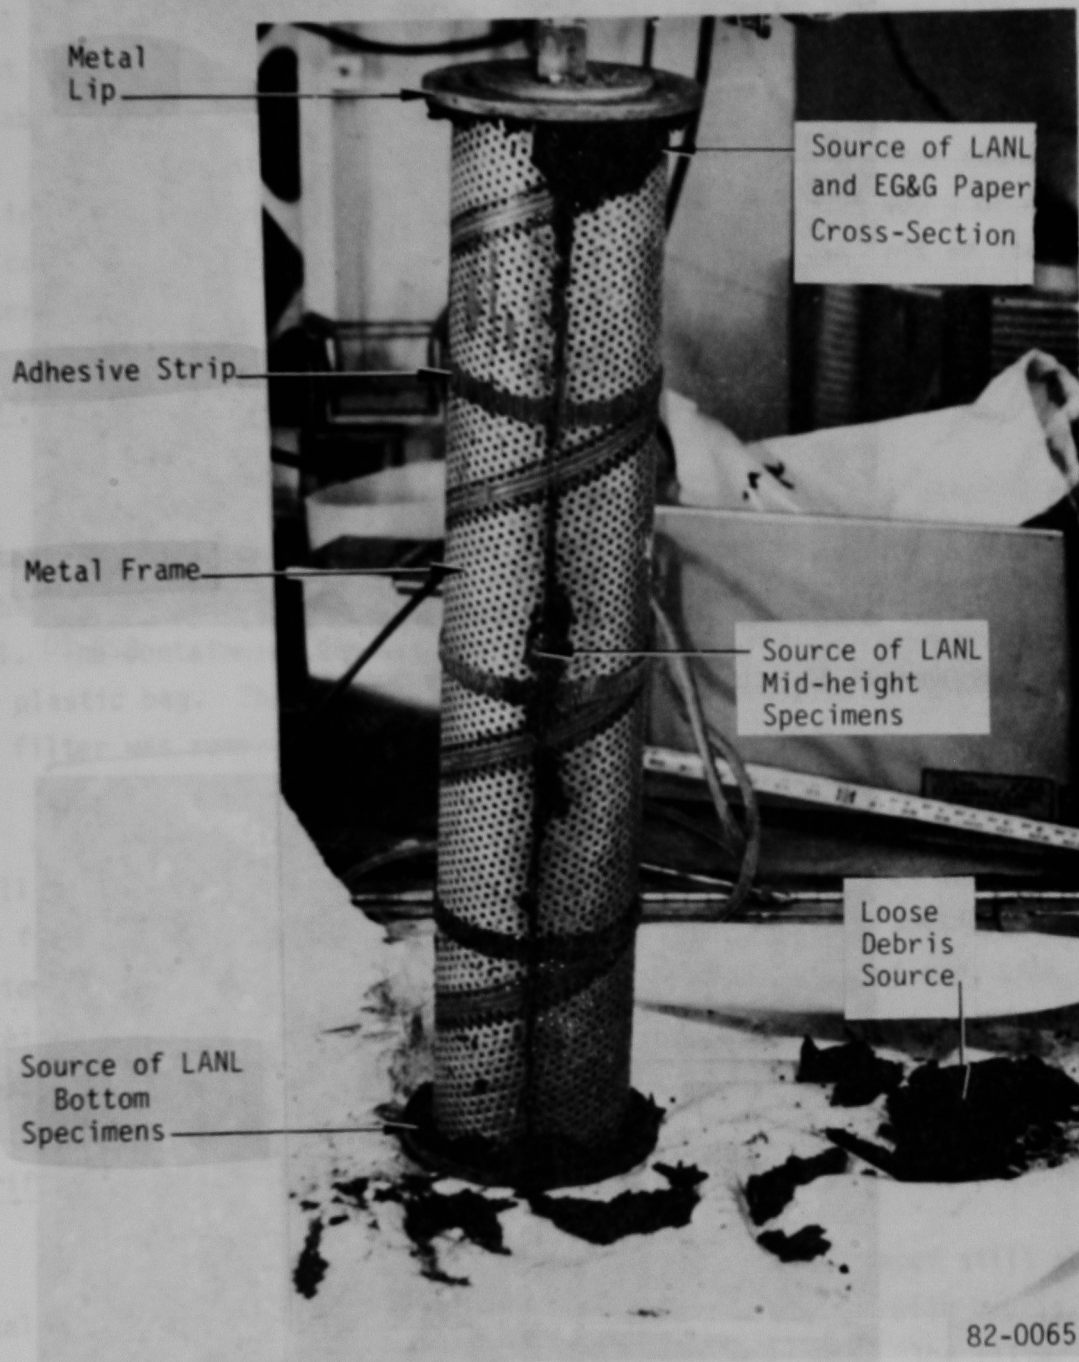
Figure B-1. Sample location of specimens taken from Filter MUF-5B.

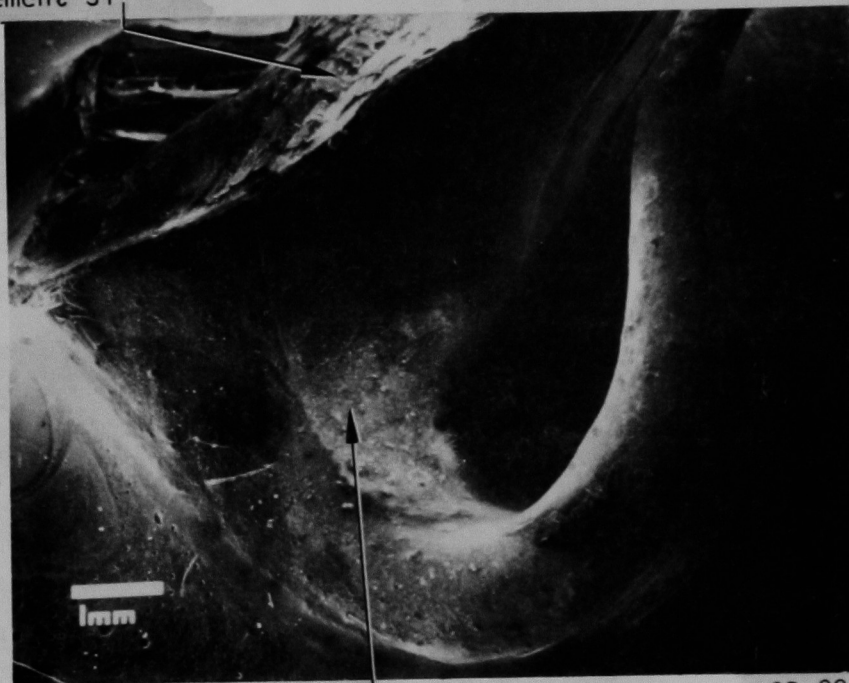
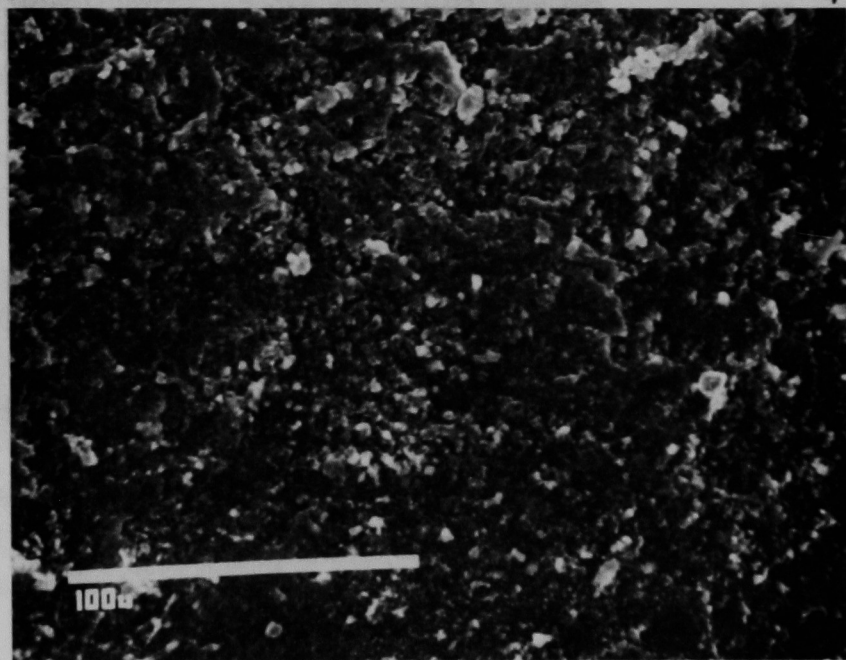
Brittle Fracture Surface  
Prominent Element Si

a. SEM Overall Structure

b. Surface Covered with Control Material and Steel/Inconel Material.

Figure B-2. Large debris piece found in the MUF-5B debris.

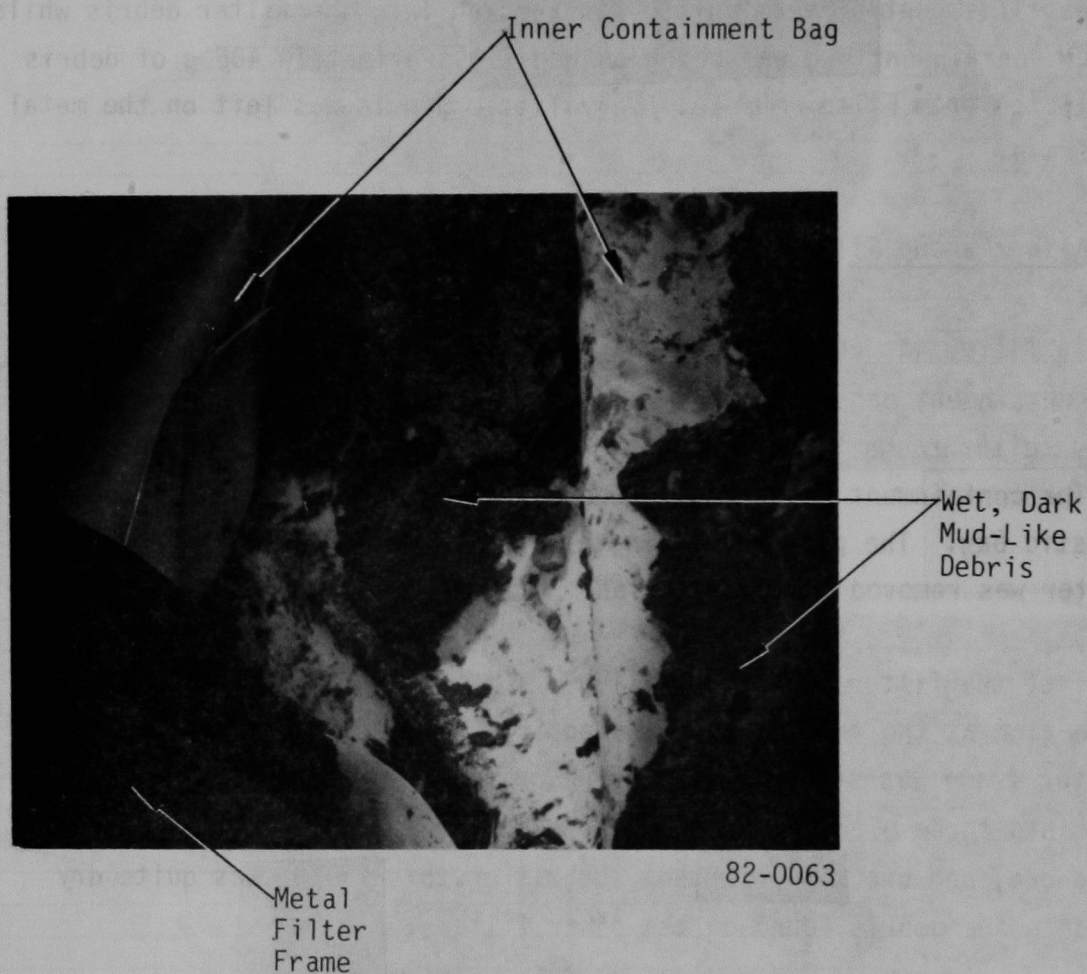
Figure B-3. Condition of filter and filter debris on Filter MUF-2A.

The metal filter frame was collapsed, but the filter paper showed no sign of being smashed. Nearly all of the filter paper was scraped off this
