## INTERIM REPORT ON THE TMI-2 PURIFICATION FILTER EXAMINATION

### Idaho National Engineering Laboratory

Filters from the purification/makeup system of the Three Mile Island Unit 2 Reactor were examined after the March 28, 1979, accident to determine the character of the debris transported to the filters. The general condition of the filters is presented. Material was removed from the filters and examined. The elemental and radionuclide makeup of the debris is discussed. Distribution of particle size and shape is presented for some of the material examined. This is an interim report. When the investigation is completed, another report summarizing all of the data will be issued.

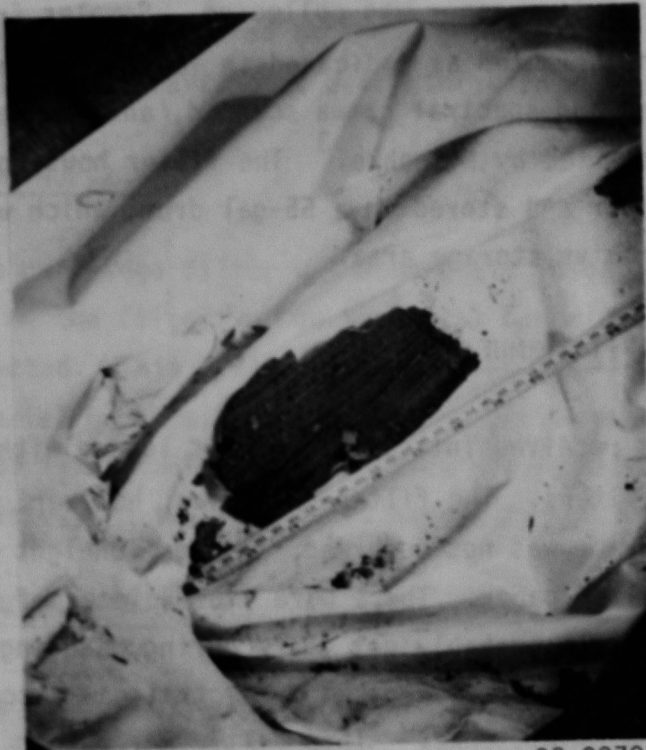
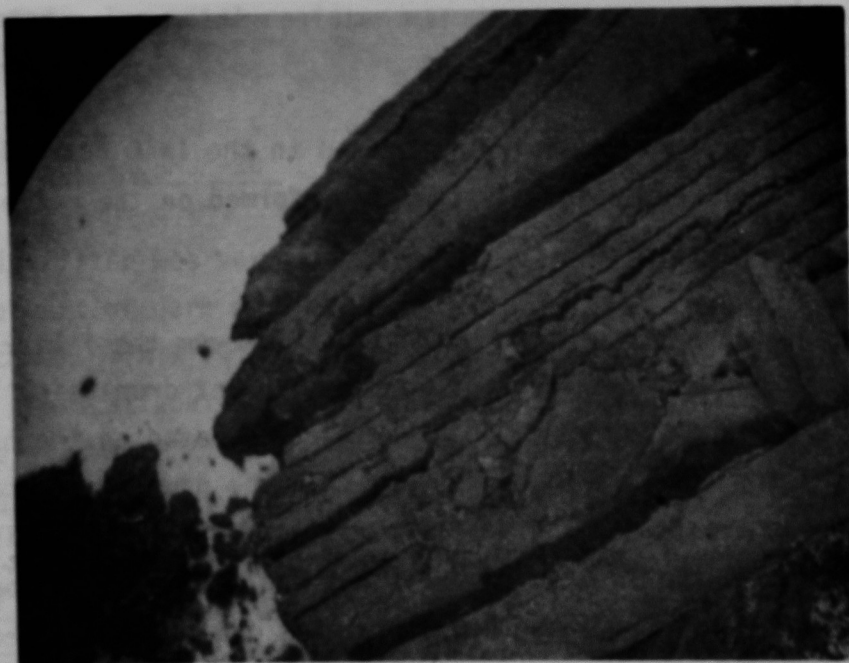
Intact Filter Paper

b. High Magnification of the Section of Filter MUF-2B Paper  
Sent to LANL

Figure B-4. Intact filter paper section found on Filter MUF-2B.

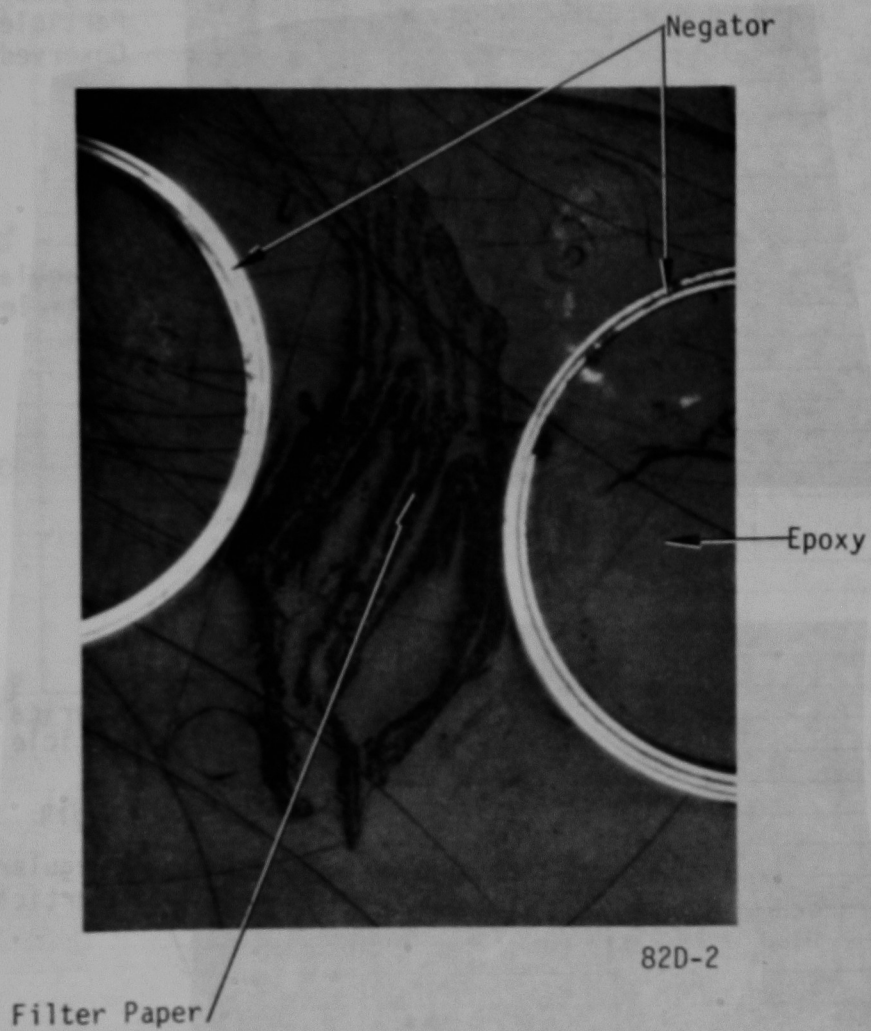
Figure B-5. Cross-section of Filter MUF-2B filter paper.

Particle shape varied tremendously in the Filter MUF-5B and -2B debris. Particle shapes range from spherical particles to very irregular particles, as illustrated in Figures B-7, B-8, and B-9. Analyses were performed on paper sections from Filters MUF-5B and -2B. Figure B-6 shows particles from Filter MUF-2A, and Figures B-8 and B-9 show particles from Filter MUF-5B. Figure B-8 shows the deposition pattern found on Filter MUF-5B. Layers of

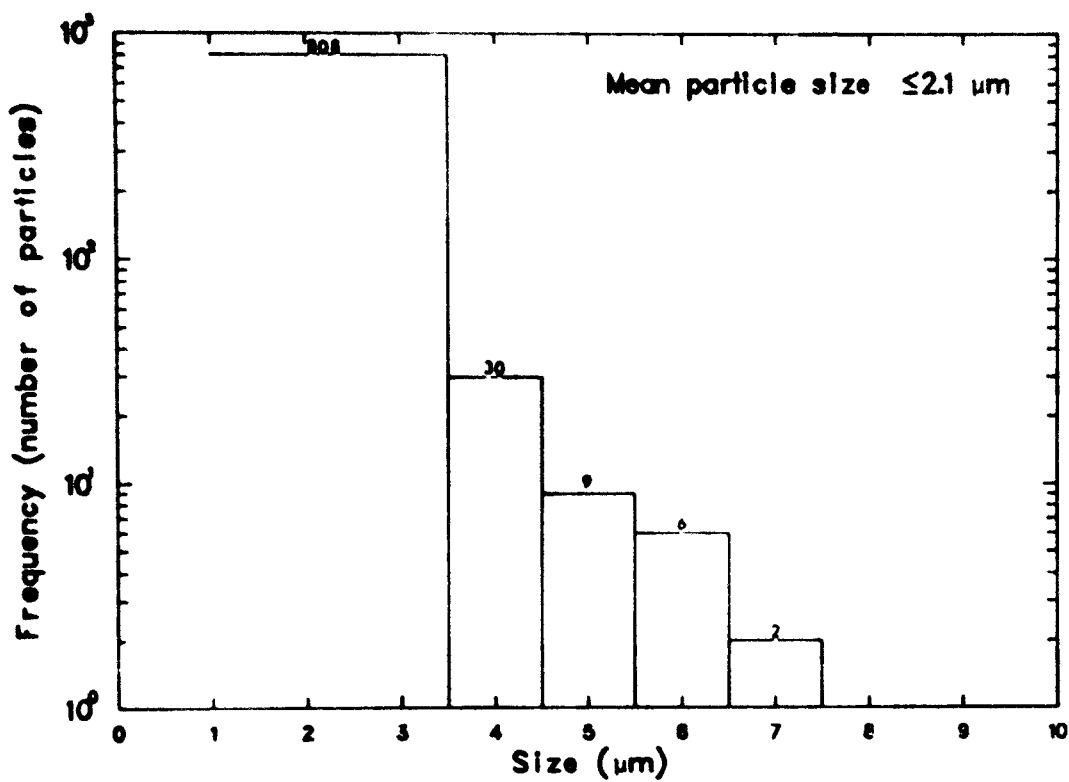
Figure B-7. Size distribution of spherical particles in Filter MUF-5B debris.

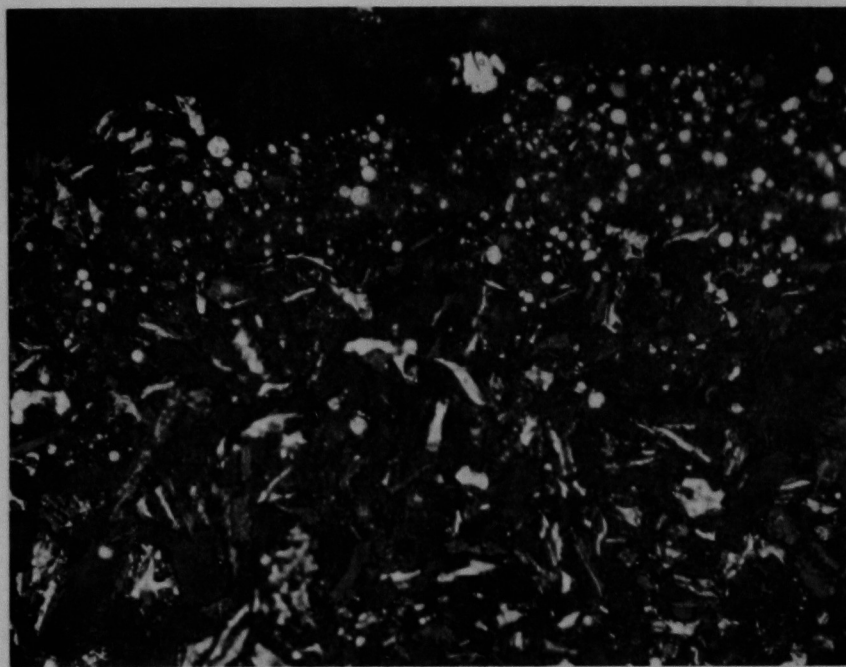
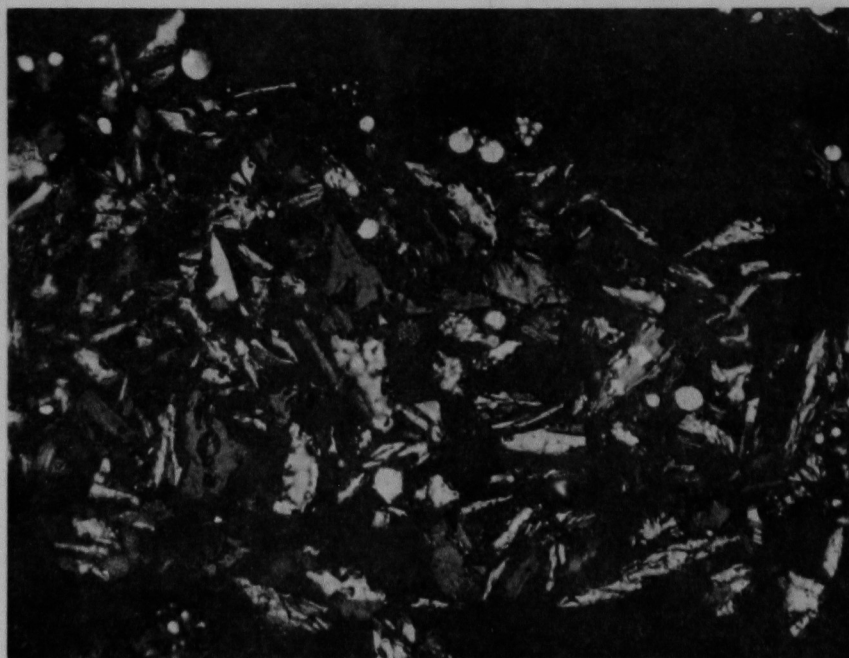
Layer of Spherical  
Particles

Layer of Irregular  
Shaped Particles

a. Stratified Particles

b. Mixture of Spherical and Irregular Shaped Particles

Figure B-8. Deposition pattern on Filter MUF-5B.

spherical and irregular shaped particles were observed. At most locations, the spherical particles were grouped in layers next to the filter paper, whereas the irregular shaped particles were deposited on top of the spherical particles. At other locations on the filter paper the spherical and irregular shaped particles were randomly deposited as illustrated in Figure B-8b. The irregular shaped and spherical particles at two other locations on the Filter MUF-5B filter paper are shown in Figure B-9.

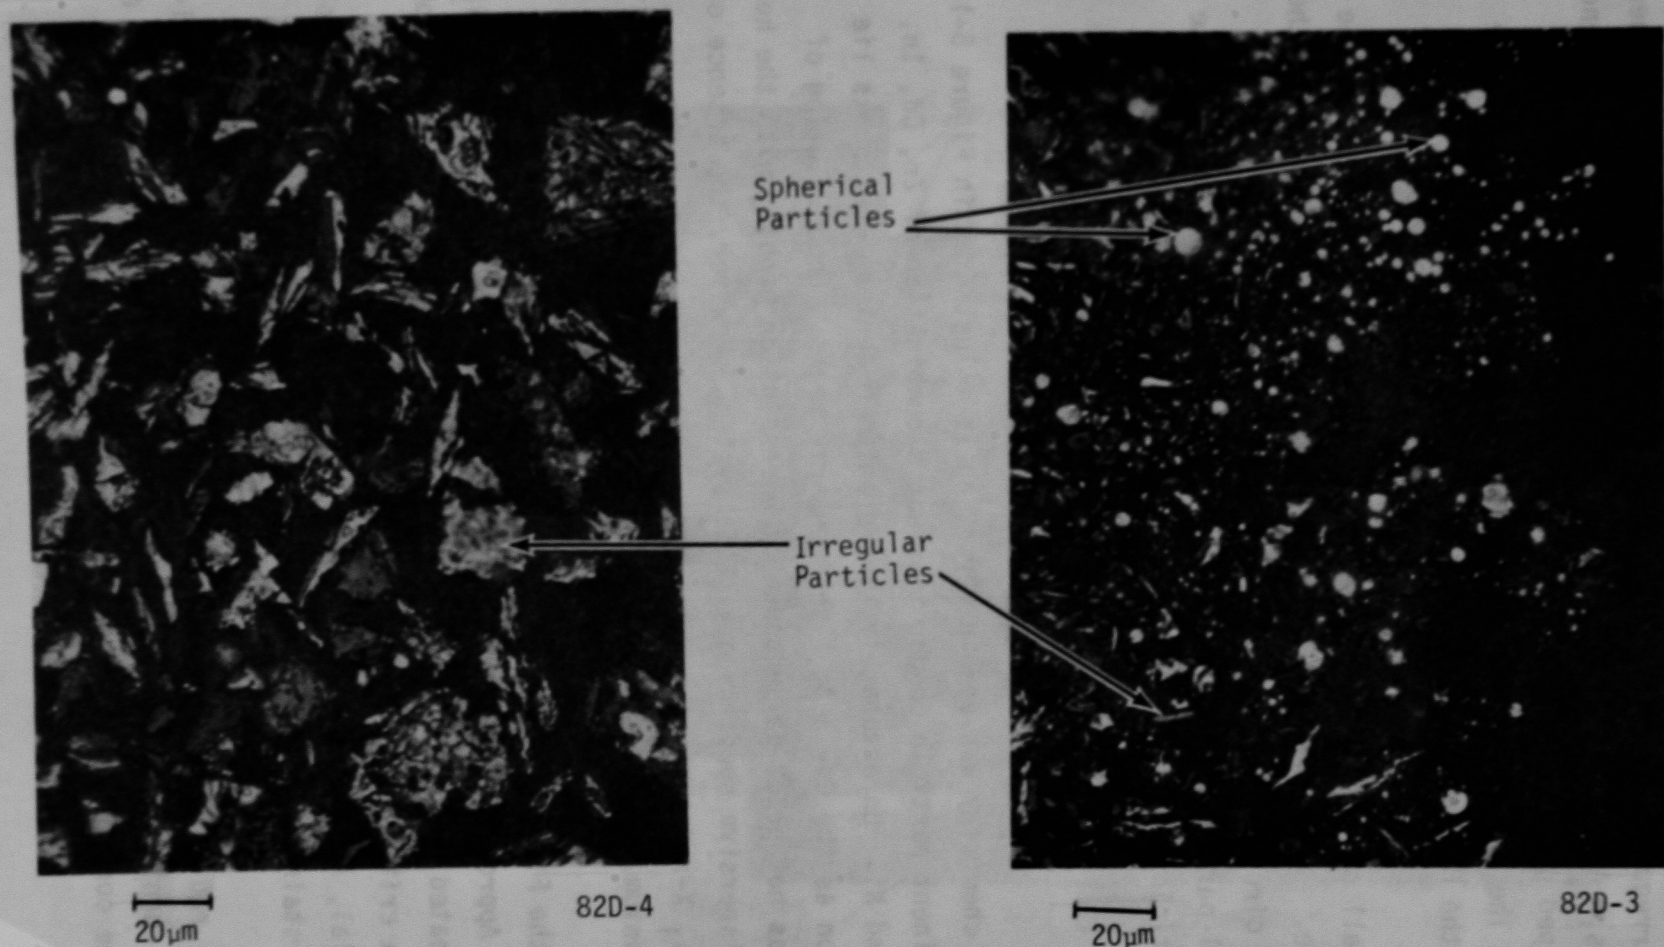
Figure B-9. Particulate patterns on the polished cross-section of Filter MUF-5B paper.

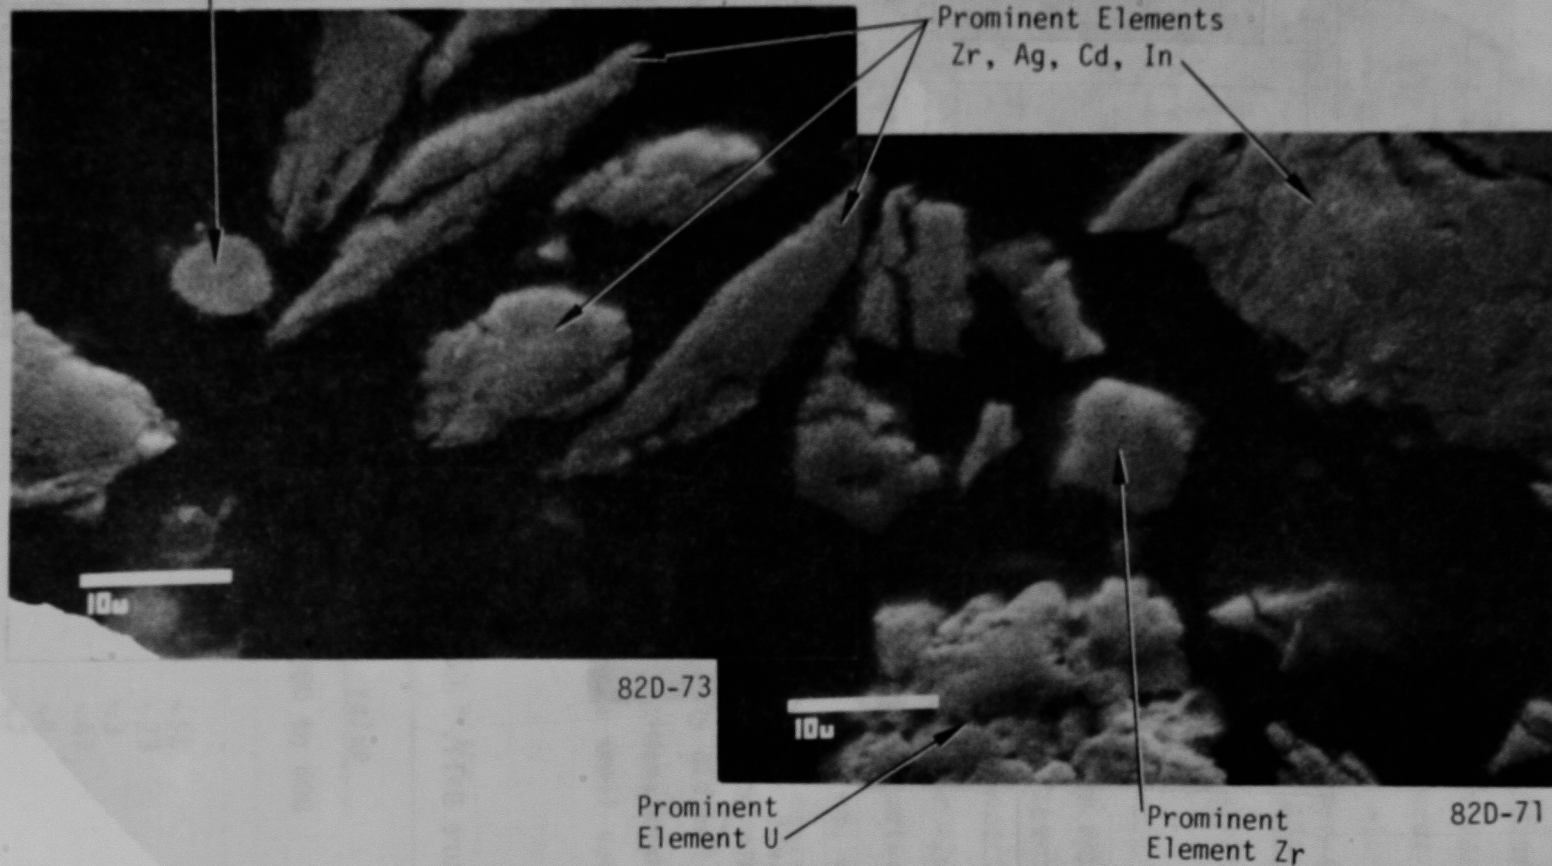
Prominent Elements  
Ag, Cd, In

Prominent Elements  
Zr, Ag, Cd, In

Figure B-10. SEM Photomicrographs of Filter MUF-5B debris particles.

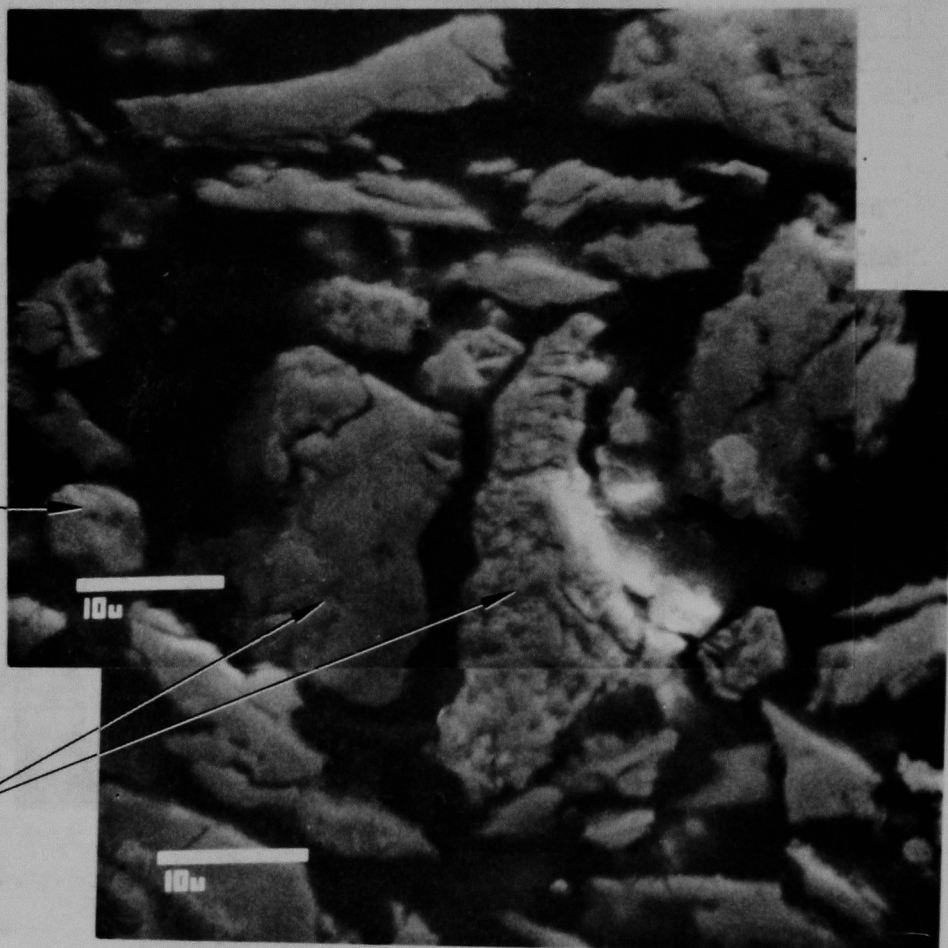
U, Zr

Figure B-11. Uranium particles in the Filter MUF-5B debris.

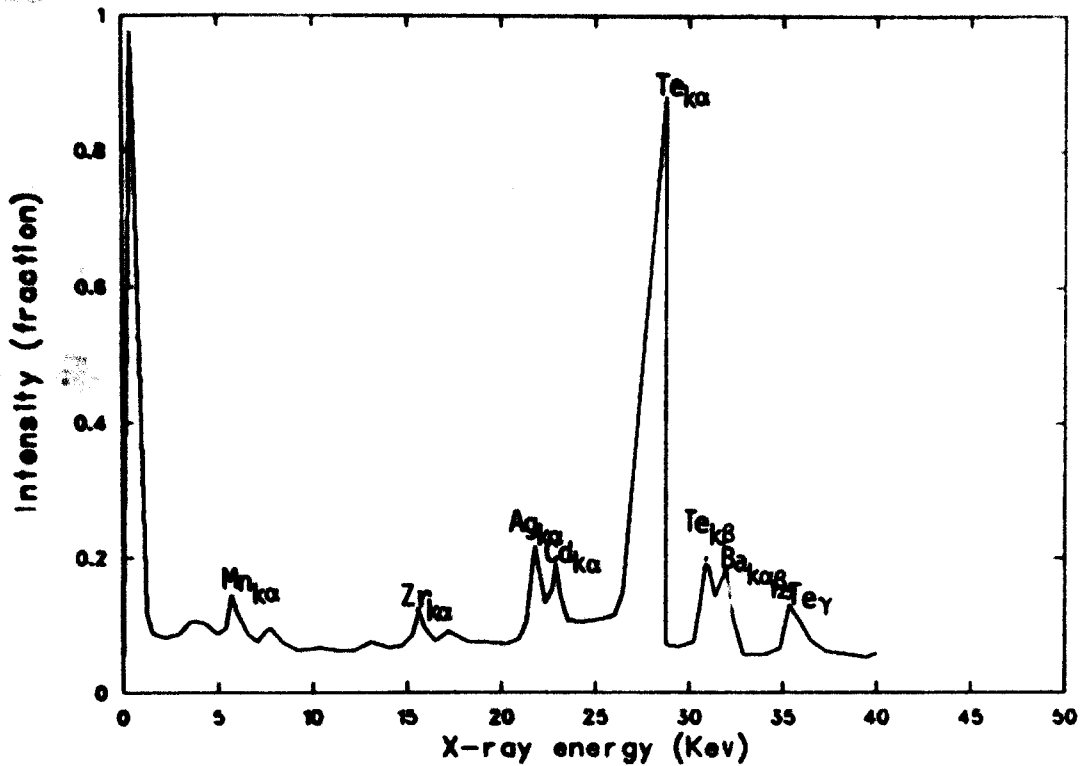
Figure B-12. Background radiation of debris from Filter MUF-5B.

Microanalysis of radioactive specimens was made difficult by the interference of low-energy gamma radiation and X-ray fluorescence radiation. This radiation was generated by bremsstrahlung X-rays, beta particles, low-energy gamma radiation, and/or X-ray fluorescence from decay activation. The photo energy background spectrum from a MUF-5B debris specimen is shown in Figure B-12. Many of the background peaks were K $\alpha$  X-ray peaks from major elements in the debris. Nuclide signatures were also evident. The  $^{125m}\text{Te}$  gamma peak at  $\sim 35.5$  keV was in the background spectrum. The Tellurium K $\alpha$  X-ray peak at 27.5 keV was, however, the most intense, followed by the K $\beta$  X-ray peak at 31 keV, and then the gamma peak at 35.5 keV. Tellurium  $^{125m}$  is a daughter of  $^{125}\text{Sb}$  and has a half-life of 58 days. The energy peak at  $\sim 32$  keV was probably the  $^{137m}\text{Ba}$  K $\alpha$  and K $\beta$  X-ray peaks. Barium is the decay daughter of  $^{137}\text{Cs}$ , the most prominent radioisotope in the debris. The other peaks shown in Figure B-12 were of similar origin. Quantitative analysis with X-rays generated from radioactive decay and low-energy gamma rays may not be feasible, but these troublesome background peaks could possibly provide useful qualitative information on fission products in the debris.

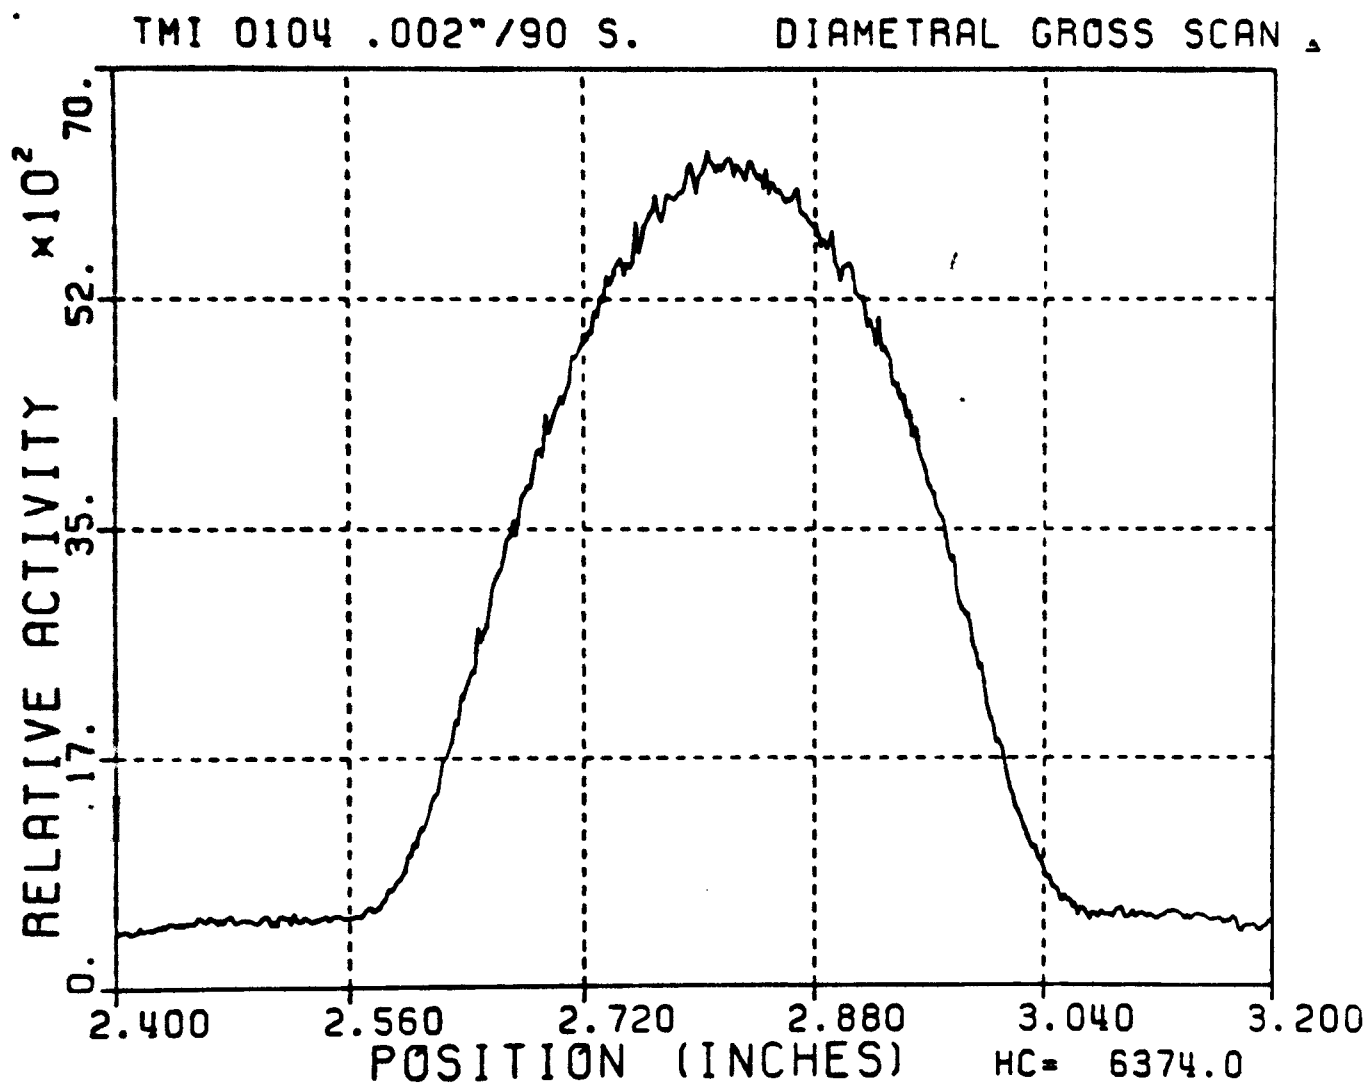
Fig. 1. Diametral gross gamma scan of sample TMI-0104.

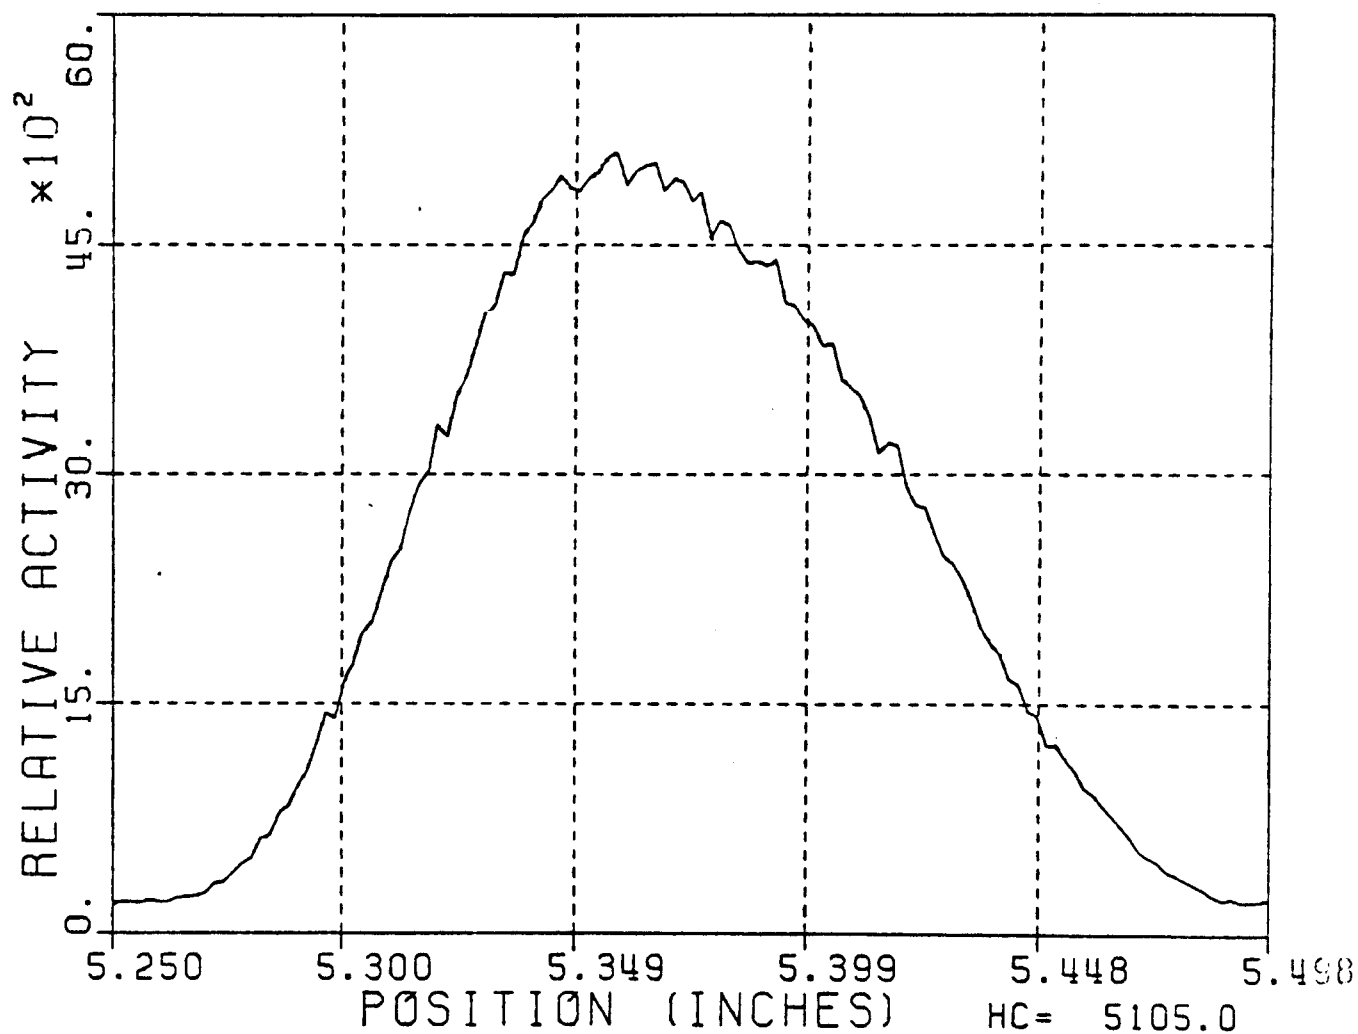
Fig. 2. Axial gross gamma scan of sample TMI-0104.

An axial multielement gamma scan of the sample was taken using a 1.27 mm primary collimator with a 7.62 mm secondary collimator taking 1.27 mm steps at 2 hours per increment. This scan provided the distributions of the gamma-emitting isotopes Cs-137, Co-60, Sb-125 and Cs-134. No unusual distribution of these isotopes were found.

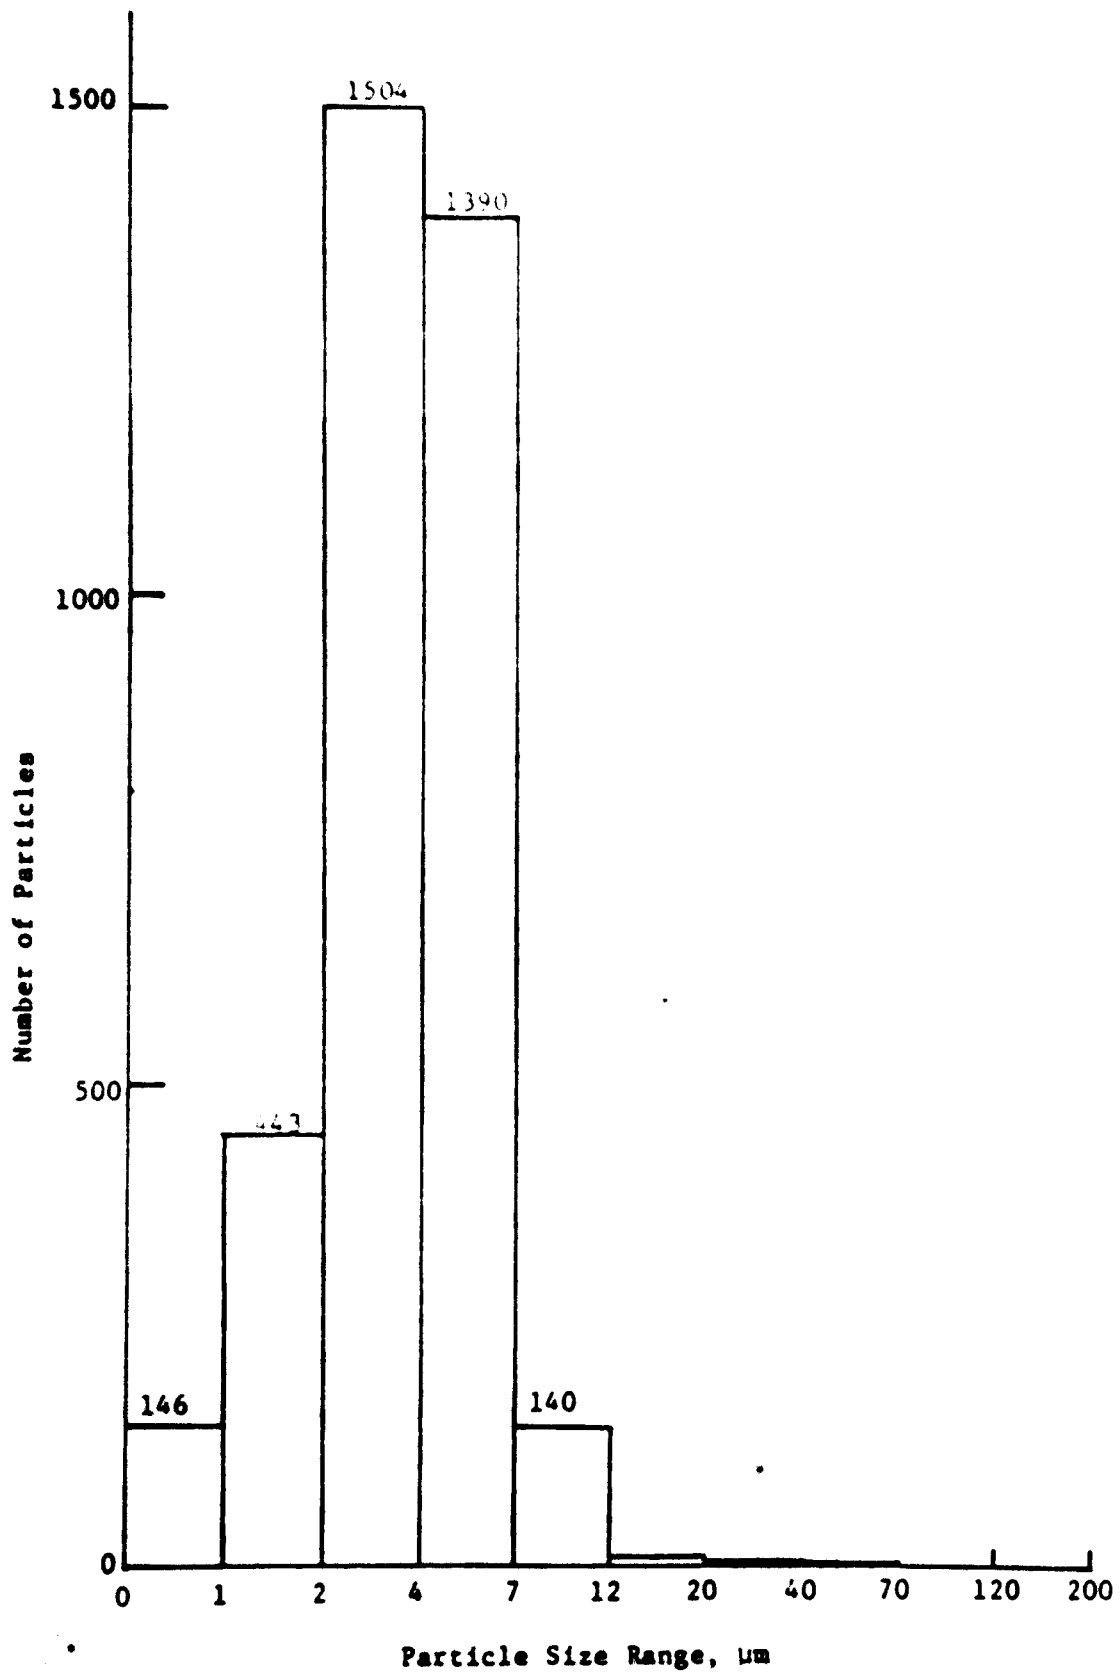
Fig. 3. Results of image analysis of TMI-0104 for particle size distribution.

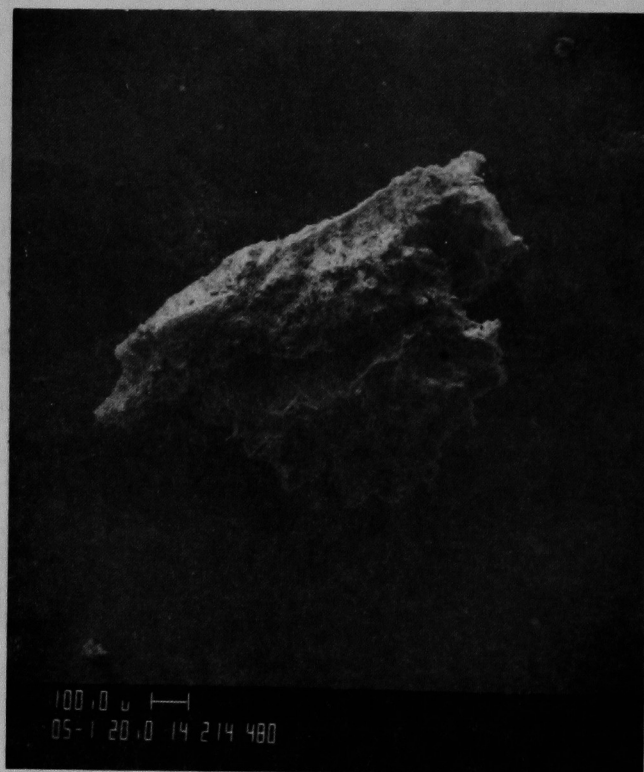
Fig. 1.

Large piece of filter material, 50X

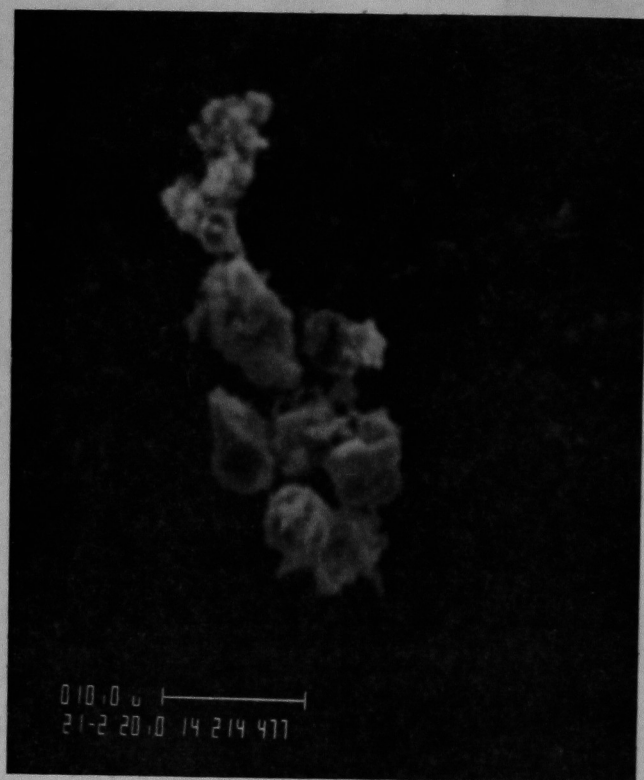
\* Fig. 9.

Cluster of particles; high U. 1900X

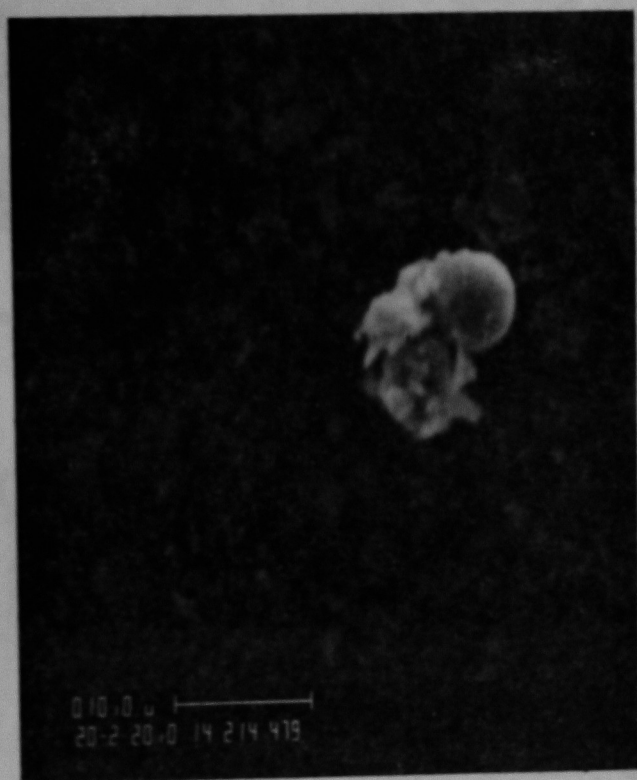
Fig. 10.

Cluster of particles; the round particle is high in Ag, Cd, In. 1800X

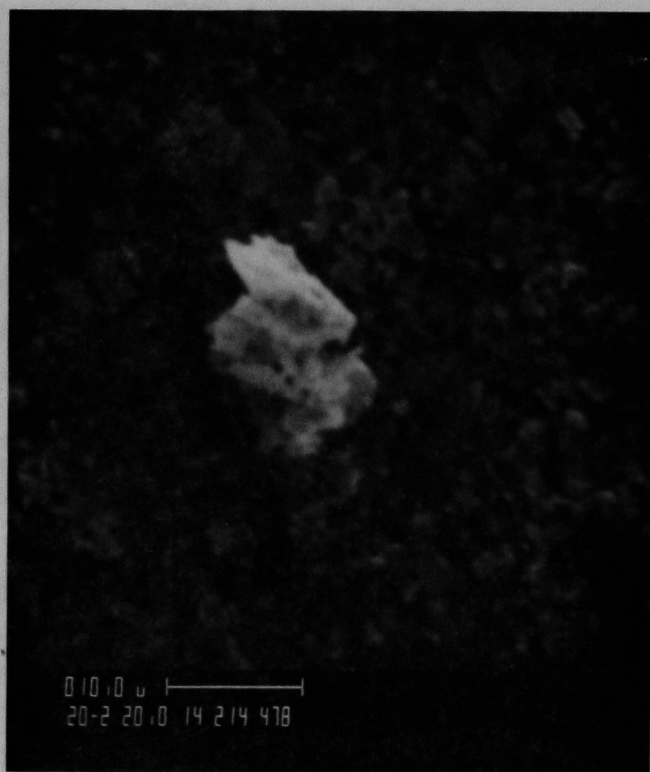
Fig. 11.

Cluster of particles; high Zr. 1800X

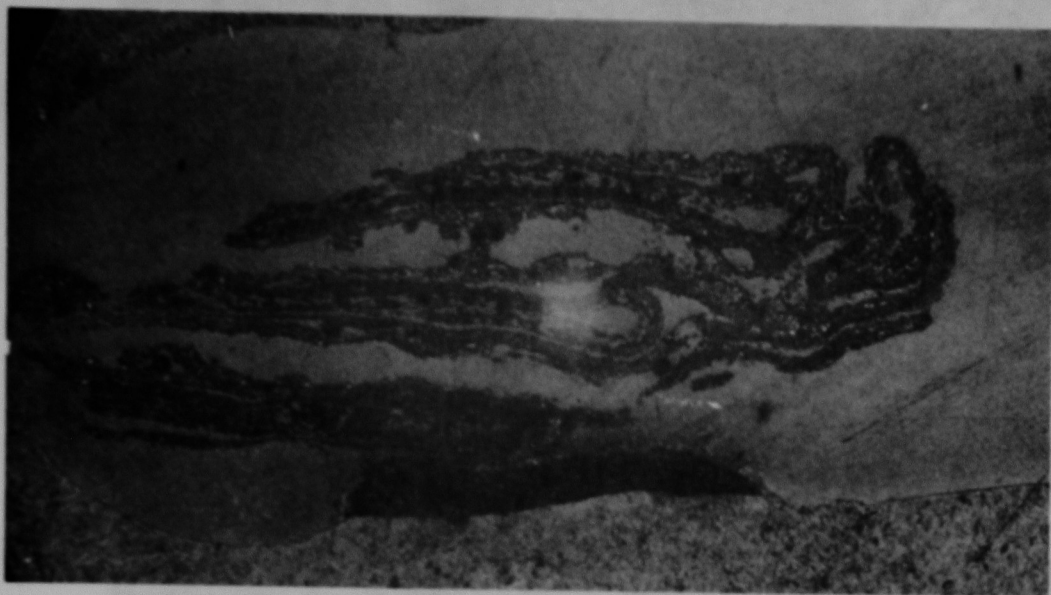
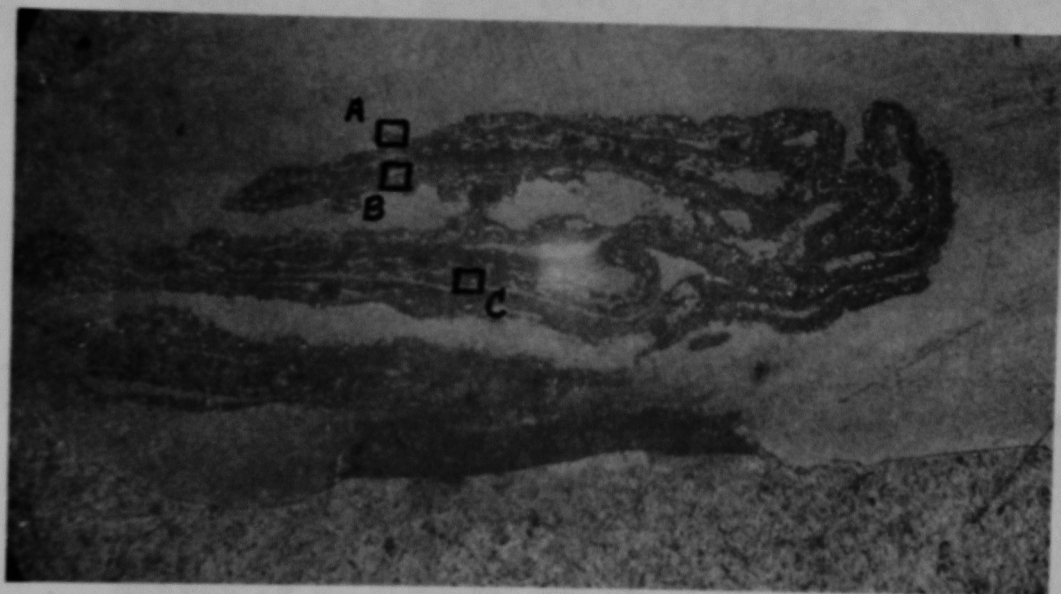
Fig. 12

Mounted Piece of Filter Material from Sample MUF-5B. Neg. Neg. MSD-229864.

Piece of Filter Shown Above with the Area of Three of the Higher Magnification Photos Identified. Neg. No. MSD-229864.

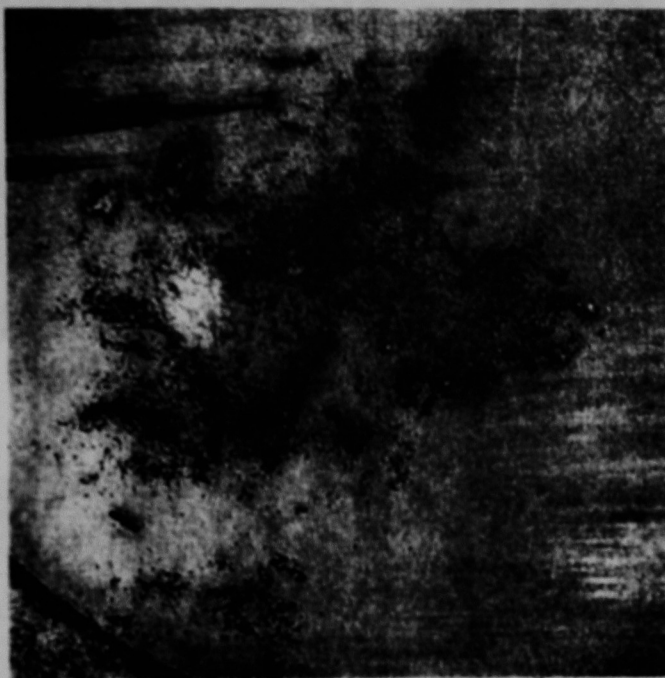
Fig. 16. Low Magnification Photo of the Broken-up Piece of Filter Material from Sample MUF-5B. 10X. Neg. No. MSD-229876.

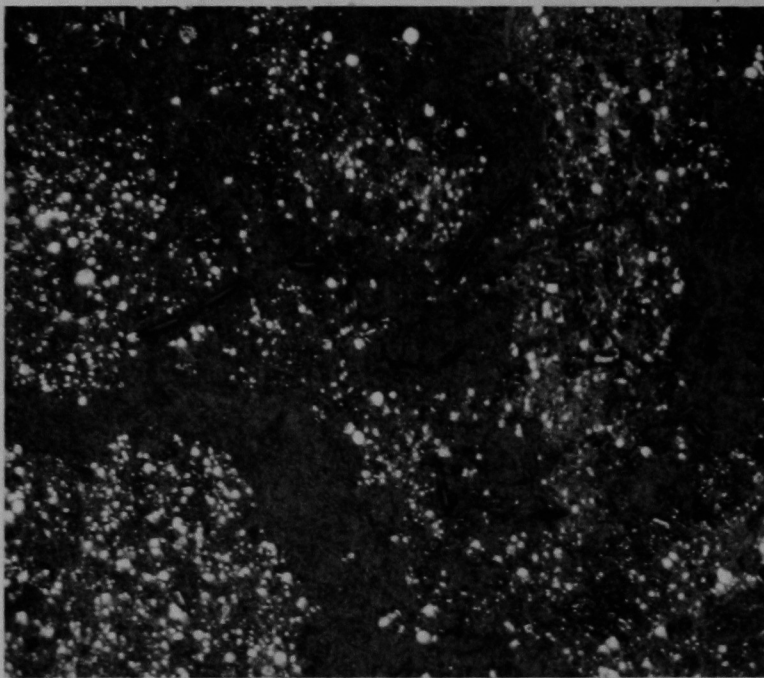
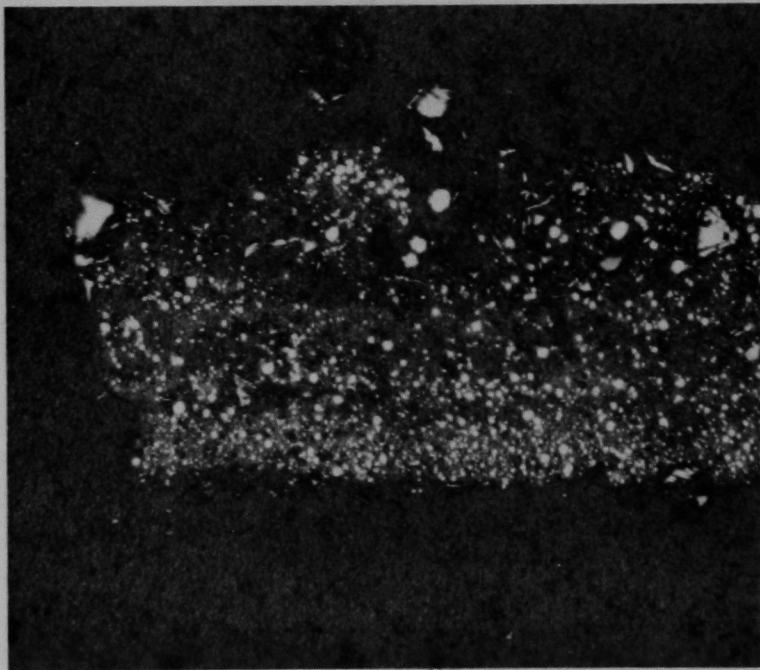
Fig. 17. Areas of the Broken-up Piece of Filter with High Concentrations of Debris.

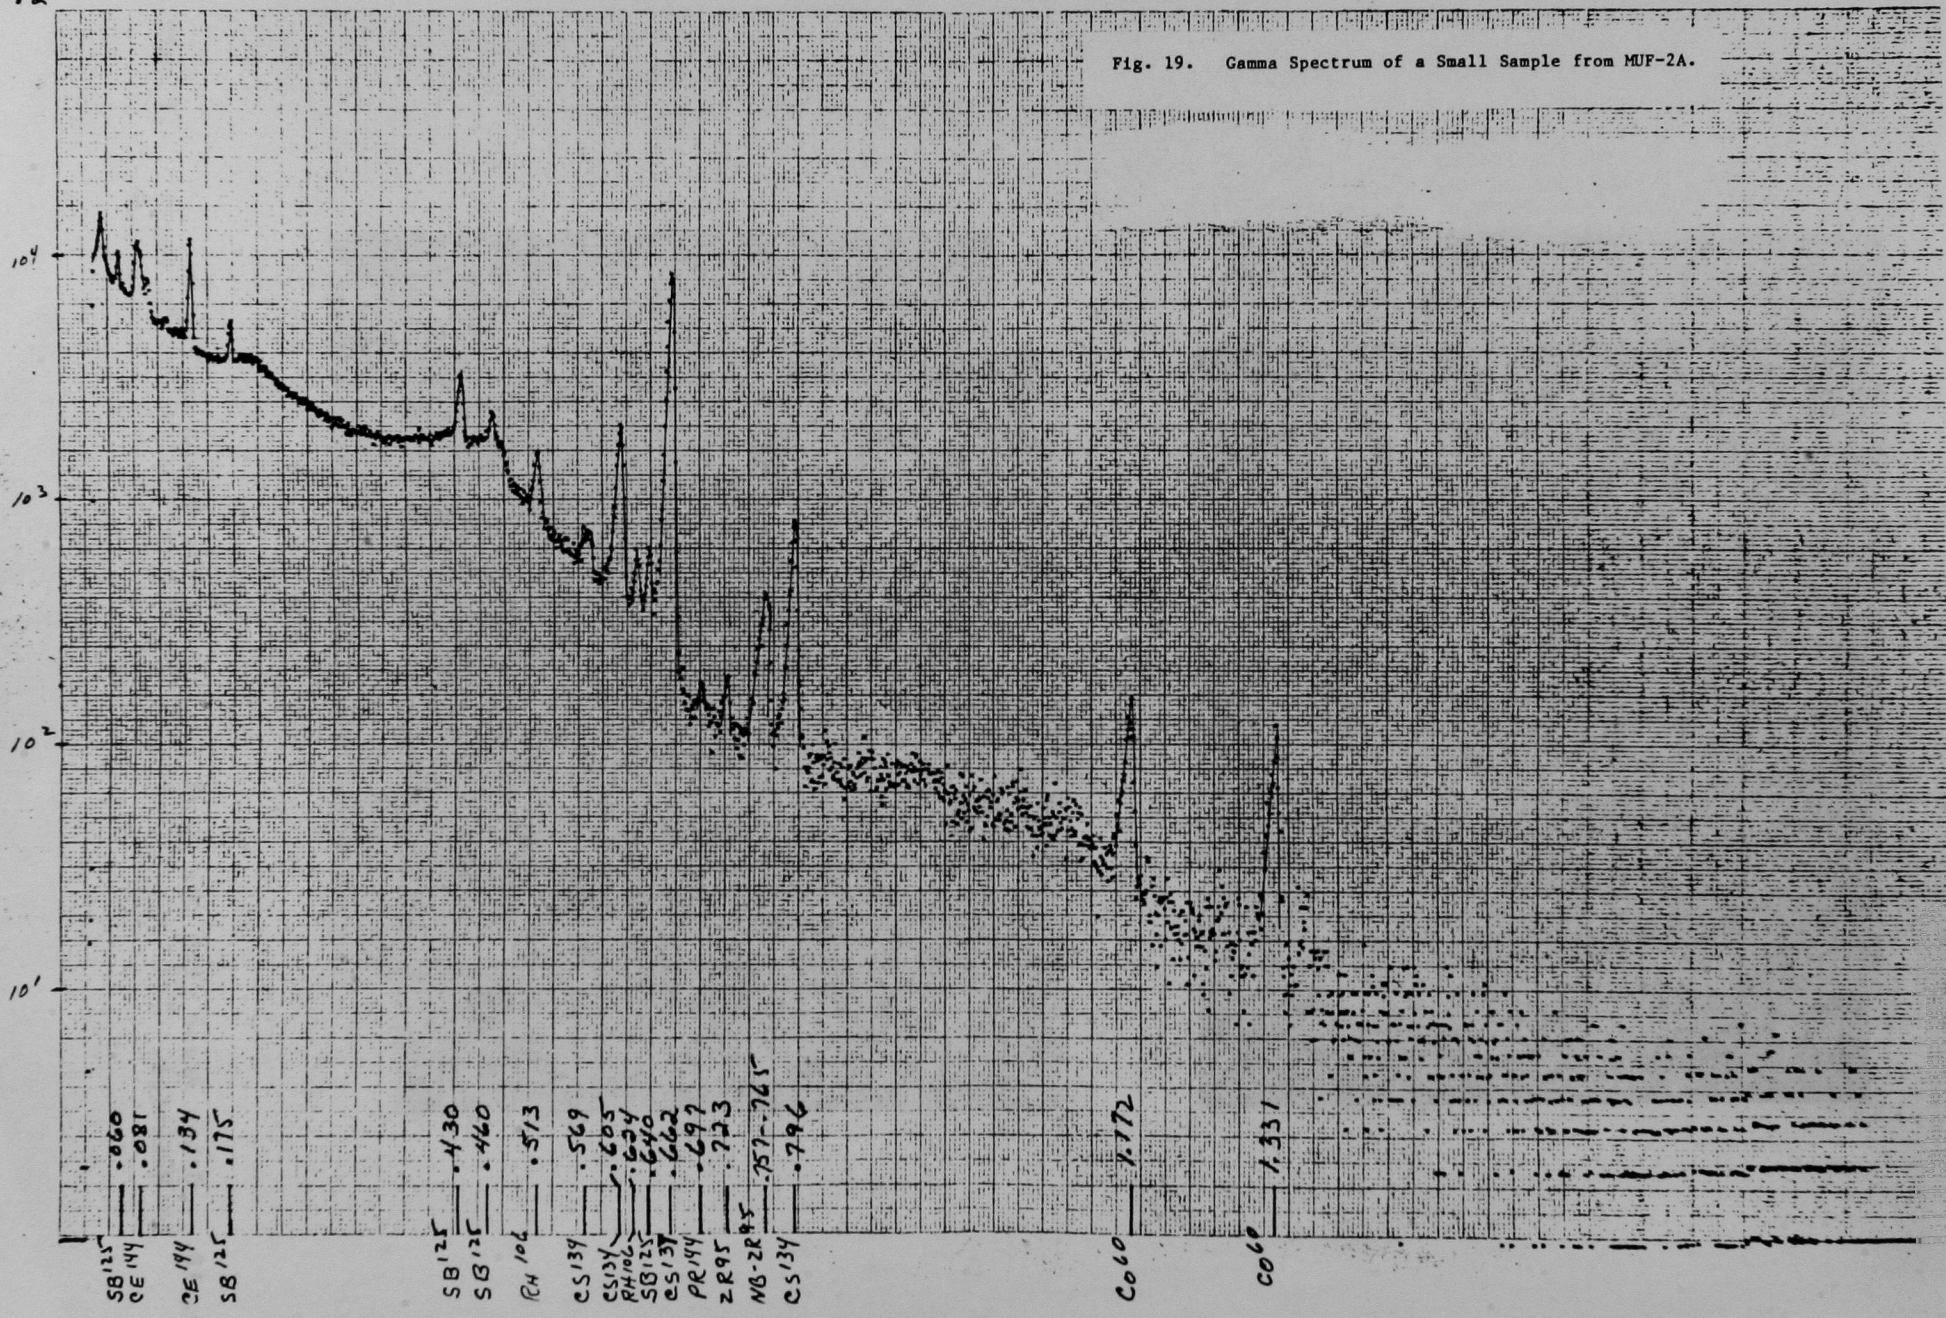
Fig. 19. Gamma Spectrum of a Small Sample from MUF-2A.
