Critical Parameters of Complex Geometries of Intersecting Cylinders Containing Uranyl Nitrate Solution

Dr. Robert E. Rothe, Consultant

June 1999

**This paper is written under contract C96-175866 with the United States Department of Energy
administered by the Idaho National Engineering and Environmental Laboratory,
although the work was performed at Rocky Flats, Colorado**

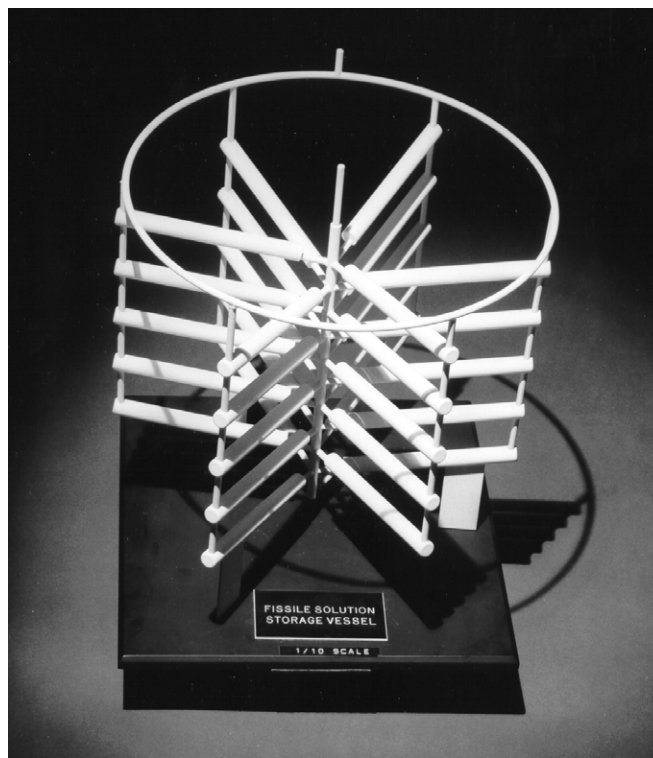
GC99 0149

Figure 1. A novel method of routine critically safe storage of large volumes of fissile solution in production facilities was proposed based on these experiments. This one-tenth scale model was built to illustrate the concept. No prototype tank was ever built for testing purposes at Rocky Flats. The notion was rejected because too many welds gave too many potential leak points.

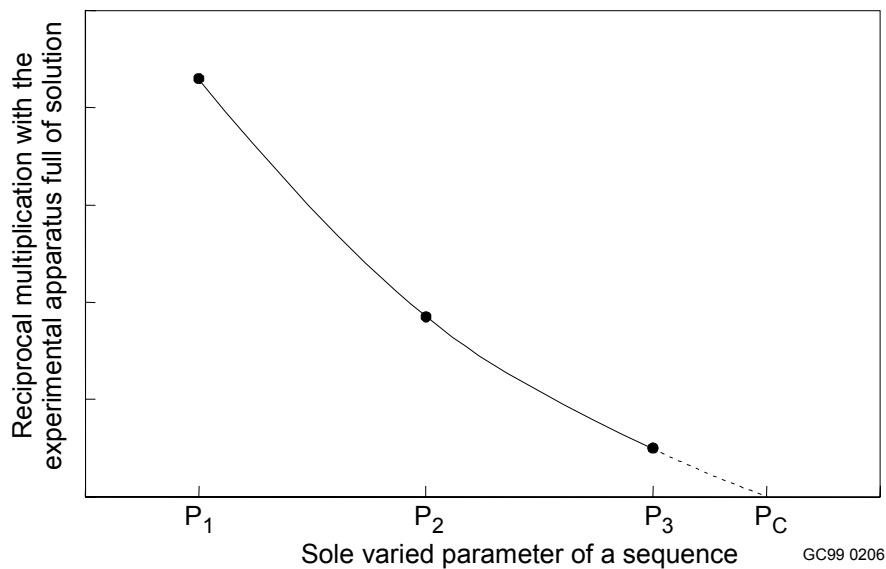
Figure 3. Less precise critical heights of uranium solution may be obtained from this extrapolation technique. The last reciprocal multiplication value recorded each time the Central Column was full of solution for a sequence of identical experiments except for one changing parameter, P_i , may be graphed as shown here. One example of this changing parameter might be the spacing, S , between arms. A smooth curve through the last few points extrapolates to a critical value of the parameter, P_C .

Still other critical heights quoted in this paper were simply extrapolated from a lesser height to the critical height which could have been reached within the limitations of the apparatus. In these rare cases, an extrapolation was deemed as good as actually attaining criticality; and the shortcut was both safer and faster. This was a questionable decision in light of present-day knowledge about curvature in extrapolation regions; but, nonetheless, it was sometimes done as a simple expedient.

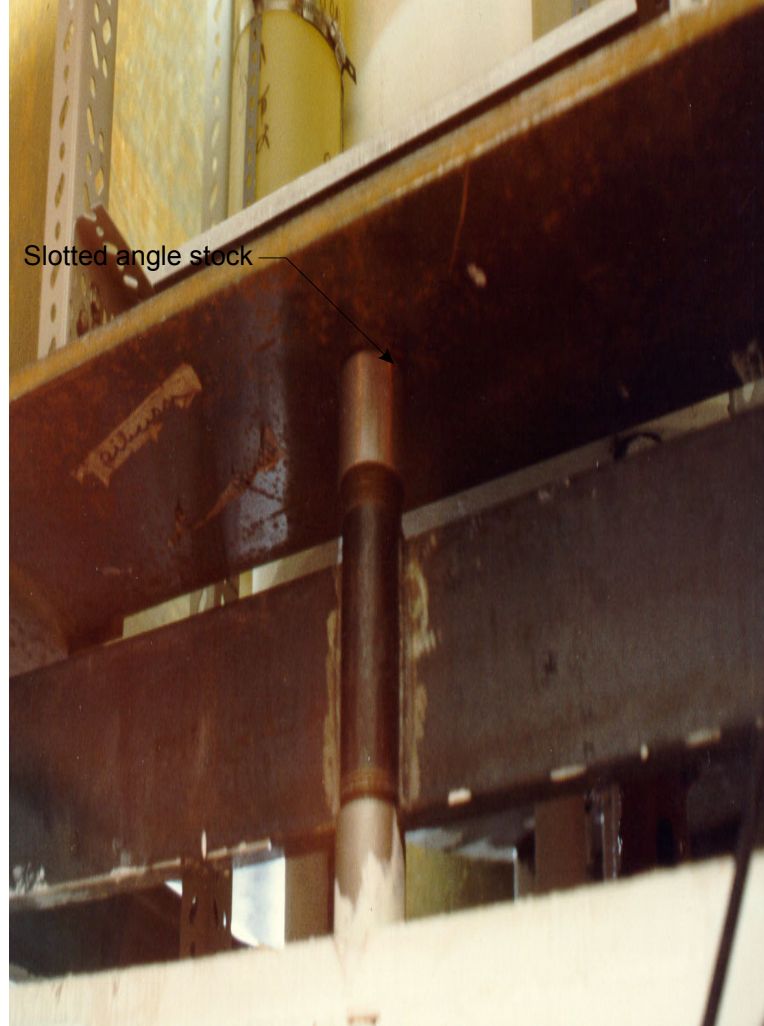
GC99 0152

Figure 8. The Slotted Angle stock supporting the arms in vertical planes was used in many subsequent programs. This 1984 photograph portrays a totally unrelated experiment almost two decades later.

The arms projecting off any one face of the Central Column were held in a vertical stack by a light-weight, L-shaped, steel structural material called Slotted Angle. This material was a gray-painted, mild steel product extruded in the shape of a thin angle iron with unequal legs. The material can be seen in a totally different application in Fig. 8. The angle stock was sheared to length as needed and bolted together. Dimensions of this stock were not recorded; but they are recalled to have been commercial 2" by 1 1/2" stock which would be 51 mm by 38 mm. The thickness was probably 1.6 mm because this would have been a common commercial thickness (one-sixteenth of an inch); and the material is recalled to have been easily sheared to length by a tool purchased for that purpose. Both faces of the L-shaped material were perforated with a regular pattern of round and oval holes. These holes covered about 30%

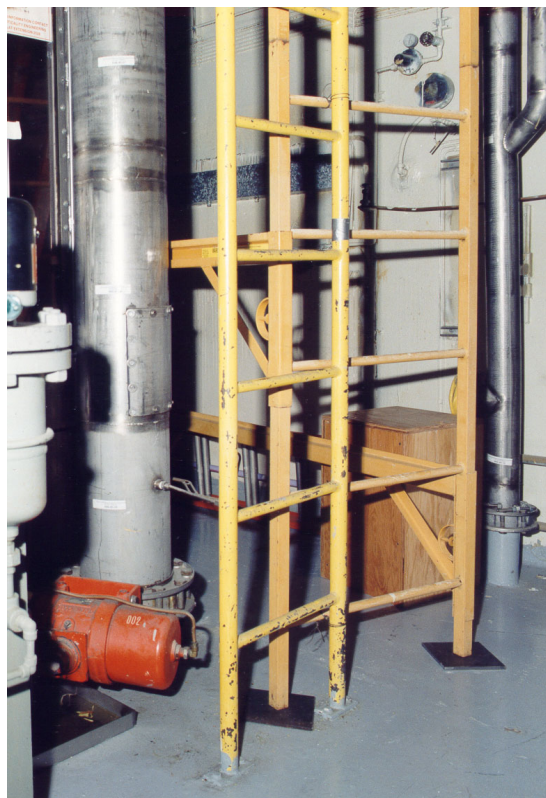
GC98 0143

Figure 28. The vertical leg of the 250-mm-diameter building exhaust duct is shown to the left as it enters the floor of the Assembly Room. Just below grade, the line curves and leads horizontally under the wall seen to the right background. The cover plate (seen on the right side of the duct in the middle of the photograph) was later installed over the hole cut into this line to view for the first time the extent of this contamination incident. Close inspection above that patch shows the weld seam when the length of exhaust line was reinstalled after completing cleanout. The horizontal object at the bottom where the duct enters the floor is the butterfly valve discussed to in the text.

Once the rectangular hole had been cut, a depressing scene was revealed. Dried and brightly colored yellow salts of uranyl nitrate spotted and streaked down 10% to 40% of the visible interior of this line. Although streaks were thin, they extended as far as could be seen inside this line. Thicker layers of dried salt were found all over internal surfaces of the Butterfly Valve - a distance below the opening and just above the floor of the Assembly Room. Obviously, a lot of uranyl nitrate solution had passed through the filter housing before it plugged up. The butterfly valve operator can be seen near the bottom of the photograph of Fig. 28. The location of the rectangular hole is revealed by the patch seen bolted to the exhaust duct in the middle of the photograph.

To facilitate cleanup and recovery of these dried salts from this large-diameter exhaust line, a 1.5 m length was removed just above the Butterfly Valve. The weldment upon returning the length after cleanup can be seen to the left in Fig. 28 between the 4th and 5th rungs of the ladders. This removal permitted unobstructed views back up the vertical exhaust line as well as down into the buried portion of the line. Both views revealed a lot of dried uranyl nitrate salts. A mirror was lowered into the buried pipe to permit viewing the buried line several meters underground. The bottom of this line was covered by a thick layer of uranyl nitrate salts as far as the hand-held light source could illuminate the interior of this 6.3-m-long underground duct. The river of dried salt was about 150 mm wide. The sight was most depressing; and the presence of such a large amount of fissile material in critically unsafe containers was disconcerting.

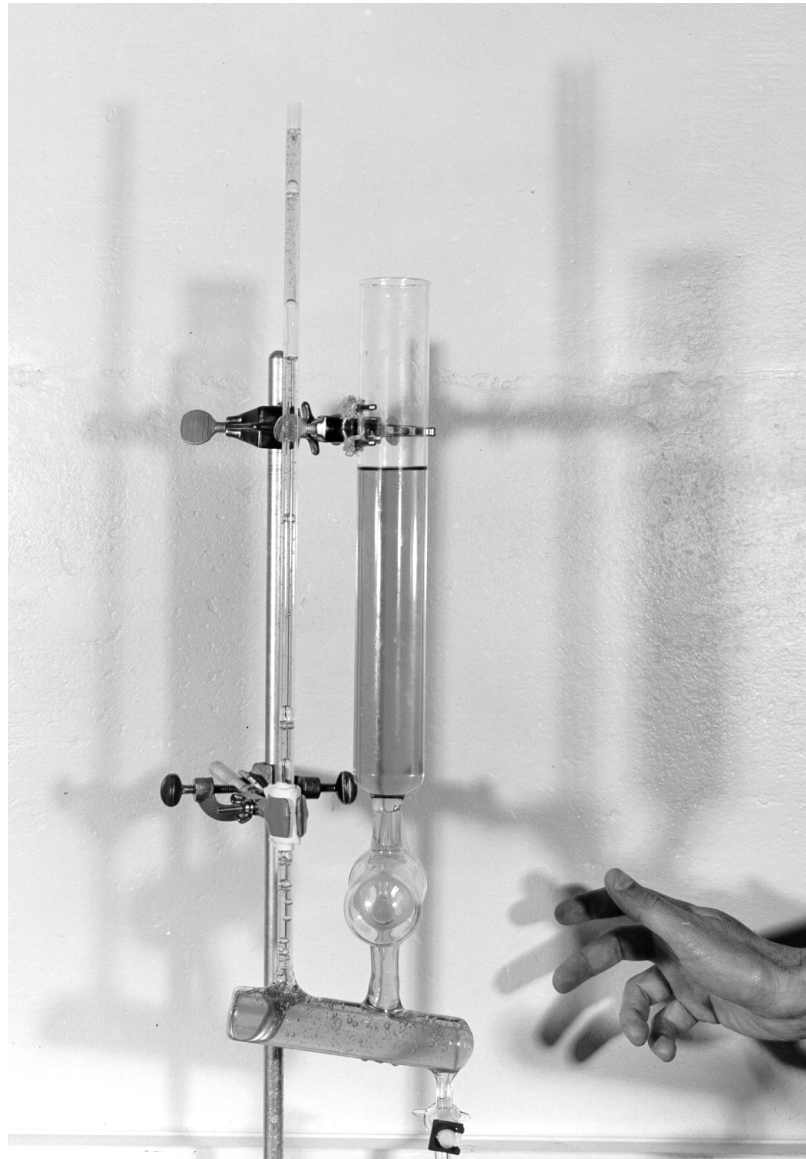
GC99 0144

filled with dark colored water. When the glass valve was opened, the situation shown in the photograph of Fig. 29 clearly demonstrated precisely the phenomenon postulated.
