INEEL/CON-99-00037
PREPRINT

Assessment of Field Experience Related to Pressurized Water Reactor Primary System Leaks

1999 ASME Pressure Vessels and Piping Conference

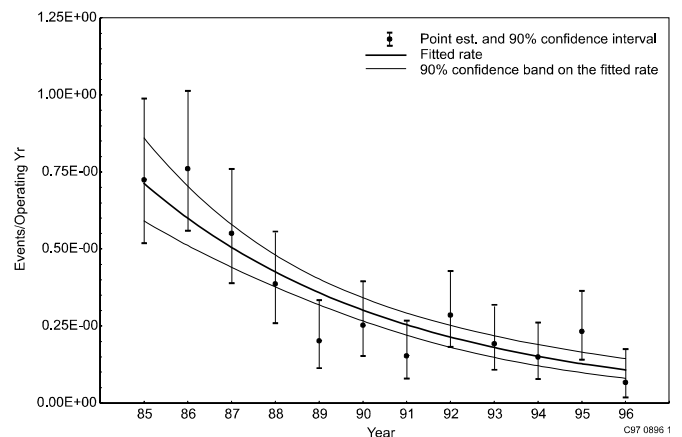
Figure 2. Statistical analysis of a trend in the frequency of reportable leak events showing point estimates, 90% confidence bands, and 90%

confidence intervals.

Investigation of the data presented in Figure 1 shows a statistically significant decreasing trend in the frequencies of the reportable leak events as presented in Figure 2. The solid line shows the estimated trend and the dotted lines show 90% confidence bands. For this investigation, the trend, if present, is assumed to have an exponential form. The data are barely consistent with this modeling assumption because two of the thirteen 90% confidence intervals do not overlap the fitted line. A formal goodness-of-fit test did not quite reject the assumed exponential form. Excluding the first 4 years from the analysis, the reportable leak events that occurred since 1988 do not show any statistically valid trend.

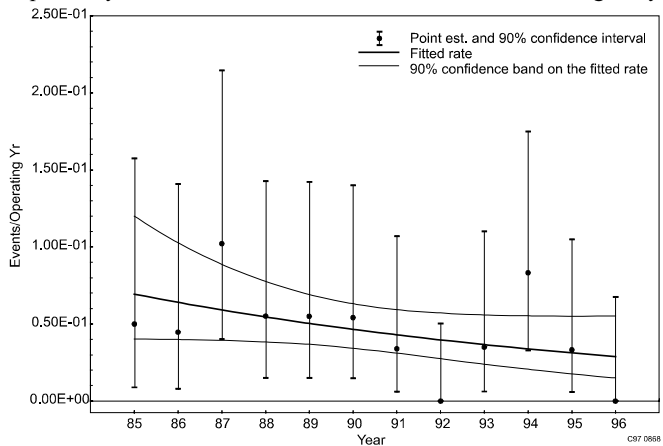
Figure 3. Statistical analysis of a trend in the reportable vibratory fatigue-related leak event frequencies estimated by calendar year. Point estimates, 90% confidence bands, and 90% confidence intervals are shown.

Trends of the vibratory fatigue-related leak events in calendar time and plant age were statistically investigated as shown in Figures 3 and 4, respectively. The effect of calendar time reflects the evolving body of

regulations, design improvements, and industry-wide learning. The effect of plant age reflects the learning of plant personnel and the aging of the hardware. Solid curves in Figures 3 and 4 show the estimated trend in calendar time and with age, respectively. The dotted lines show 90% confidence bands. A trend in this investigation, if present, is assumed to have an exponential form. The data are consistent with this modeling assumption, because all point estimates of 90% confidence intervals overlap the fitted trend line. The results in Figure 3 reveal no statistically significant trend in calendar time, whereas the results in Figure 4 reveal a statistically significant decreasing trend with age. Apparently, the decreasing trend implies that the vibratory fatigue failures are caused by premature aging because of inadequacy of the initial design and fabrication. In other words, the decreasing trend implies that the vibratory fatigue failures are not caused by aging damage resulting from long-term operation.

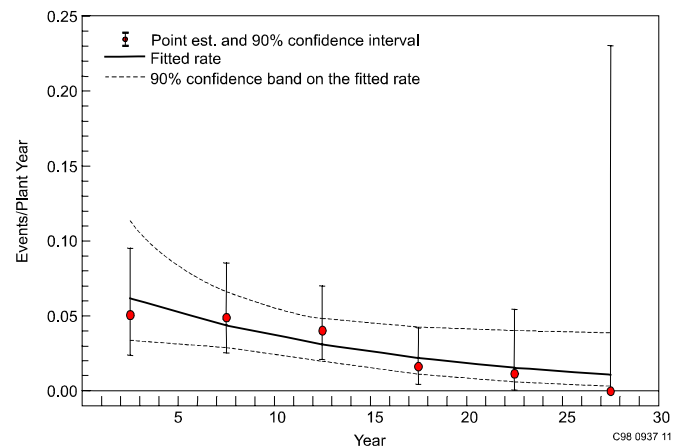
Figure 4. Statistical analysis of a trend in the reportable vibratory fatigue-related leak event frequencies estimated by plant age (years in service). Point estimates, 90% confidence bands, and 90% confidence intervals are shown.

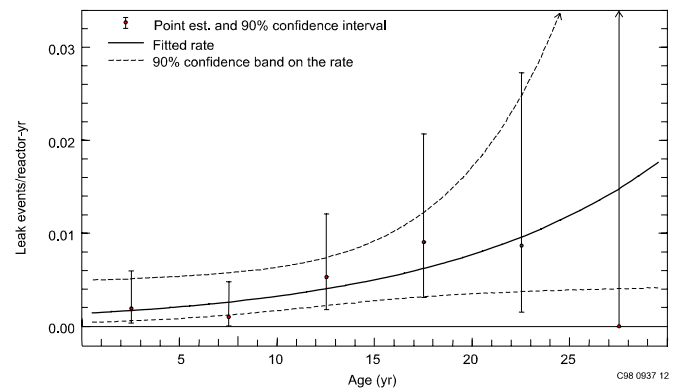
Figure 5. Statistical analysis of a trend in the thermal fatigue-related leak event frequencies estimated by plant age (years in service). Point estimates, 90% confidence intervals, and 90% confidence bands are shown.

Trends of the thermal fatigue-related leak events (listed in Table 2) in terms of plant age were statistically investigated, as shown in Figure 5. We used the world list of nuclear power plants (as of December 1997) published in the March 1998 issue of Nuclear News. All Western-designed PWRs were counted from this list; two Loviisa units from Finland were also included. Both operating reactors and the reactors that have been shutdown were counted, 217 reactors in all. For the reactors that have been shutdown, the years when the reactors were in operation were included in the analysis. The plant ages were collapsed into 5-year groups, as shown in Table 3, and the number of leak events was counted for each group. The ages of the plants were calculated as of May 31, 1998. The zero count for age group 25-30 is not surprising because very few plants are that old. The extrapolated value of estimated leak frequency (leak events per reactor year) for this age group is $1.5E-2$. For this frequency, it is more likely to see zero leak events in 43.9 reactor years than to see one or more events in that time period.

The dots and vertical bars show point estimates and 90% confidence intervals for the leak frequency, each based only on the data for one 5-year age group. A trend in this investigation, if present, is assumed to have an exponential form. The solid curve in the figure shows the estimated trend with age. The dotted lines show a 90% confidence band. The data are consistent with the exponential modeling assumptions because all the confidence intervals overlap the fitted trend. The results in the figure reveal that the leak events associated with thermal fatigue follow a statistically significant increasing trend with age.

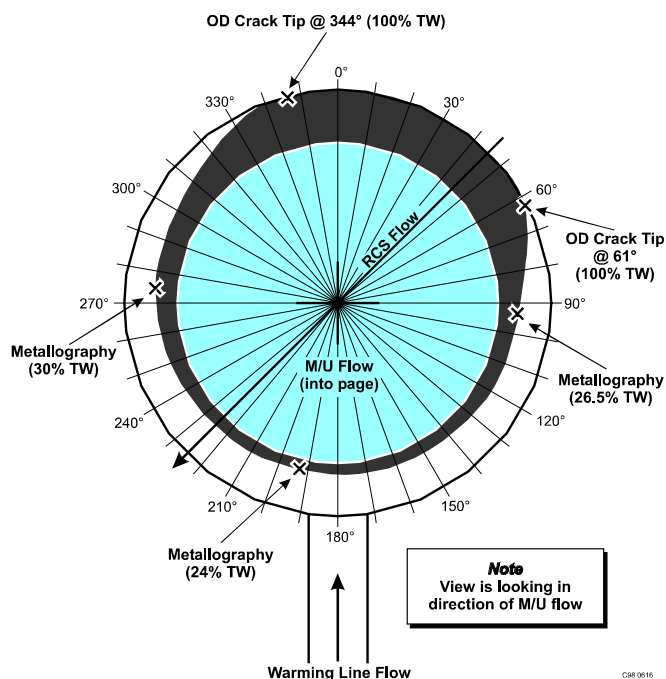
Figure 6. Angular distribution of depth of the circumferential crack at the safe-end-to-MU/HPI line weld.

The recent cracking at Oconee 2 suggests the possibility of uniform crack growth that may lead to a long throughwall crack. The growth of the circumferential crack was uniform (~ 30% through wall) over about 78% of the circumference as shown in Figure 6 (USNRC 1997b). The faster growth in the remaining portion of the crack was probably due to cold fluid flowing up from the warming line, causing thermal mixing in the upper portion of the pipe cross section near the damaged weld. In the absence of the warming line flow, the crack growth would have been more uniform, which could eventually lead to a longer throughwall crack accompanied by a larger leak rate.
