AGR 5/6/7 Disassembly and Metrology

AGR-5/6/7 Disassembly and Metrology

DOE ART Gas-Cooled Reactor (GCR) Review Meeting

AGR-5/6/7 Irradiation Disassembly and Metrology First Look

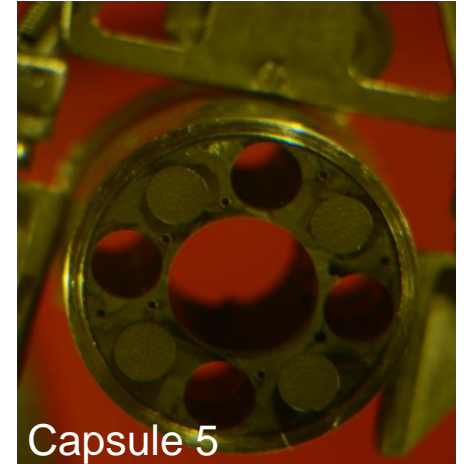
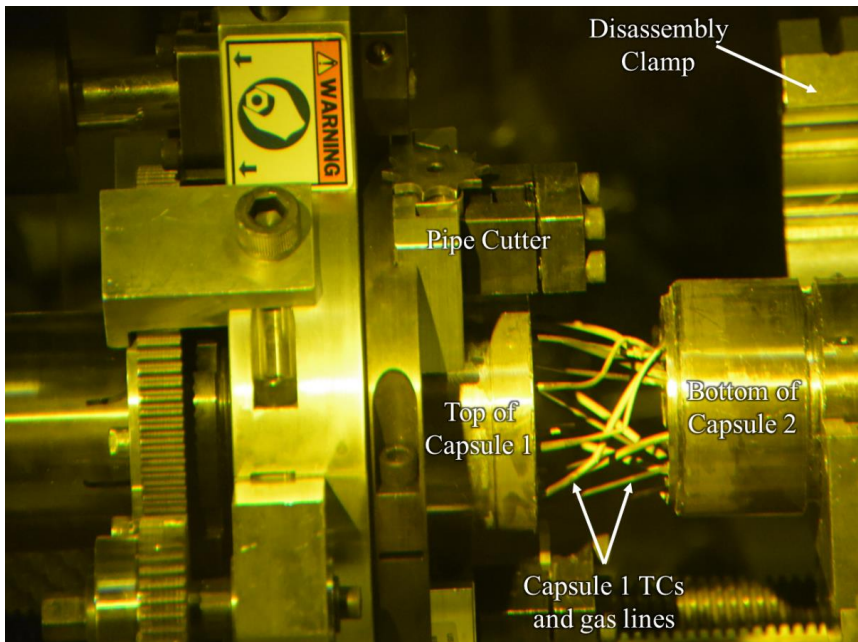
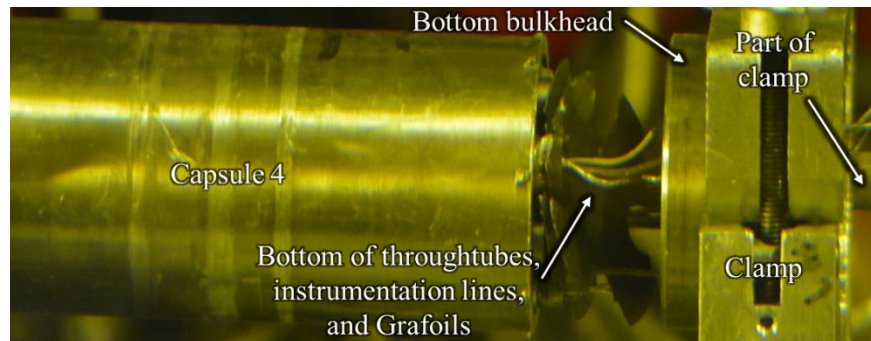
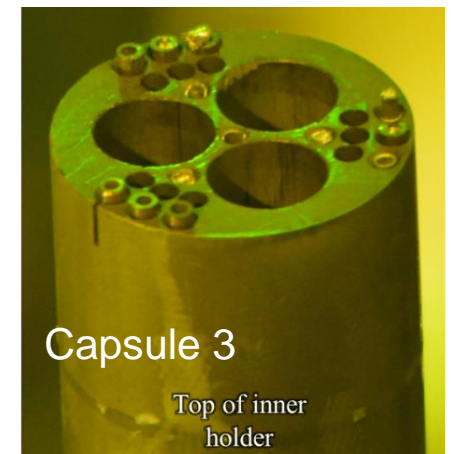
Disassembly and Metrology Complete

Level 2 Milestone report completed February 2023

Components	Number
Capsules Disassembled	5/5
Holder Measured	6/6
Compacts Recovered	194*/194

*Compact 2-8-4 was broken during disassembly

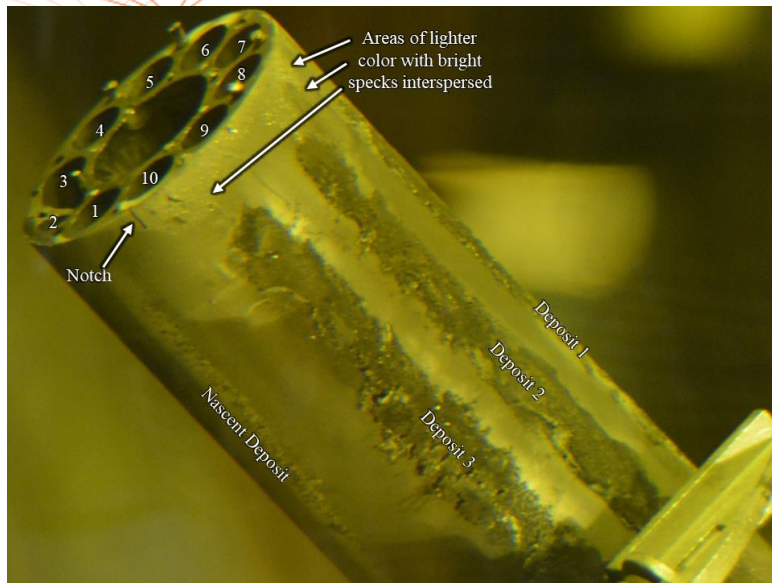
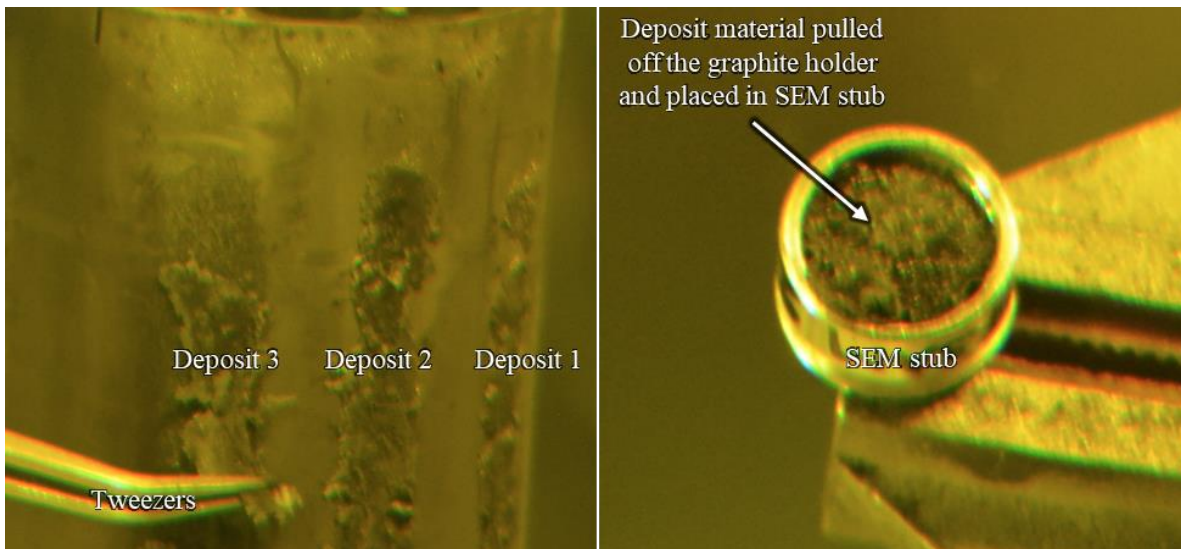
Graphite Holder – Capsule 1

- 32% C
- 5% Mg
- 4% Cr
- 59% Ni

- The disassembly and metrology work for AGR-5/6/7 is complete. Initial analysis of deposits on the graphite holder of Capsule 1 confirmed the existence of nickel, which was mostly likely from overheated thermocouples.
- The fuel compact dimensional changes are related to both fast neutron fluence and TAVA temperatures.
- For the graphite holders, the fuel channel diameter change, ID change, and OD change did not seem to be strongly correlated with the irradiation temperature and fluence. The differences in structure and geometry of graphite holders likely have some effect on the dimensional change.
- These dimensional changes are generally consistent with what has been observed in prior AGR campaigns.
- These dimensions will be fed back into the thermal model to refine the calculations.

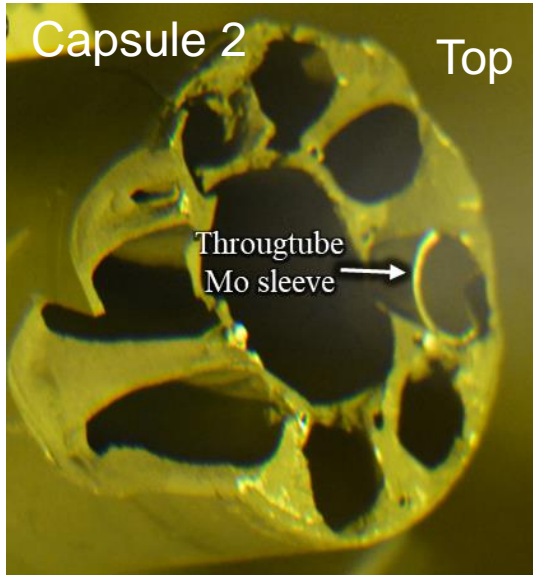
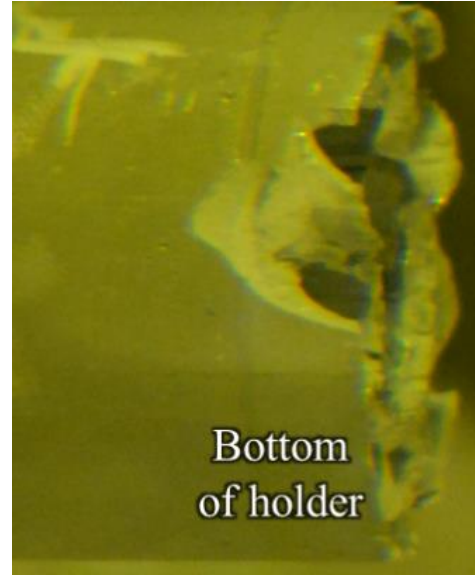
Graphite Holders – Capsules 2-5

For Capsule 2 graphite holder, the bottom was damaged when the shell was mistakenly cut in the wrong place, and the top was damaged when the through-tubes were pulled out.

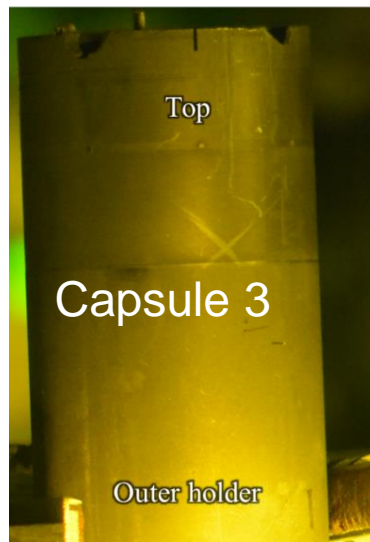
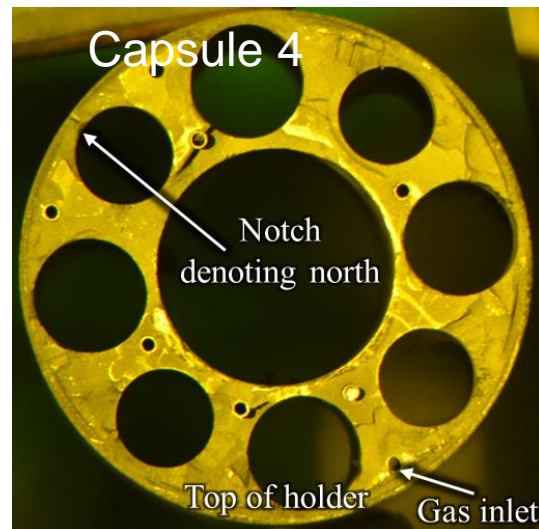
Minor chipping occurred mainly around the through-tube holes of the graphite holders of Capsules 3 (outer holder), 4 and 5.

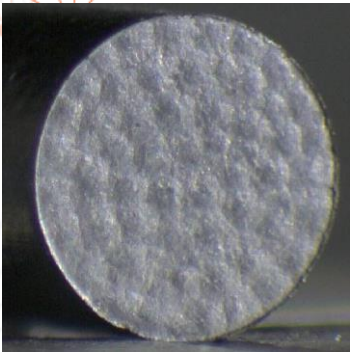
Compact 2-6-4

Typical As-irradiated Matrix Appearance

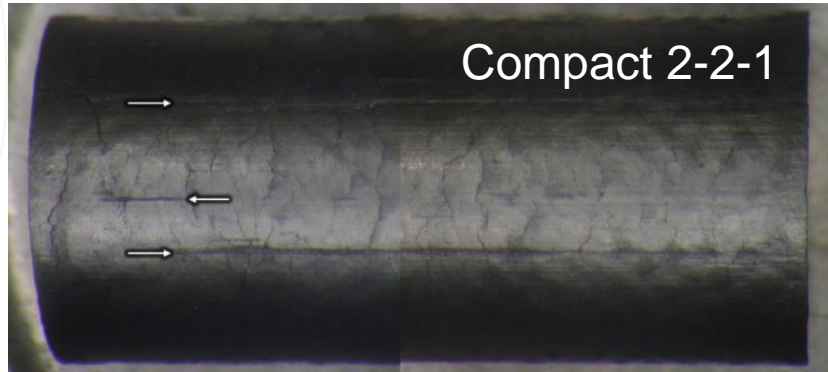
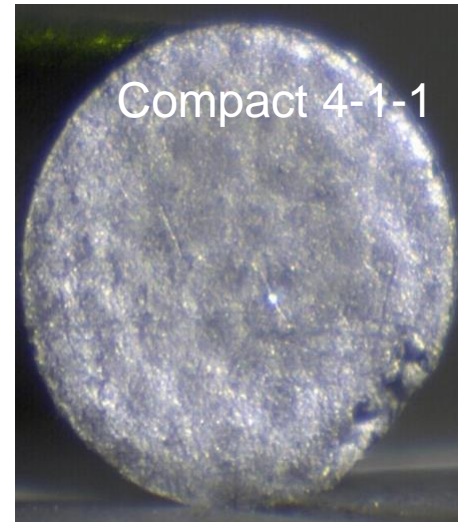
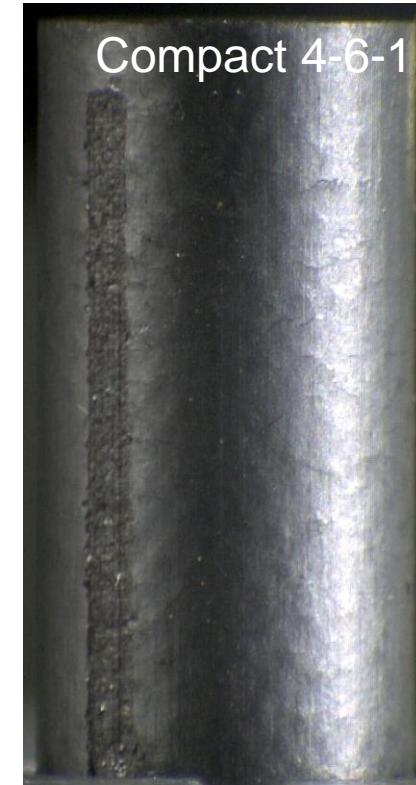
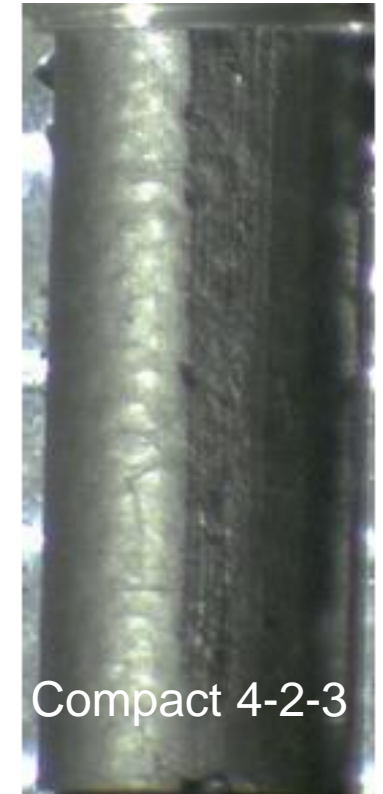
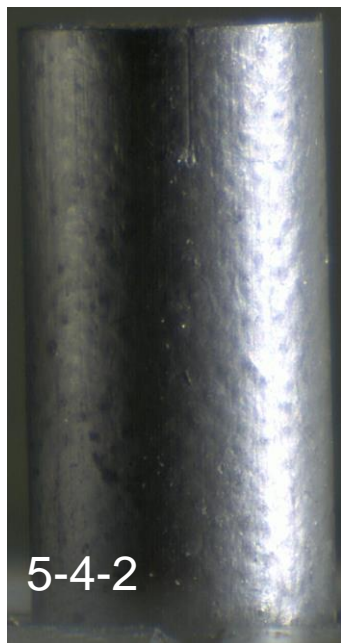
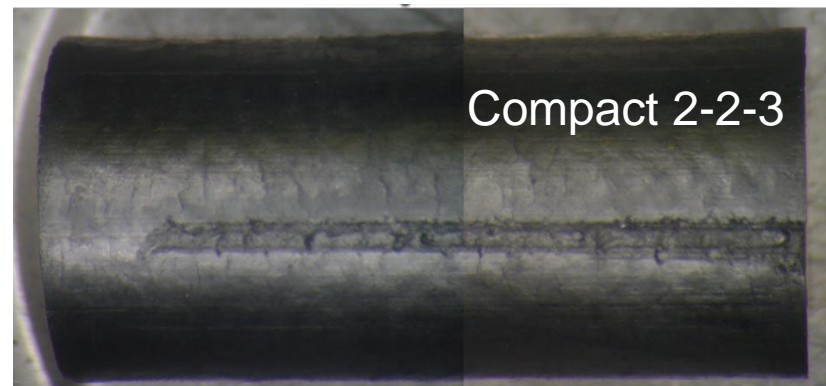
Unusual Compact Appearance and Damage

- Compacts not already sent to ORNL or used in DLBL will be examined via in-cell camera
- Compacts with damage could be screened in NRAD plus simplified furnace or possibly FACS for damage
- Compacts could also face DLBL to assess damage
- The point is to distinguish in-pile damage from disassembly/handling damage and potentially allow some compacts to be salvaged for fuel performance exams

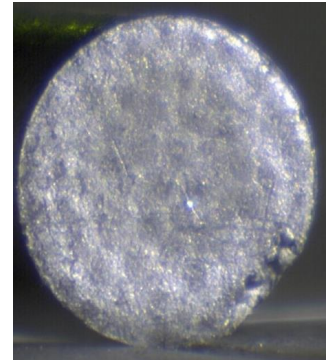
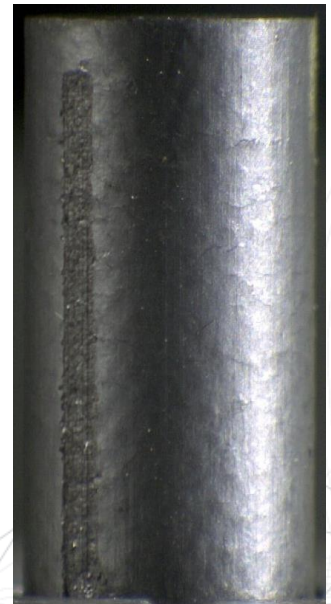
Complete In-cell Visual Examinations, Assess Frequency of Compact Damage, Determine Severity of Damage

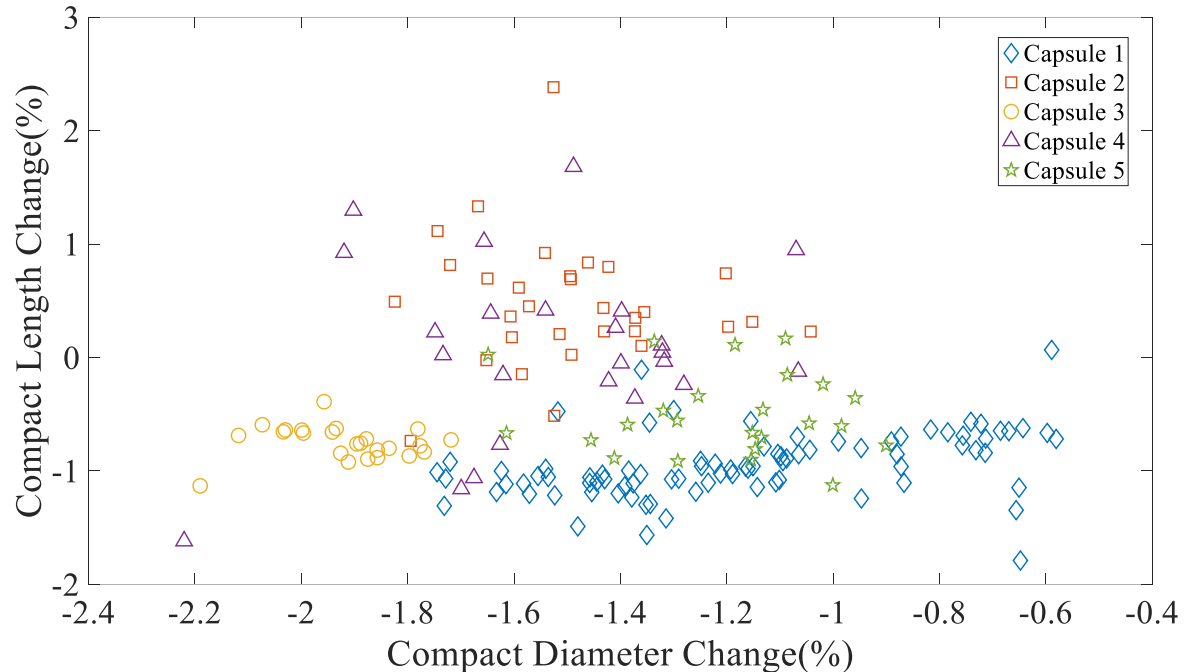
AGR – 5/6/7 - Fuel Compacts Overall

Nominal Packing Factor (PF):
25% - Capsules 1 and 5
40% - Capsules 2, 3, and 4

- The PIE dimensions of 188 compacts were compared with as-fabricated dimensions.
- For PF~40%, the fuel compacts from Capsules 2 and 4 had similar irradiation conditions, and their length changes vs. diameter changes (ΔL vs. ΔD) are similar. The Capsule 3 compacts exhibited length reduction instead of the length increase seen in Capsules 2 and 4, probably due to higher irradiation temperature at Capsule 3.
- For PF~25%, the fuel compacts from Capsules 1 and 5 show different trends in ΔL vs. ΔD despite having similar neutron fluence ranges, likely due to different irradiation temperature.

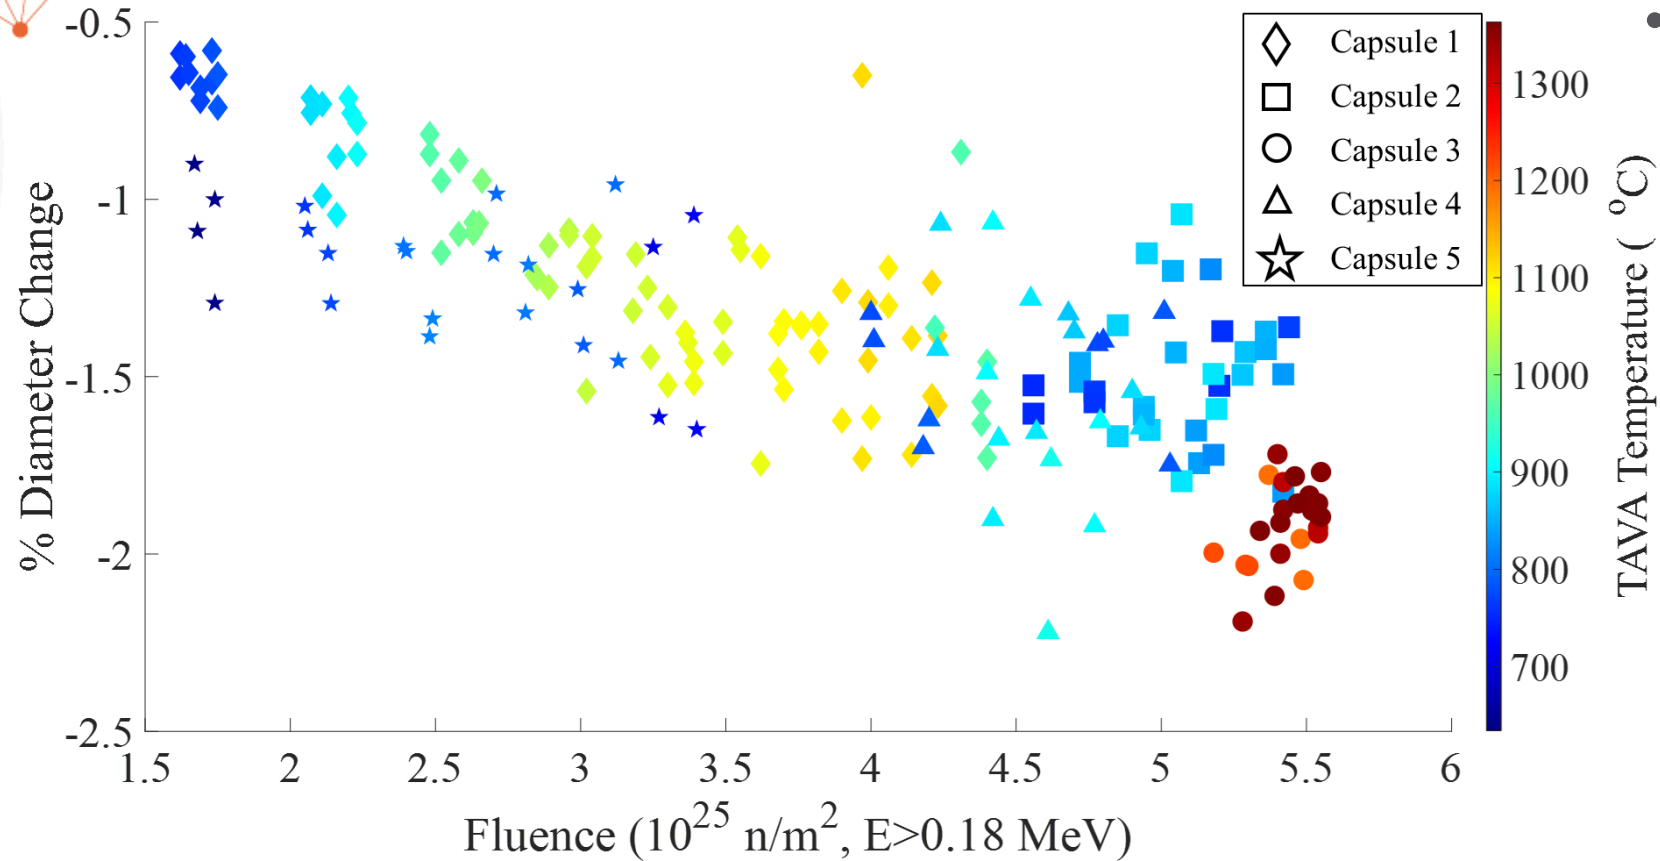
Fuel Compacts - Diameter

- The diameters decrease with increasing fast neutron fluence until about 4.5×10^{25} n/m² (E>0.18 MeV). Above this fluence, the diameter reduction of compacts with TAVA temperatures <1000°C becomes less pronounced.

- The hotter Capsule 3 compacts (TAVA>1190°C) have generally greater diameter reduction than the cooler Capsule 2 compacts (TAVA≤890°C).

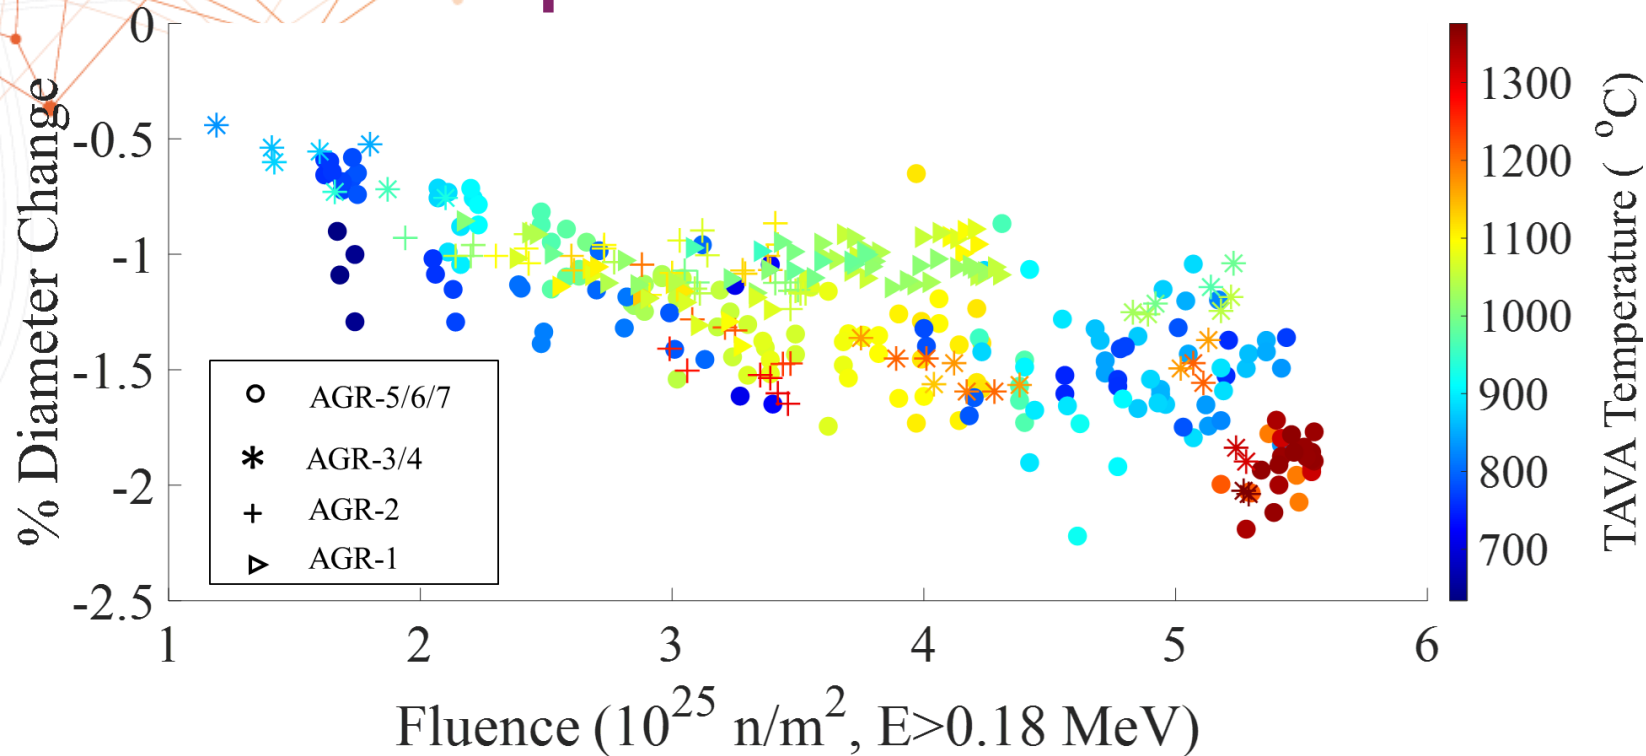
Fuel Compacts - Diameter

- A similar trend is observed for all AGR campaigns.

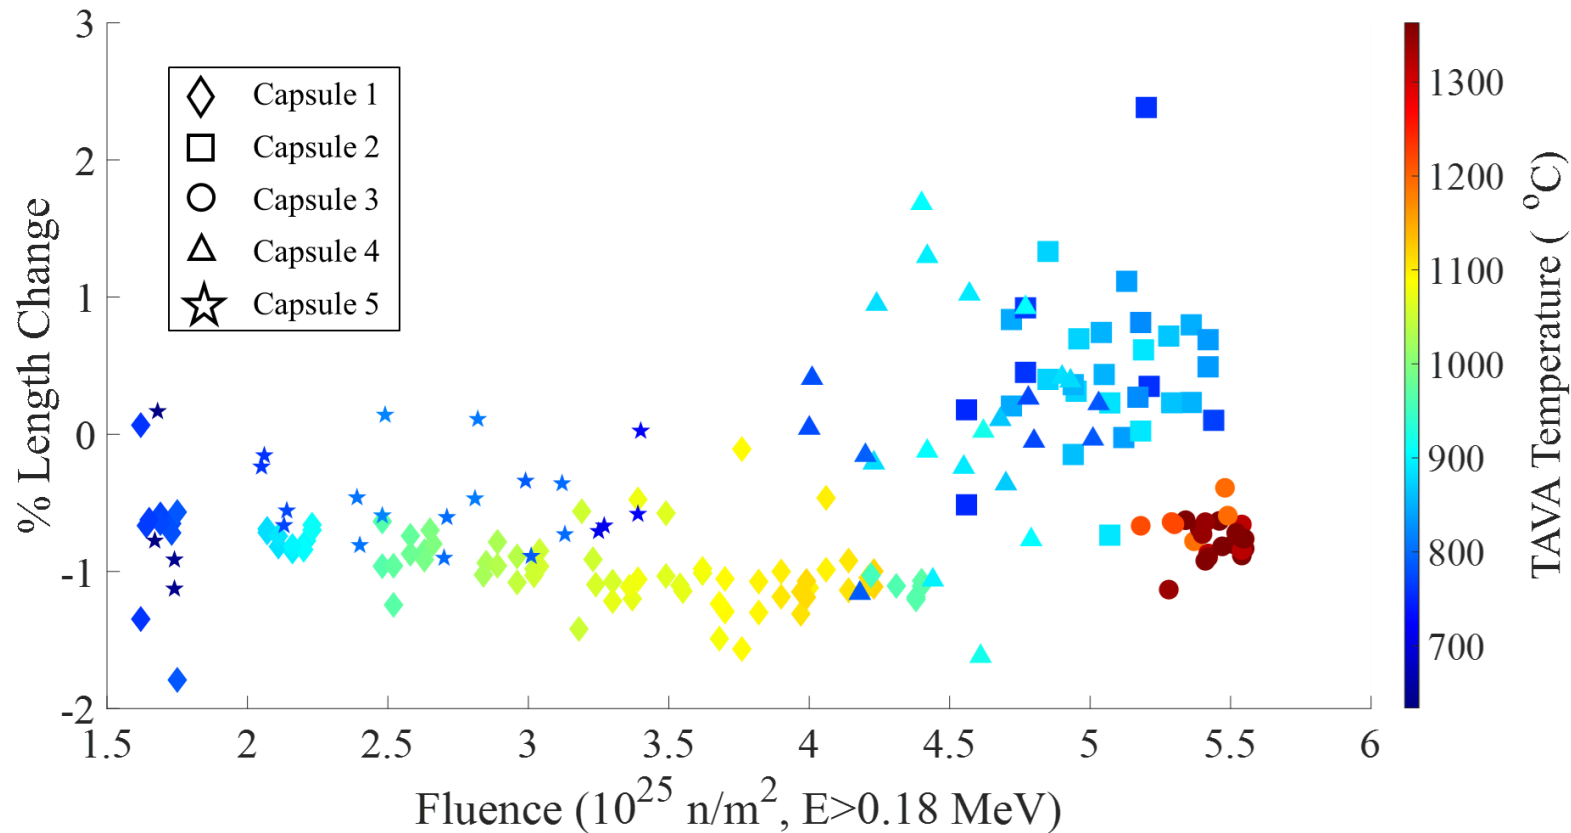
Fuel Compacts - Length

- The compact length changes scatter between -2% and 0% until about $4.5 \times 10^{25} \text{ n/m}^2$ ($E>0.18 \text{ MeV}$), above which the length changes for compacts with TAVA temperatures less than about 950°C in AGR-5/6/7 increase with increasing fluence.

- At the similar fluence, the hotter compacts from Capsule 3 have length shrinkage while the cooler compacts from Capsule 2 have length expansion.

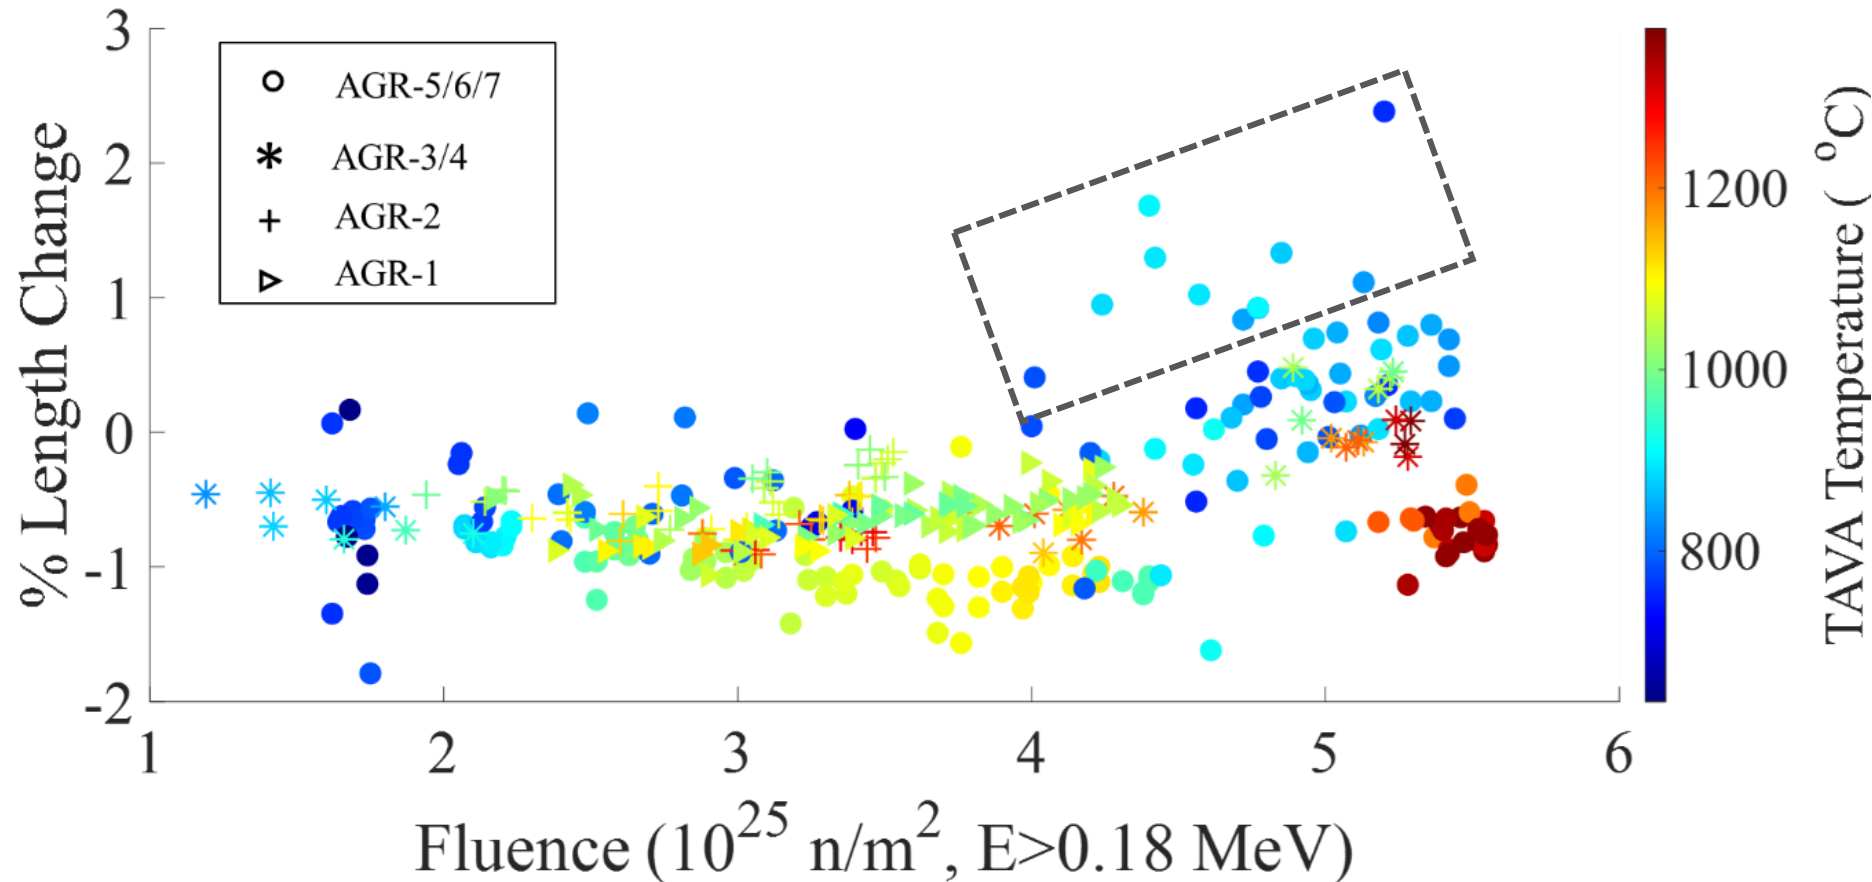
Fuel Compacts - Length

- Trends are generally consistent among all AGR campaigns.
- The high fluence low temperature realm covered by AGR-5/6/7 Capsules 2 and 4 is different than in prior experiments

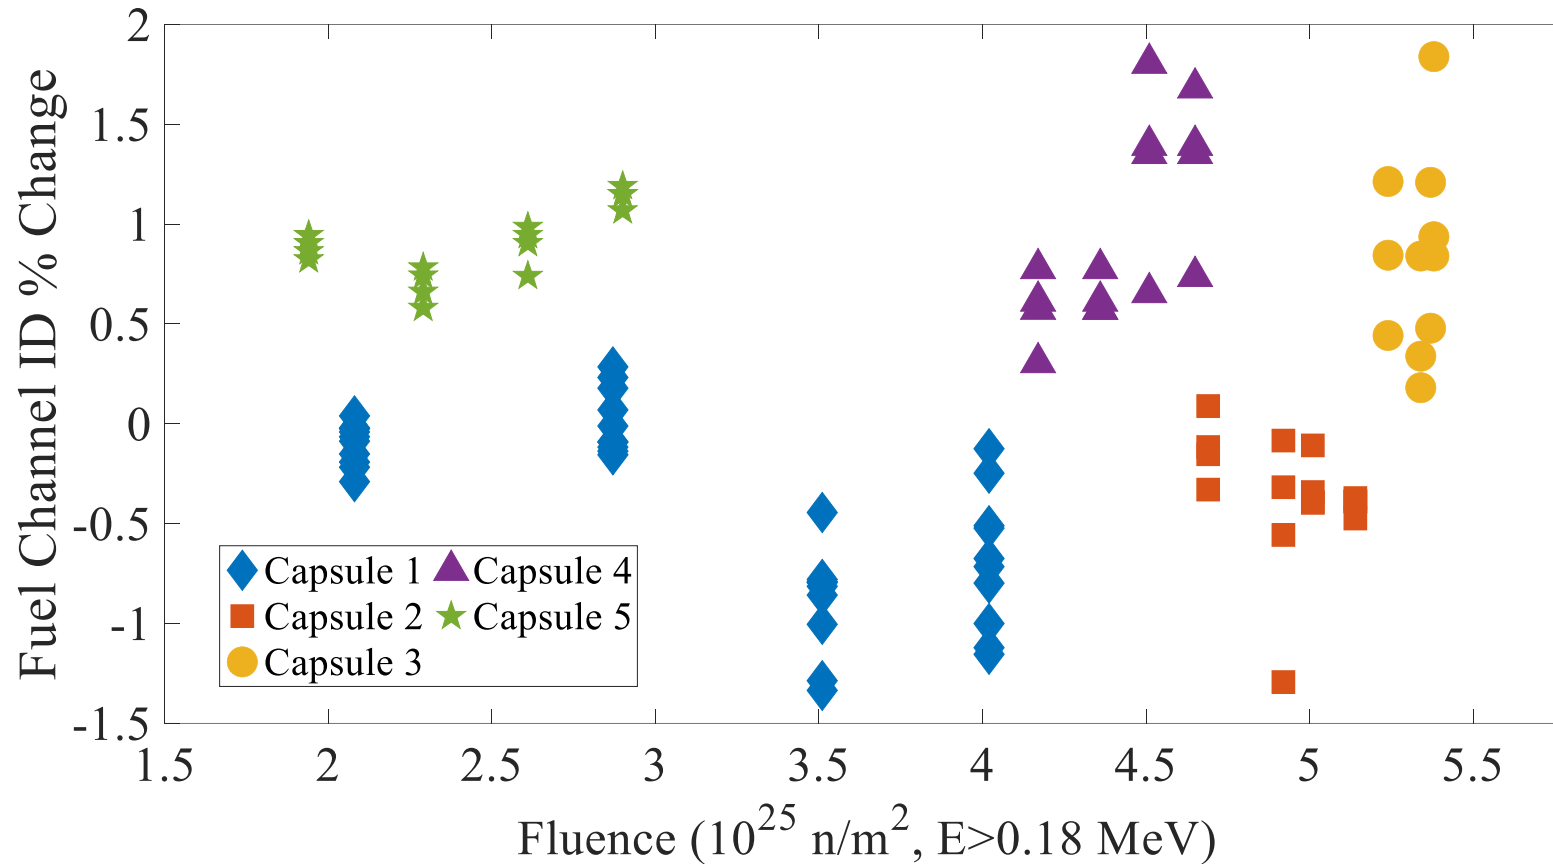
Graphite Holder - Fuel Channel ID

- The fuel hole diameter in Capsules 1 and 2 exhibit reductions. The largest compact diameter is less than the smallest measured fuel hole diameter, so there is no hard contact between fuel compacts and graphite holder .

- There is no clear dependence of fuel hole diameter changes as a function of dpa, irradiation temperature, or fluence.

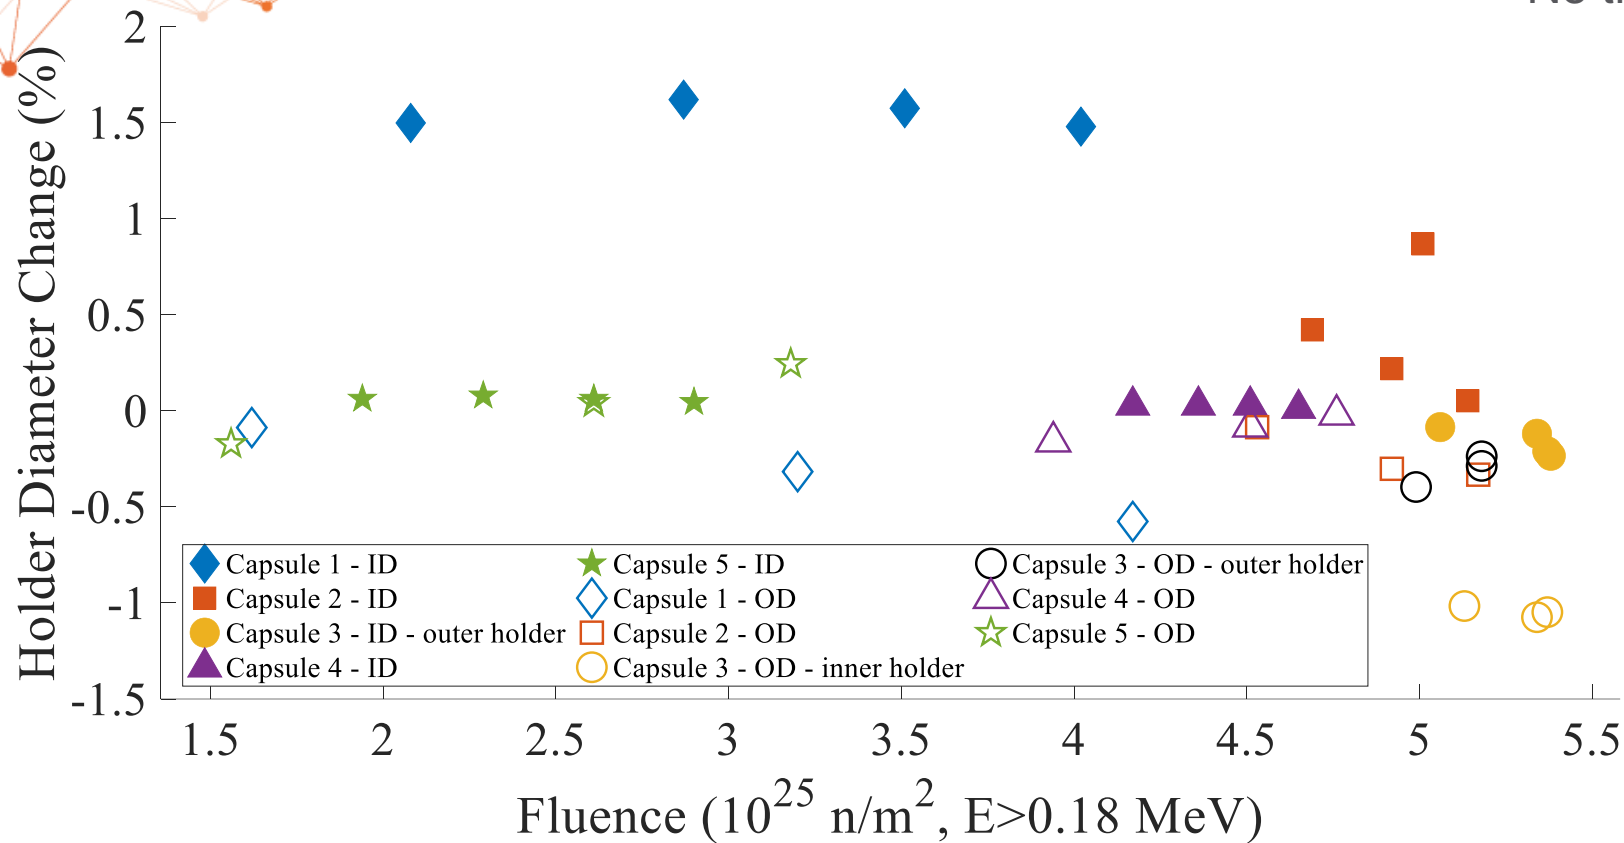
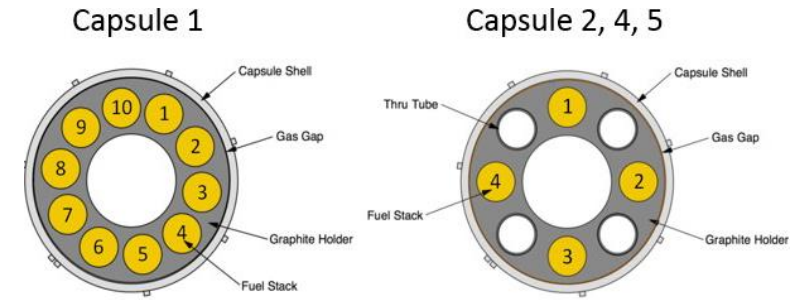
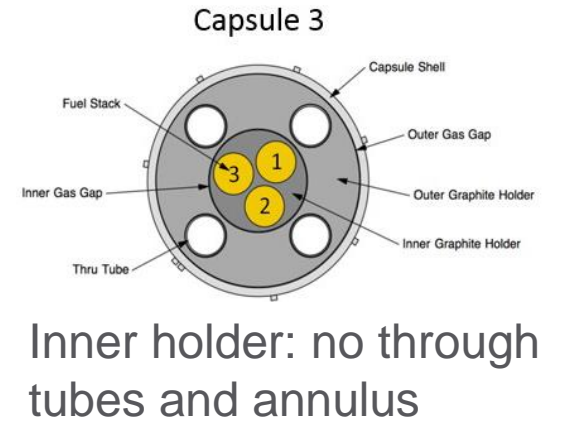
Graphite Holder - Diameter

No through tubes

- The ID and OD changes are not strongly related with the irradiation temperature and fluence.
- The differences in structure and geometry of graphite holders likely have some effect on the dimensional change.
