**Color Photographs
Of The Three Mile Island Unit 2
Reactor Containment Building:
Volume 1—Entries 1, 2, 4, 5, 6**

October 1981

**EG&G Idaho, Inc.
Idaho Falls, Idaho 83415**

This report is a collection of the 308 color photographs taken during the first six entries into the Three Mile Island Unit 2 Reactor Containment Building (July 1980—February 1981). The

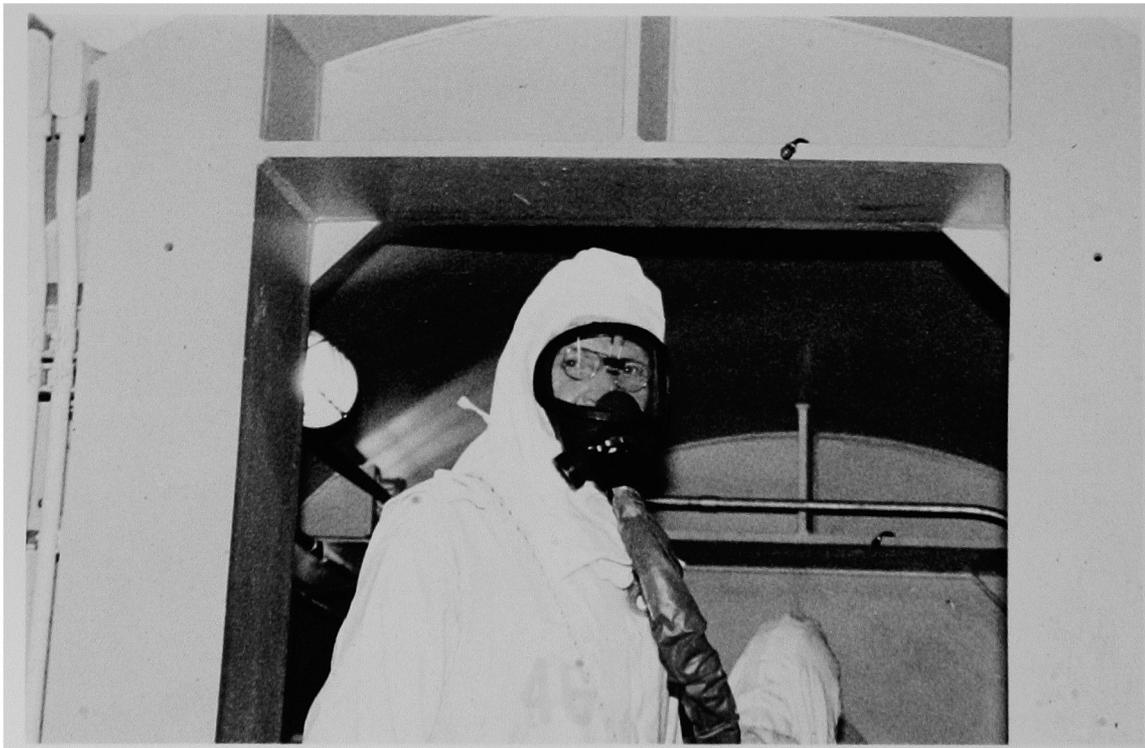
Figure 4 (5B). Technician standing within doorway of personnel air lock 2.

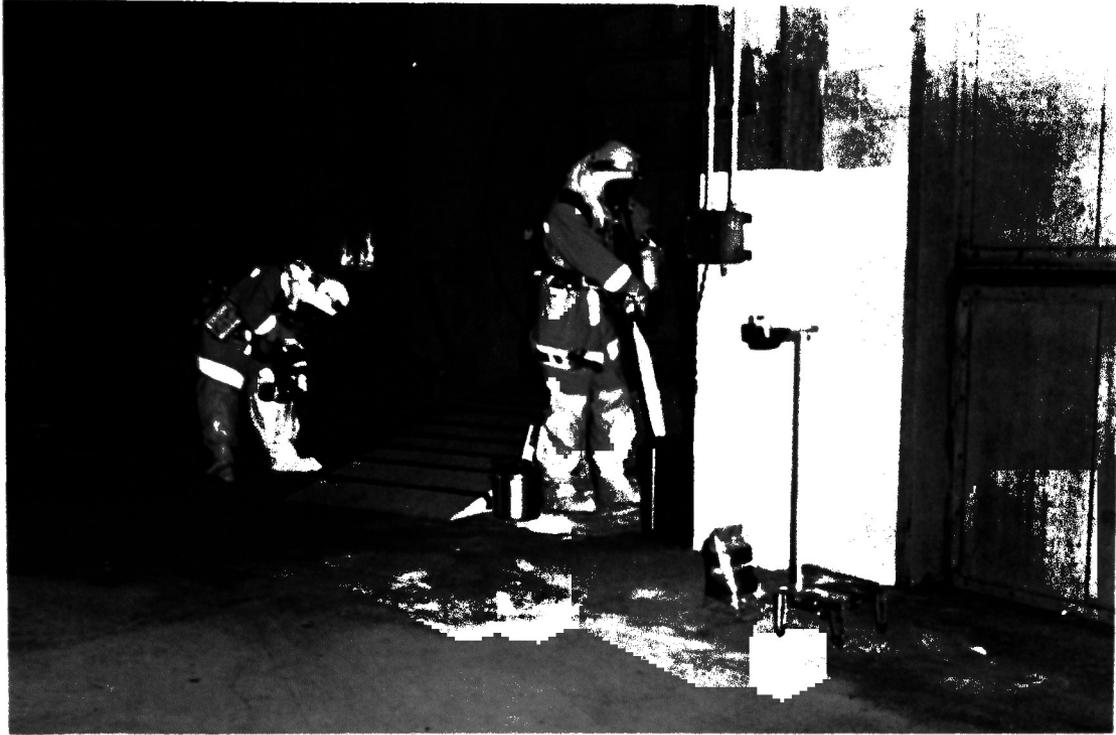
Figure 5 (2A). Technicians setting up decontamination test equipment inside of containment; air lock 2 in background, elevator door right.

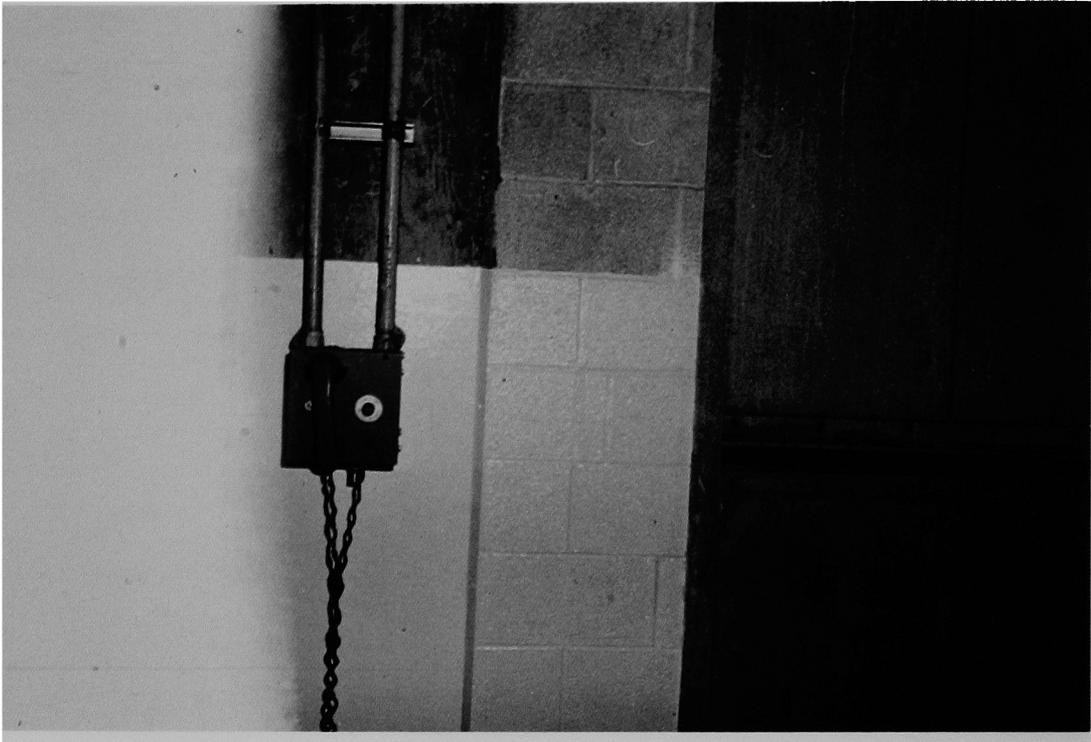
Figure 11 (4A). Surface detail of Gai-tronic phone and elevator door.

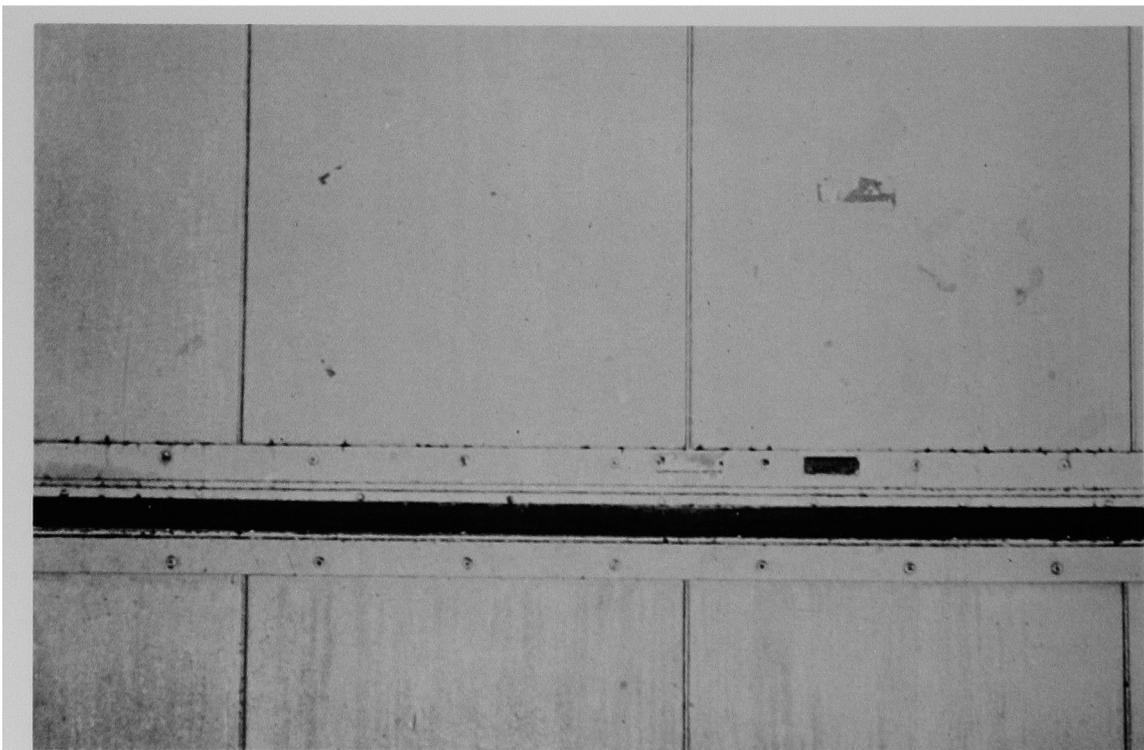
Figure 12 (1A). Close-up of elevator door at elevation 305.

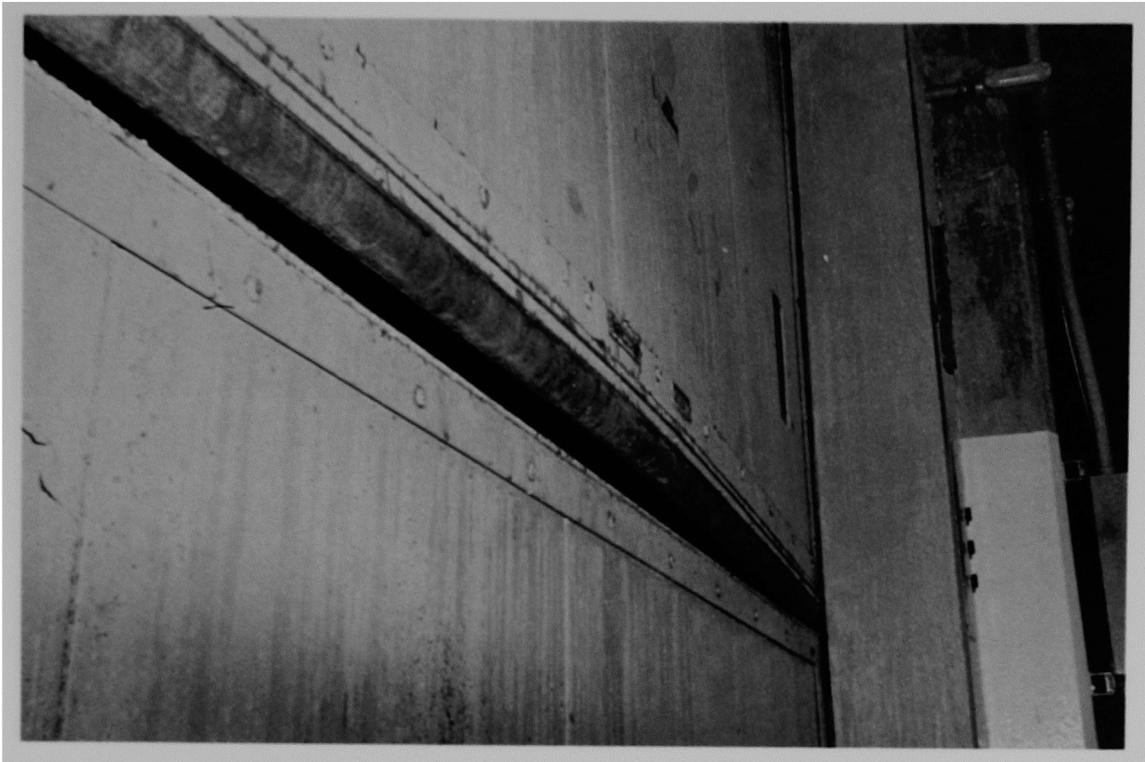
Figure 13 (6A). Close-up of gap in elevator door.

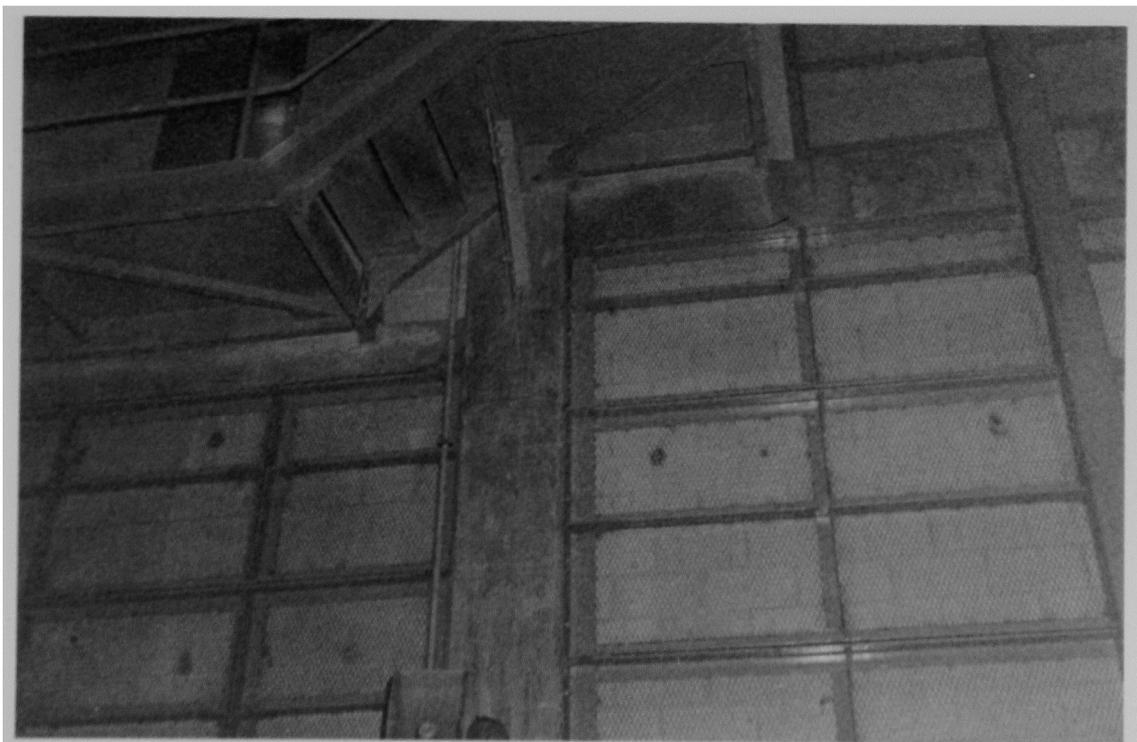
Figure 14 (6A). Platform on the enclosed elevator-stairwell, view up from elevation 305.

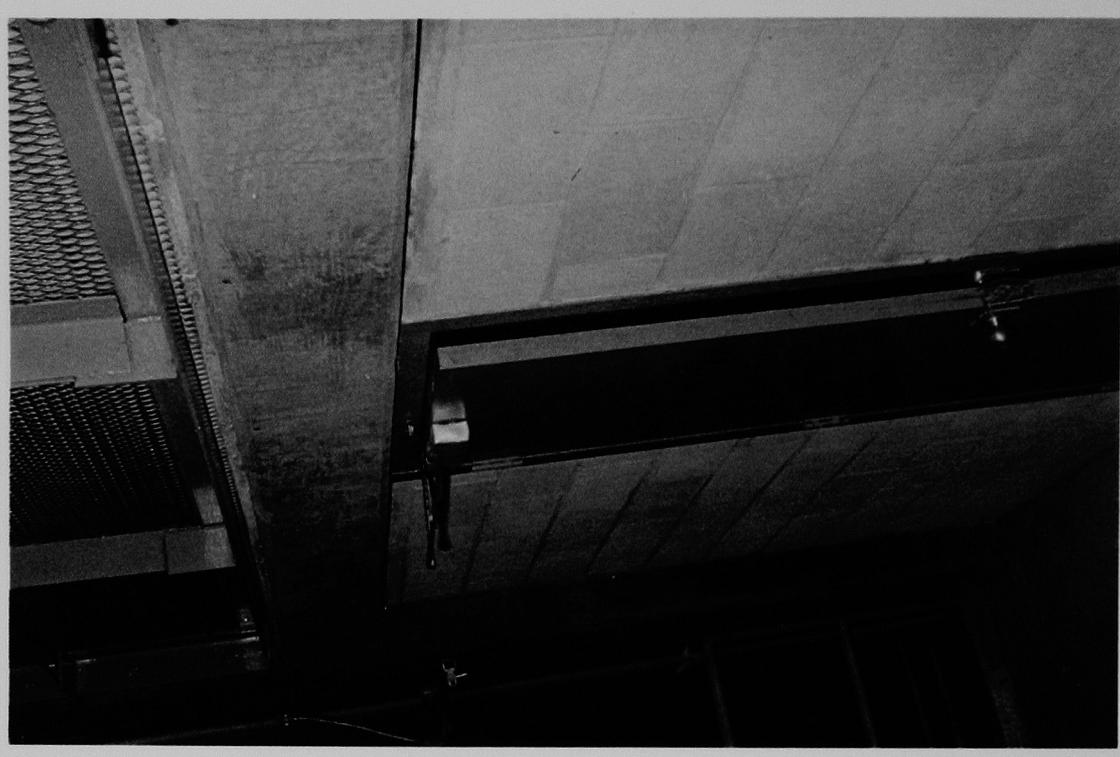
Figure 15 (6A). Door and corner of platform on the enclosed elevator-stairwell (photograph turned sideways).

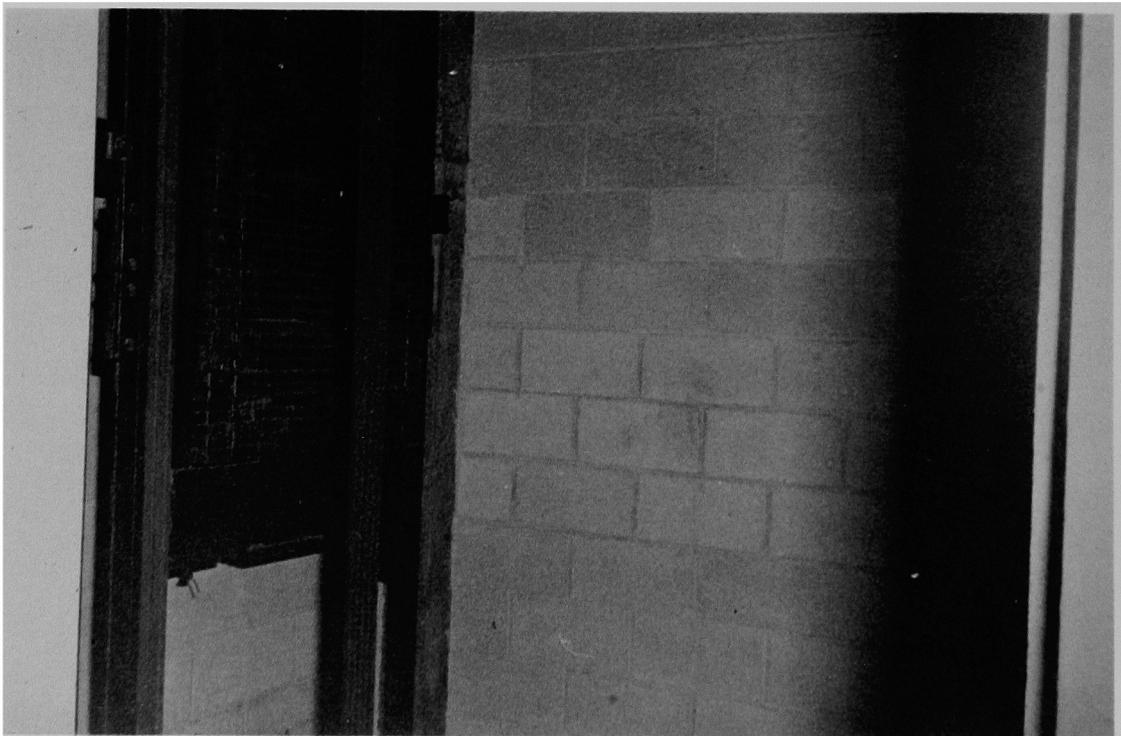
Figure 16 (6A). Inside of the elevator shaft, view through door shown in Figure 15.

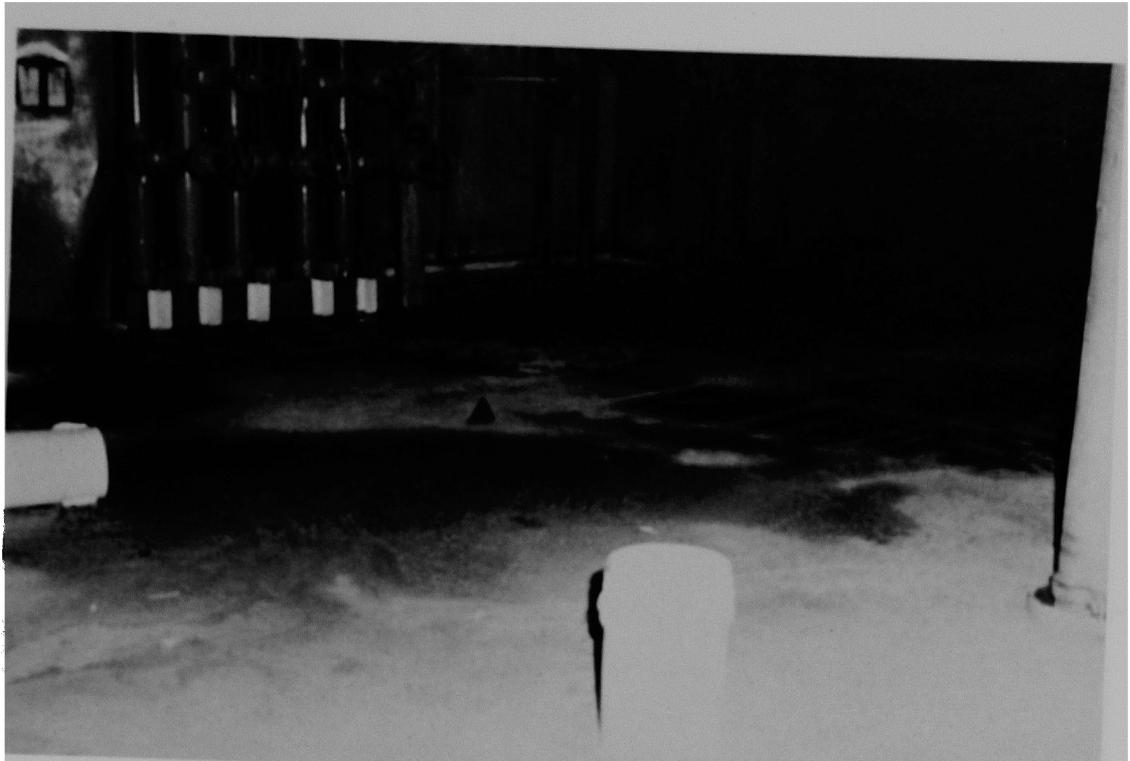
Figure 17 (1A). Floor; covered hatch and air coolers in background.

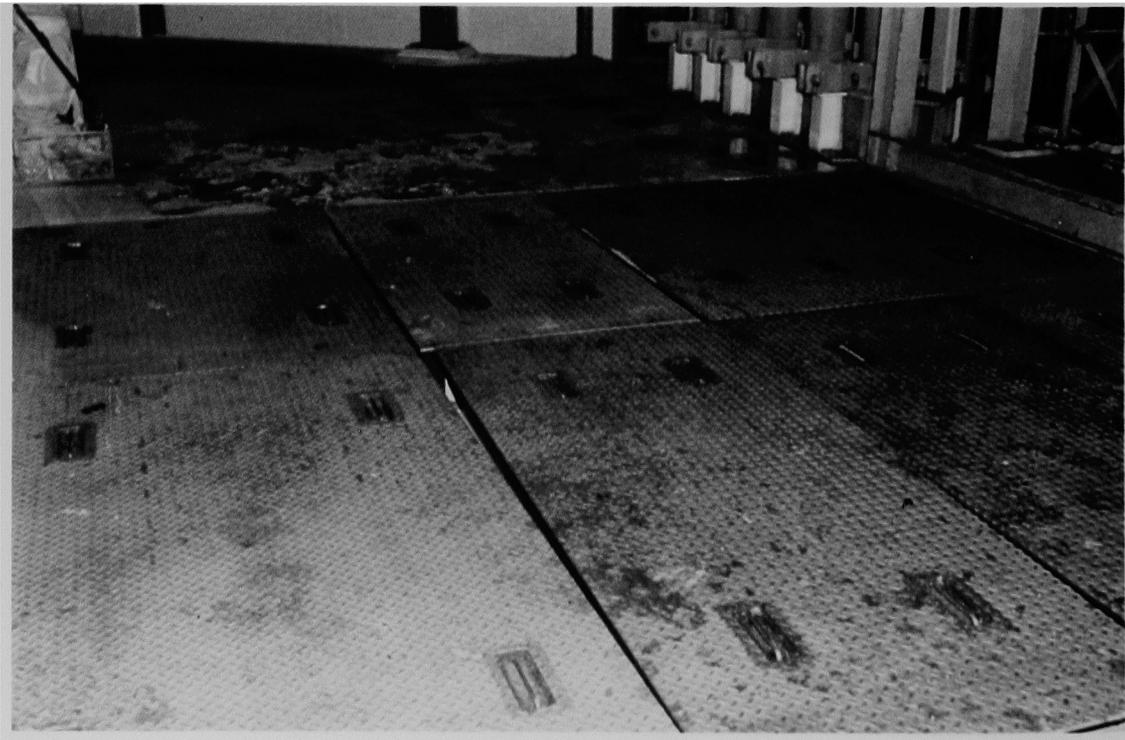
Figure 20 (2A). Covered hatch; air coolers right.

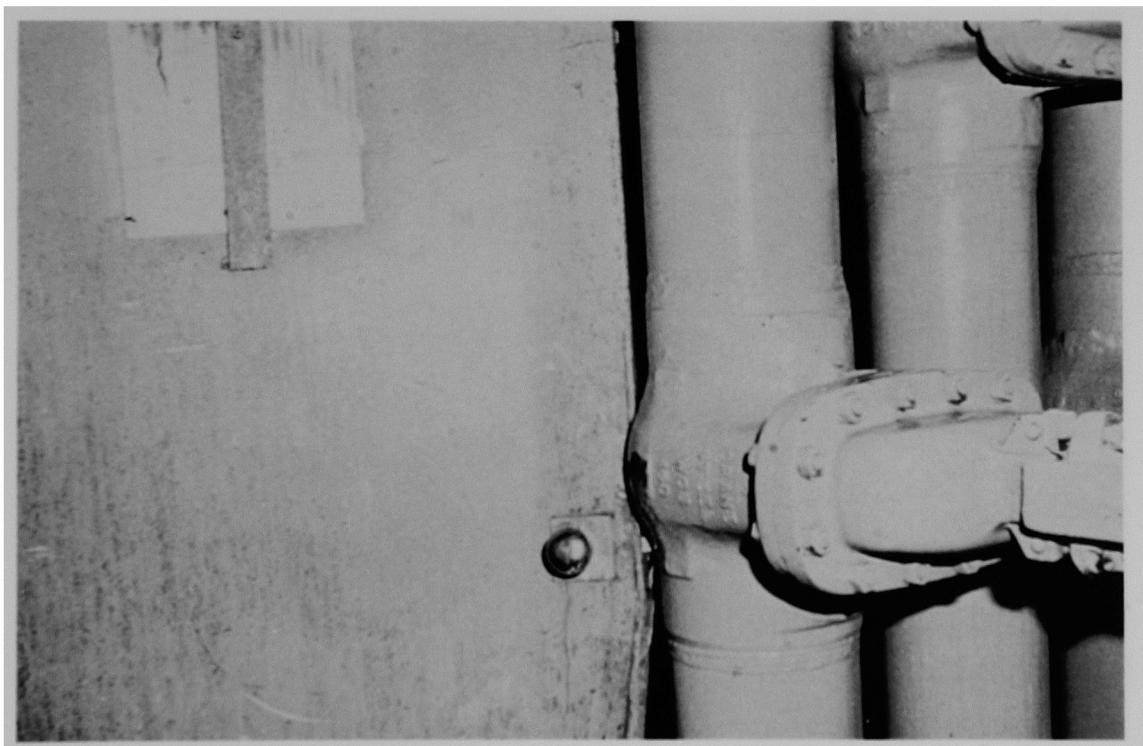
Figure 26 (1A). Close view of door to enclosed stairwell and river water piping to air cooling assembly.

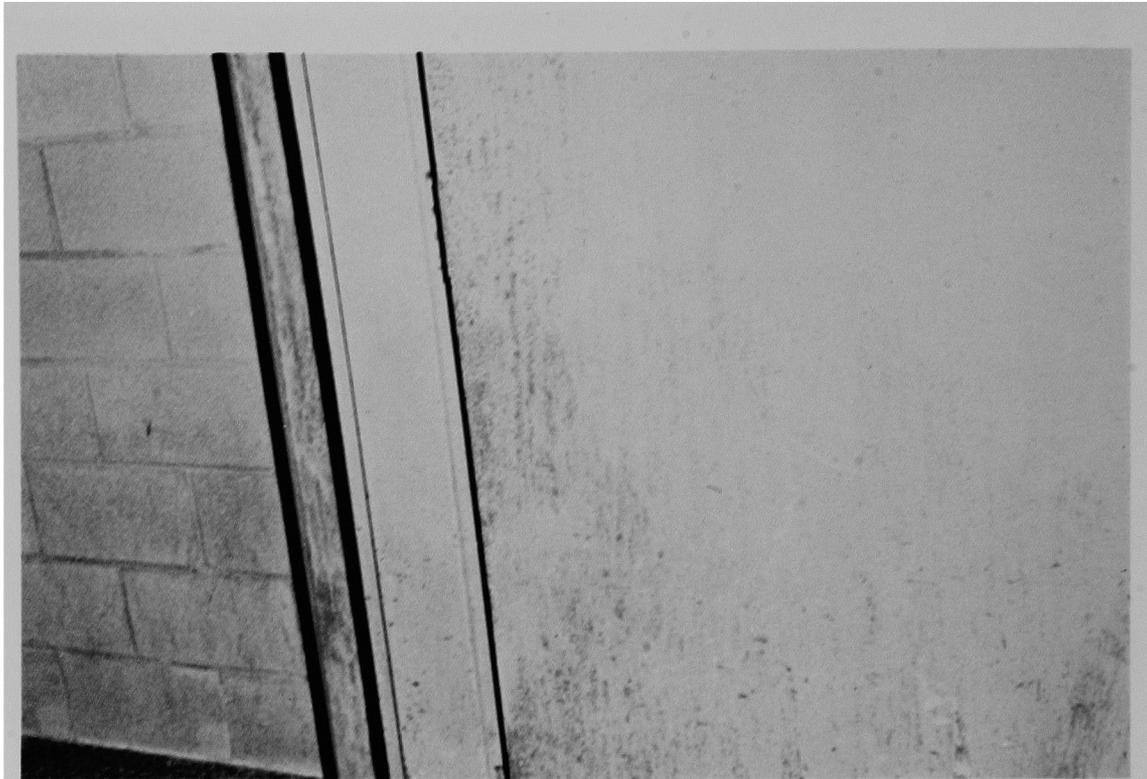
Figure 27 (1A). Surface of door to enclosed stairway.

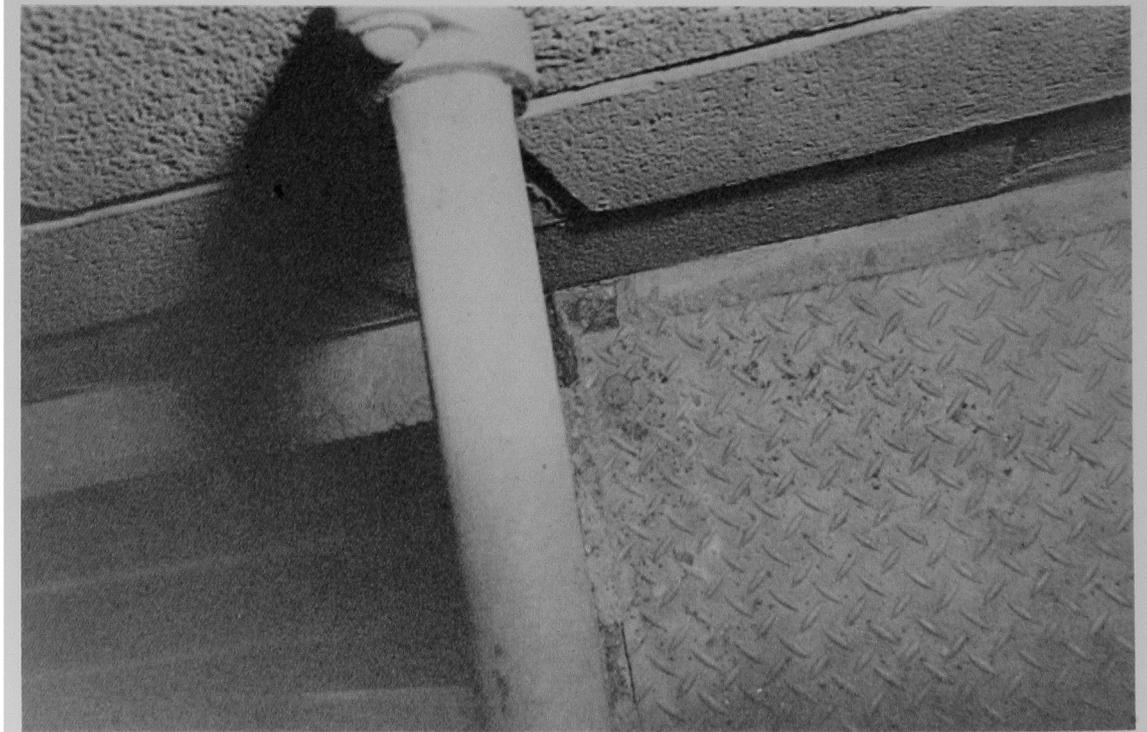
Figure 29 (6A). Close-up of landing within the enclosed stairwell.

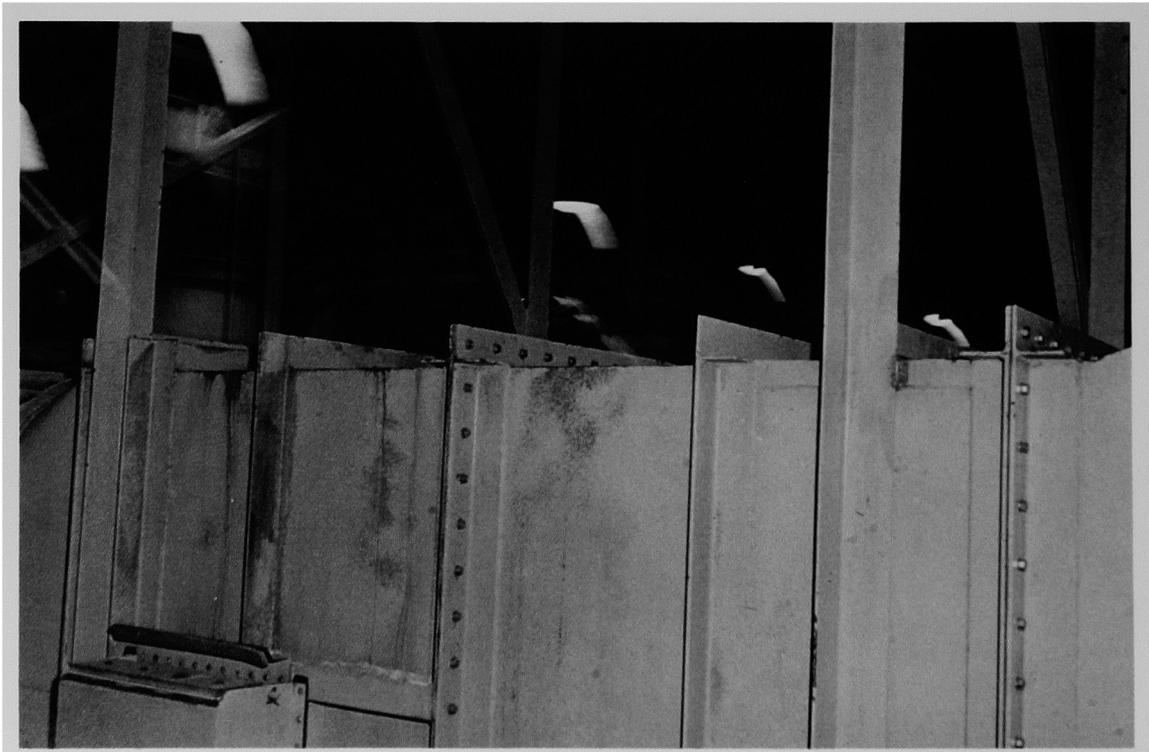
Figure 32 (6A). Portion of top section of the air coolers, view from platform on enclosed stairwell.

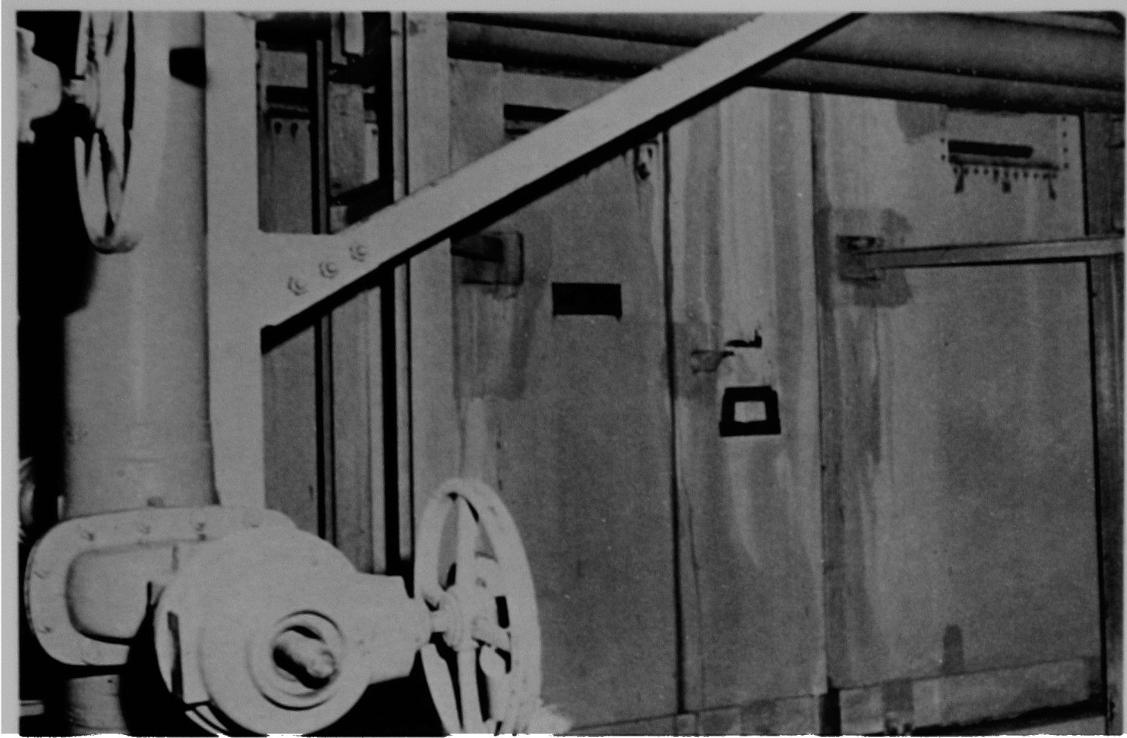
Figure 33 (1A). East units of air cooling assembly; river water piping at left.

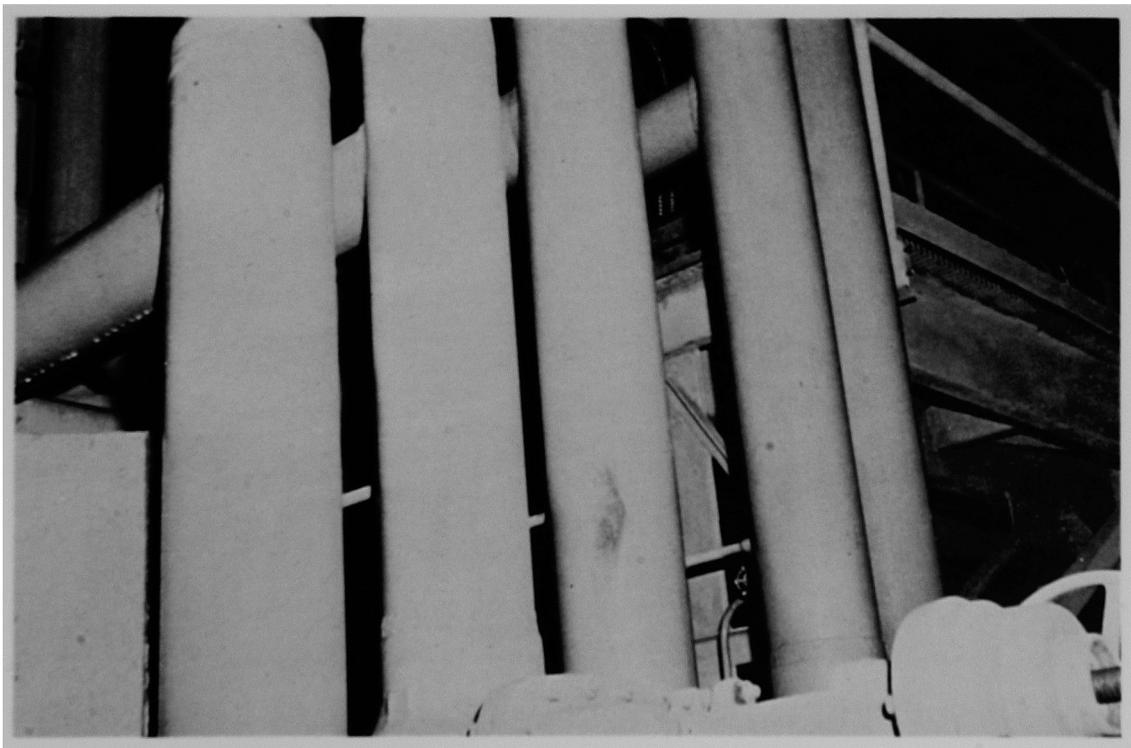
Figure 34 (1A). Close-up of river water piping associated with air coolers.

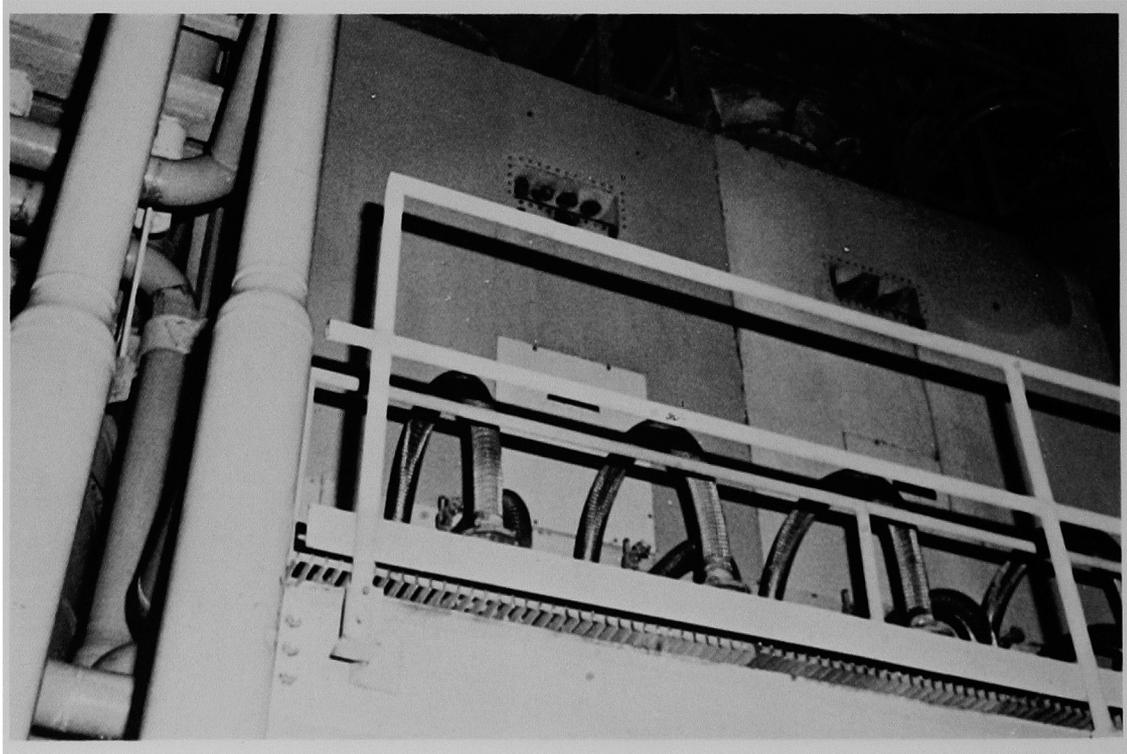
Figure 36 (1A). Upper east end of air cooling assembly.

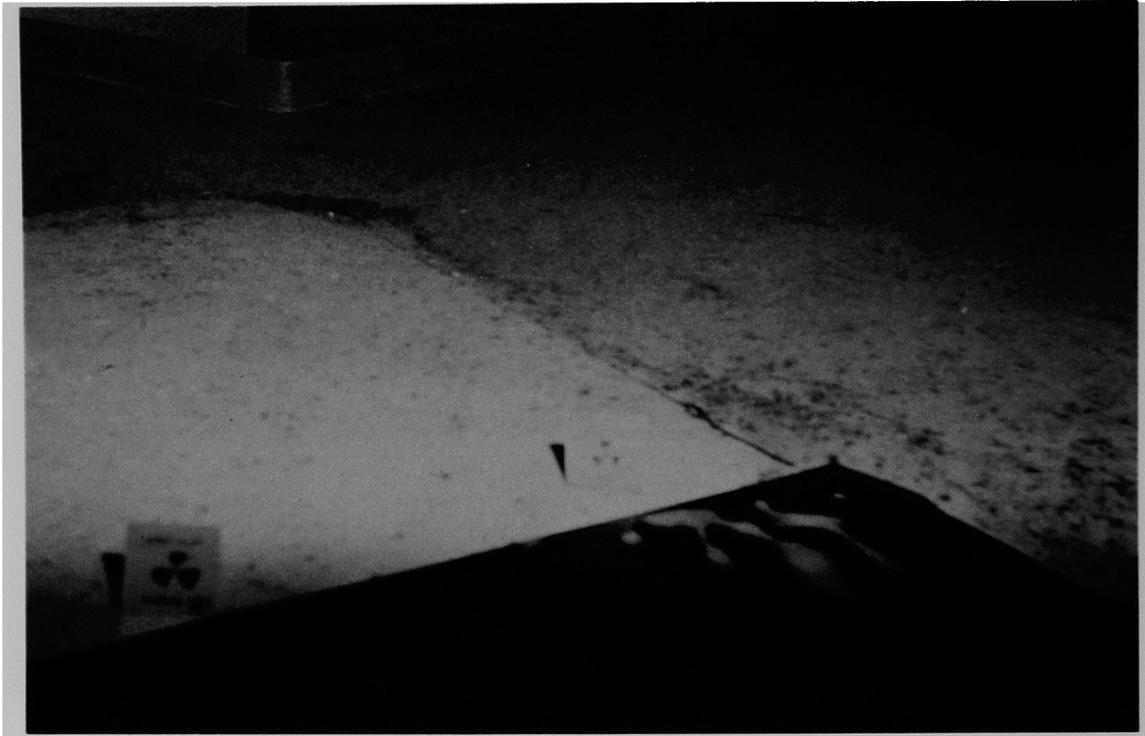
Figure 39 (4A). Floor area for decontamination test (black matting in foreground used for beta shielding).

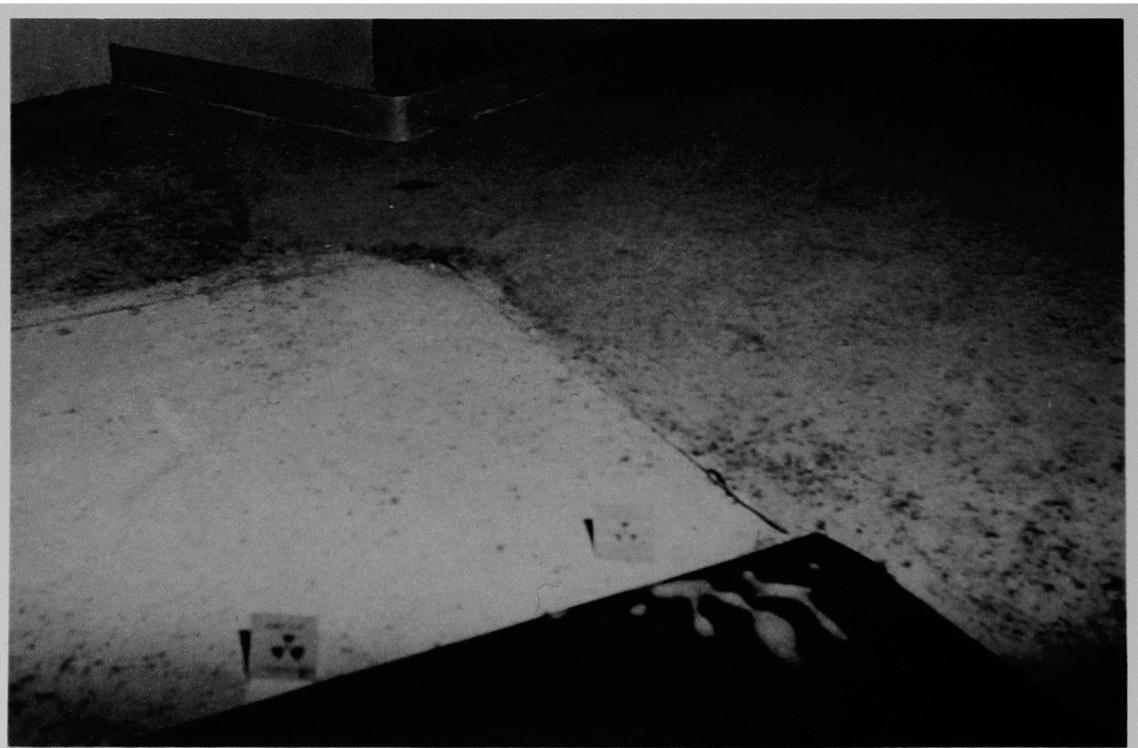
Figure 40 (4A). Floor area for decontamination test, second view.

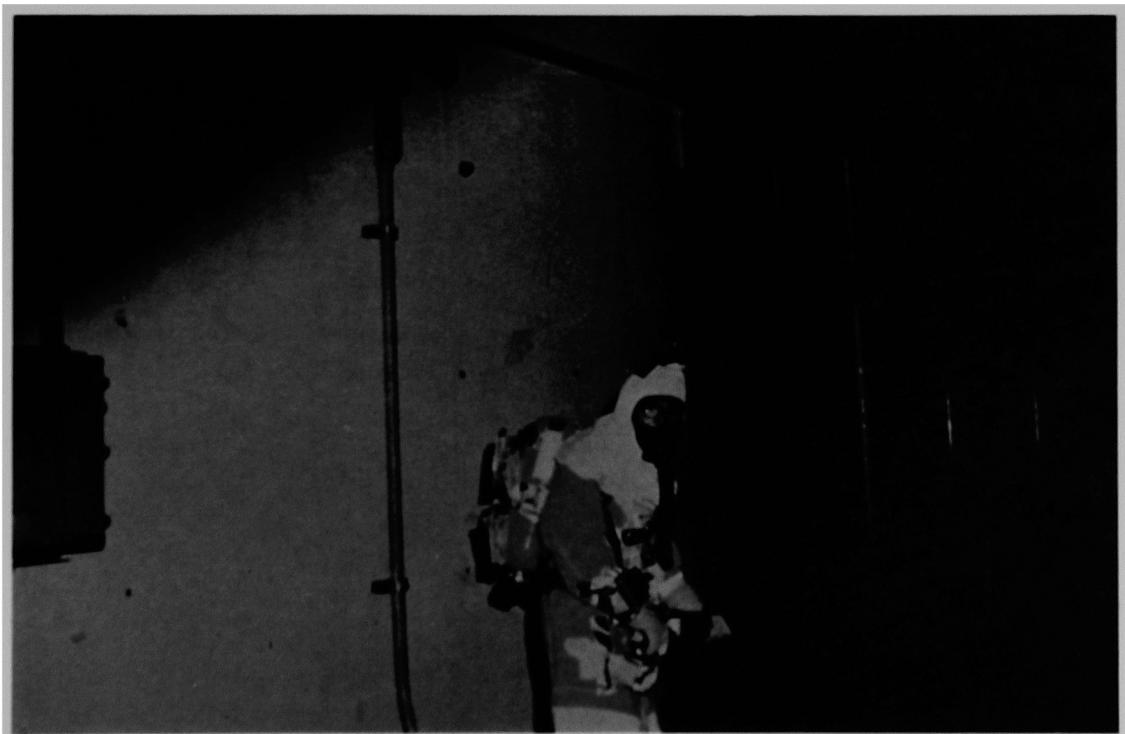
Figure 42 (1A). Technician in first-entry protective clothing holding teletector; D-ring in background, corner of enclosed elevator/stairwell right edge of photograph.

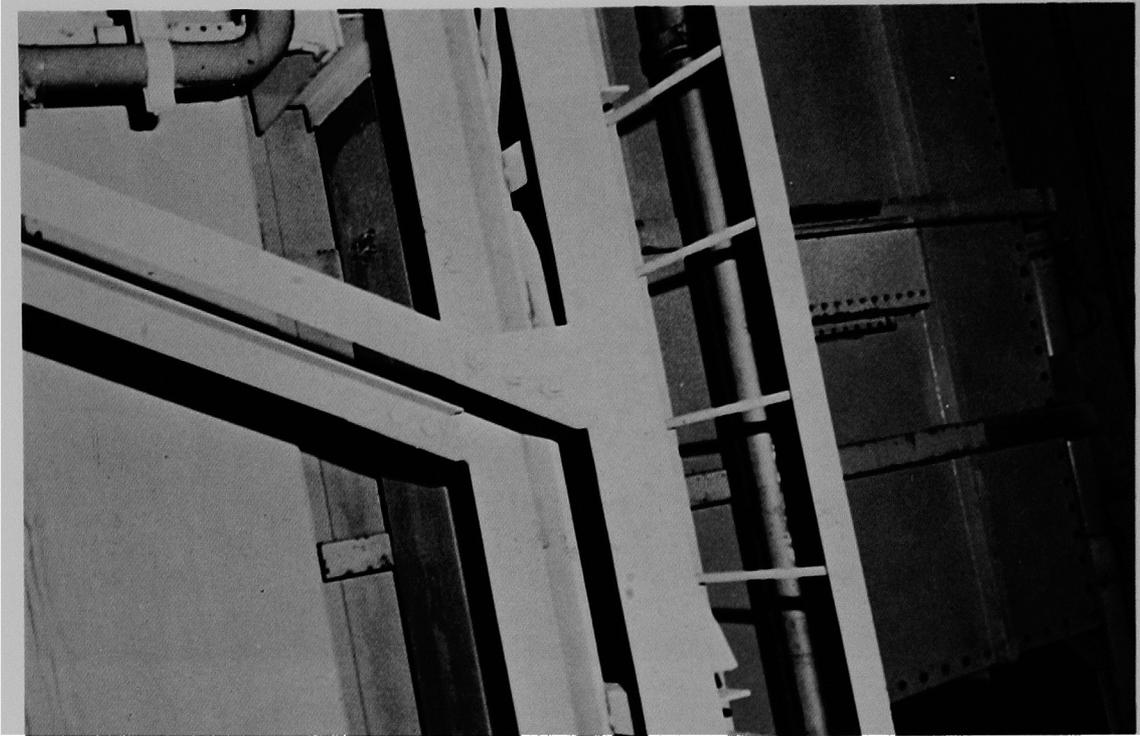
Figure 46 (1A). Brace and ladder at west end of air cooling assembly.

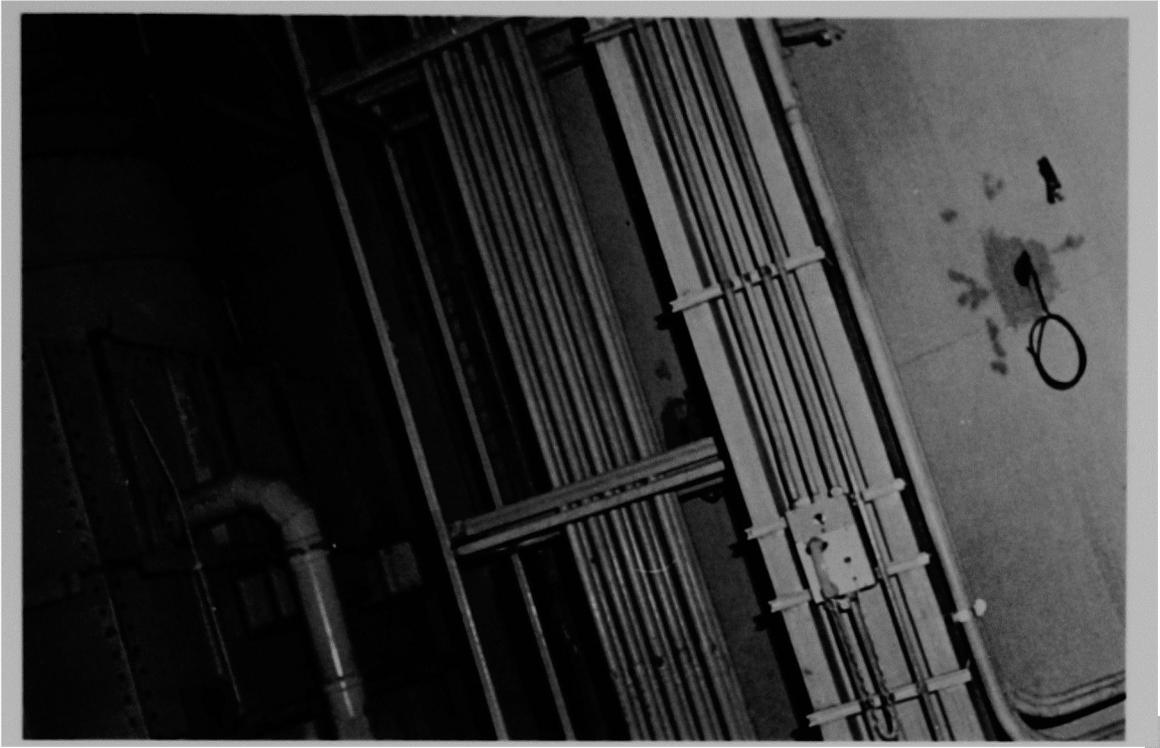
Figure 48 (1A). Conduit runs, plenum at west end of air cooling assembly left.

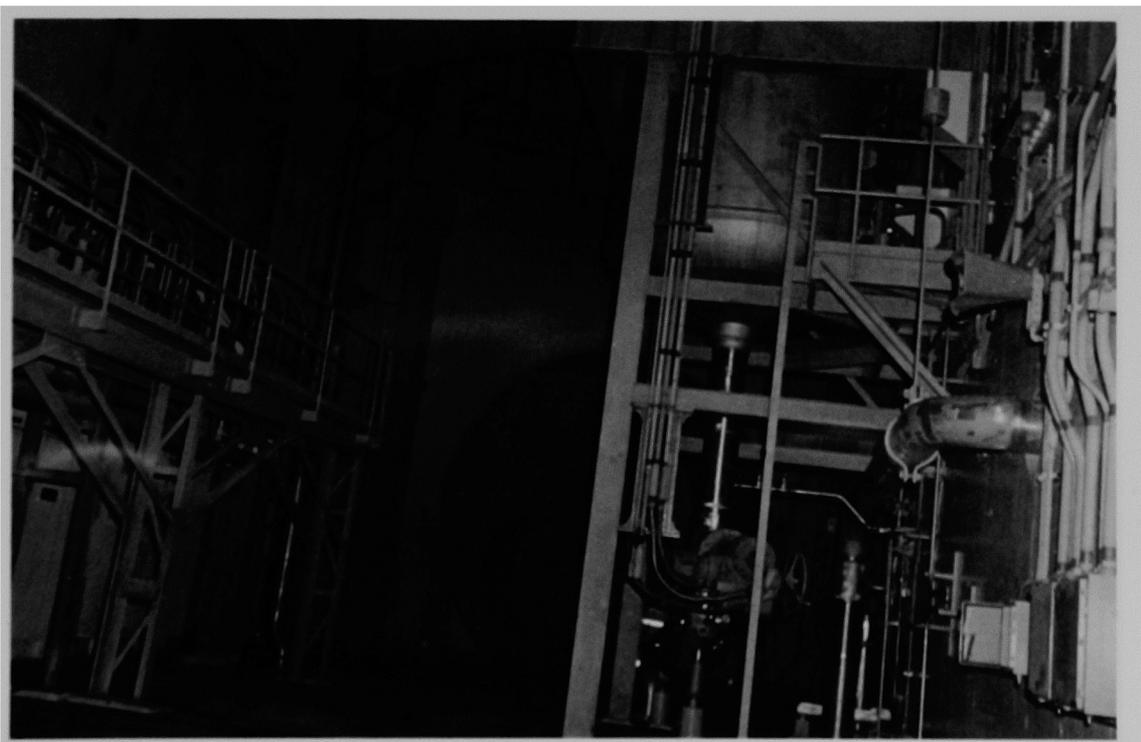
Figure 49 (2A). From left: air coolers, personnel air lock 1 within equipment hatch, core flood tank B, D-ring wall.

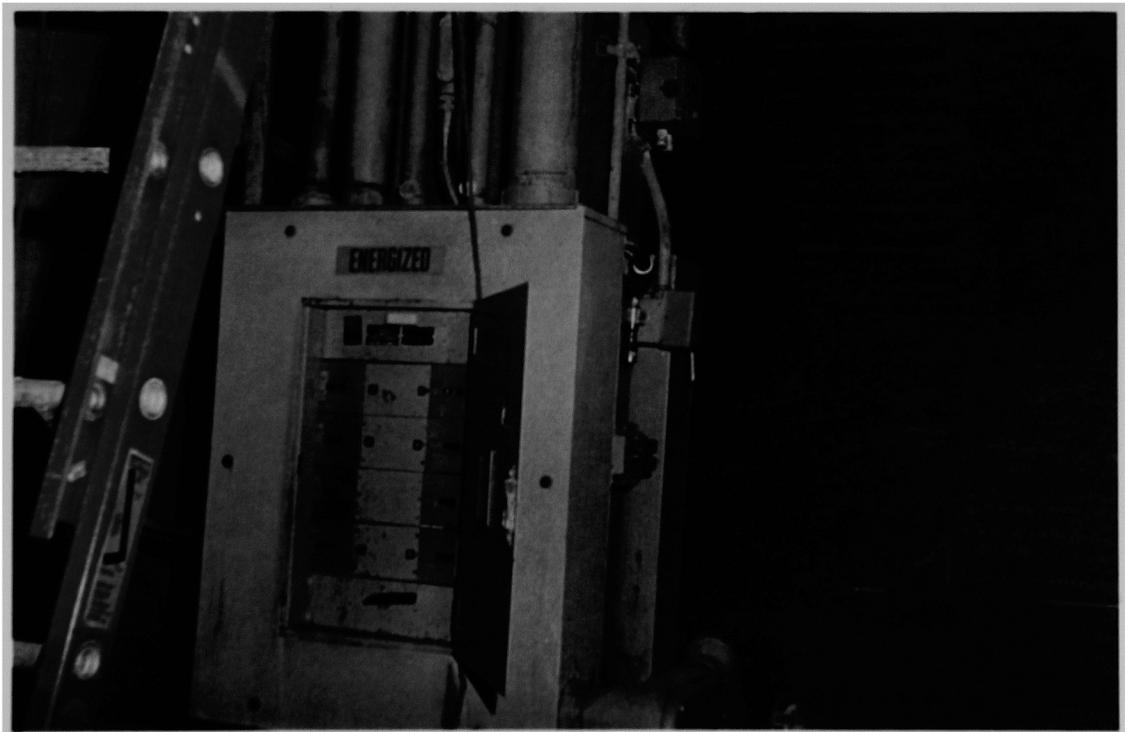
Figure 53 (2A). Power panel on I beam; open stairway in background.

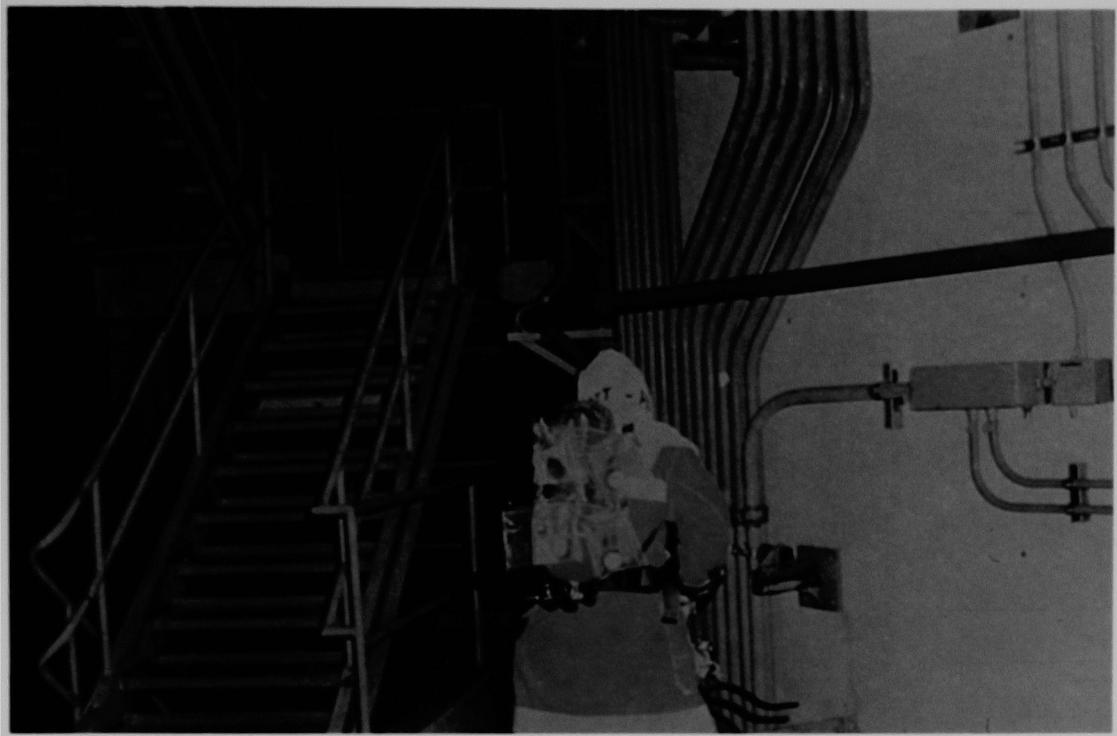
Figure 56 (1A). Open stairway, HP technician taking radiation surveys.

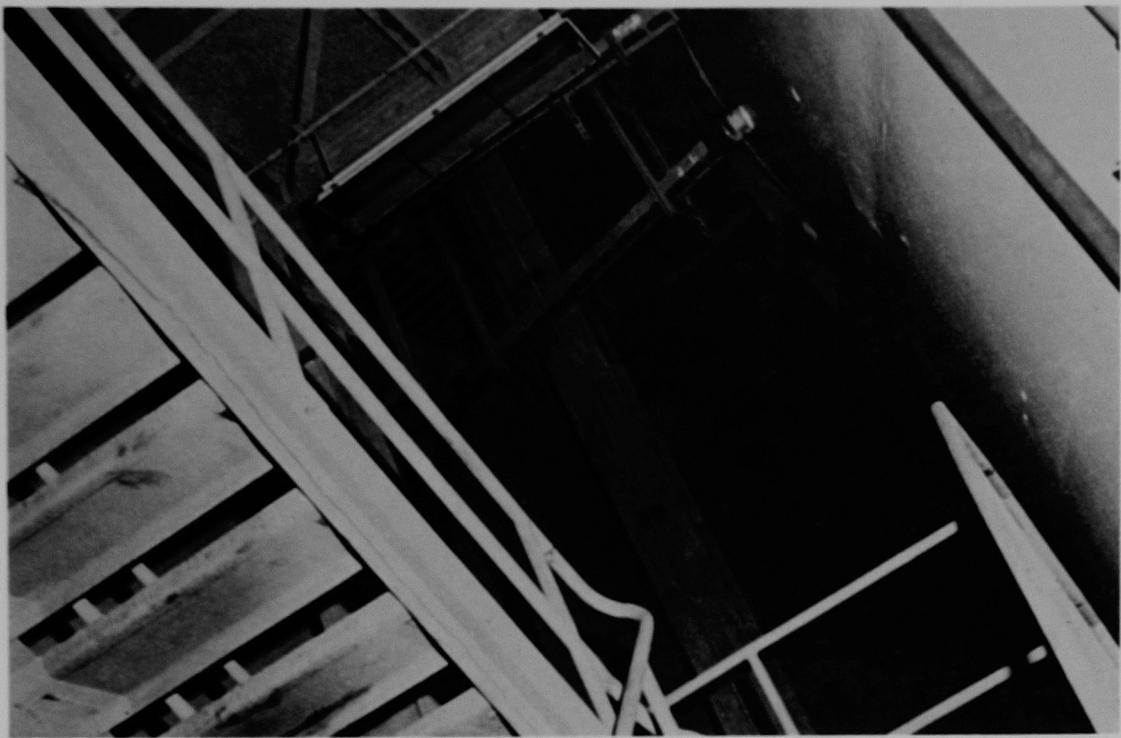
Figure 66 (1A). View up open stairway.
