**Color Photographs
Of The Three Mile Island Unit 2
Reactor Containment Building:
Volume 1—Entries 1, 2, 4, 5, 6**

October 1981

**EG&G Idaho, Inc.
Idaho Falls, Idaho 83415**

This report is a collection of the 308 color photographs taken during the first six entries into the Three Mile Island Unit 2 Reactor Containment Building (July 1980—February 1981). The

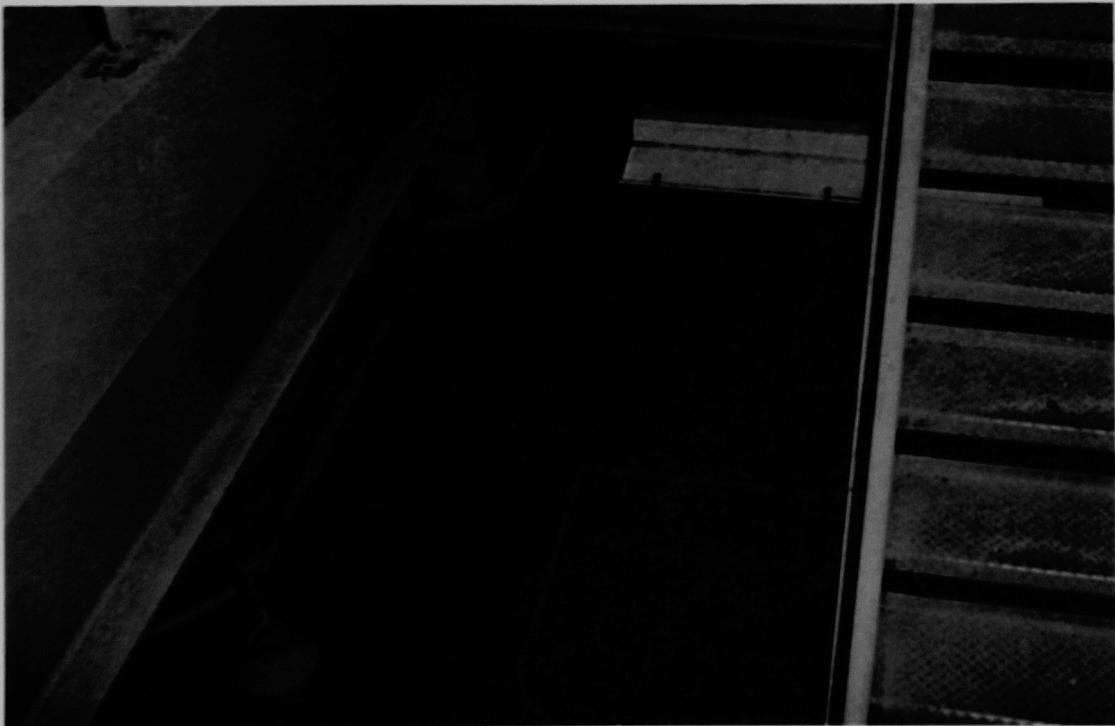
Figure 67 (2A). Steep-angle view down open stairway to water in basement. Note that the water level appears to be 1 to 2 inches above the lower landing.

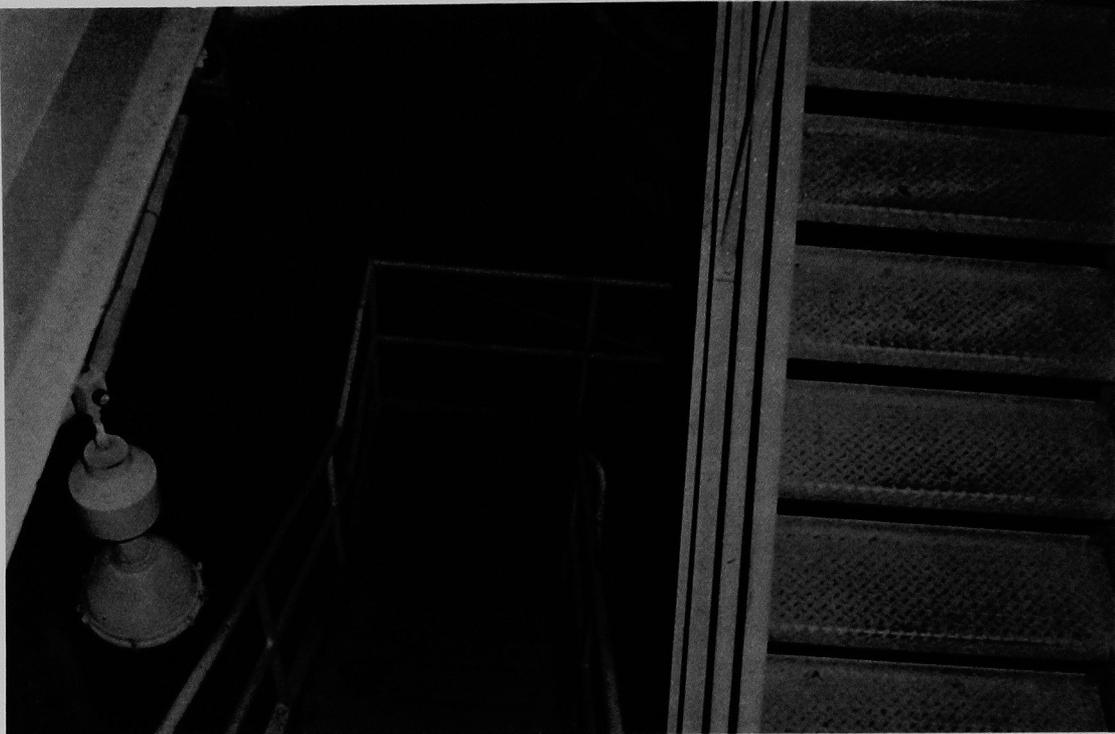
Figure 68 (2A). View down open stairway to water in basement. Note that the water appears to be 1 to 2 inches above the lower landing.

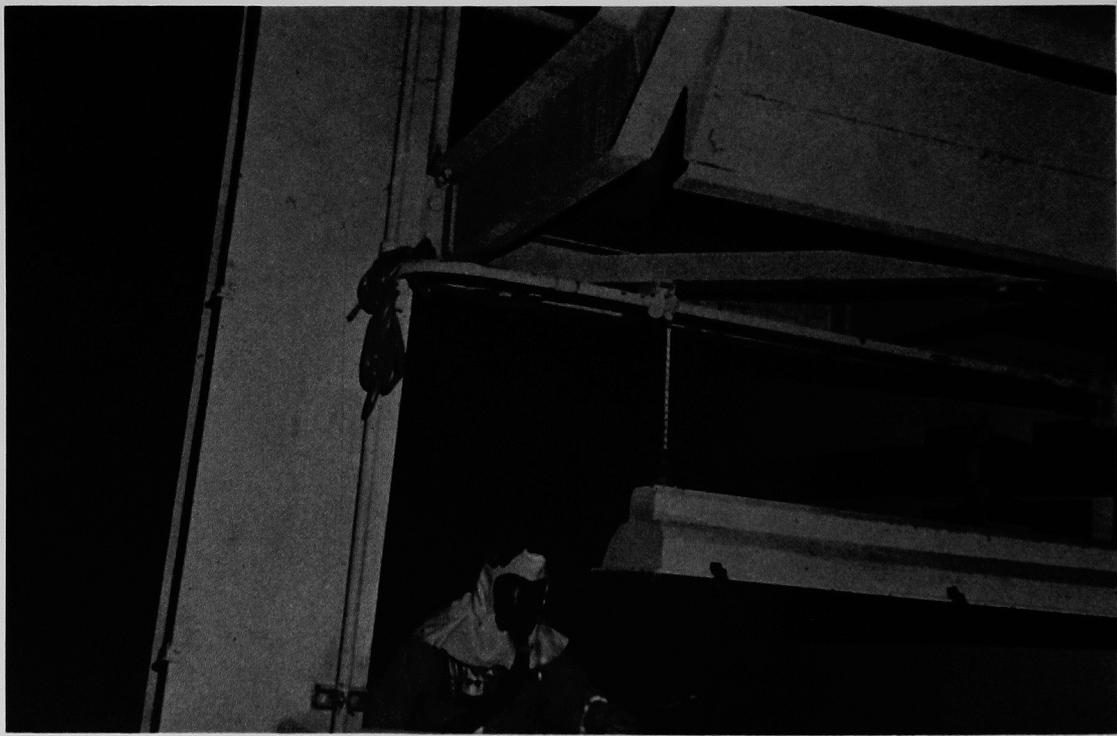
Figure 69 (2A). Northeast view through open stairway to D-ring, HP technician taking radiation survey.

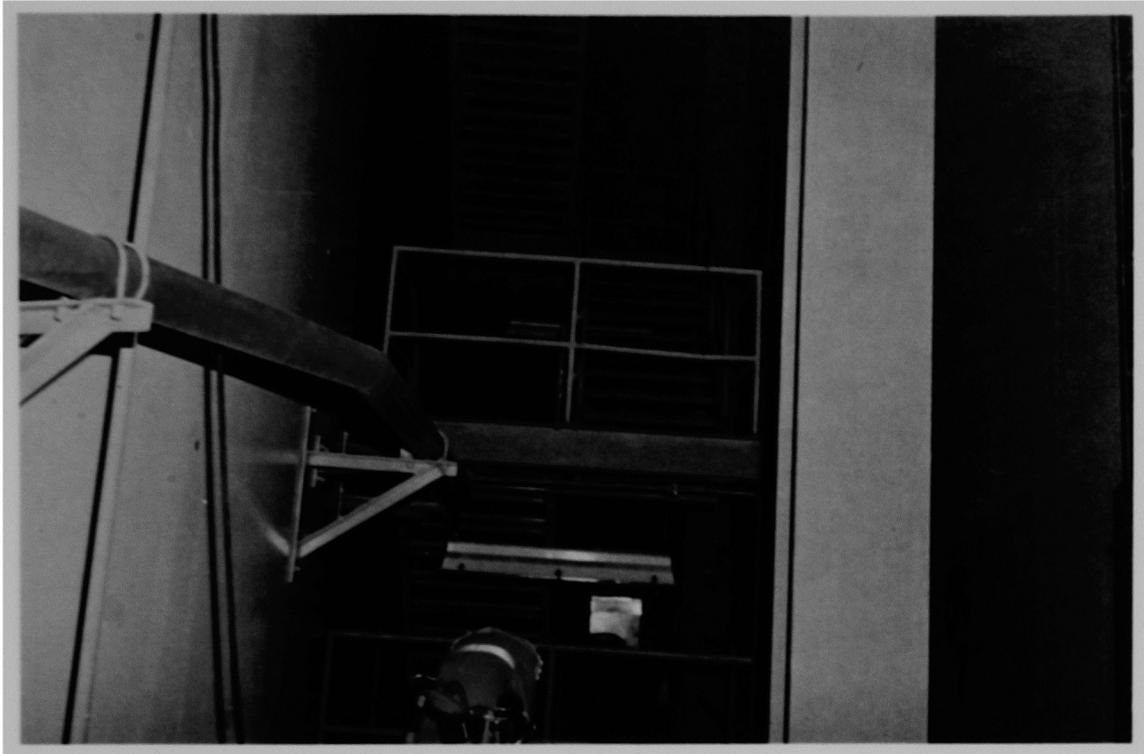
Figure 70 (2A). South view to open stairway, HP technician taking radiation survey.

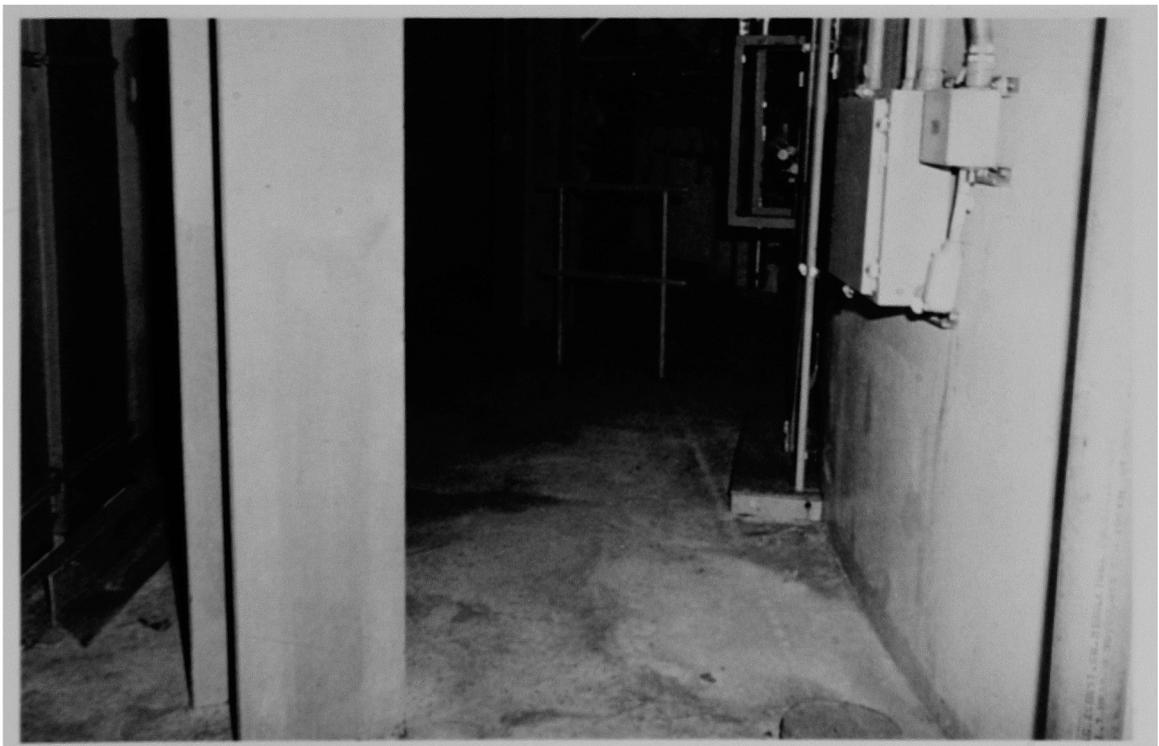
Figure 71 (5A). Northeast view taken north of open stairway; wall shielding incore instrumentation cable chase in background.

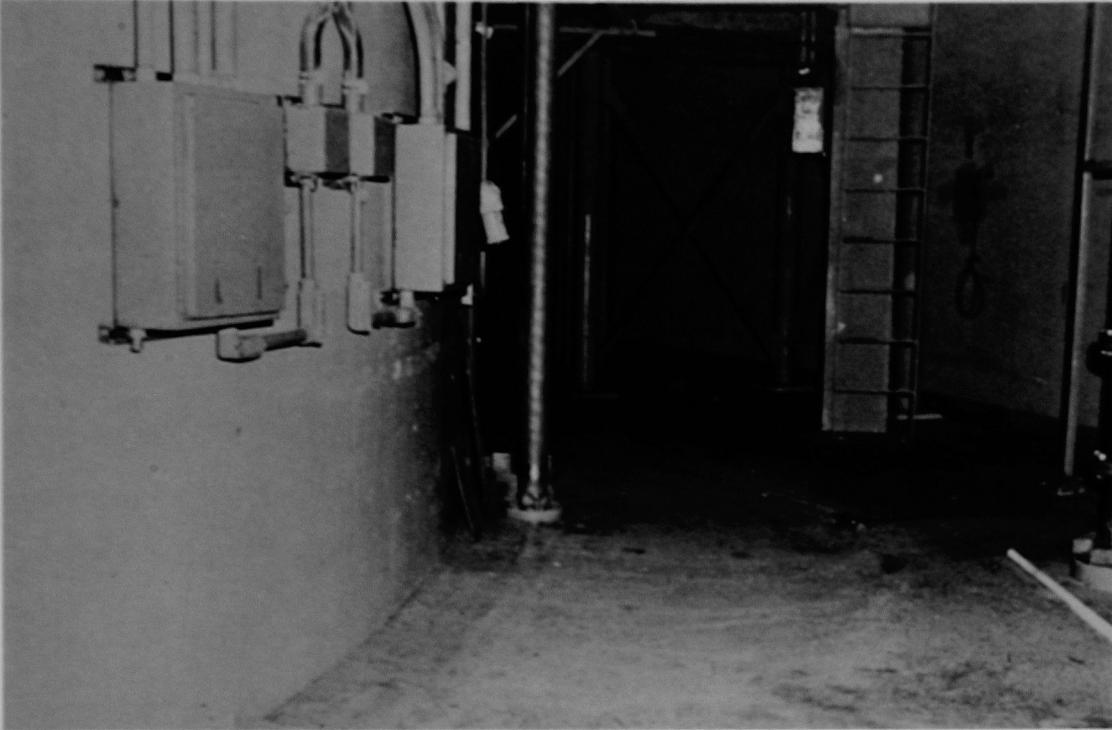
Figure 74 (1A). General view of flow area within quadrant 4 north of personnel airlock 2.

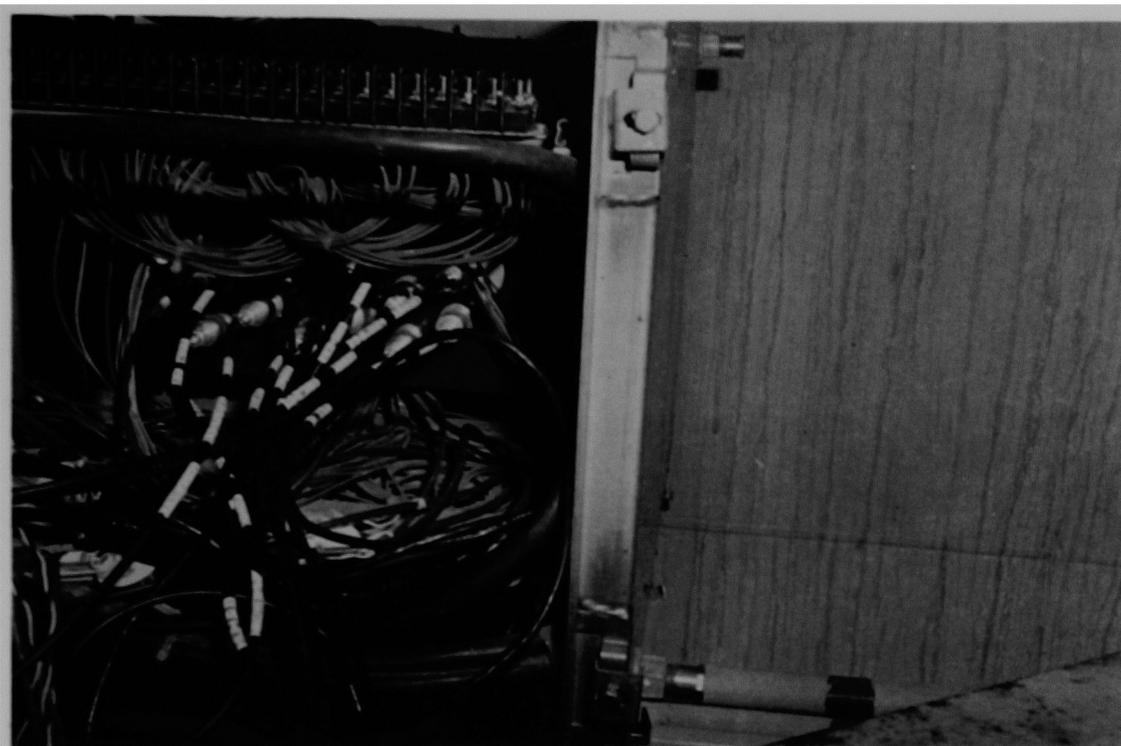
Figure 78 (6A). Right frontside of electrical penetration R-507 (cf. Figure 77).

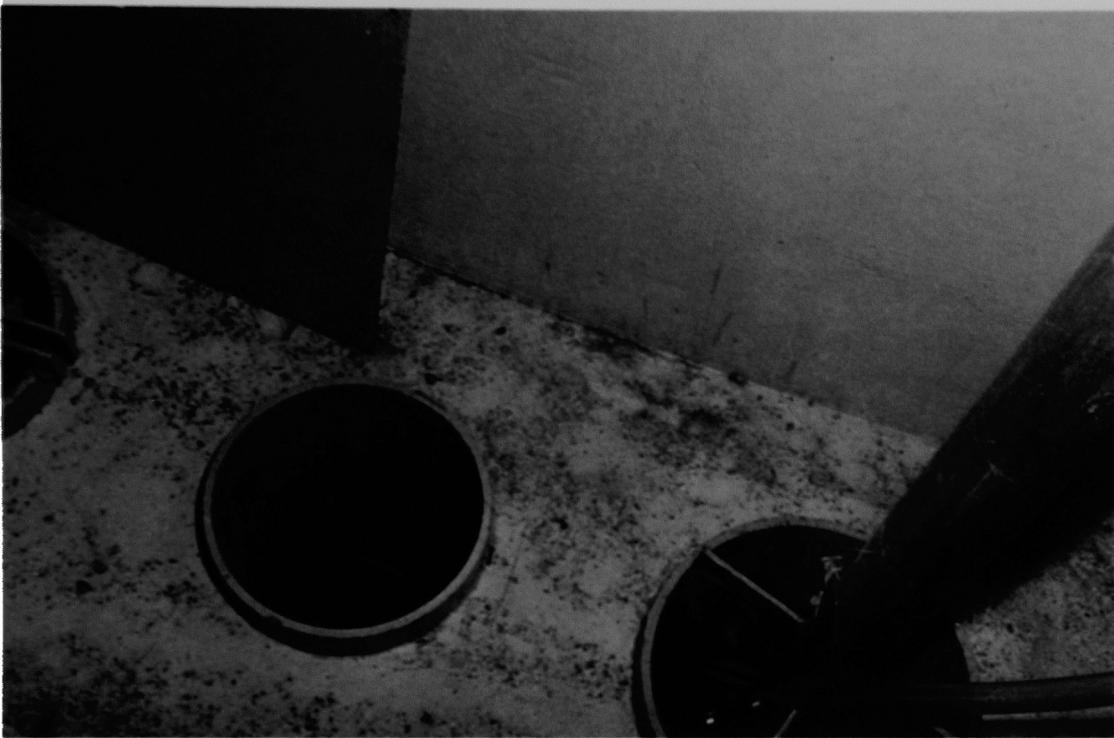
Figure 82 (6A). Floor penetrations 211 and 212 (cf. Figure 81).

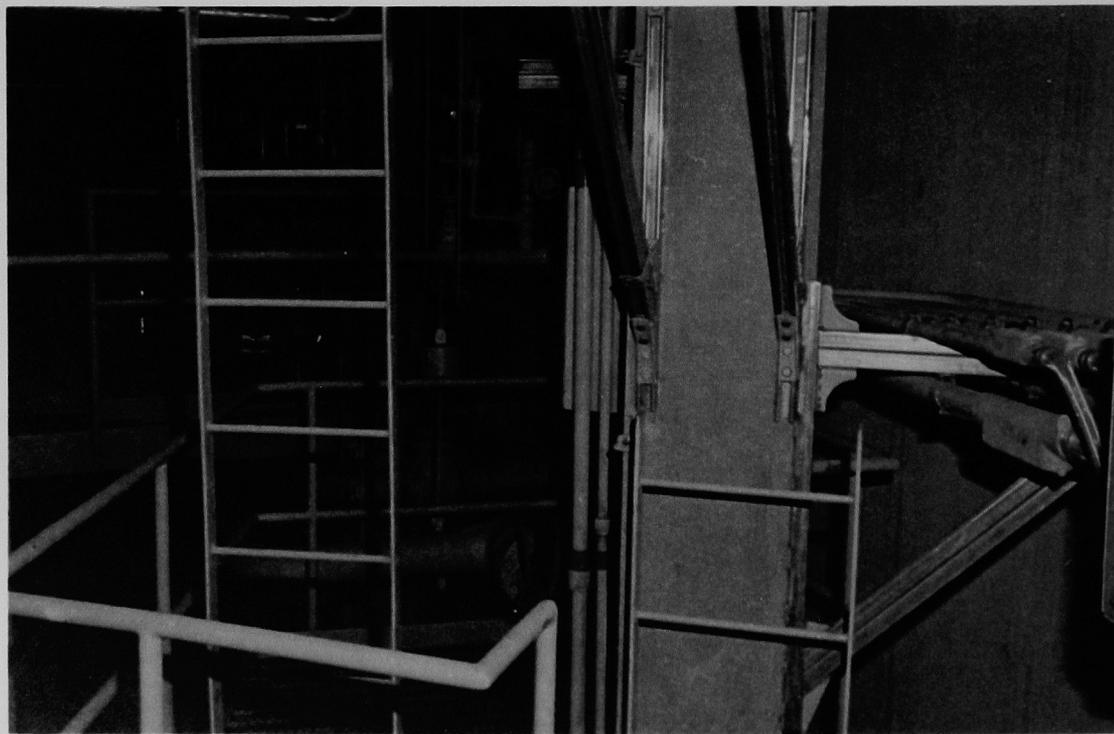
Figure 85 (6A). View north from scaffolding erected at overhead piping, near core flood tank A.

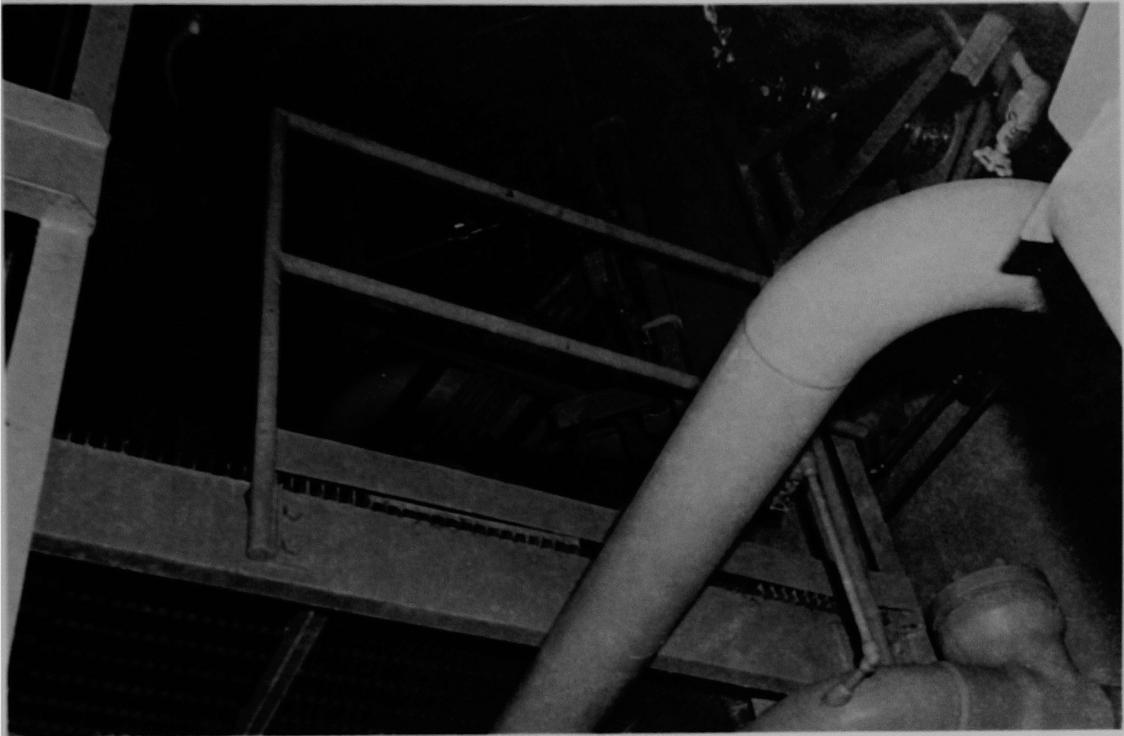
Figure 86 (6A). View up to the overhead piping, grating, and cables near core flood tank A.

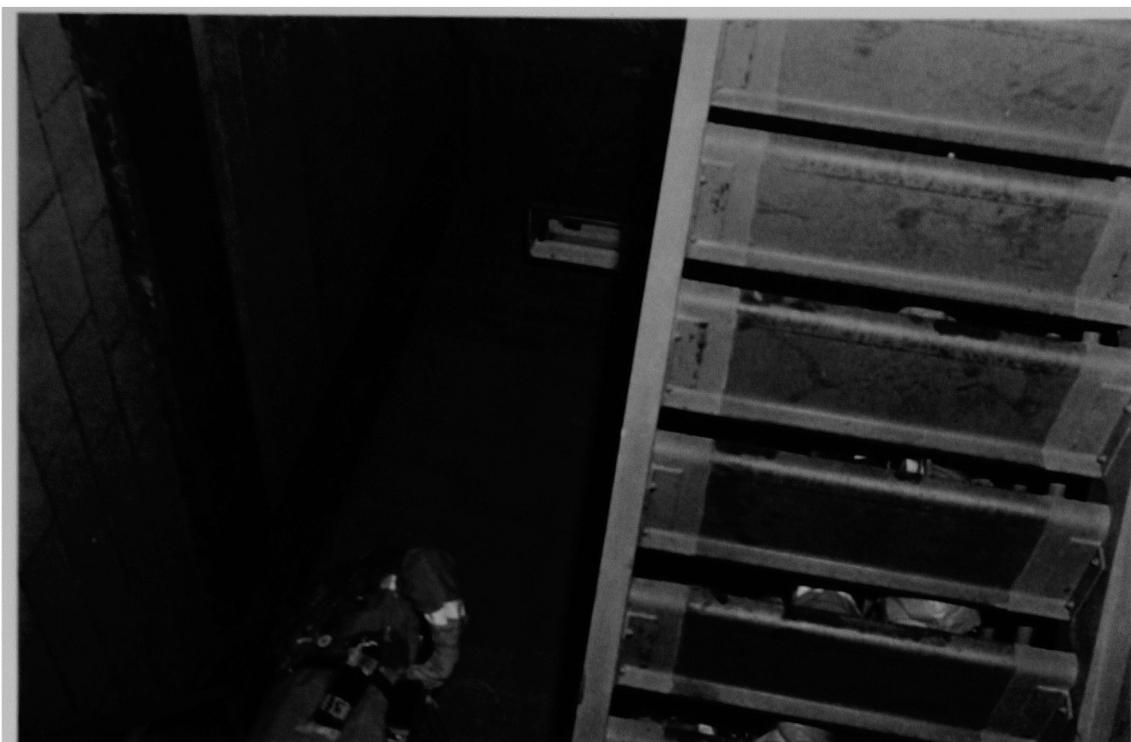
Figure 93 (2A). Ascent up the enclosed stairway.

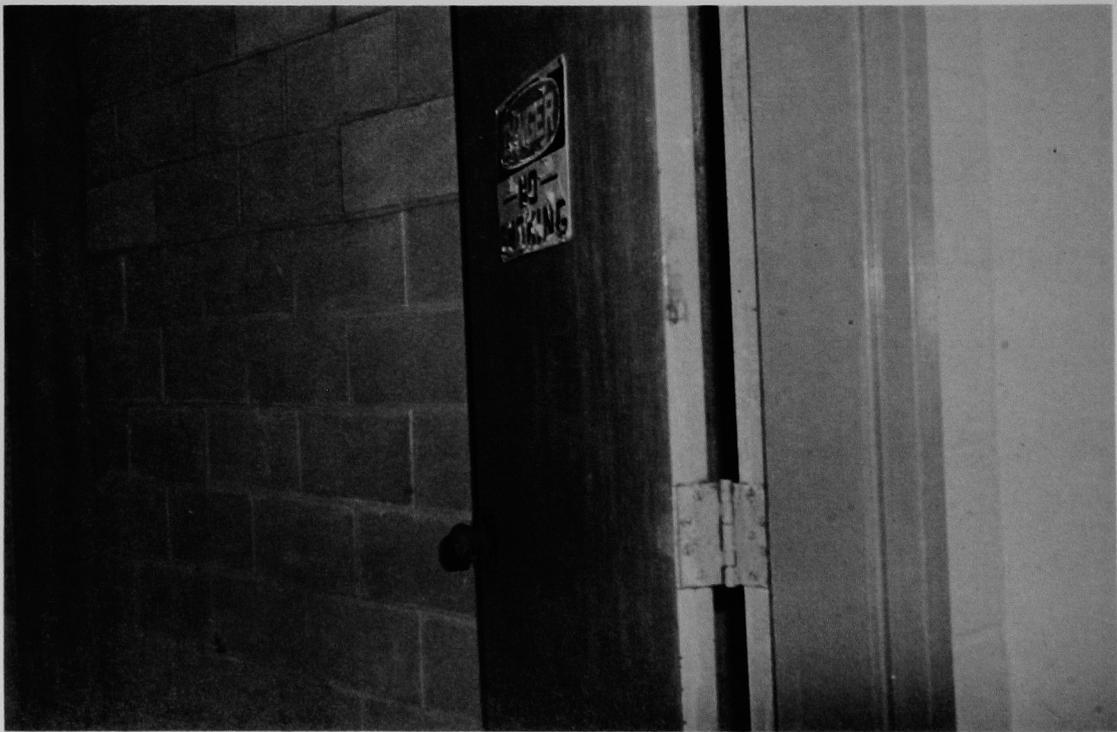
Figure 96 (2A). Door to enclosed stairwell, elevation 347 (closed before entry).

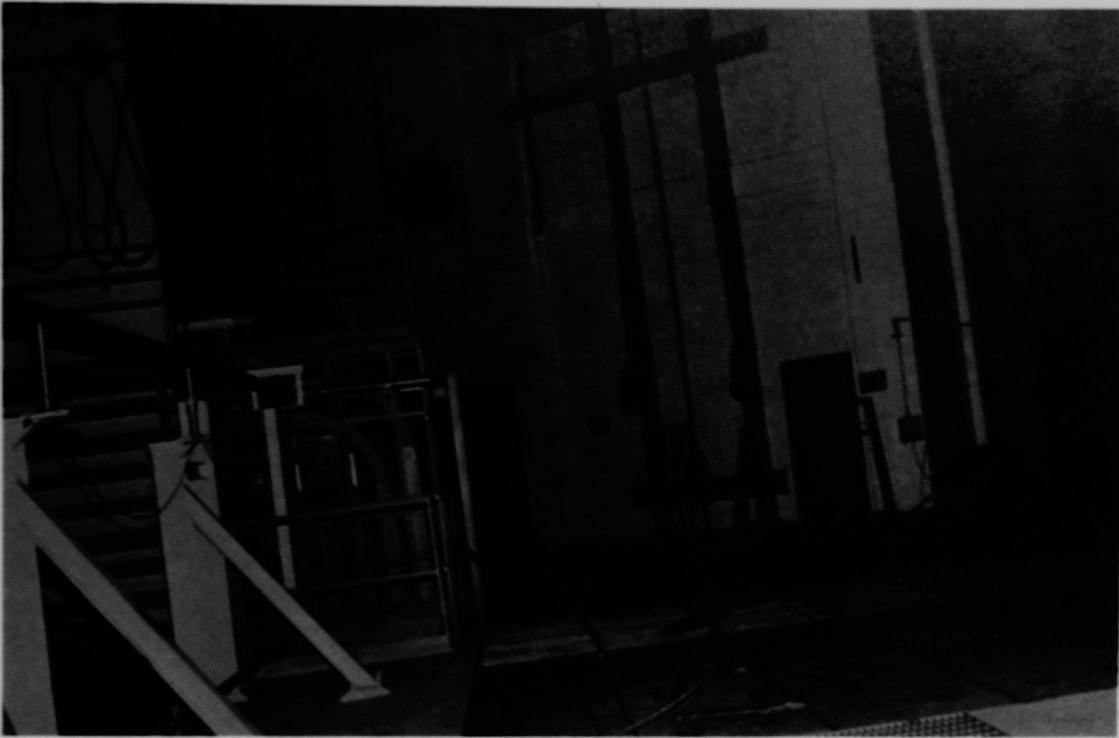
Figure 97 (2B). General view across operating deck to enclosed stairwell; CRDM cable trays left, indexing fixture right.

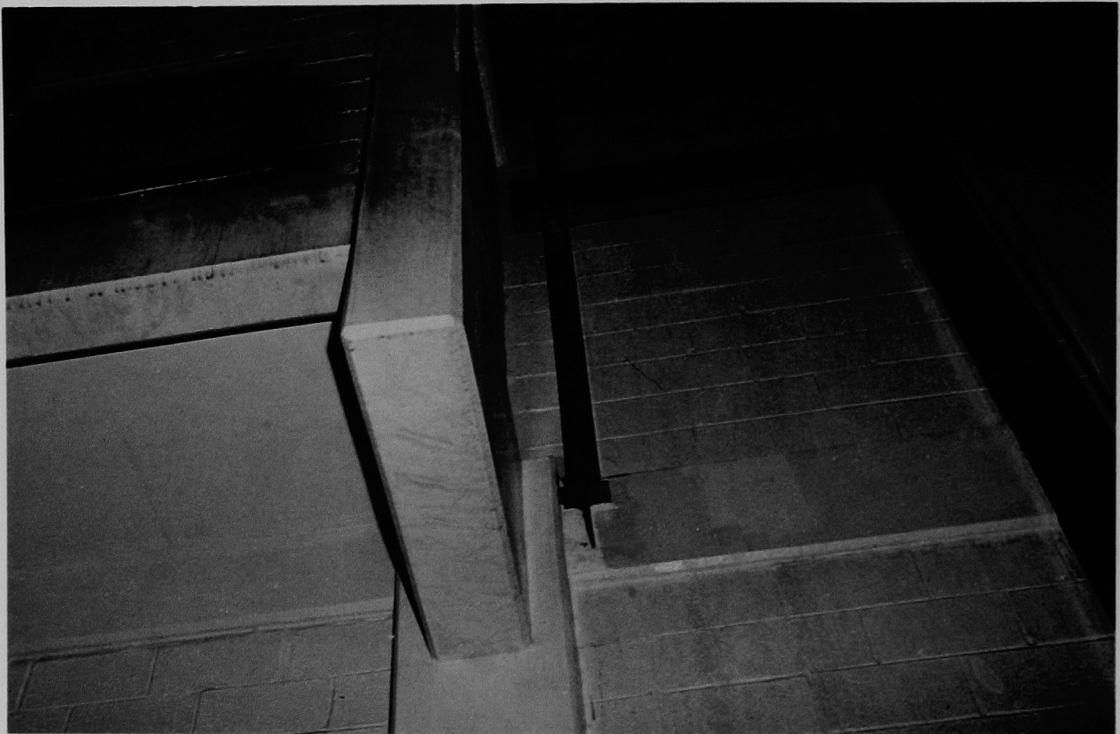
Figure 99 (4A). Ventilation grill into the elevator shaft motor room (see Figure 97, upper left center).

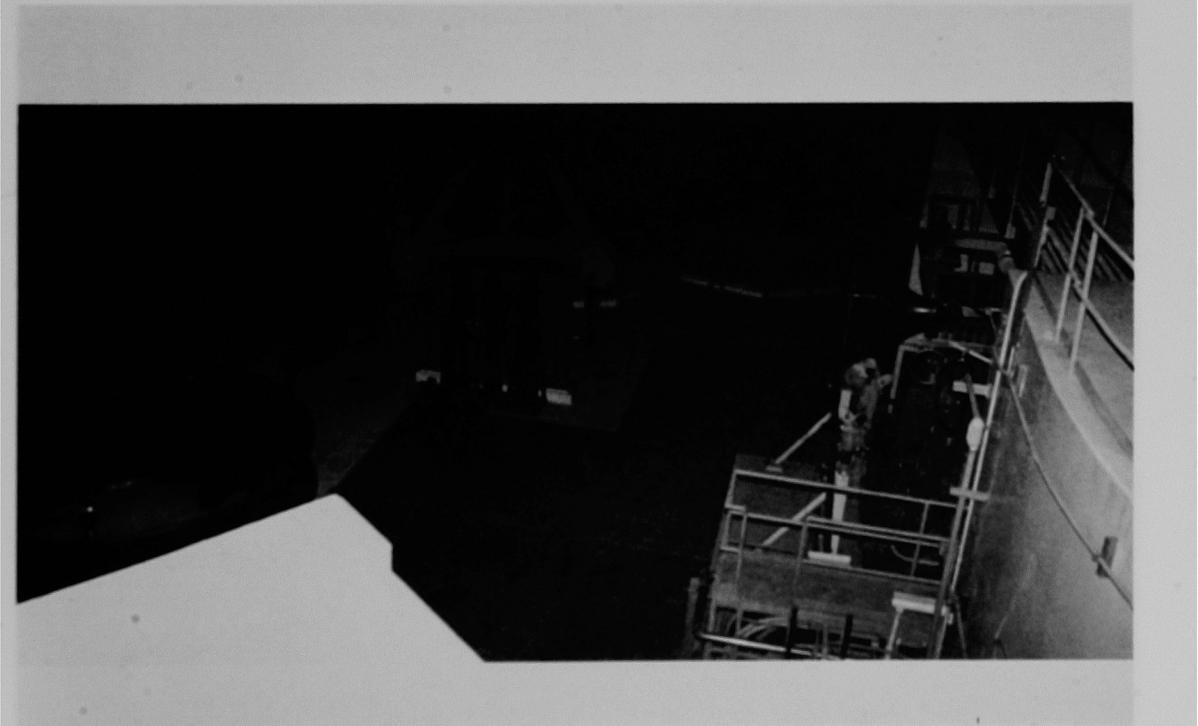
Figure 102 (5C). General view of operating deck from atop elevator shaft.

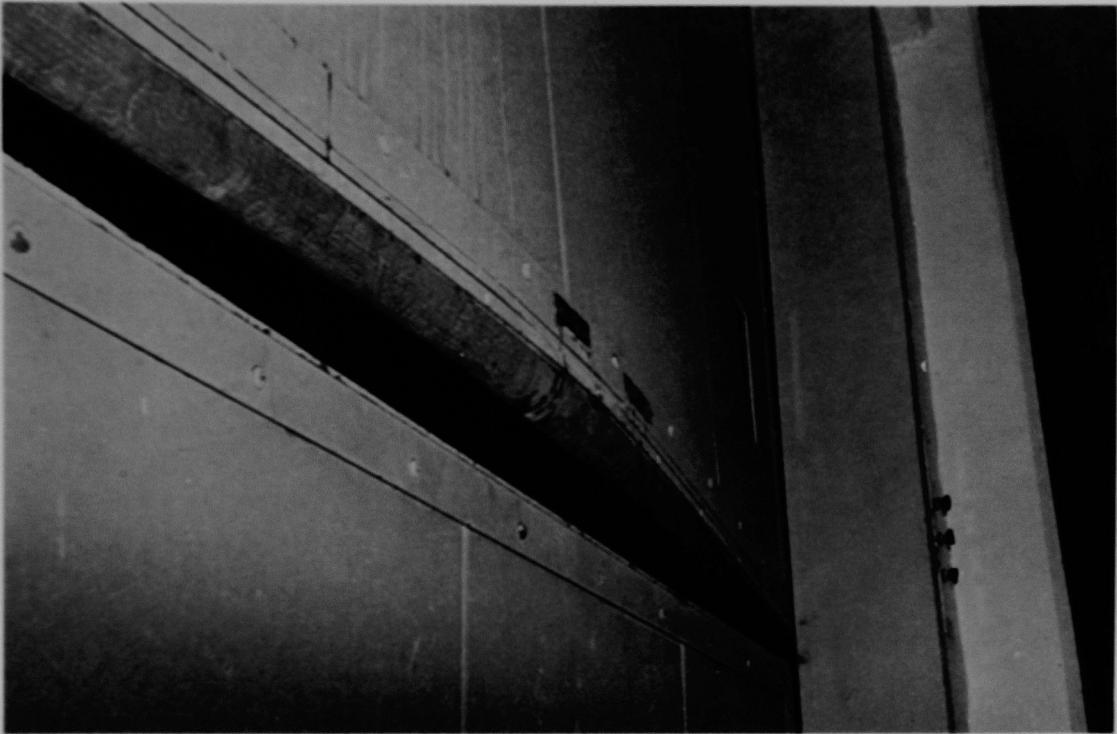
Figure 109 (6A). Close-up of gap in elevator door (elevation 347).

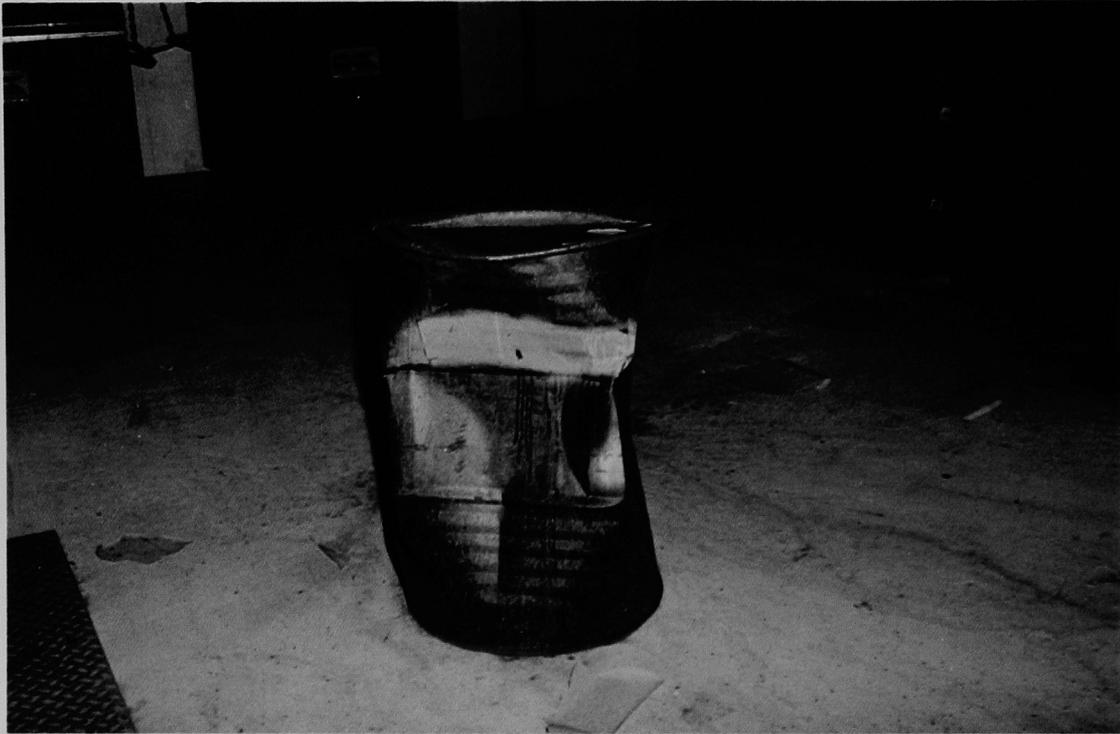
Figure 115 (4A). Fifty-five gallon drum; corner of elevator wall left, D-ring wall background. Patches of paint lie on the floor.

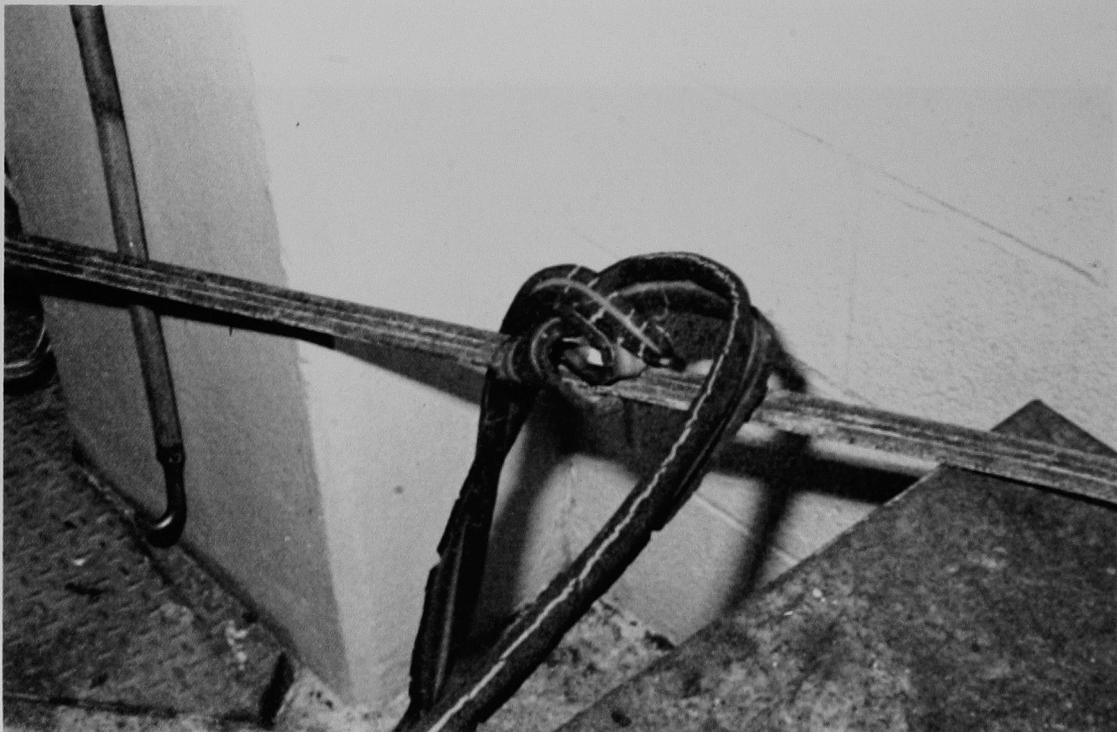
Figure 120 (4). Crane power cable and insulation lying over tool box south of enclosed stairwell (see Figure 119).

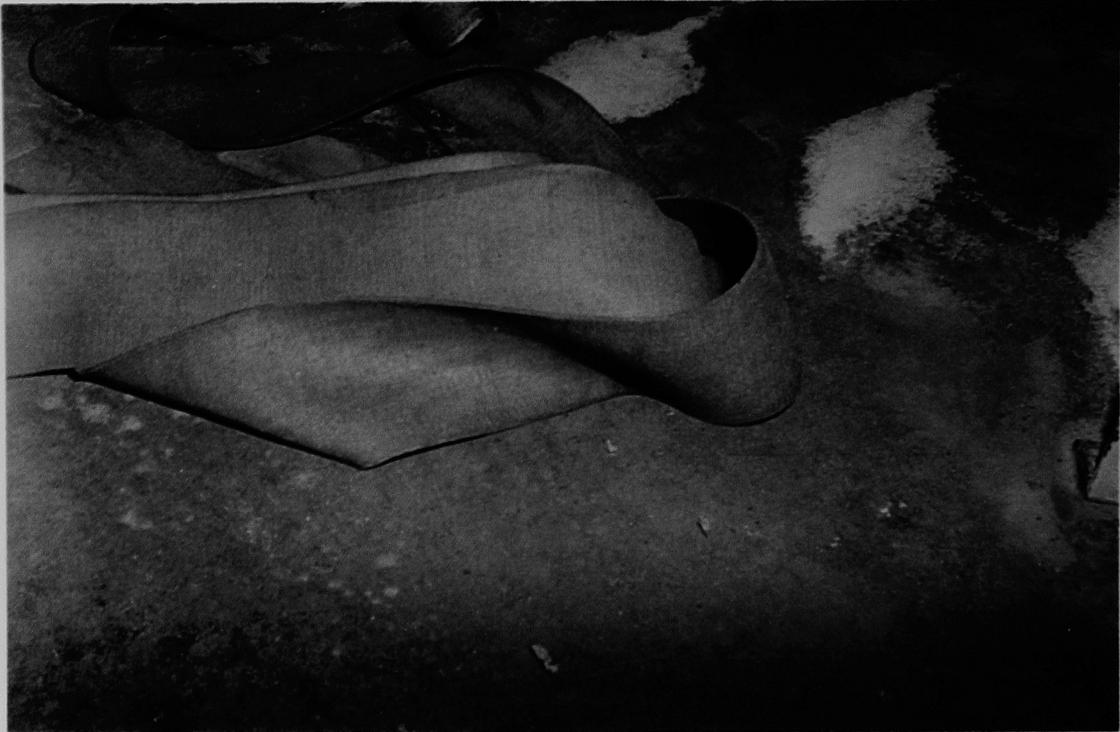
Figure 123 (6A). Lifting sling lying on floor south of enclosed stairwell (see Figure 118).

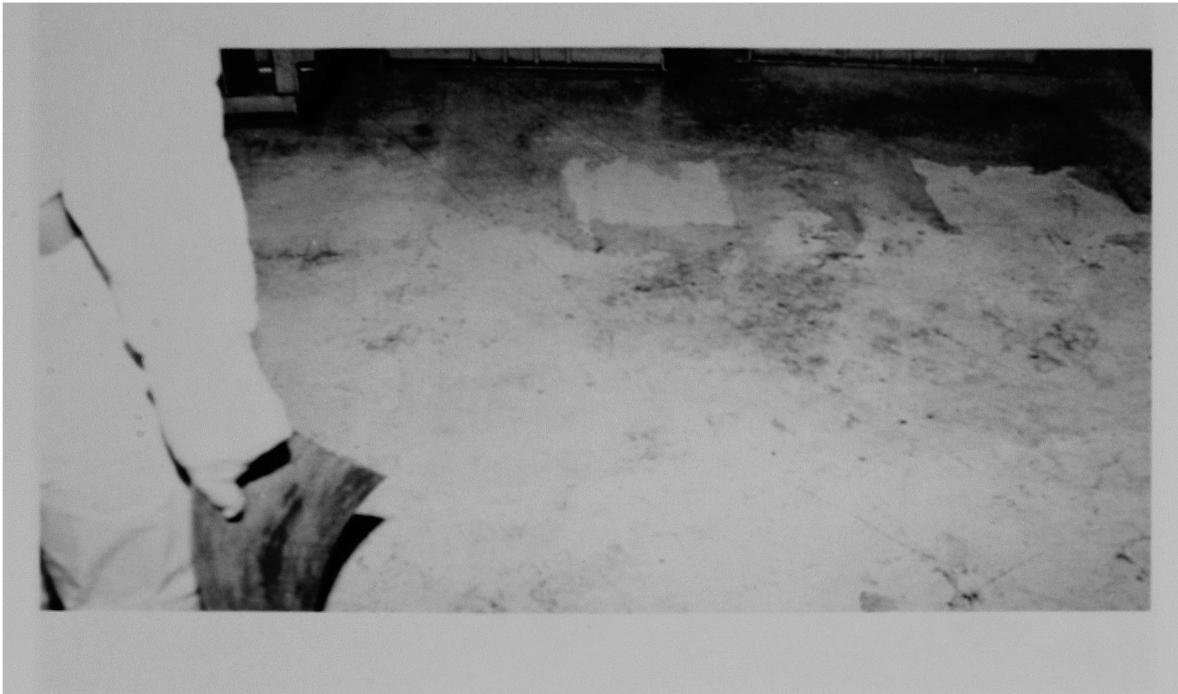
Figure 141 (5C). Decontamination test area in front of mirror insulation storage stands.

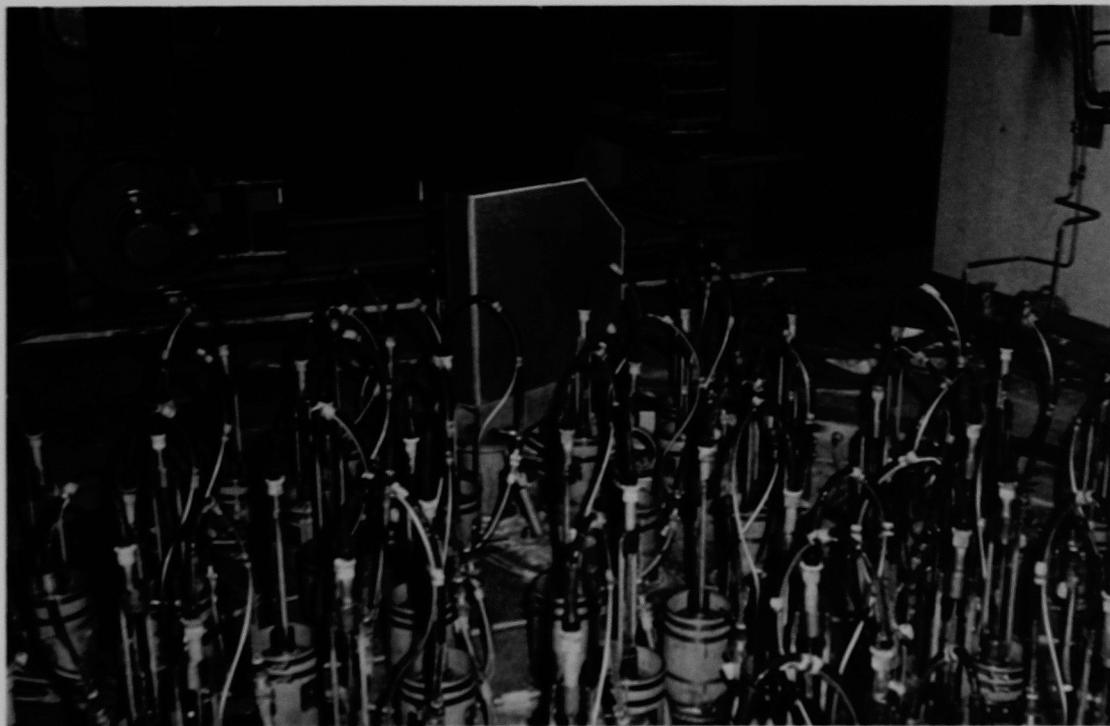
Figure 176 (4A). Incore instrumentation electrical connections, main fuel handling bridge background, closer view. (This photograph was taken to document boron crystal accumulation.)

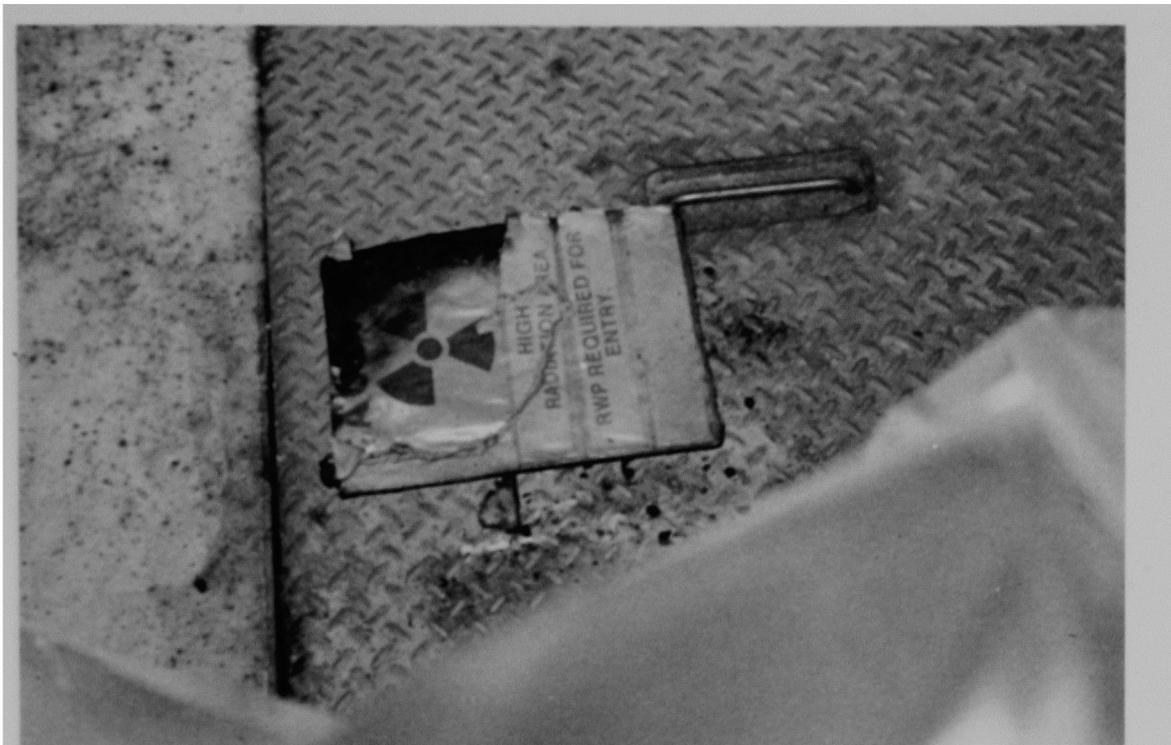
Figure 196 (4). Charred radiation sign lying on the decking over core flood tank A.

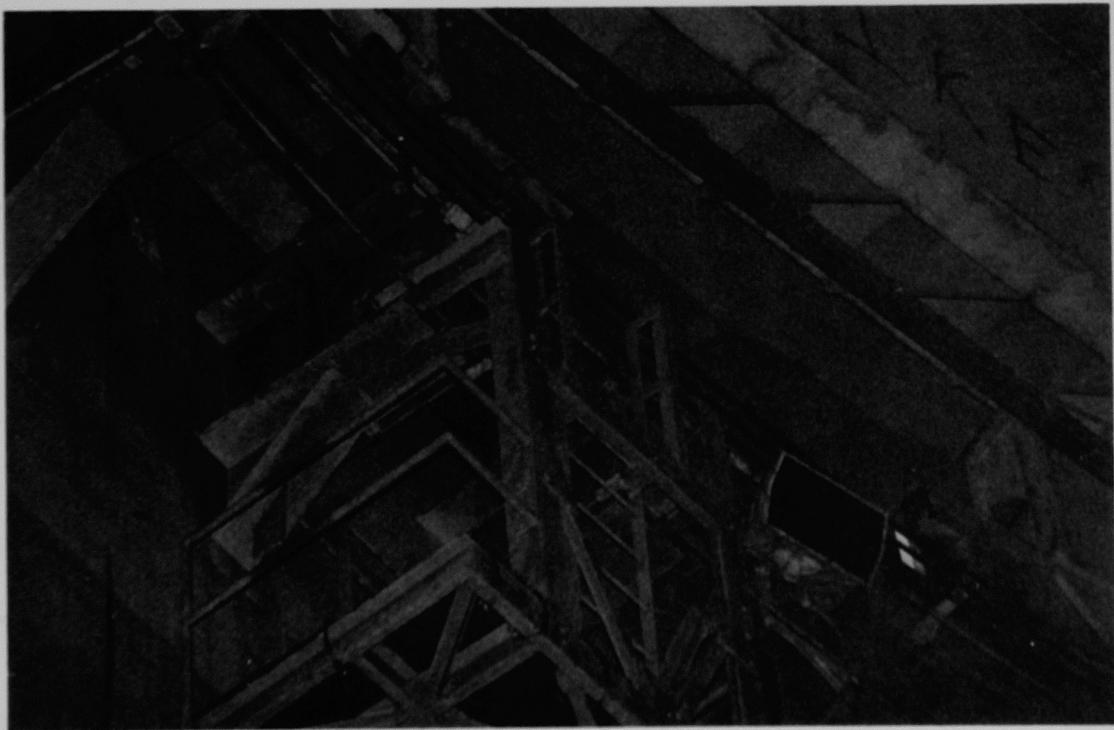
Figure 269 (5B). Close-up of the access platform to the polar crane.

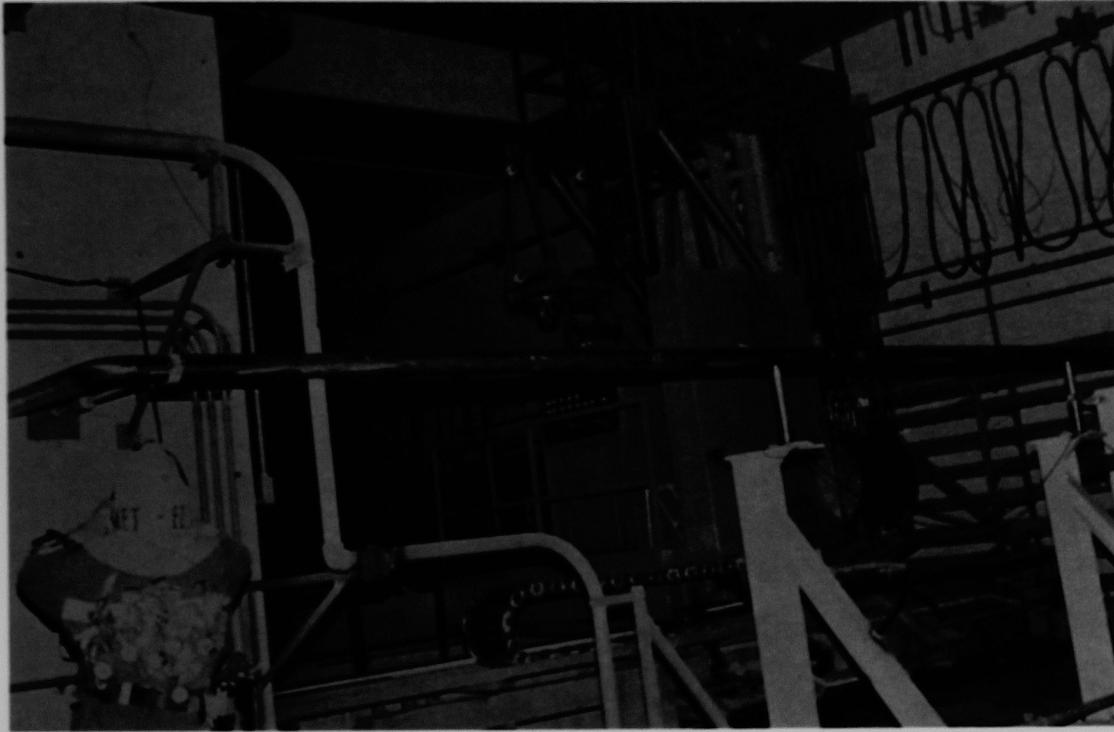
Figure 221 (2B). Auxiliary fuel handling bridge.

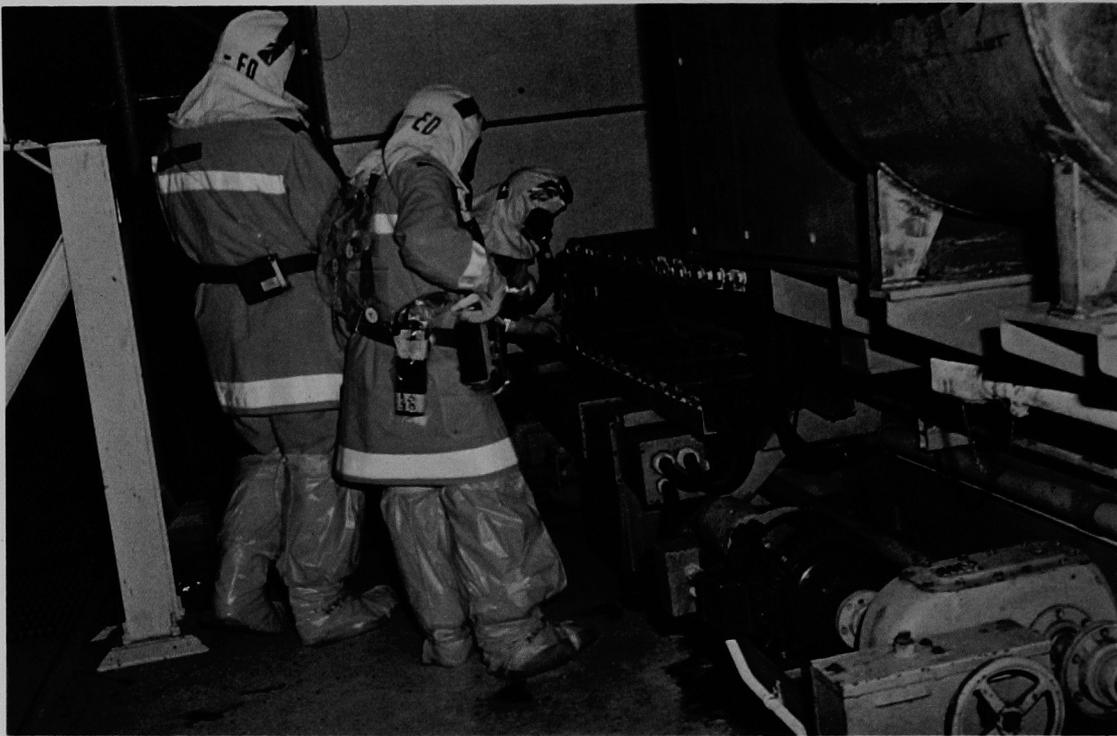
223. Power track and bridge motor of auxiliary fuel handling bridge, view from southeast, with HP technicians	182
224. Rusted coupling and motor on auxiliary fuel handling bridge	182

Figure 223 (2A). Power track and bridge motor of auxiliary fuel handling bridge, view from southeast, with HP technicians.

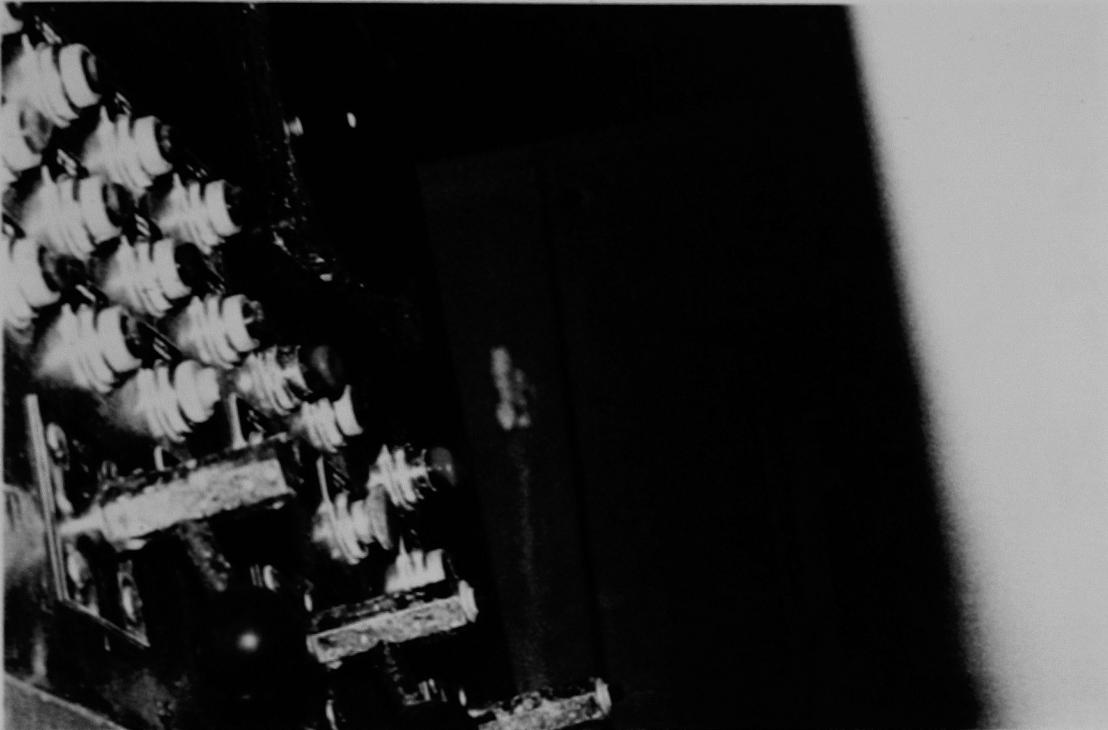
Figure 237 (5B). Close-up of the control panel on the auxiliary fuel handling bridge, second view.

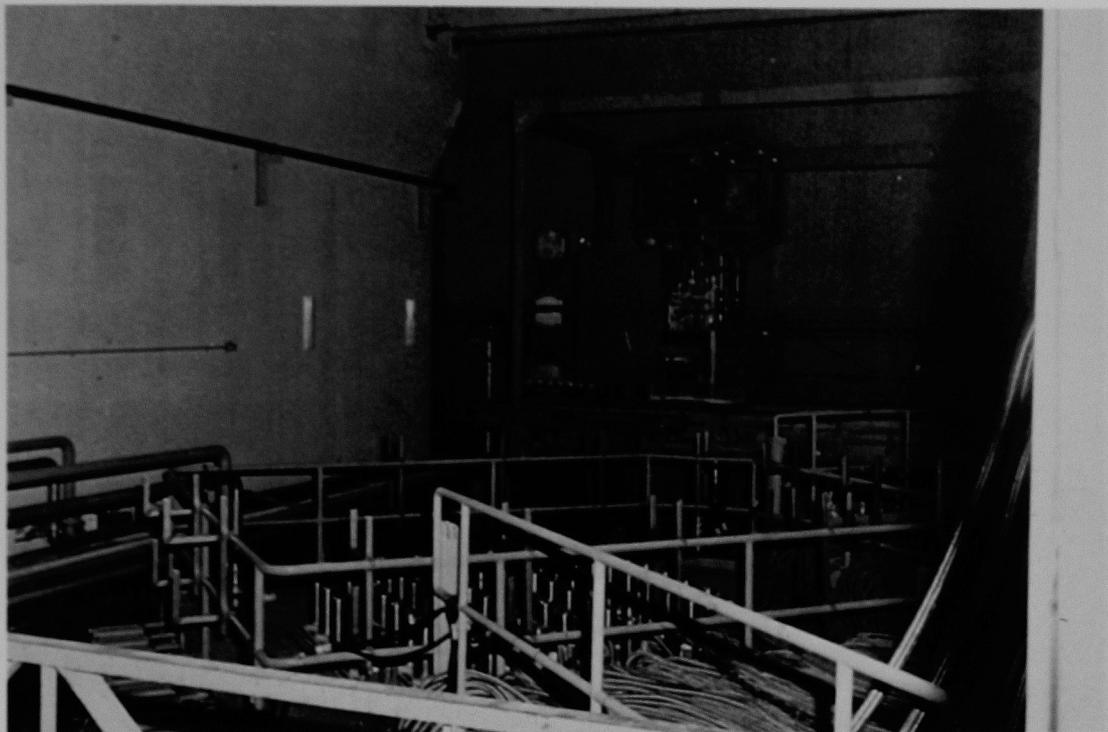
Figure 241 (2A). Control rod drive mechanism platform and power cables; main fuel handling bridge background, second view.
