**Color Photographs
Of The Three Mile Island Unit 2
Reactor Containment Building:
Volume 1—Entries 1, 2, 4, 5, 6**

October 1981

**EG&G Idaho, Inc.
Idaho Falls, Idaho 83415**

This report is a collection of the 308 color photographs taken during the first six entries into the Three Mile Island Unit 2 Reactor Containment Building (July 1980—February 1981). The

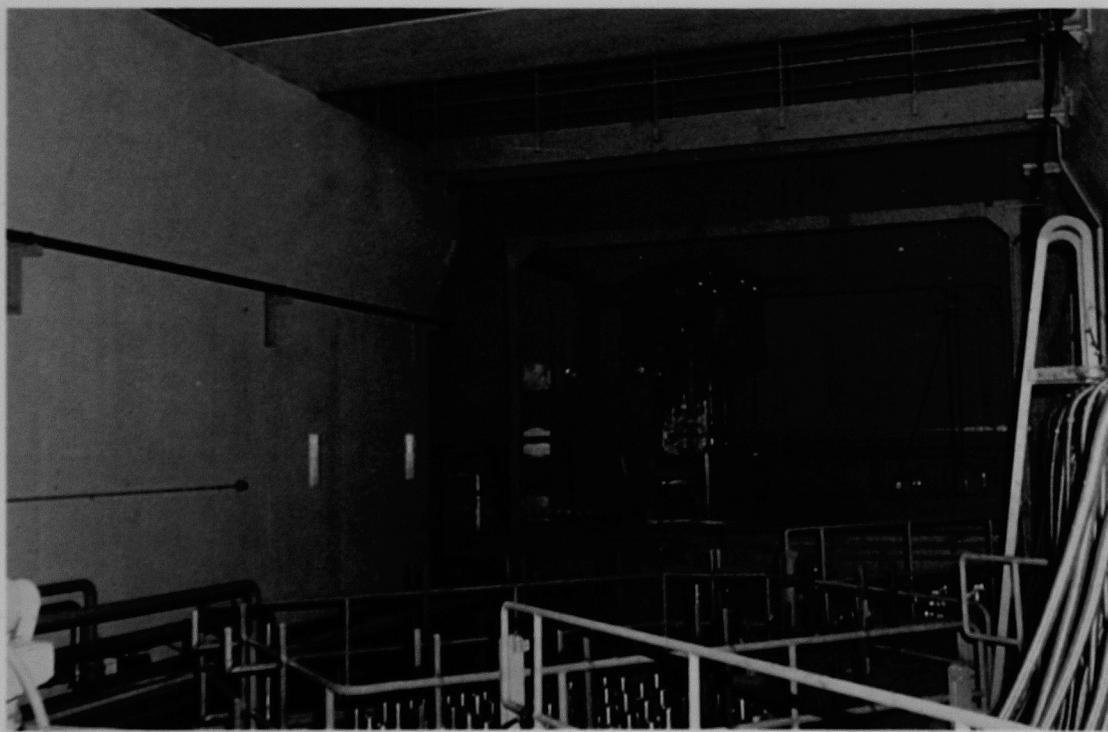
Figure 242 (2A). CRDM platform and incoming power cables, third view.

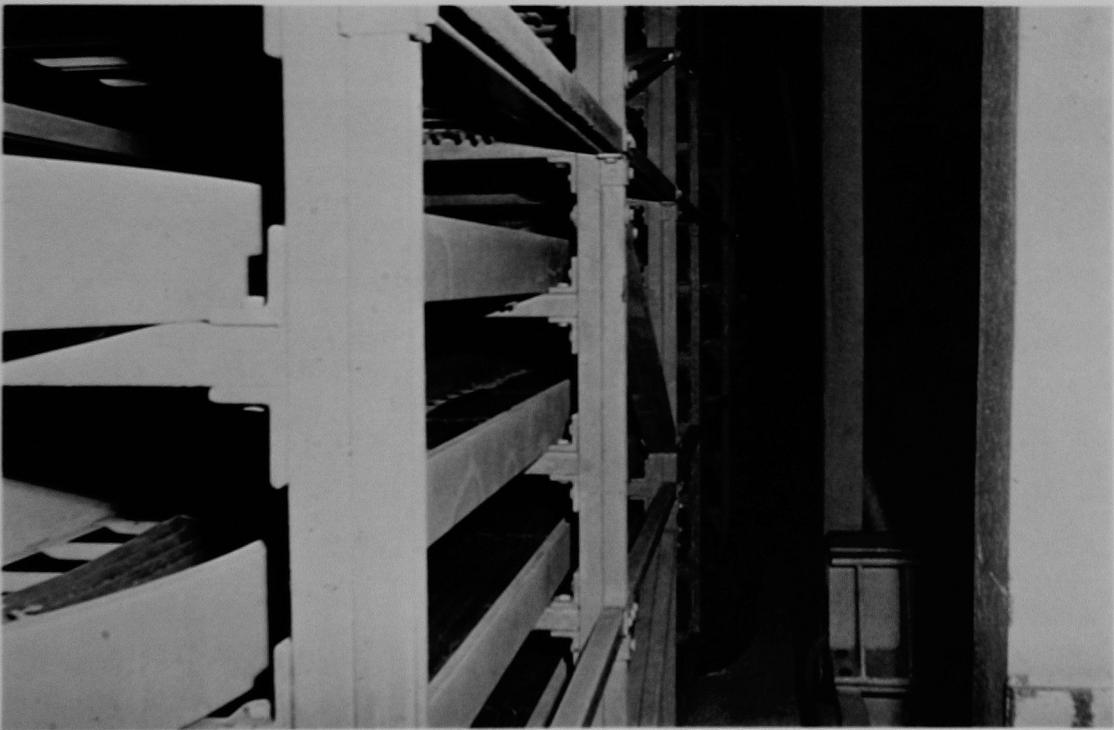
Figure 250 (6A). View south along CRDM cable trays; CRDM cables protruding in background.

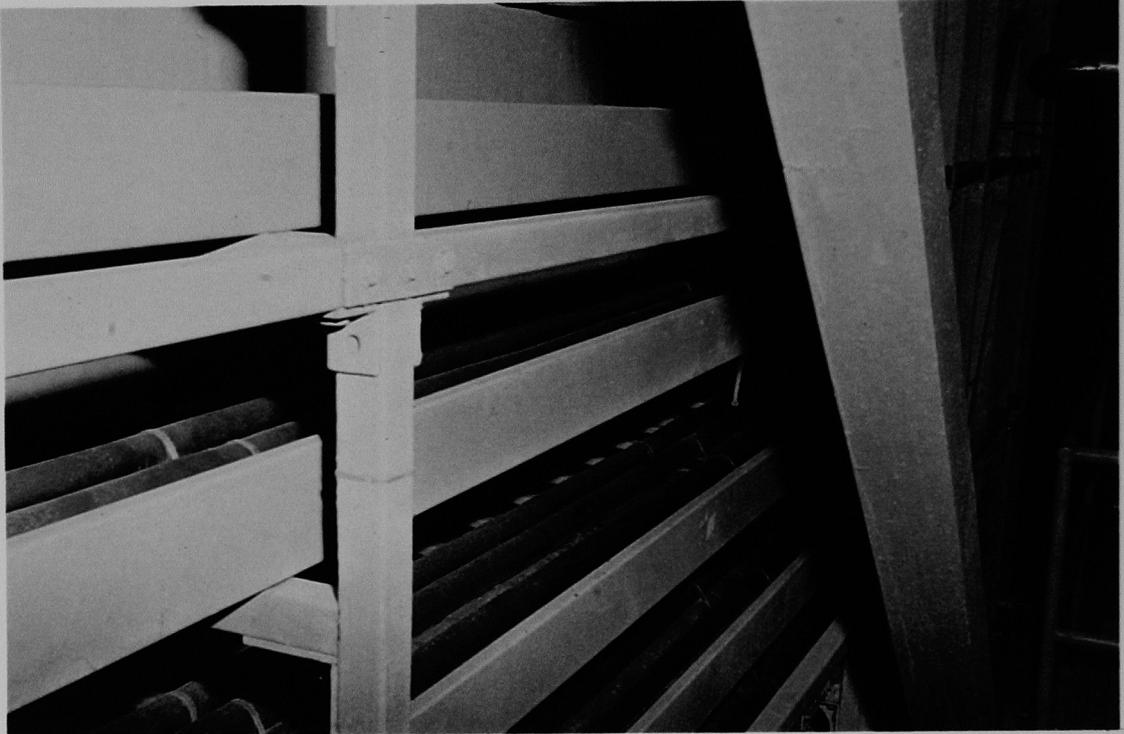
Figure 251 (6A). Close view of CRDM cable trays; hand rail to auxiliary fuel handling bridge right.

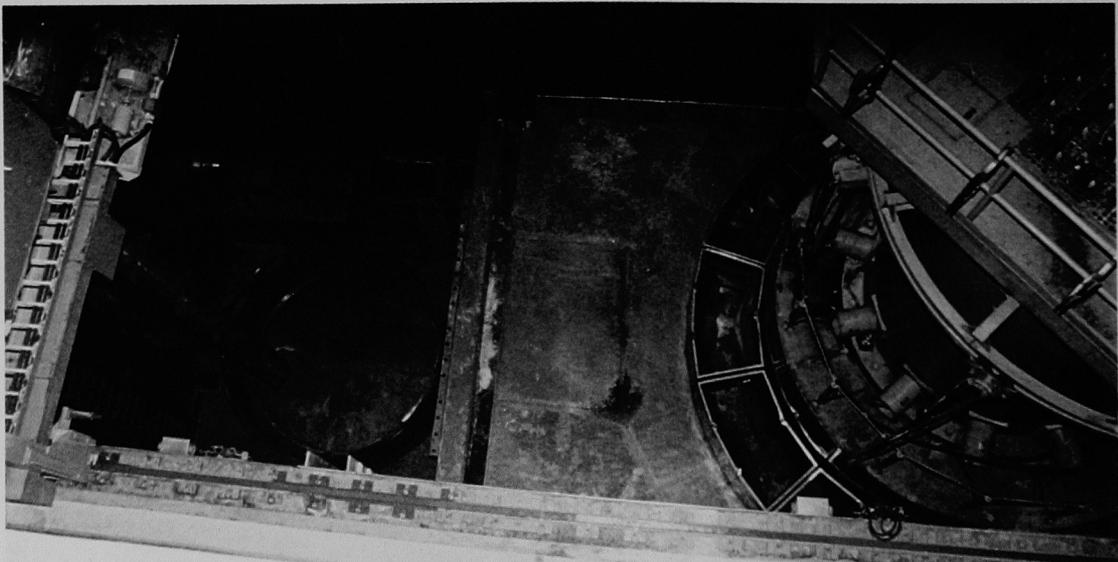
Figure 252 (5C). North end of fuel pool; main fuel handling bridge left, up ender and internals storage stand left center in deep portion of the pool.

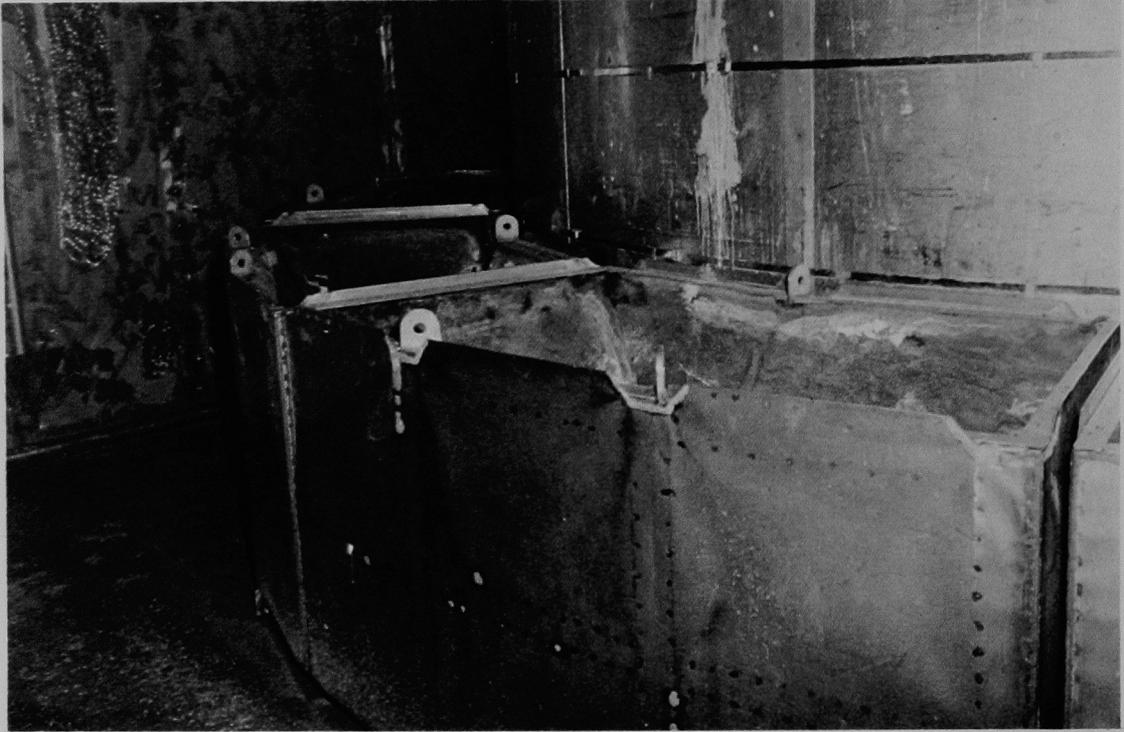
Figure 255 (5A). Base of the reactor vessel with neutron shield tanks.

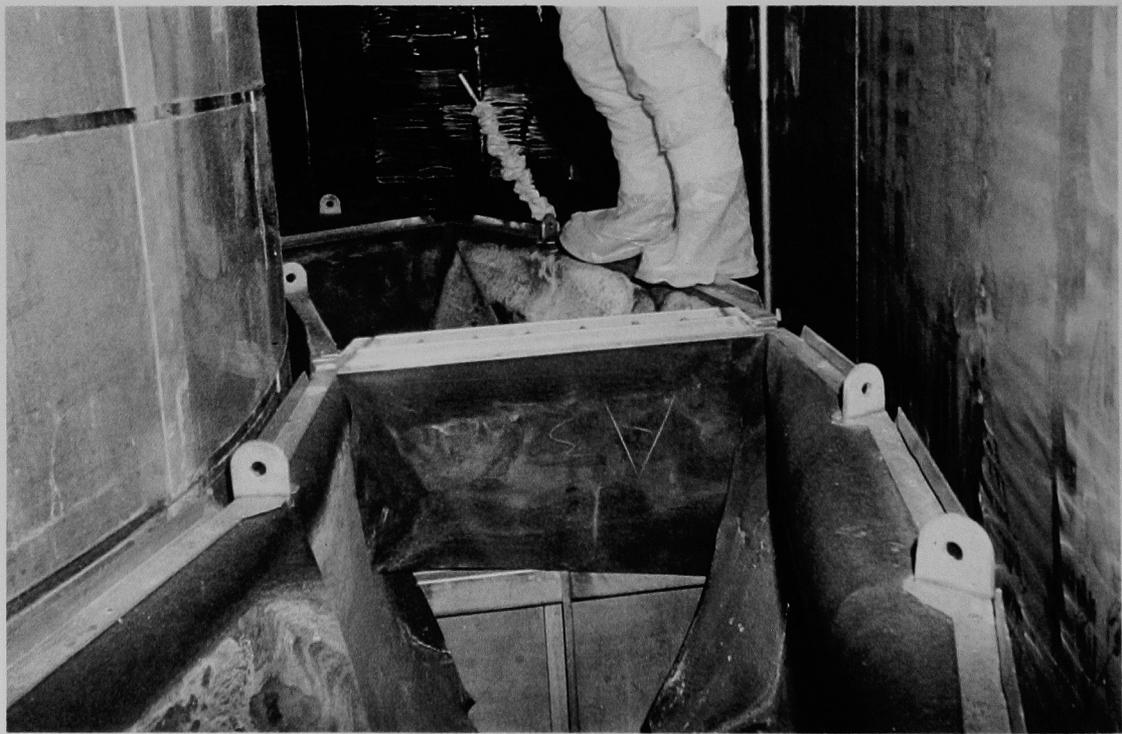
Figure 256 (5A). View inside of neutron shield tank (technician on shield tank to gain access to the north side of the reactor vessel).

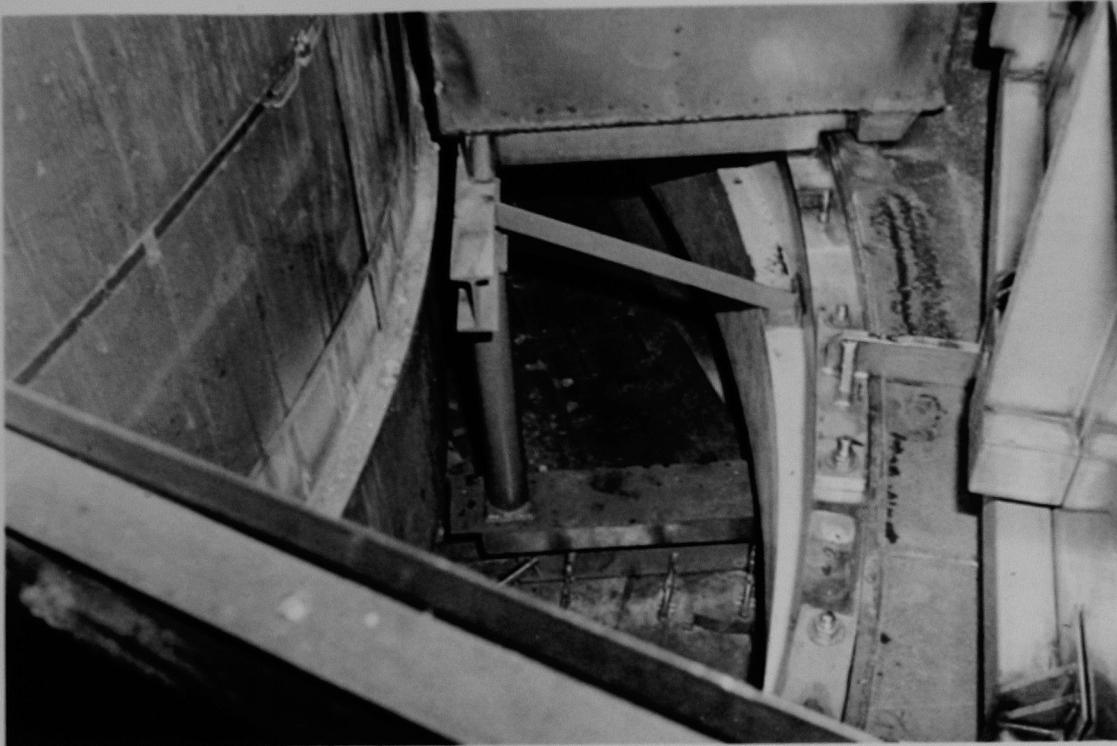
Figure 257 (5A). View underneath a neutron shield tank.

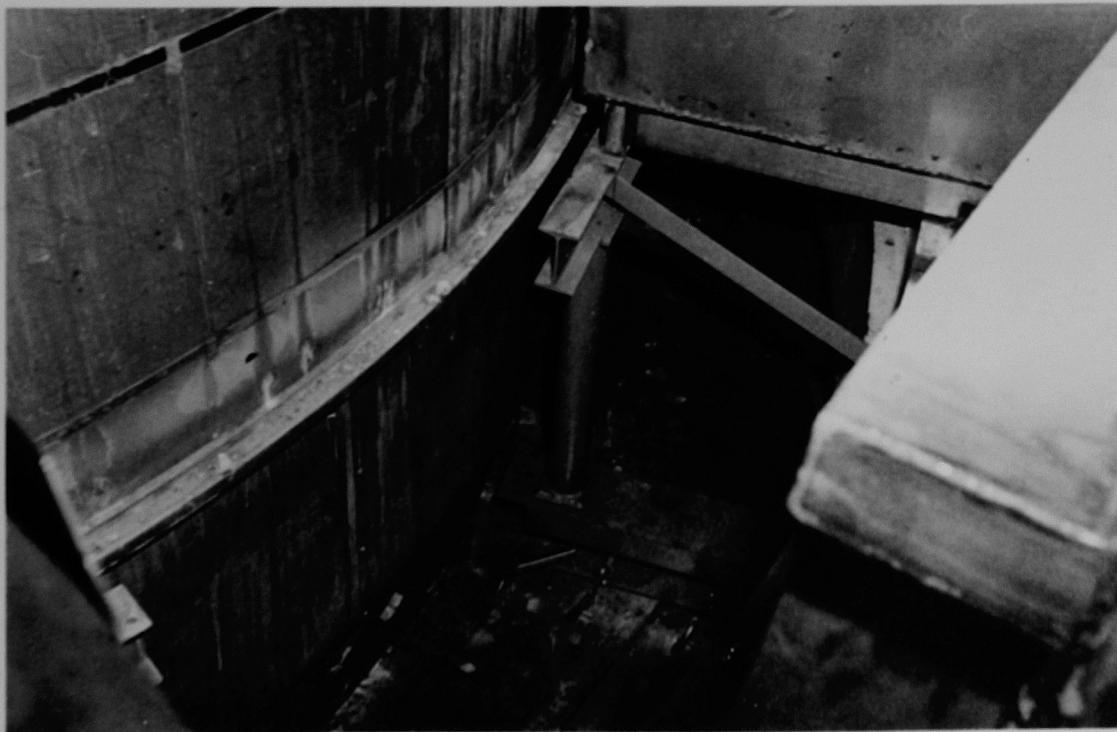
Figure 258 (5A). Second view underneath a neutron shield tank.

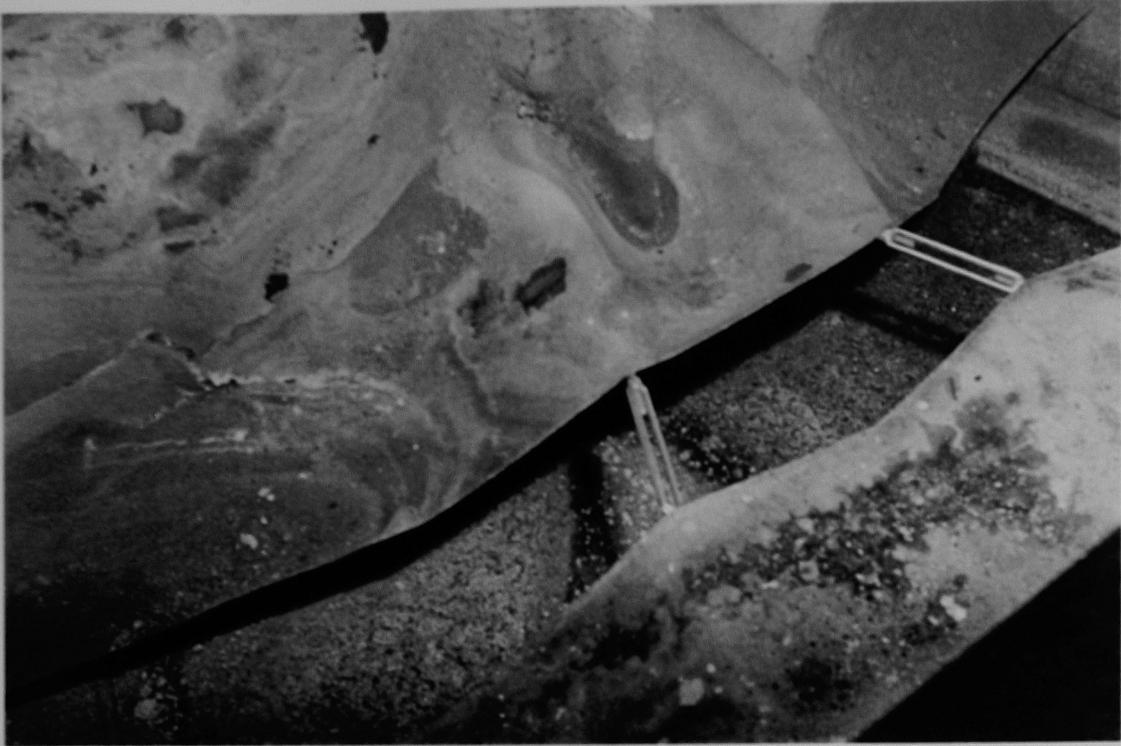
Figure 261 (5A). Close-up of a portion of a neutron shield tank (see Figure 260 foreground right center).

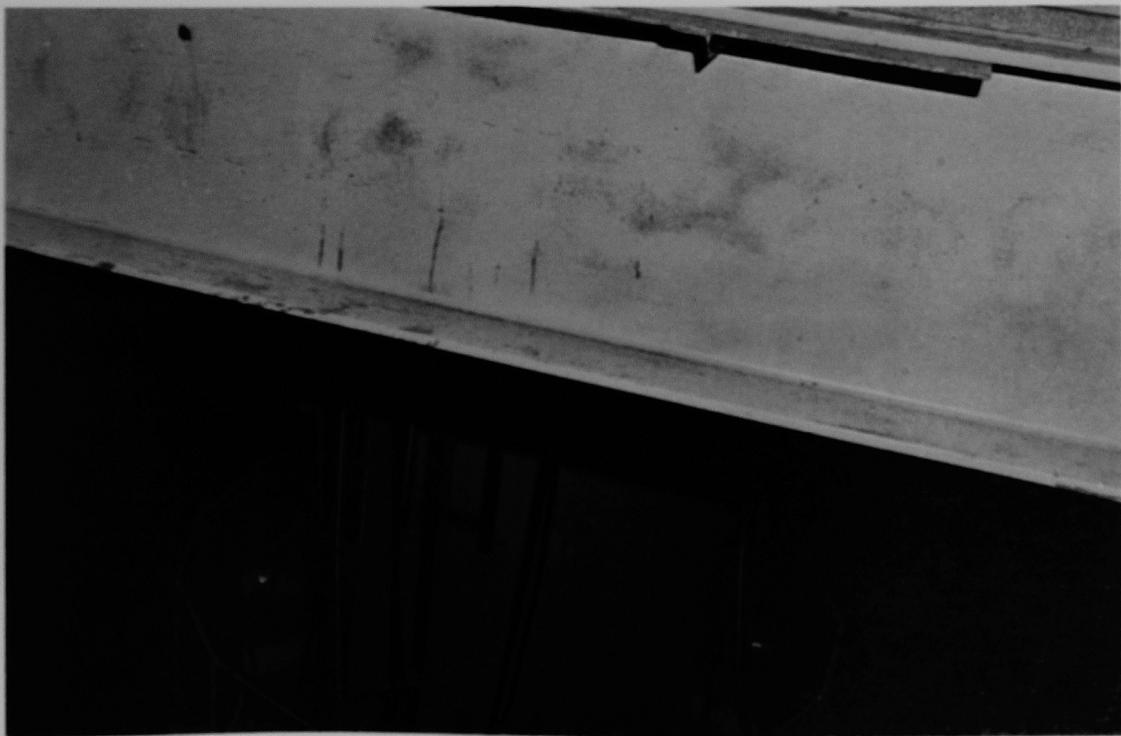
Figure 262 (2A). Reactor vessel head, fuel handling girder above
