Dry Cask Storage Characterization Project- Phase I: CASTOR V/21 Cask Opening And Examination

*W. C. Bare
L. D. Torgerson*

August 2001

*Idaho National Engineering and Environmental Laboratory
Bechtel BWXT Idaho, LLC*

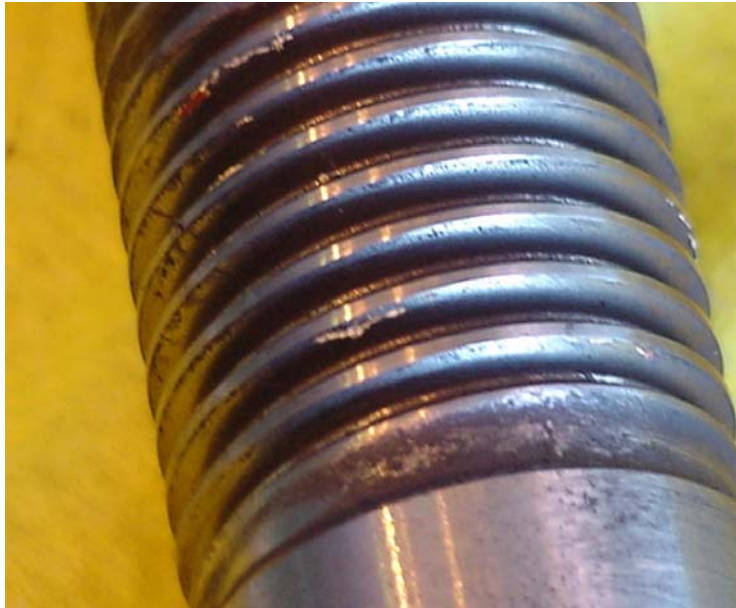
Figure 2-6. Typical cask primary lid bolt after removal.

All bolts were in satisfactory condition. The exposed portion of all bolt heads were found to be in very good condition. None of the primary lid bolts as shown in Figures 2-6 and 2-7 had any indications of

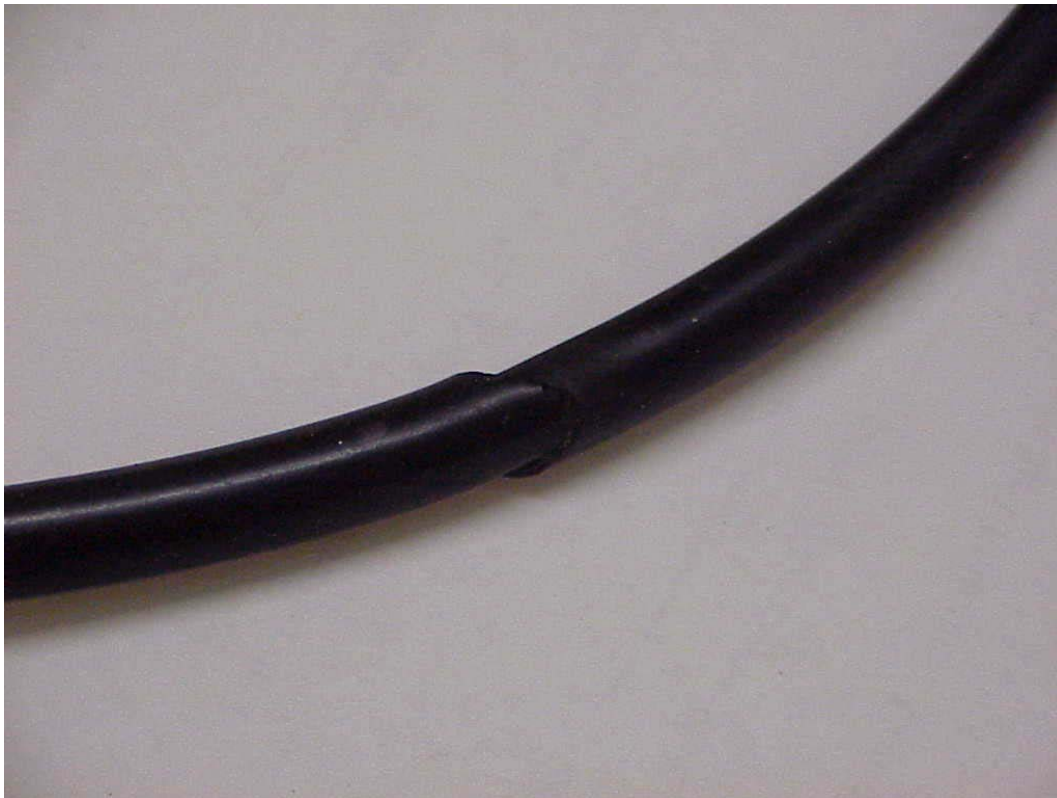
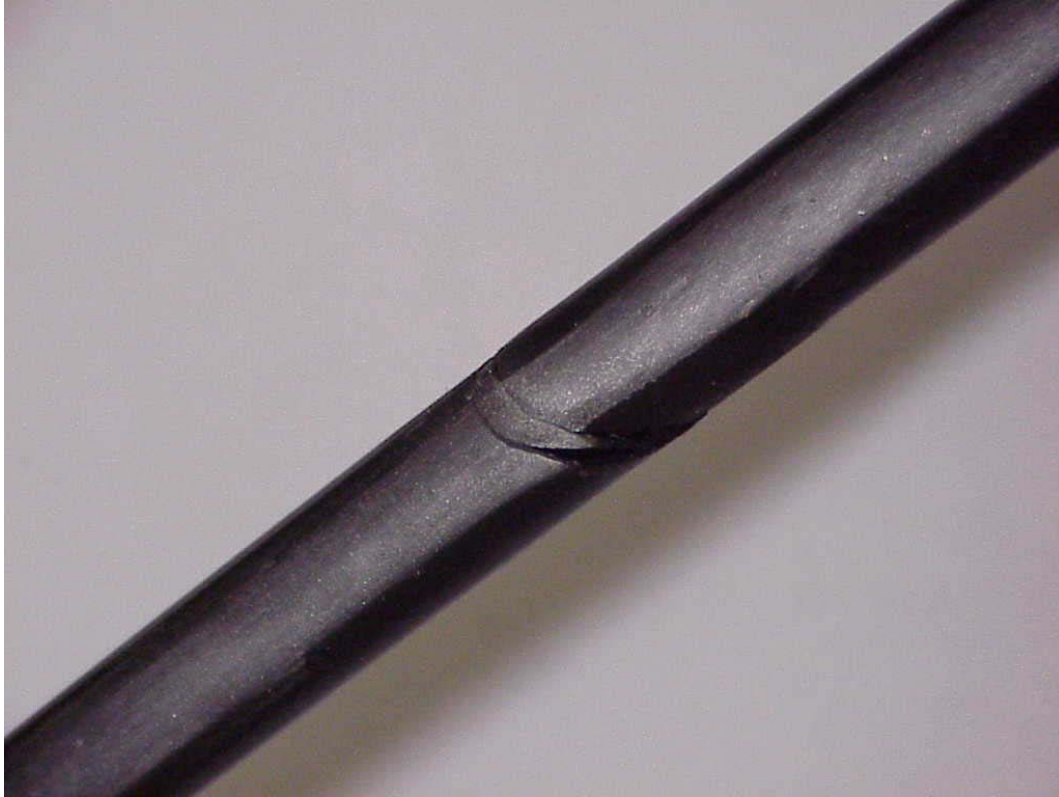
The elastomer O-ring was fabricated with a 45-degree scarf splice joint. As was noted in the remote camera inspections, the splice joint was slightly misaligned and partially open; the glue did not completely fill the gaps in the joint as shown in the Figures 2-9 and 2-10. However, the joint still had good strength and could not be pulled apart manually.

Figure 2-9. Elastomer O-ring splice joint configuration.

Figure 2-10. Elastomer O-ring splice joint configuration.

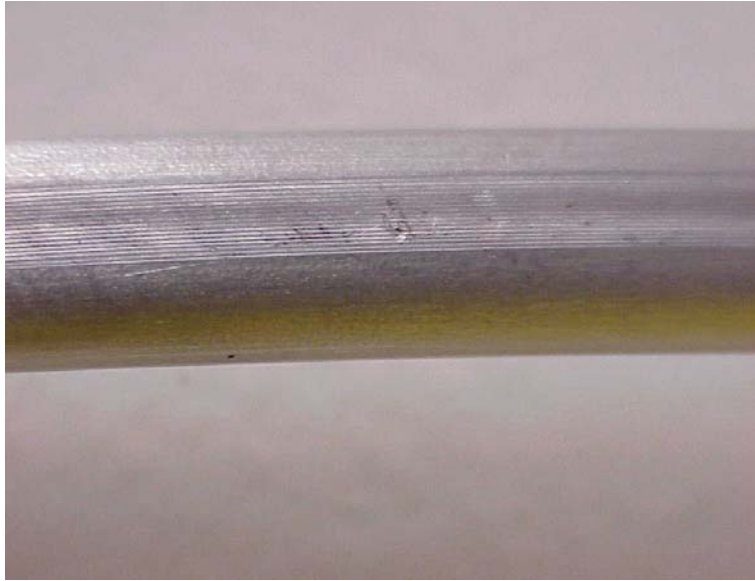
Figures 2-12. Primary lid metal O-ring.

The top surface of the metal O-ring, which was in contact with the seat of the O-ring groove, did not have any defects except for a few fresh (unoxidized) shallow scratches that have been attributed to handling damage during removal from the lid. The bottom surface as shown in Figure 2-12, which was in contact with the seal surface of the cask body, exhibited approximately 20 small pin-point indentations into the surface. The indentations were typically less than 1 mm (0.04 in.) in lateral dimension and did not appear to puncture the thickness of the metal O-ring. Because these were not spotted in the initial remote camera inspection, these features are being attributed to compression damage from environmental grit on the seal surface of the cask body. The grit was probably transfer from the bottom of the seal protector to the seal area during the fuel examination operations.

- Several pinpoint indentations, some on sealing surface; typically <0.5 mm dia, probably <0.5 mm deep

- Several light scratches, a few across the sealing surface; most have metal glint in scratch root, indicating fresh scratches
- No evidence of significant general corrosion, pitting corrosion, stains
- Sealing surface defined by the impression of the machining marks from the seal surface on cask
- No evidence of significant oxidation or spallation of these fine line features
- No deformation of the individual line impressions despite numerous cycles of lid removal/replacement during fuel inspection.

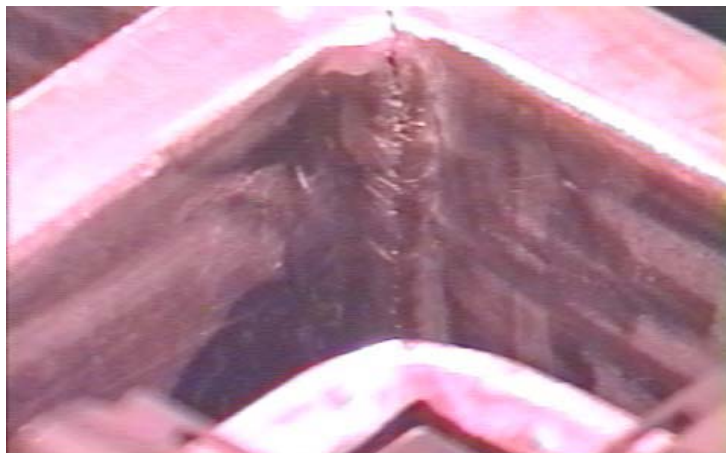
Figure 2-19. Crack in basket weld below weld crack 4 (120 degree side) identified in Figure 2-13.

The stitch welds in the triangular air channels appear to be nonstructural welds and were only intended to add additional stability for holding the fuel basket in place during 1985 fuel loading and vertical and horizontal thermal testing. The 1985 cask heat transfer performance testing (EPRI NP-4887) thermal analysis, concluded that the tightly fitted fuel basket expanded and came in contact with the basket barrel and the fuel barrel came in contact with the inner wall of the cask. The results of the thermal analysis indicated that thermal stresses in the weld joints at the eight crack locations identified in 1985 were well above yield stresses measured during tensile testing of applicable weld samples. Based on these results and speculations, it appears that all new cracks identified in 1999 occurred during the 1985 thermal testing. Further, it is concluded the cracks are not relevant to normal long-term storage and presents no adverse safety implications on the cask or components to perform their safety related function.

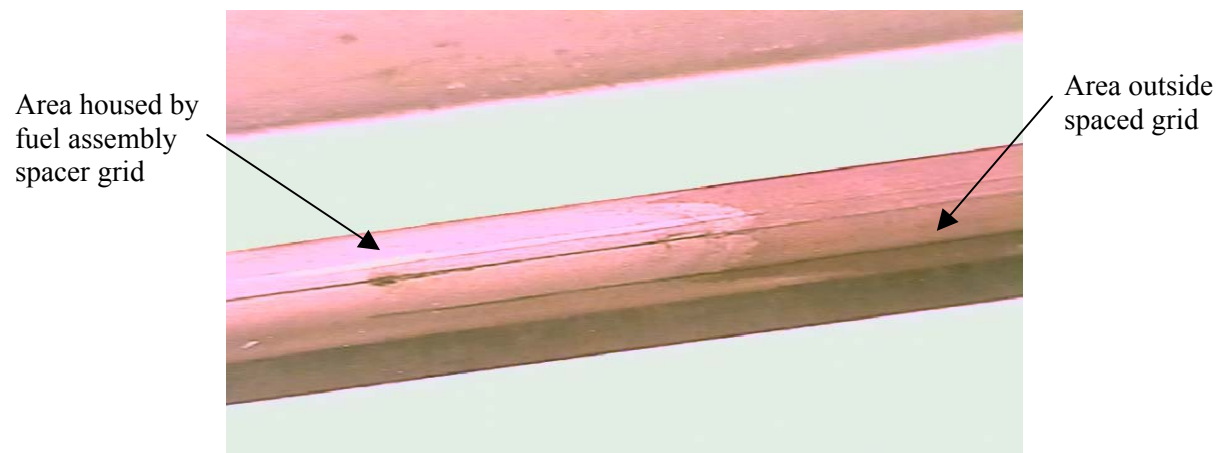
The twelve fuel rods were free of physical damage, except for long, continuous longitudinal scratches in the cladding from initial installation into the fuel assembly (Figure 2-23, 2-24 and Appendix E). The longitudinal scratches were old scratches, for the roots of the scratches were thinly coated with oxide (crud). Several of the rods had many (6-12) parallel longitudinal scratches running most of the rod length; none of the scratches had perforated the cladding and are not caused by creep failure. There was no evidence on any of the rods of extensive corrosion, pitting, or creep failure.

Each rod was covered with a thin but uniform coating of oxide. The oxide coating seemed to comprise two layers, a light tan and a red-brown layer with sharp delineations between them, especially in the vicinity of the spacer grids (Figure 2-23 & Appendix E). These rods, drawn from within the bundle, appeared to have a more uniform oxide coating than the peripheral rods in the array. In general, the oxide layers appeared to be very thin and tenacious. On the upper portions of the rods, the incident lighting reflected diffusely from the thin oxide, imparting a pearly or vitreous satin sheen to the surfaces.

Figure 2-23. Close up of Fuel rod removed from fuel assembly T11 position 7H identified in Figure 2-22.

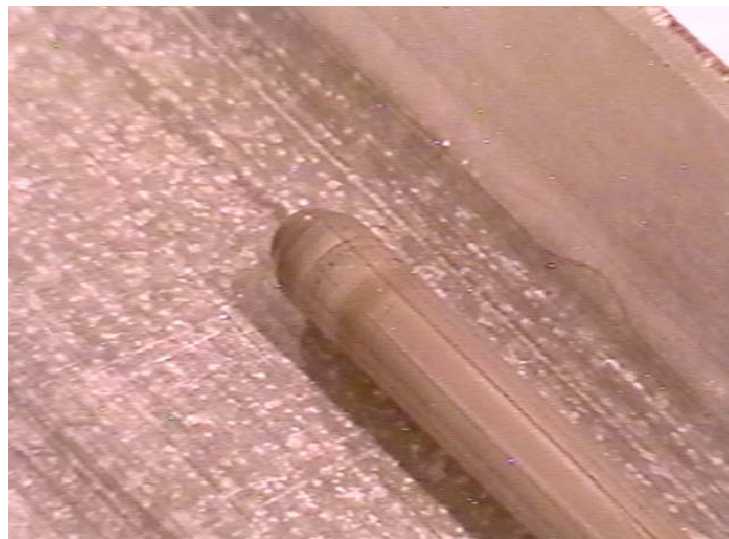
Figure 2-24. Fuel rod removed from fuel assembly T11 position 8I identified in Figure 2-22.

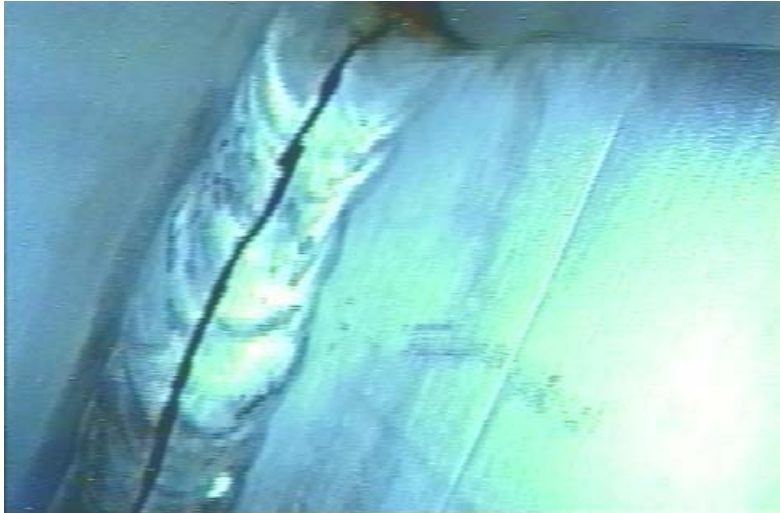
Figure B-1. Top weld crack at location 9 identified in Figure B-19.
(Triangular air channel between fuel tube A7 & B8)

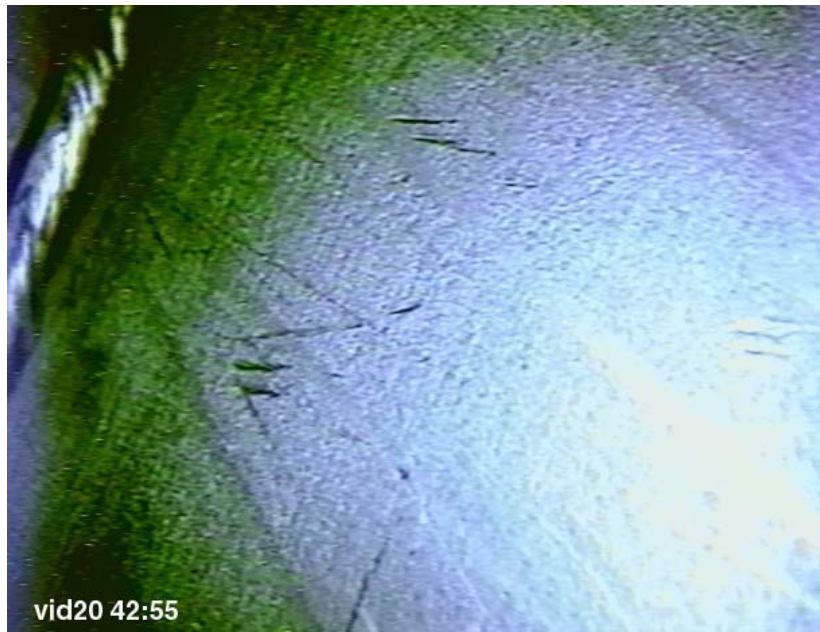
Figure B-2. Bottom weld crack at location 9 identified in Figure B-19.
(Triangular air channel between fuel tube A7 & B8)

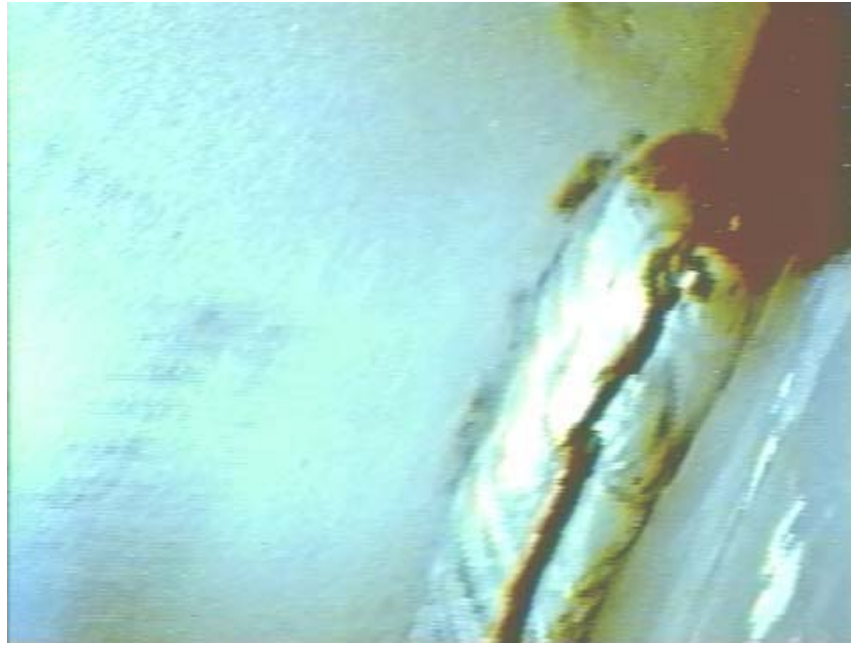
Figure B-5. Top weld crack at location 11 identified in Figure B-19.
(Triangular air channel between fuel tube A3 & B6)

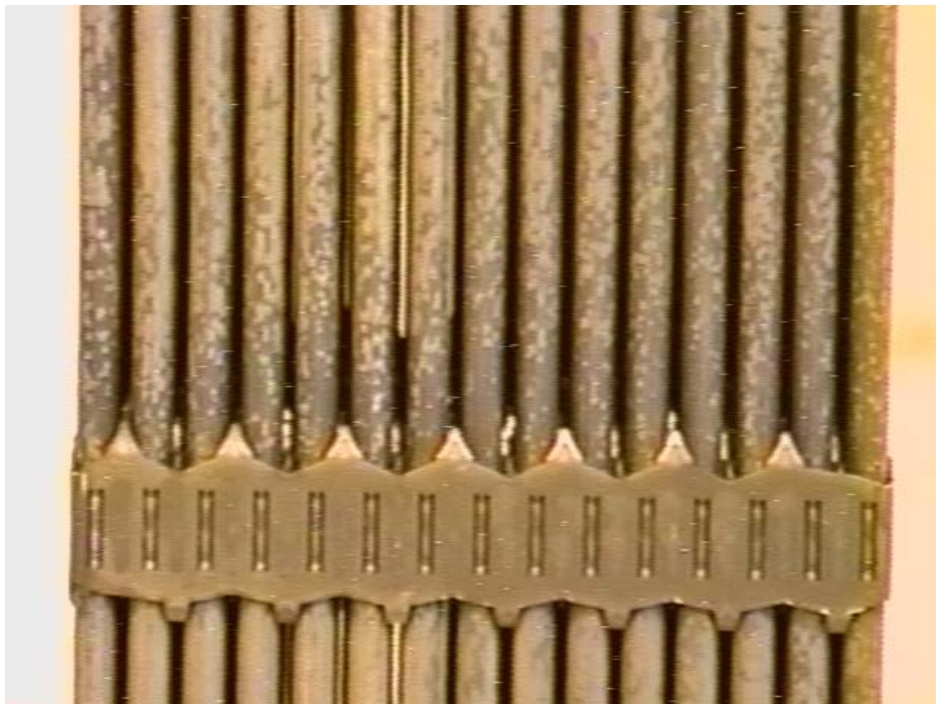
Figure C-26. Fuel assembly V-14 oxide mottling at fifth grid spacer.

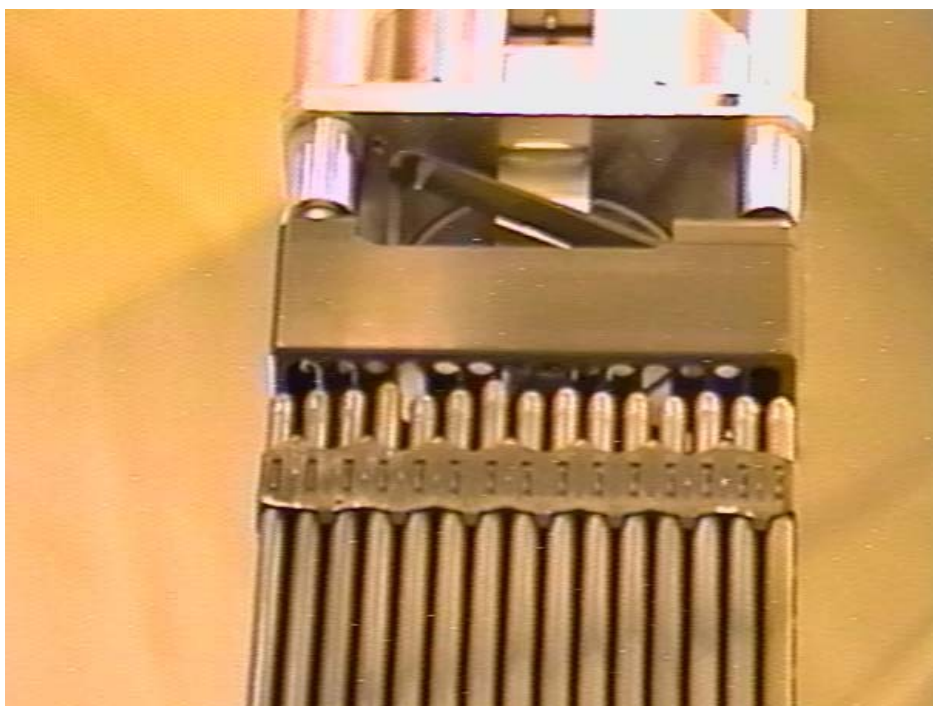
Figure C-44. Fuel assembly T-09—note uneven rods.

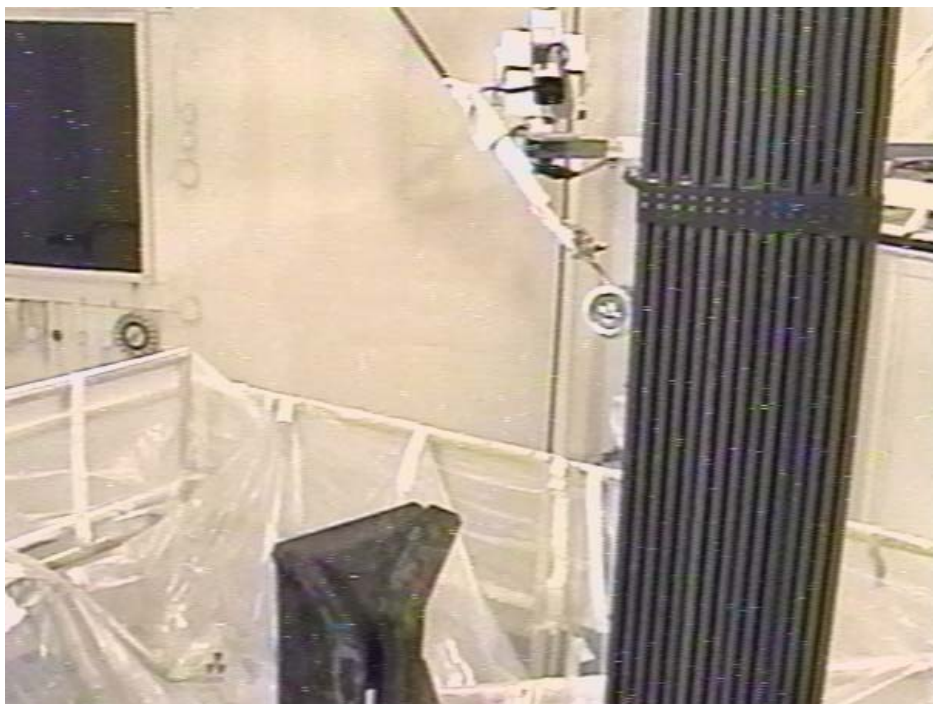
Figure C-64. Fuel assembly T-11 attempt to obtain loose material.

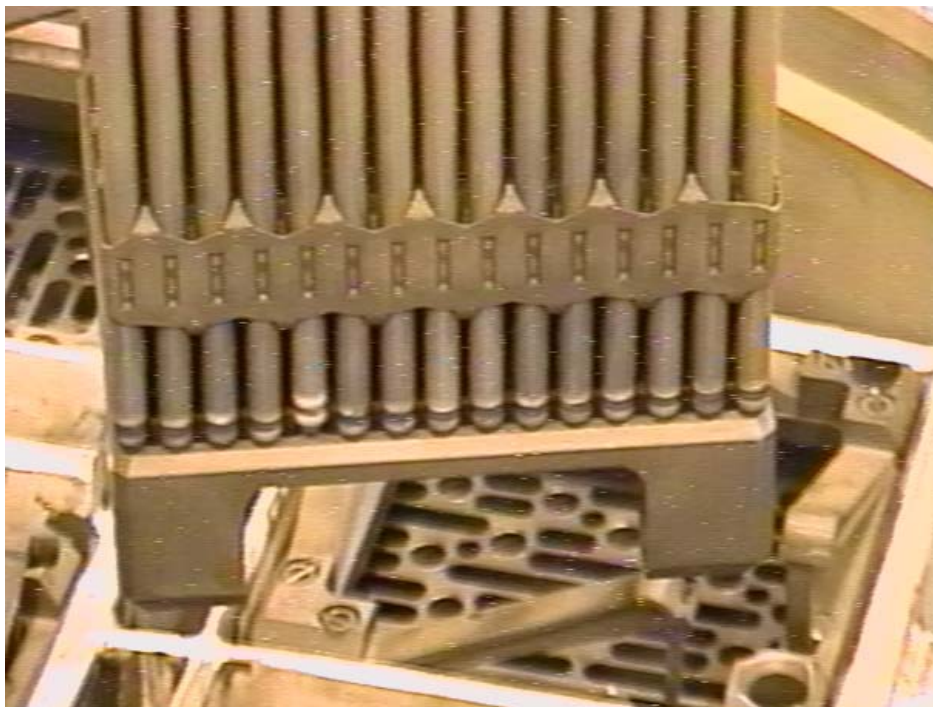
Figure 67. Fuel assembly V-04—bottom—rod having greatest indication of oxide appears to be slightly above the nozzle plate—no conclusion made.

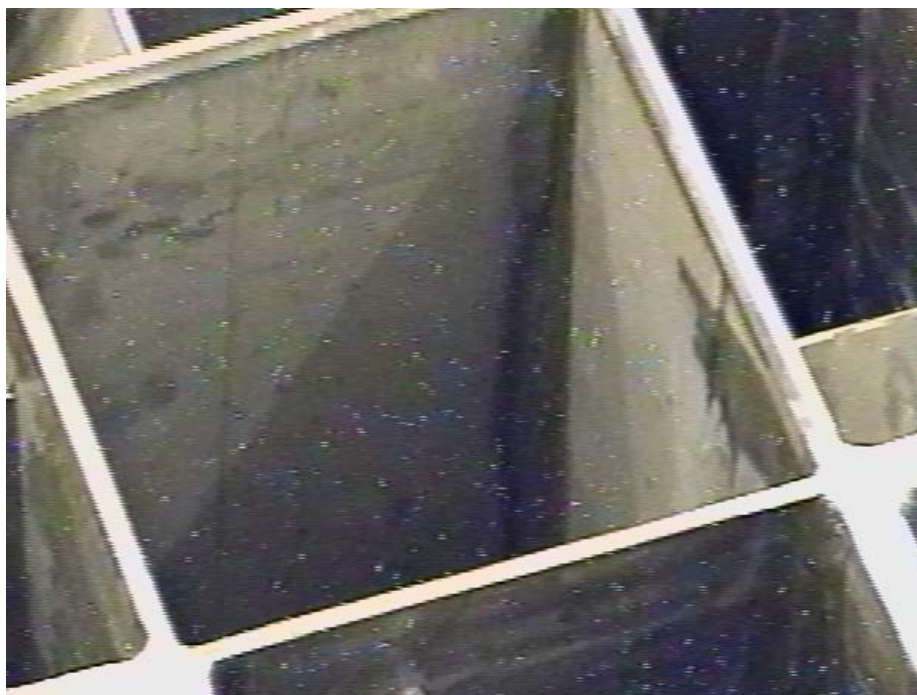
Figure D-1. Fuel Tube A-1 top-appears clean. Typical appearance and cleanliness of all fuel tubes.

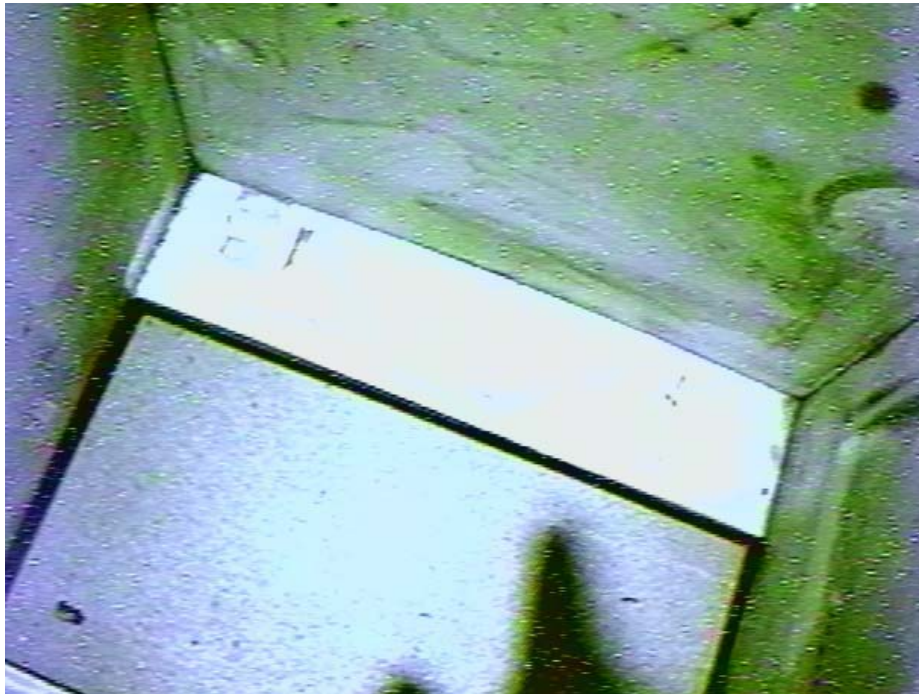
Figure D-6. Fuel tube A-3 bottom – Surfaces clean and bright.

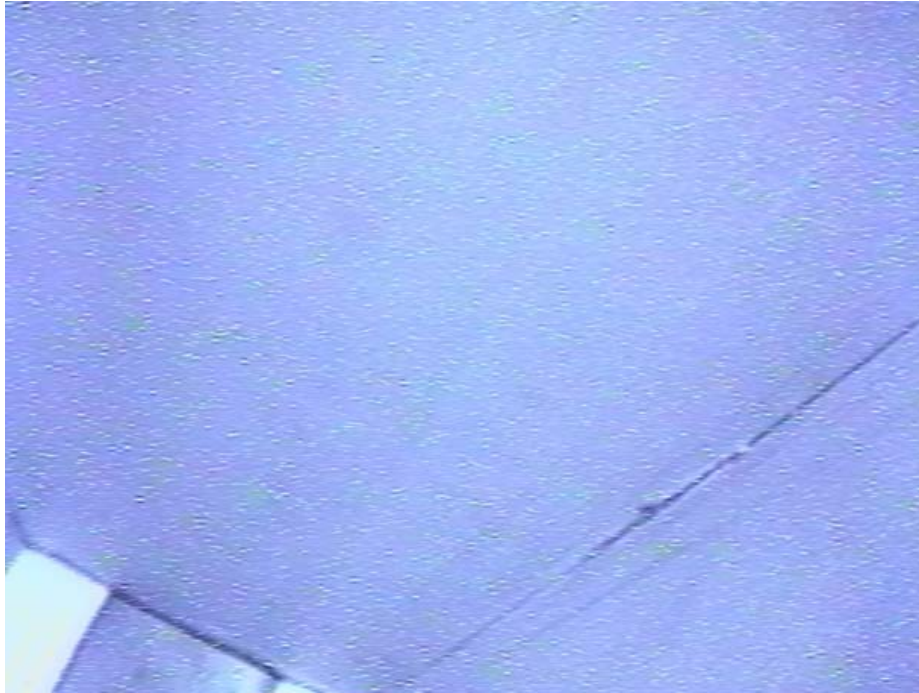
Figure D-17. Fuel tube C-6 – Appeared quite clean.

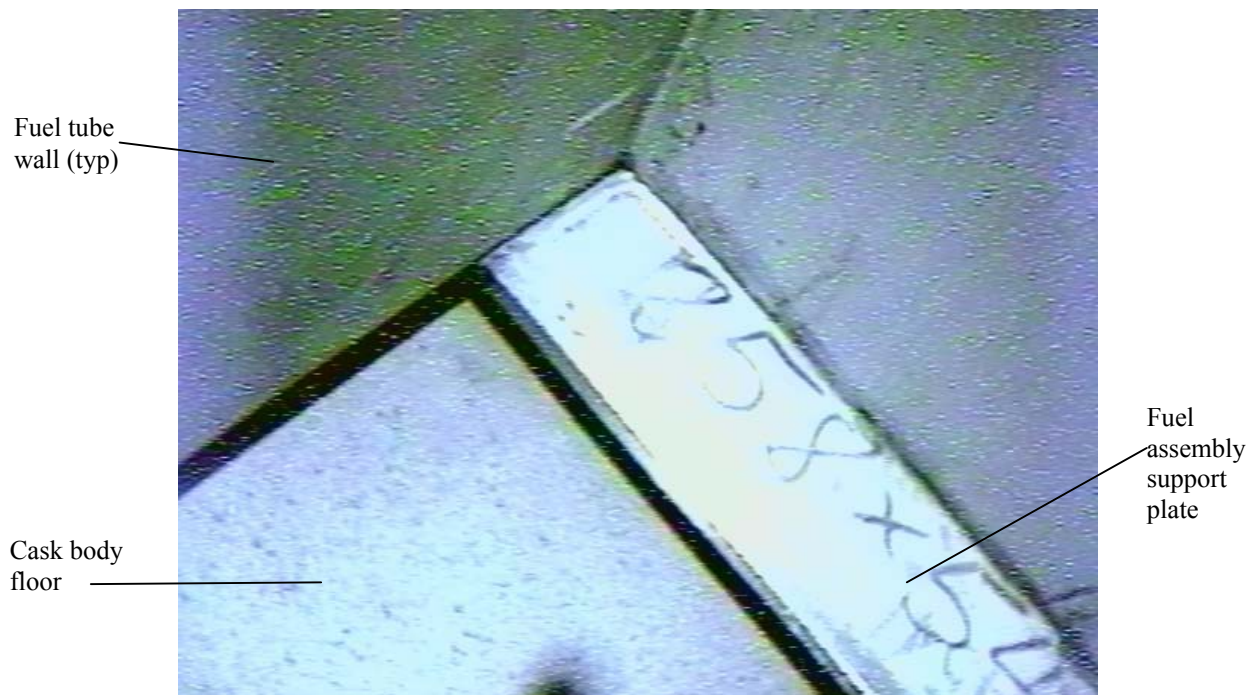
Figure D-20. Fuel tube C-5 reflective surfaces and existence of original fabrication/layout characters.

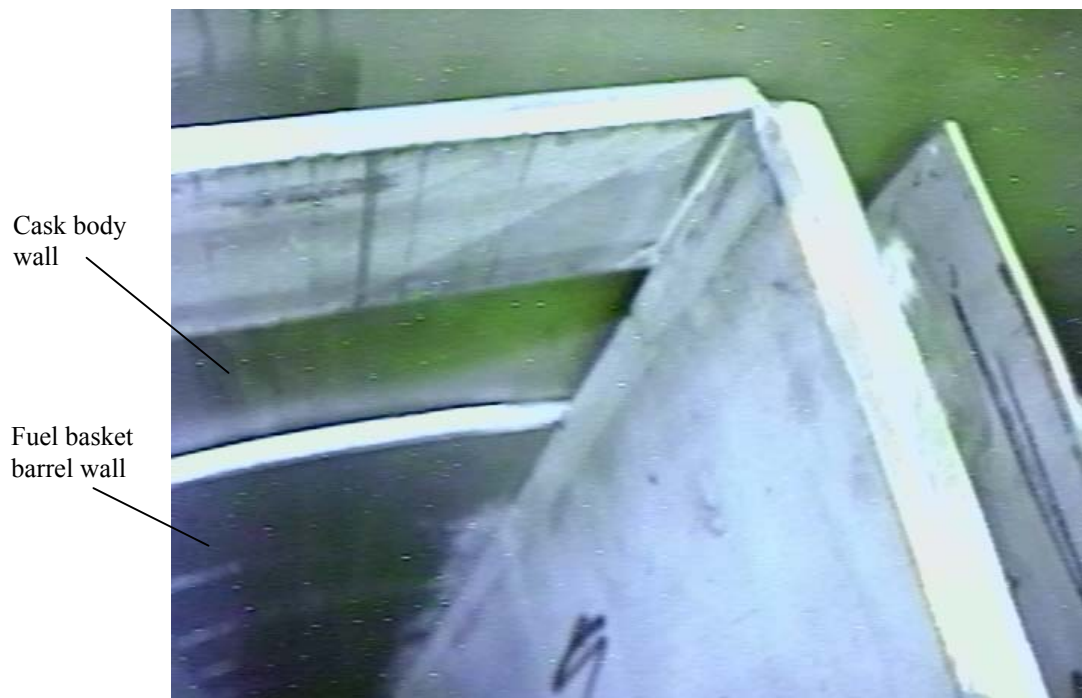
Figure D-22. Fuel tube B-7 – near top – showing side plates and basket wall.

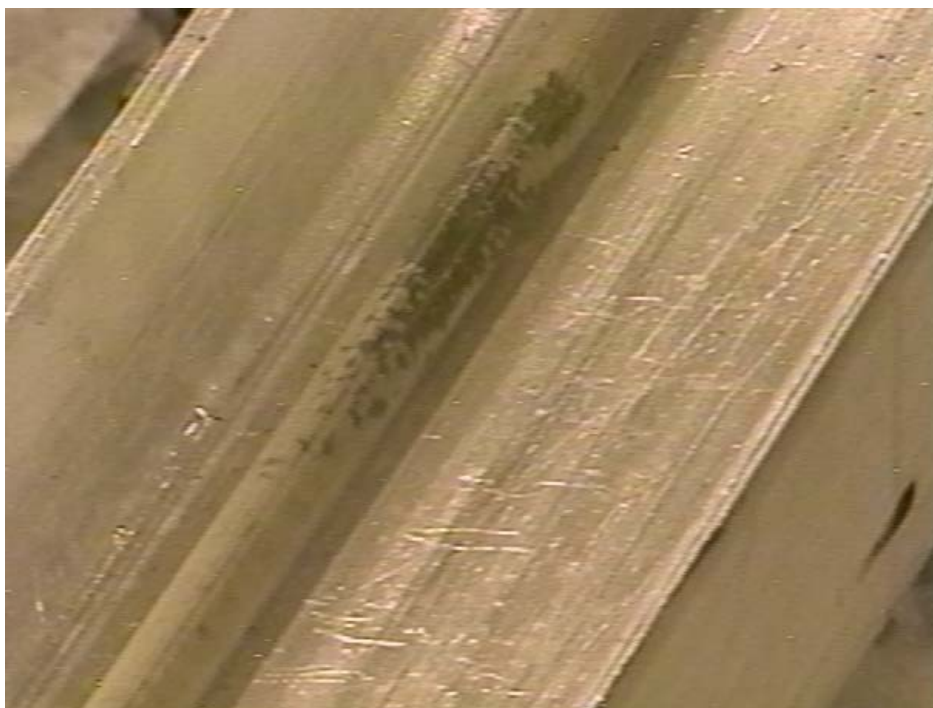
Figure E-6. Oxide mottling on fuel rod.

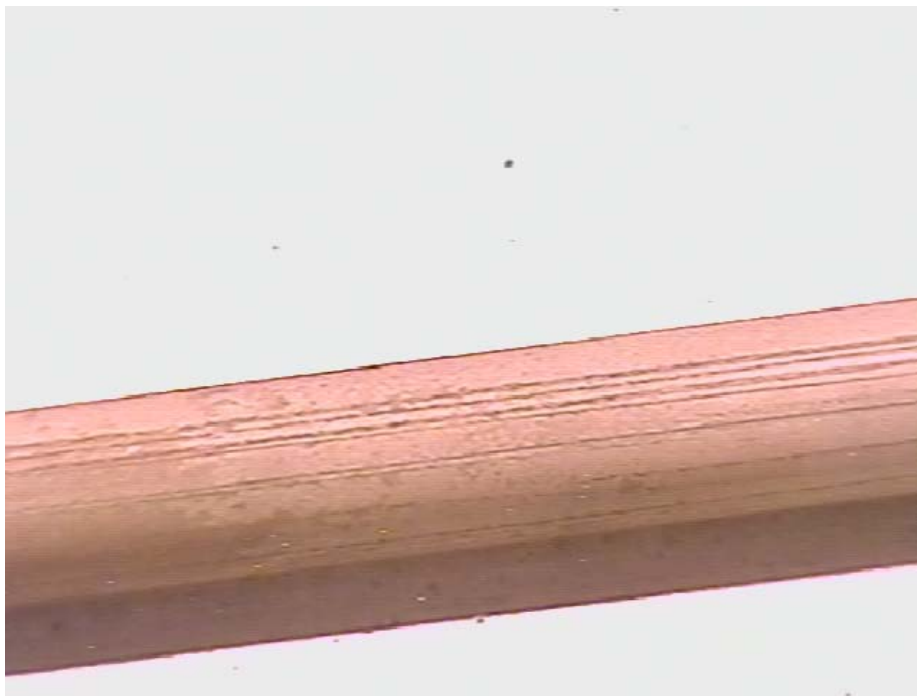
Figure E-9. Fuel rod-linear scratches believed from moving rod through spacer grid plates.

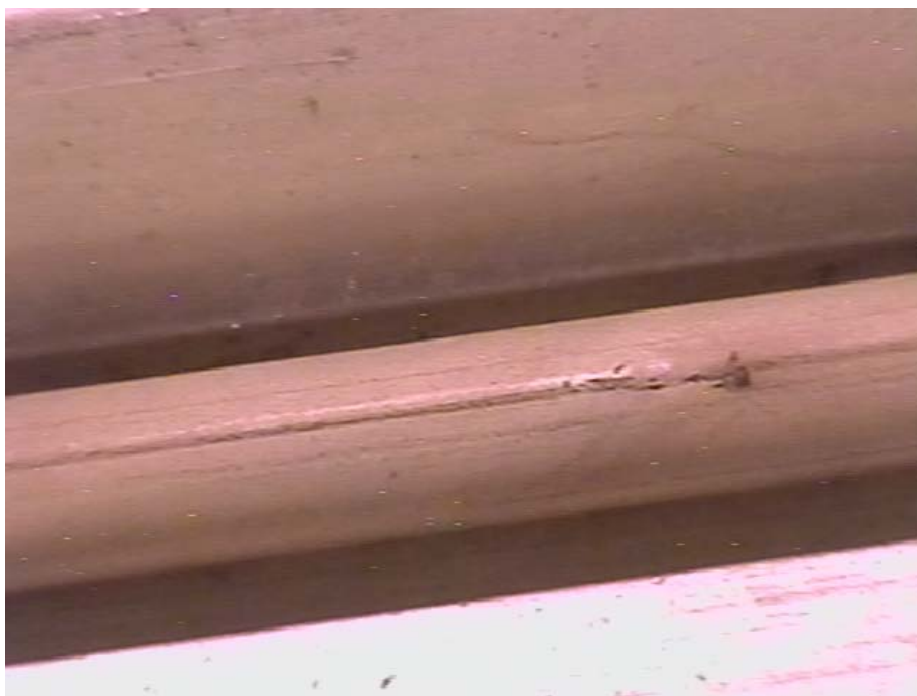
Figure E-10. Fuel rod with linear scratch.

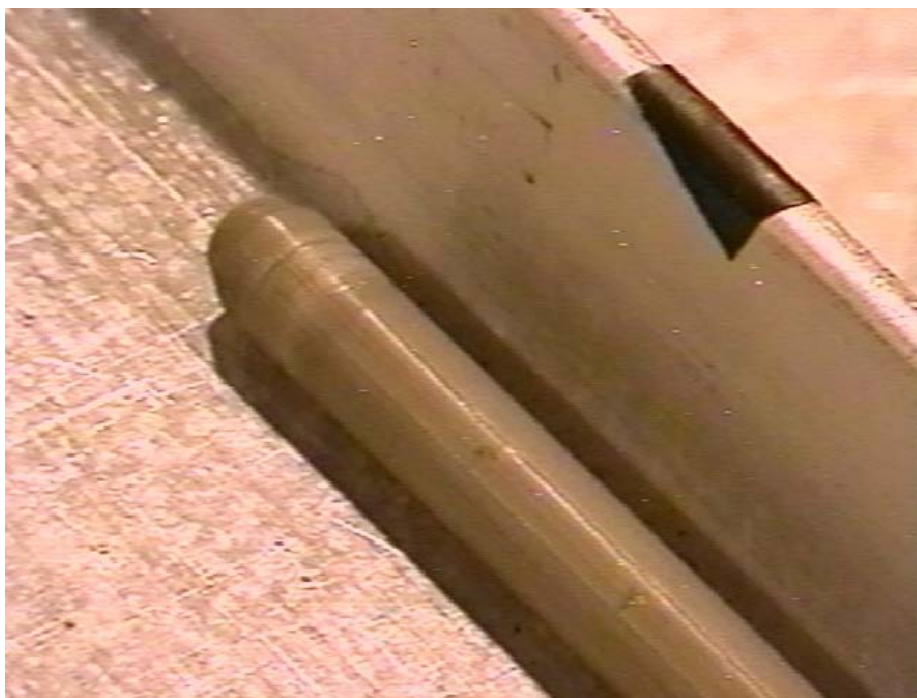
Figure E-11. Fuel rod with linear scratch.

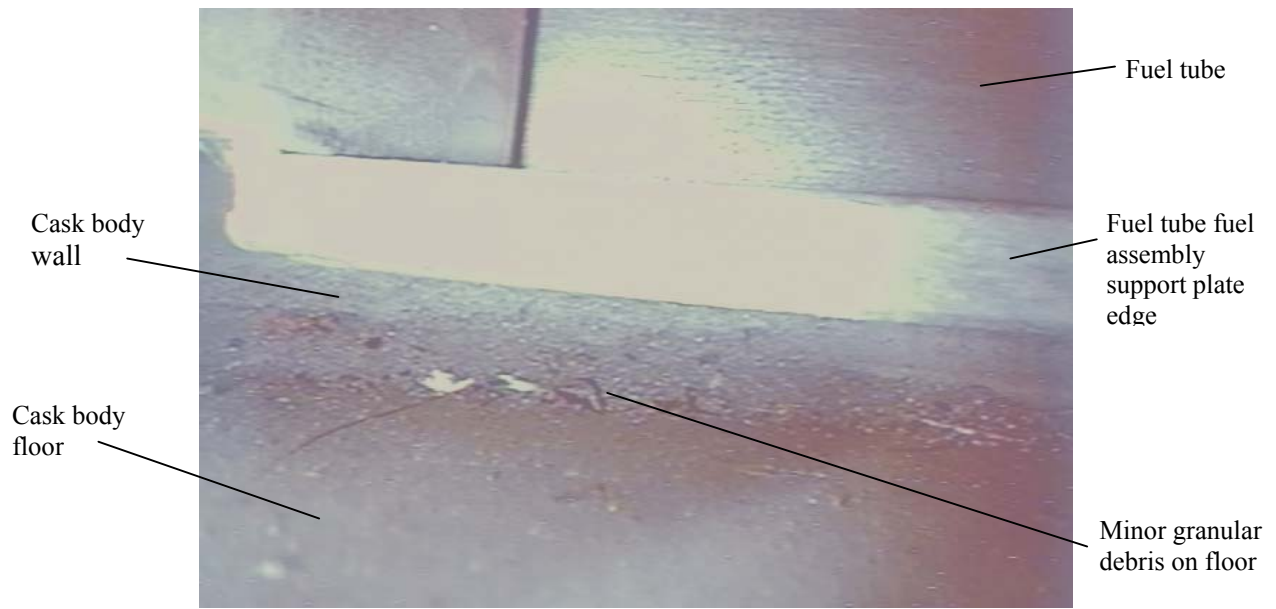
Figure F-3. Cask floor and wall below fuel tube B7.

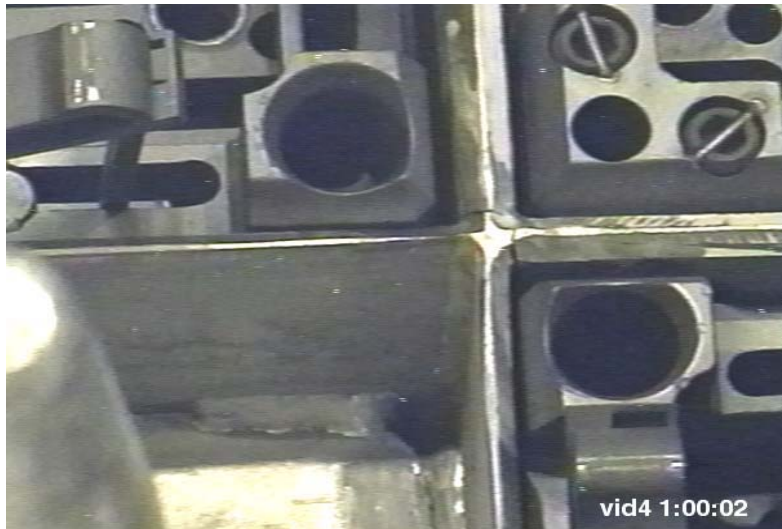
Figure G-1. Existing 1985 weld crack at location No. 1 identified in Figure G-9.

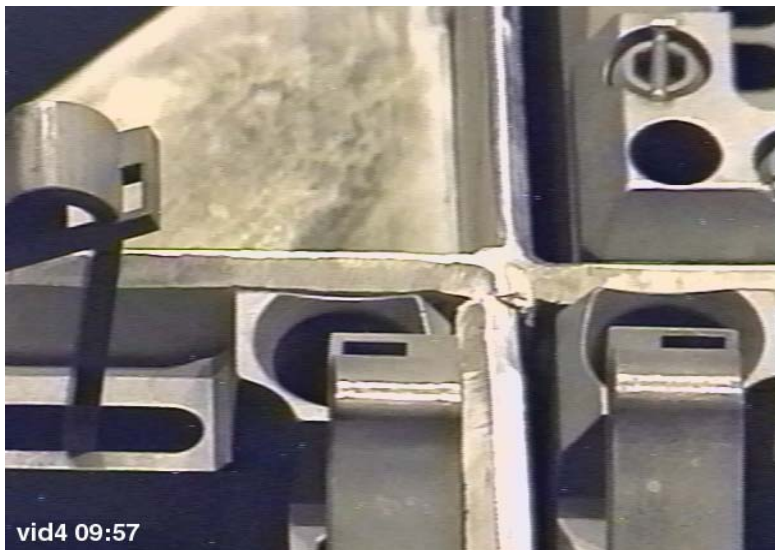
Figure G-2. Existing 1985 weld crack at location No. 2 identified in Figure G-9.

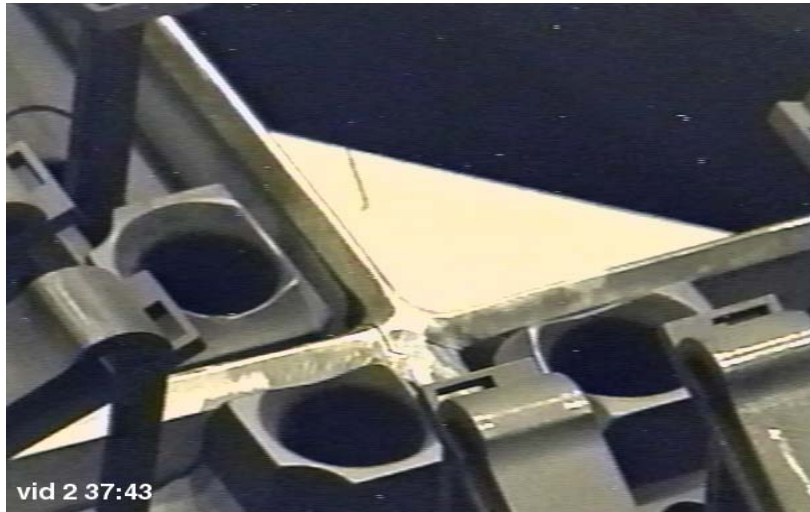
Figure G-3. Existing 1985 weld crack at location No. 3 identified in Figure G-9.

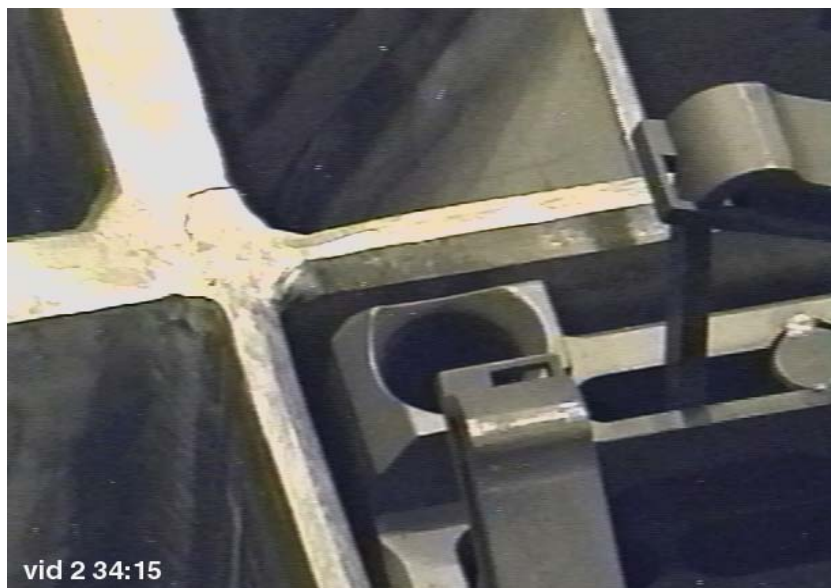
Figure G-5. Existing 1985 weld crack at location No. 5 identified in Figure G-9.

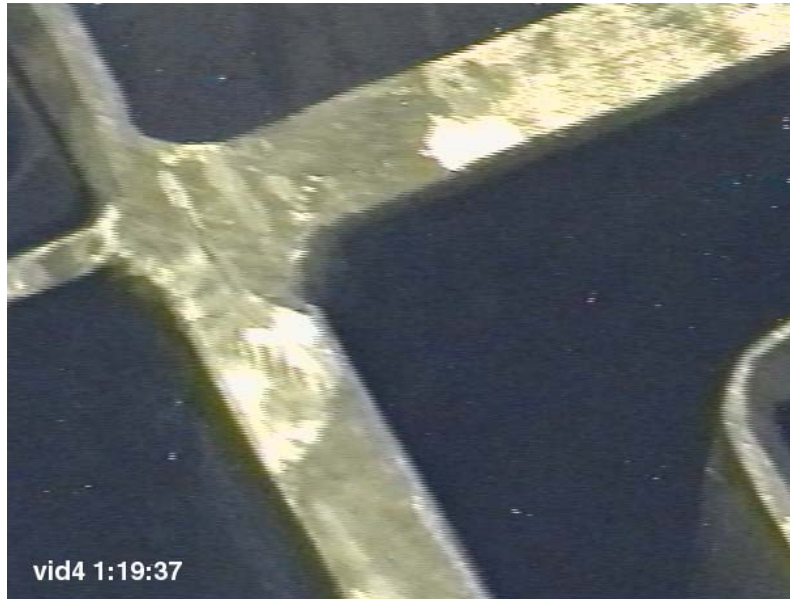
Figure G-7. Existing 1985 weld crack at location No. 7 identified in Figure G-9.

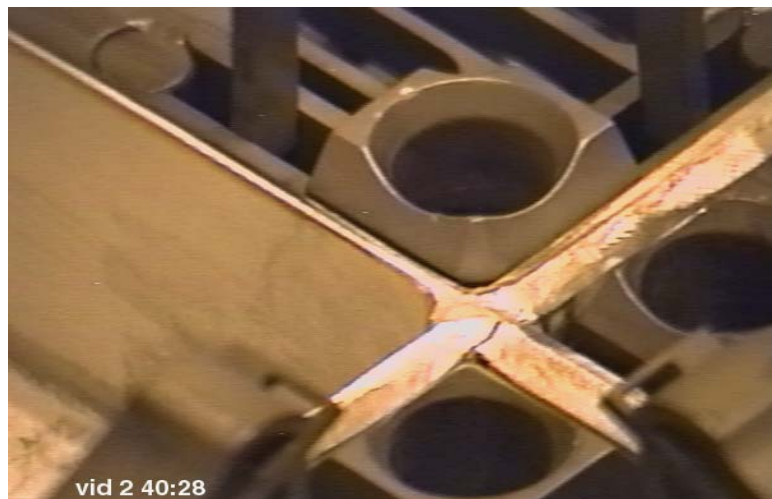
Figure G-8. Existing 1985 weld crack at location No. 8 identified in Figure G-9.
